Subject: Field Notes on New Orleans

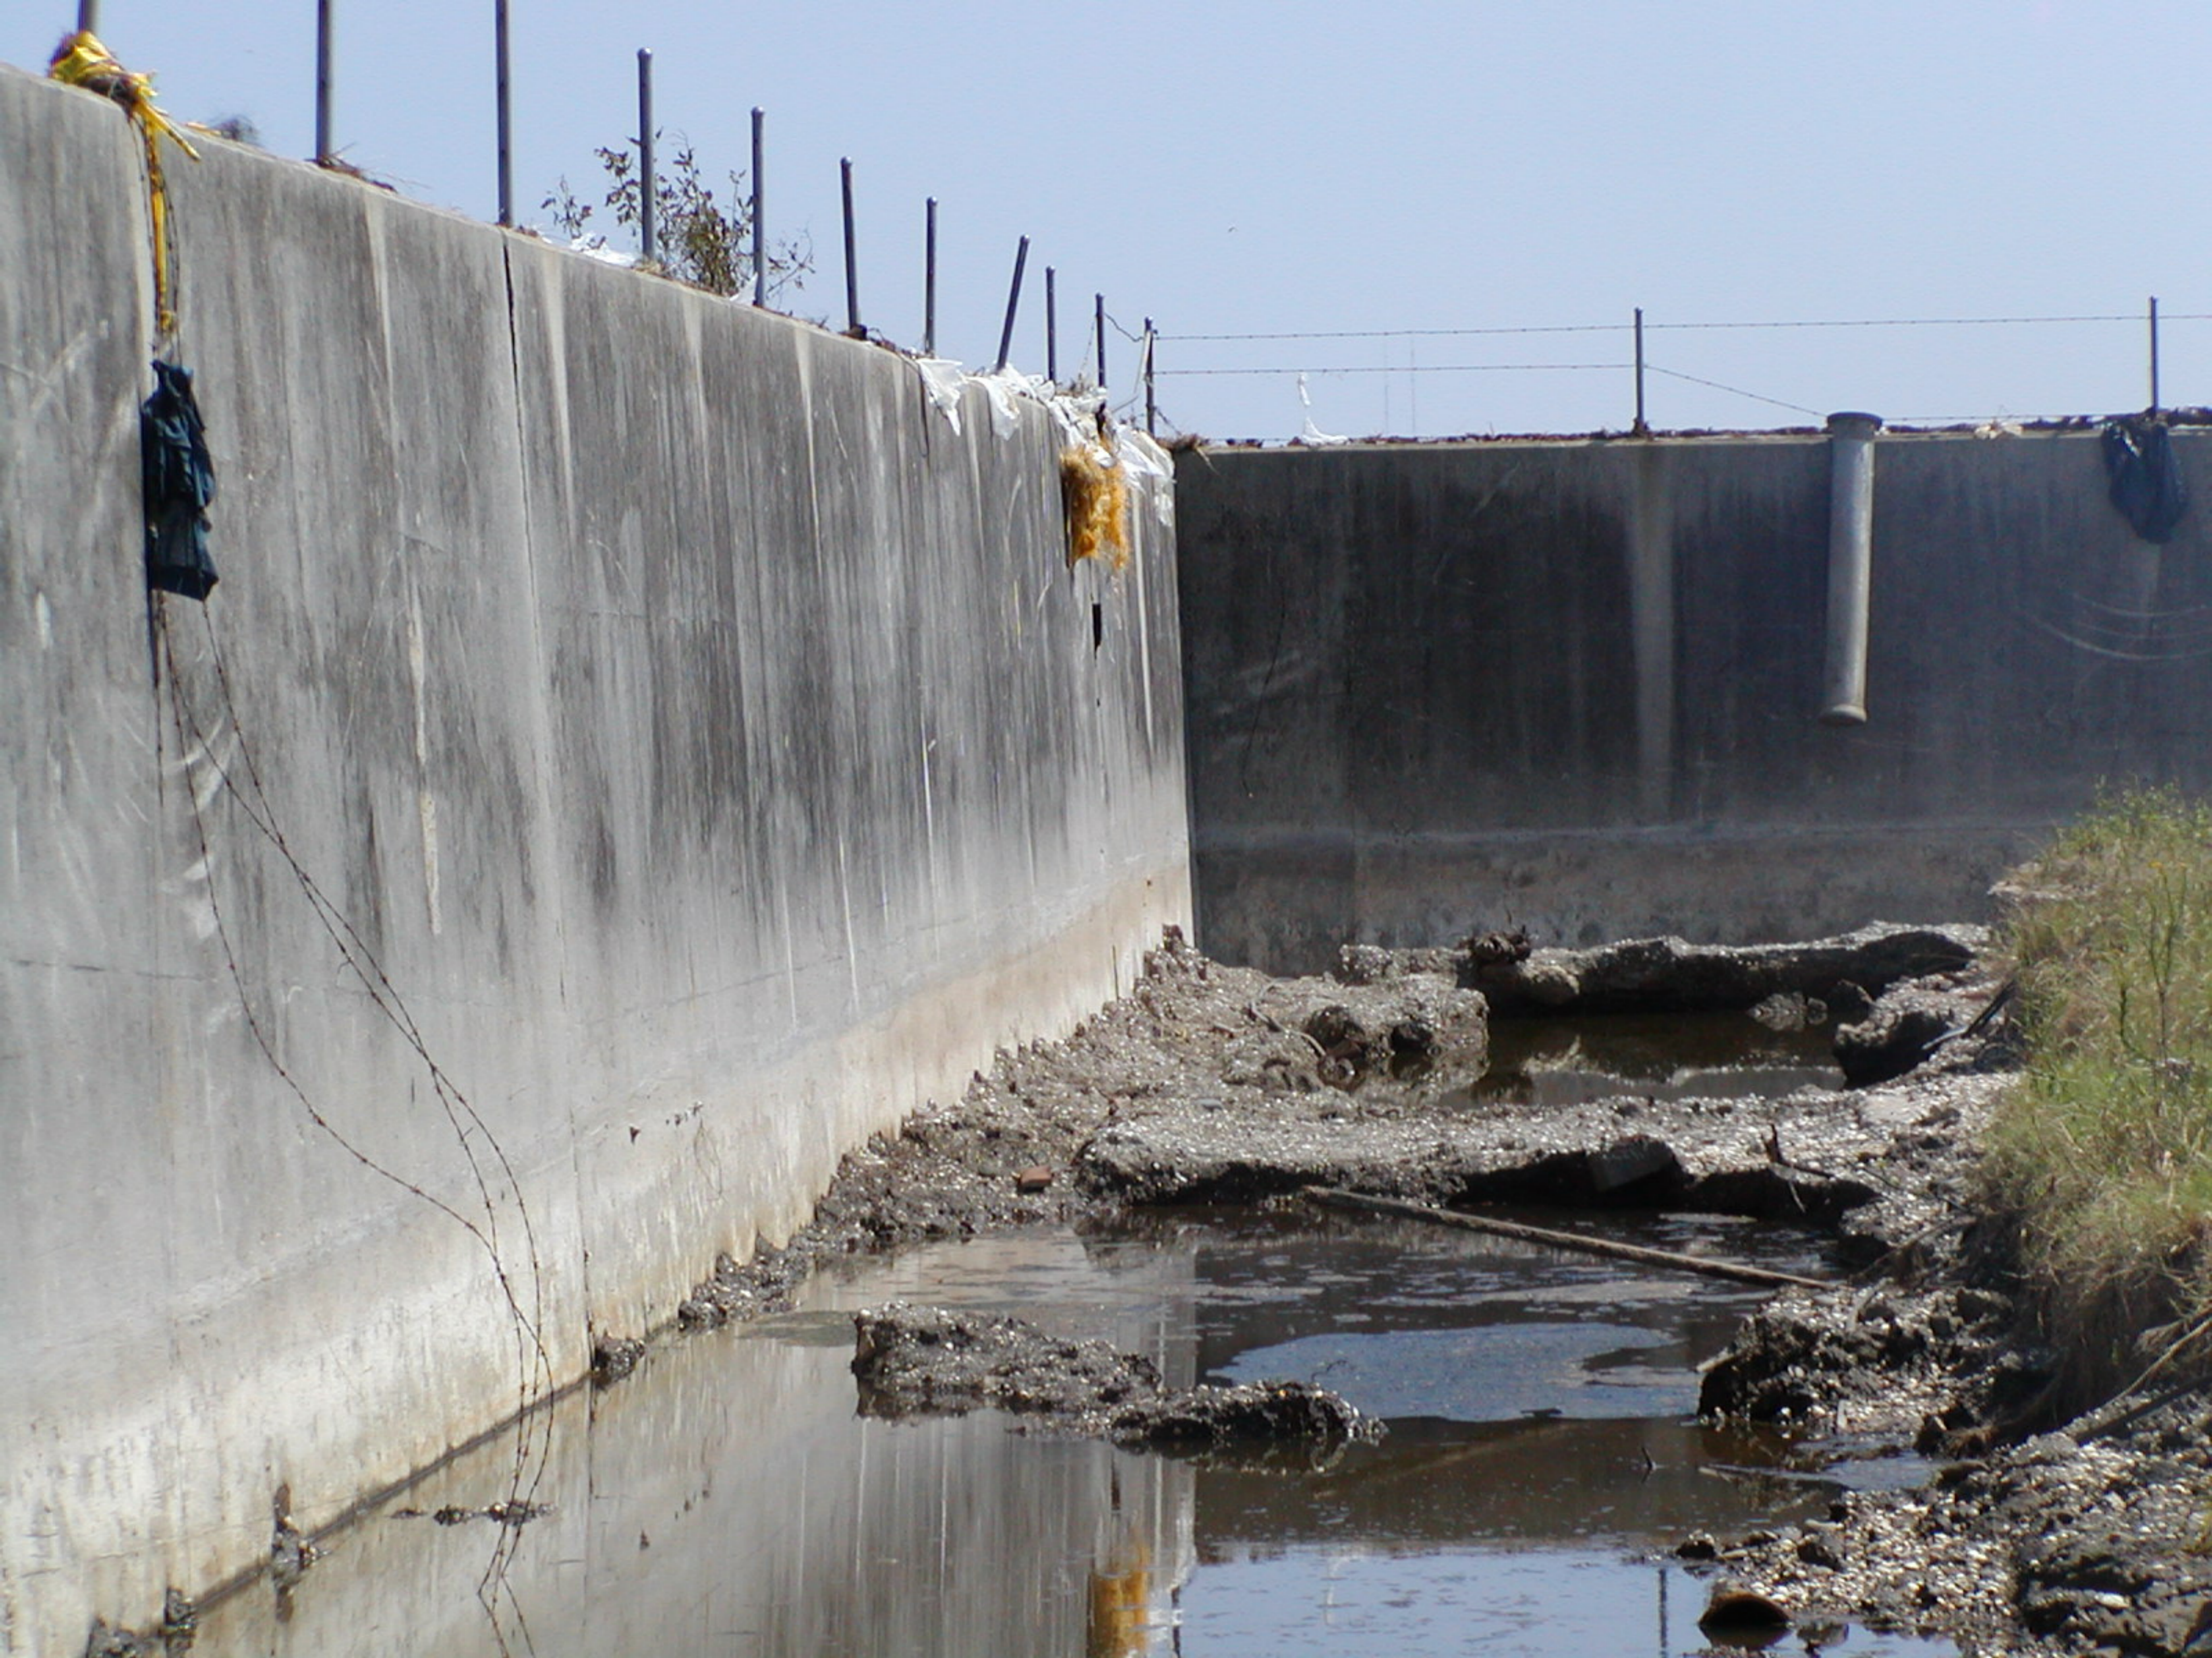
- j. Picture 9270012- Looking at scour behind floodwall from ground level at area just north of Claiborne Bridge on west side of IHNC. Same area as pictures 9270007 & 8.

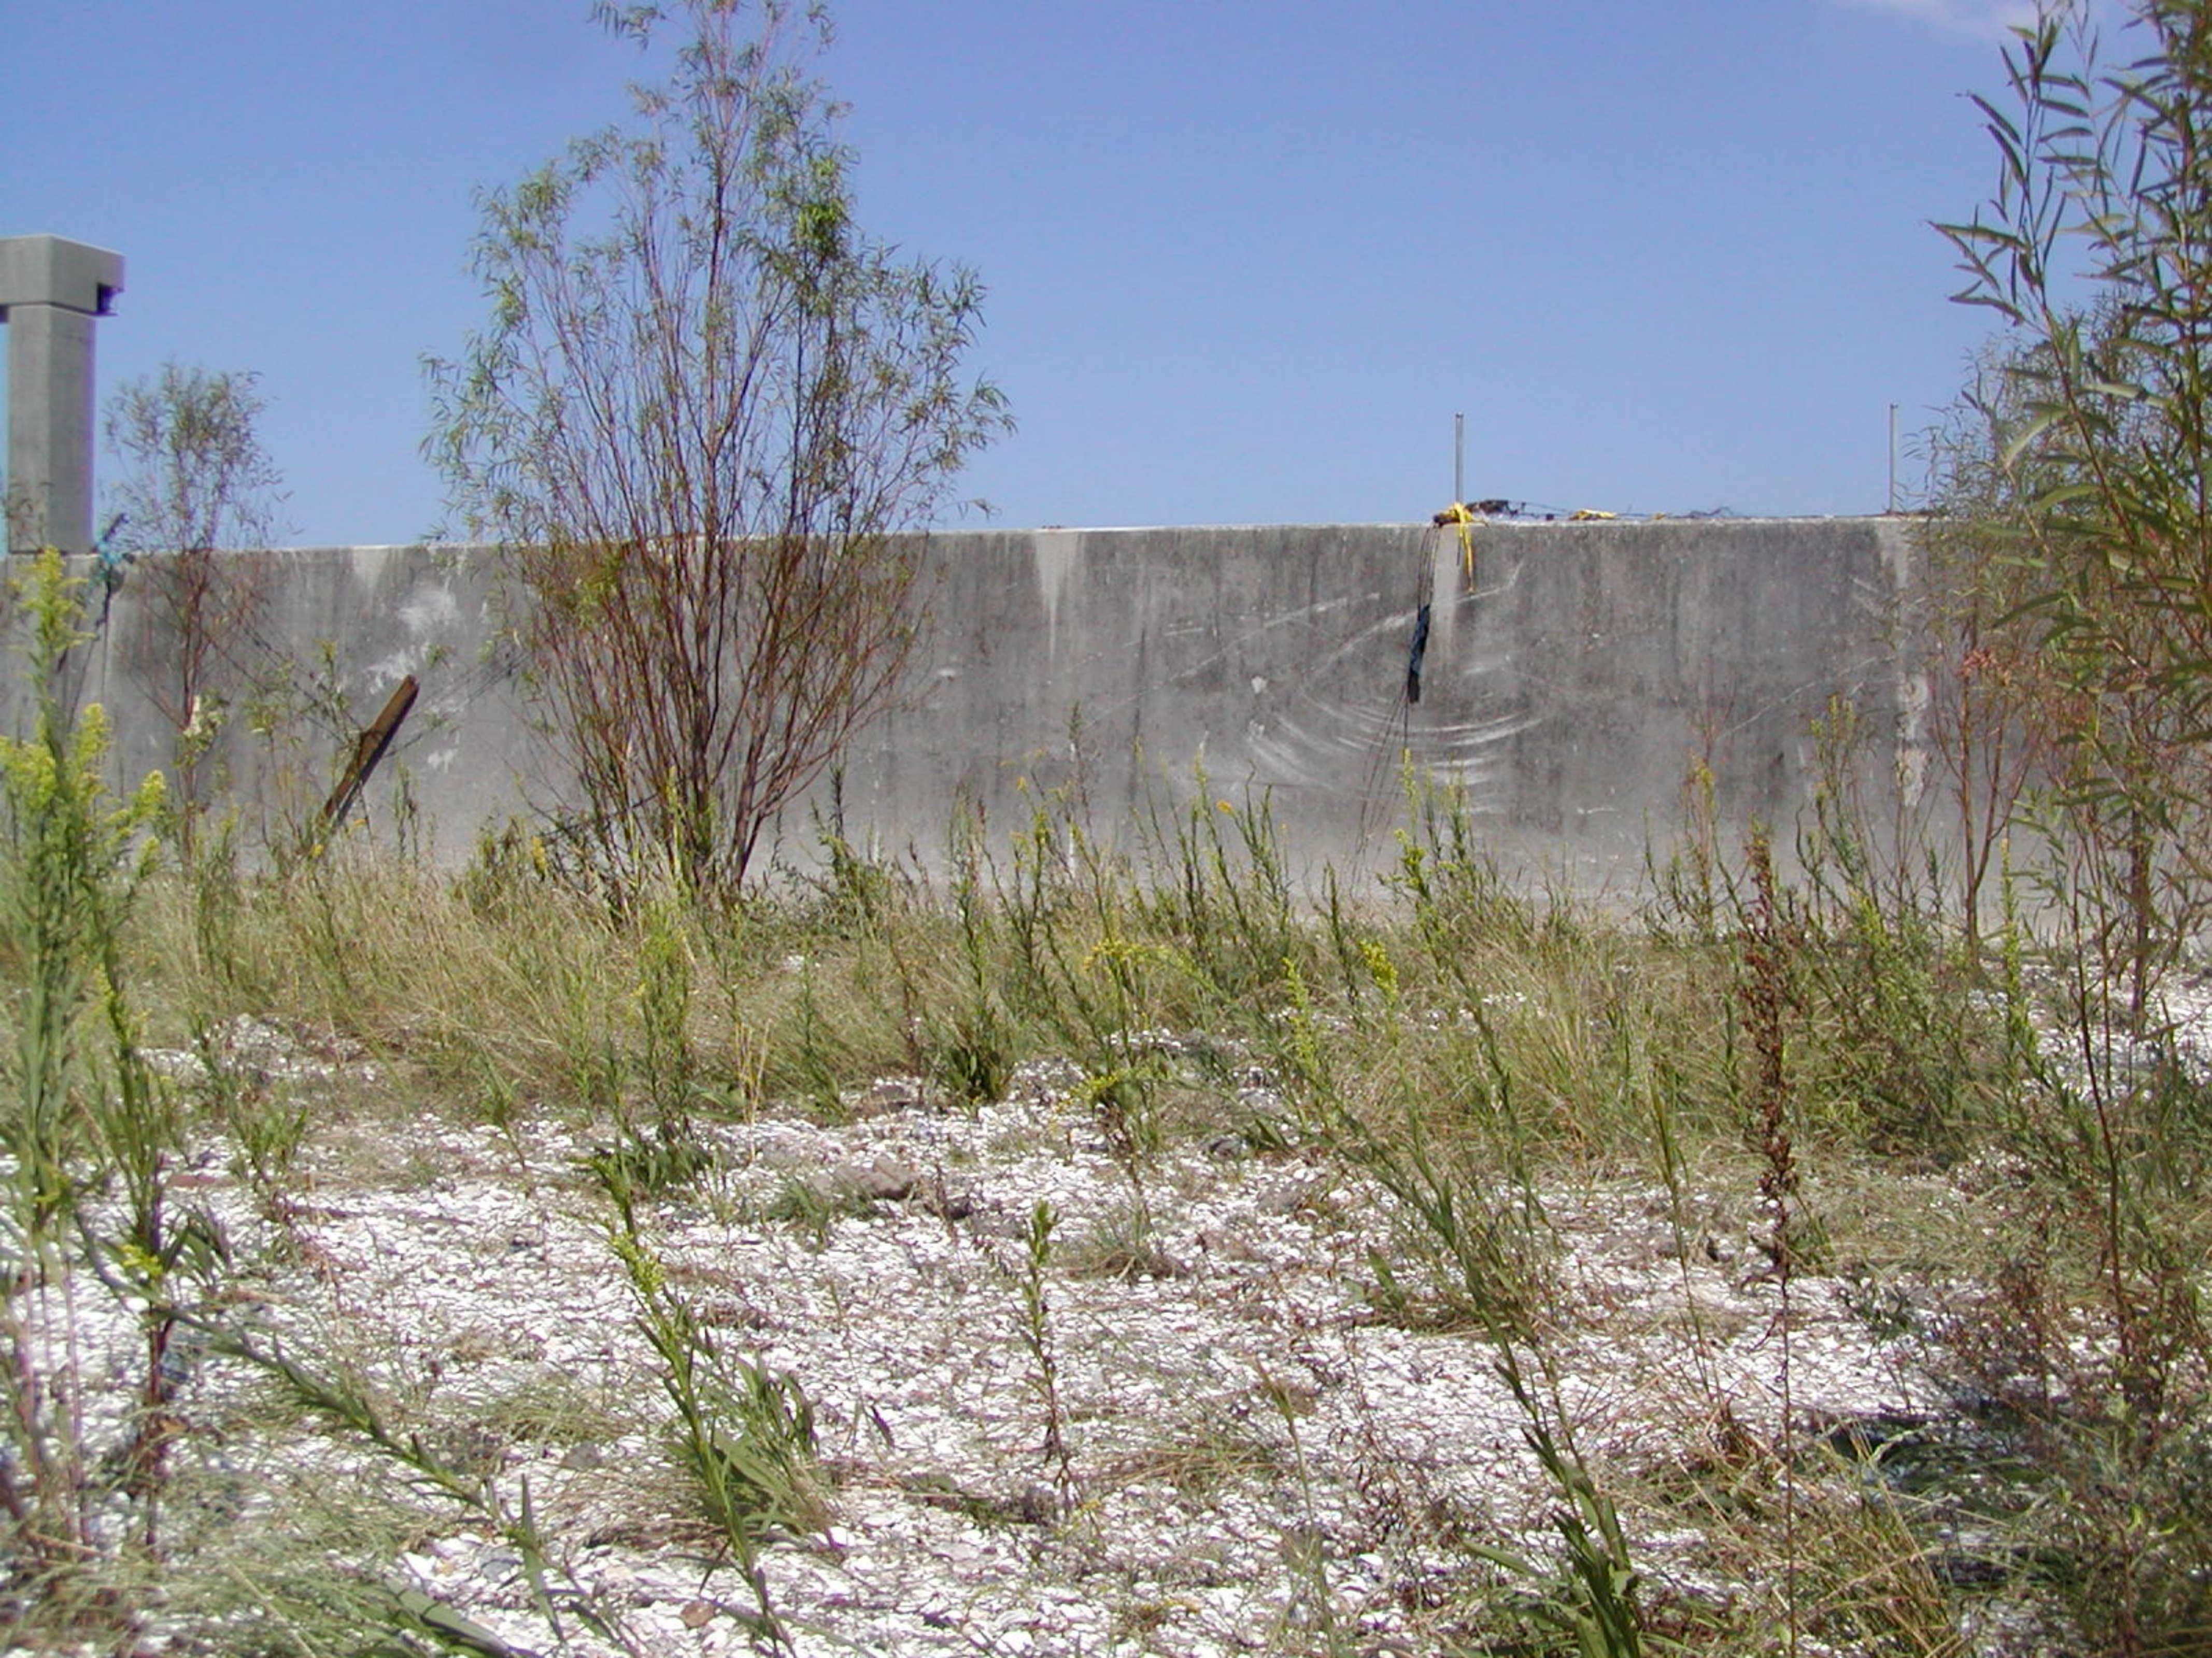
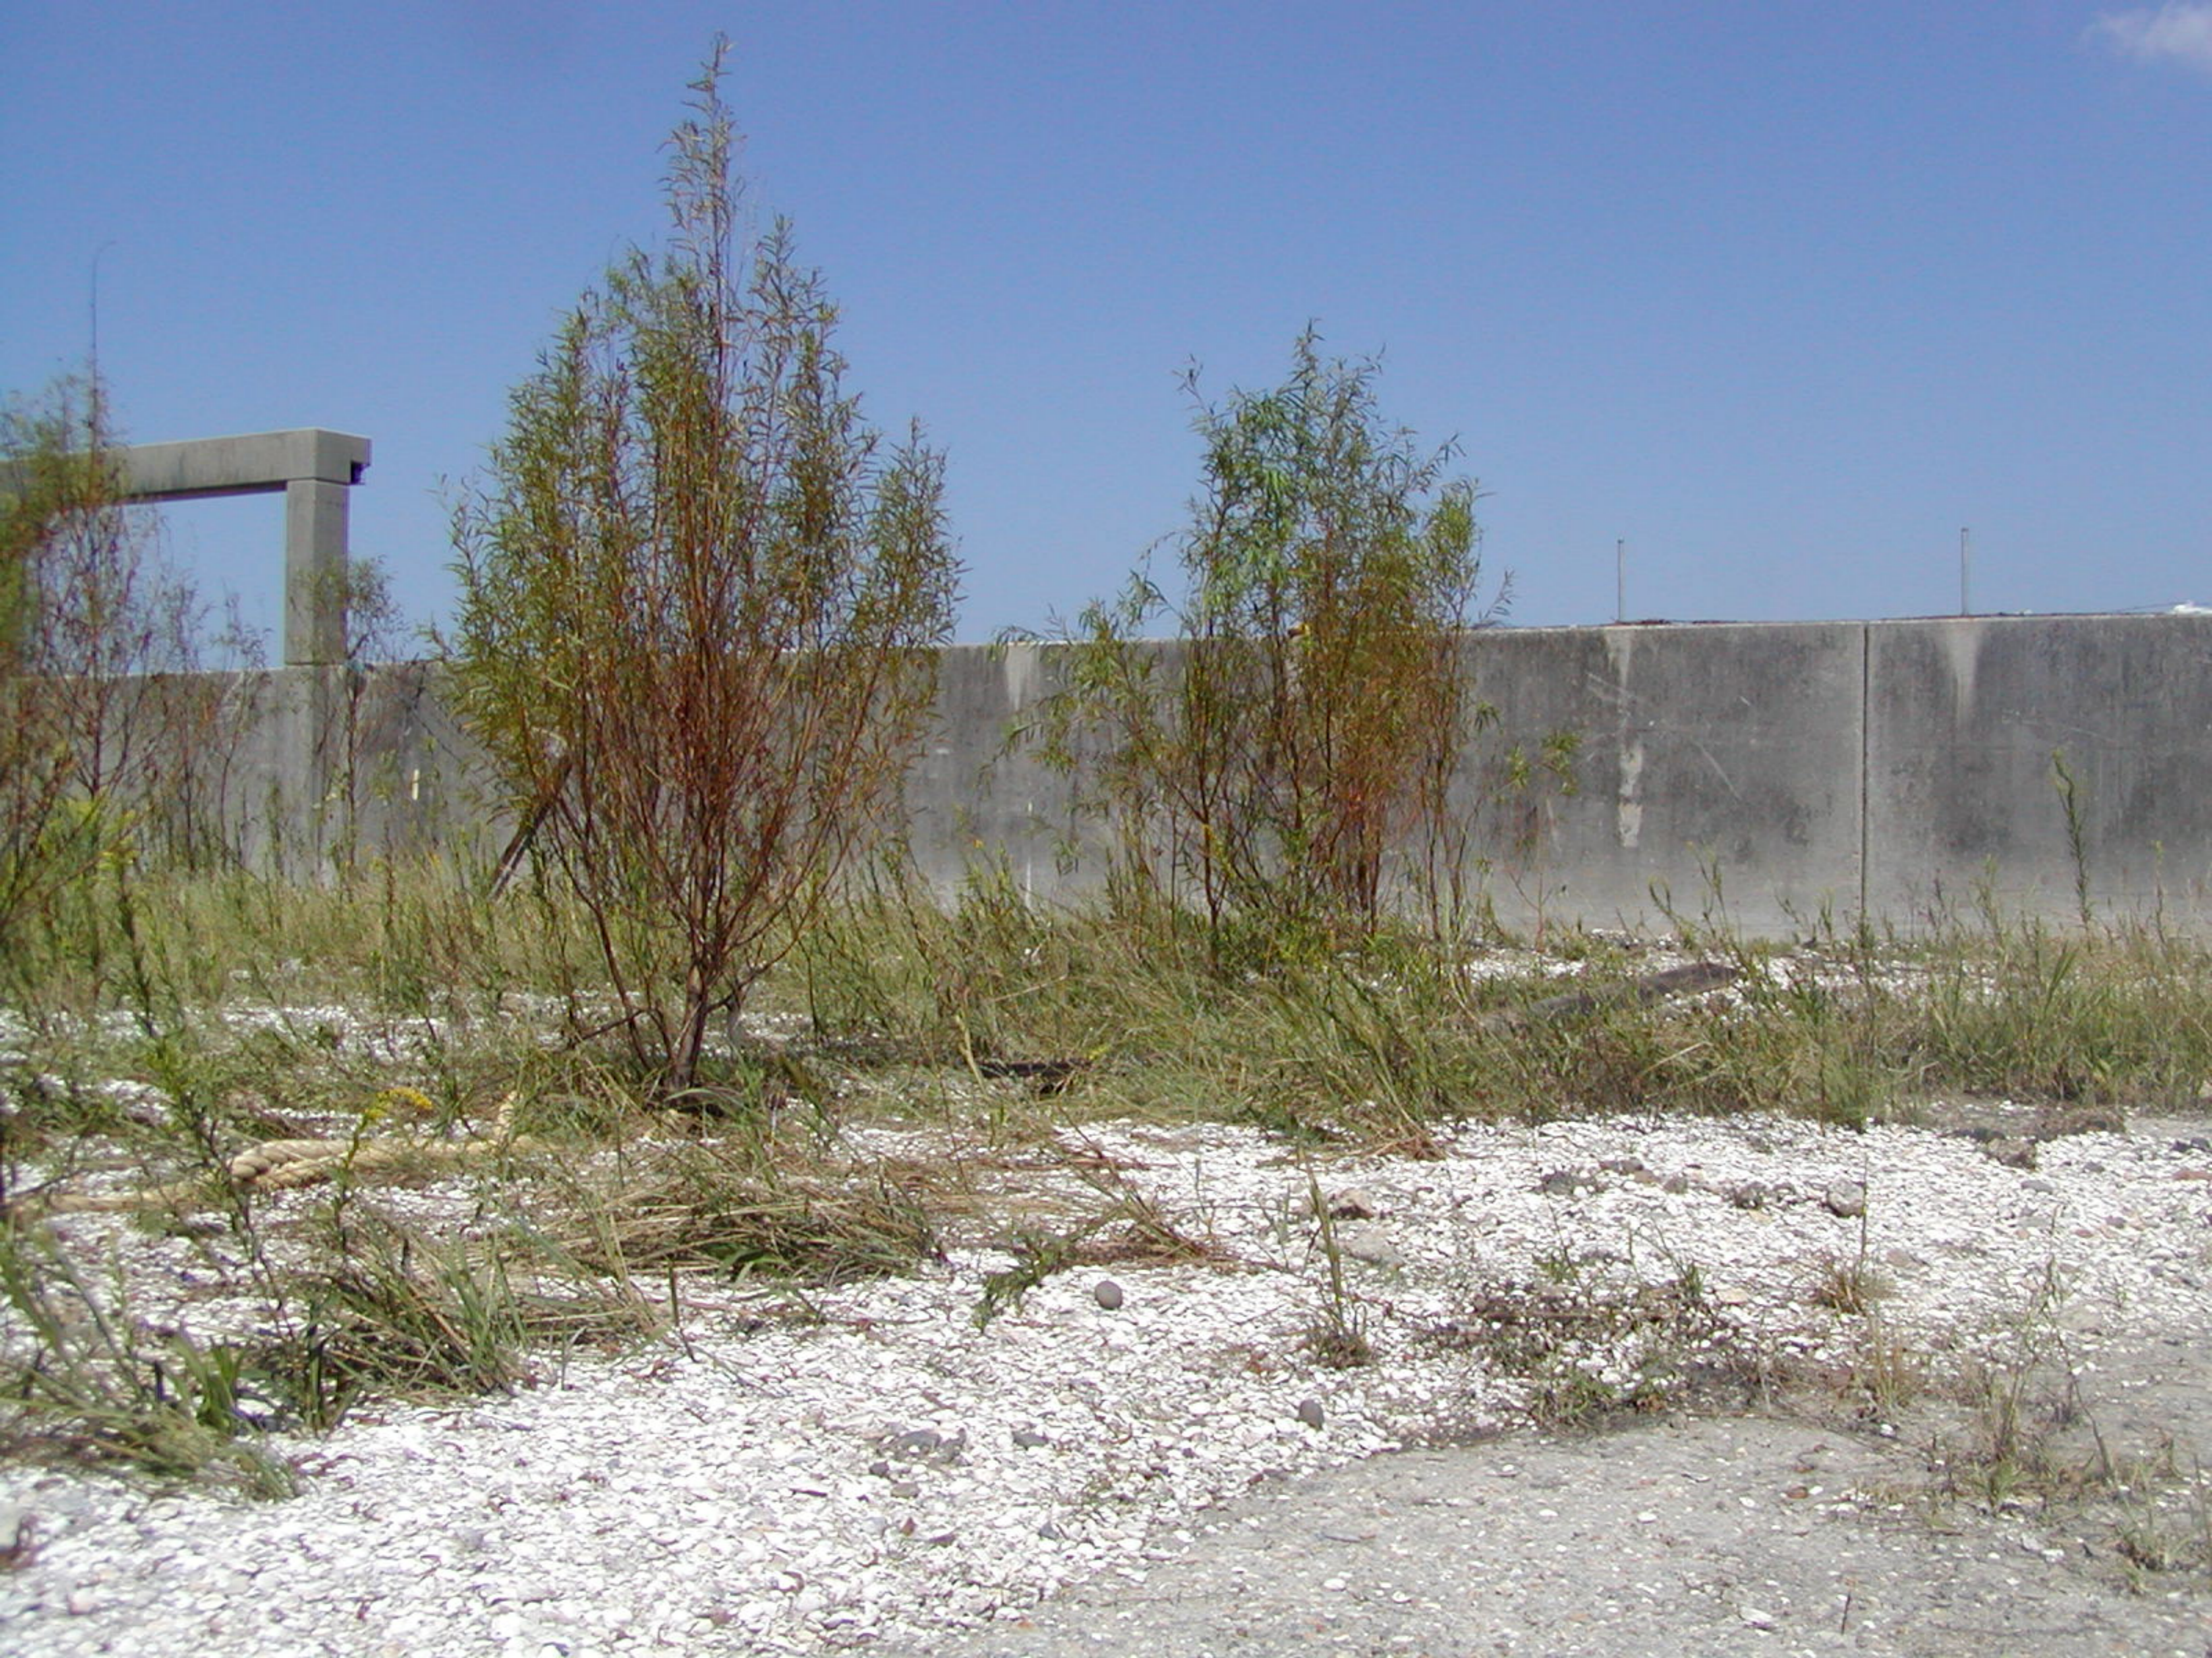
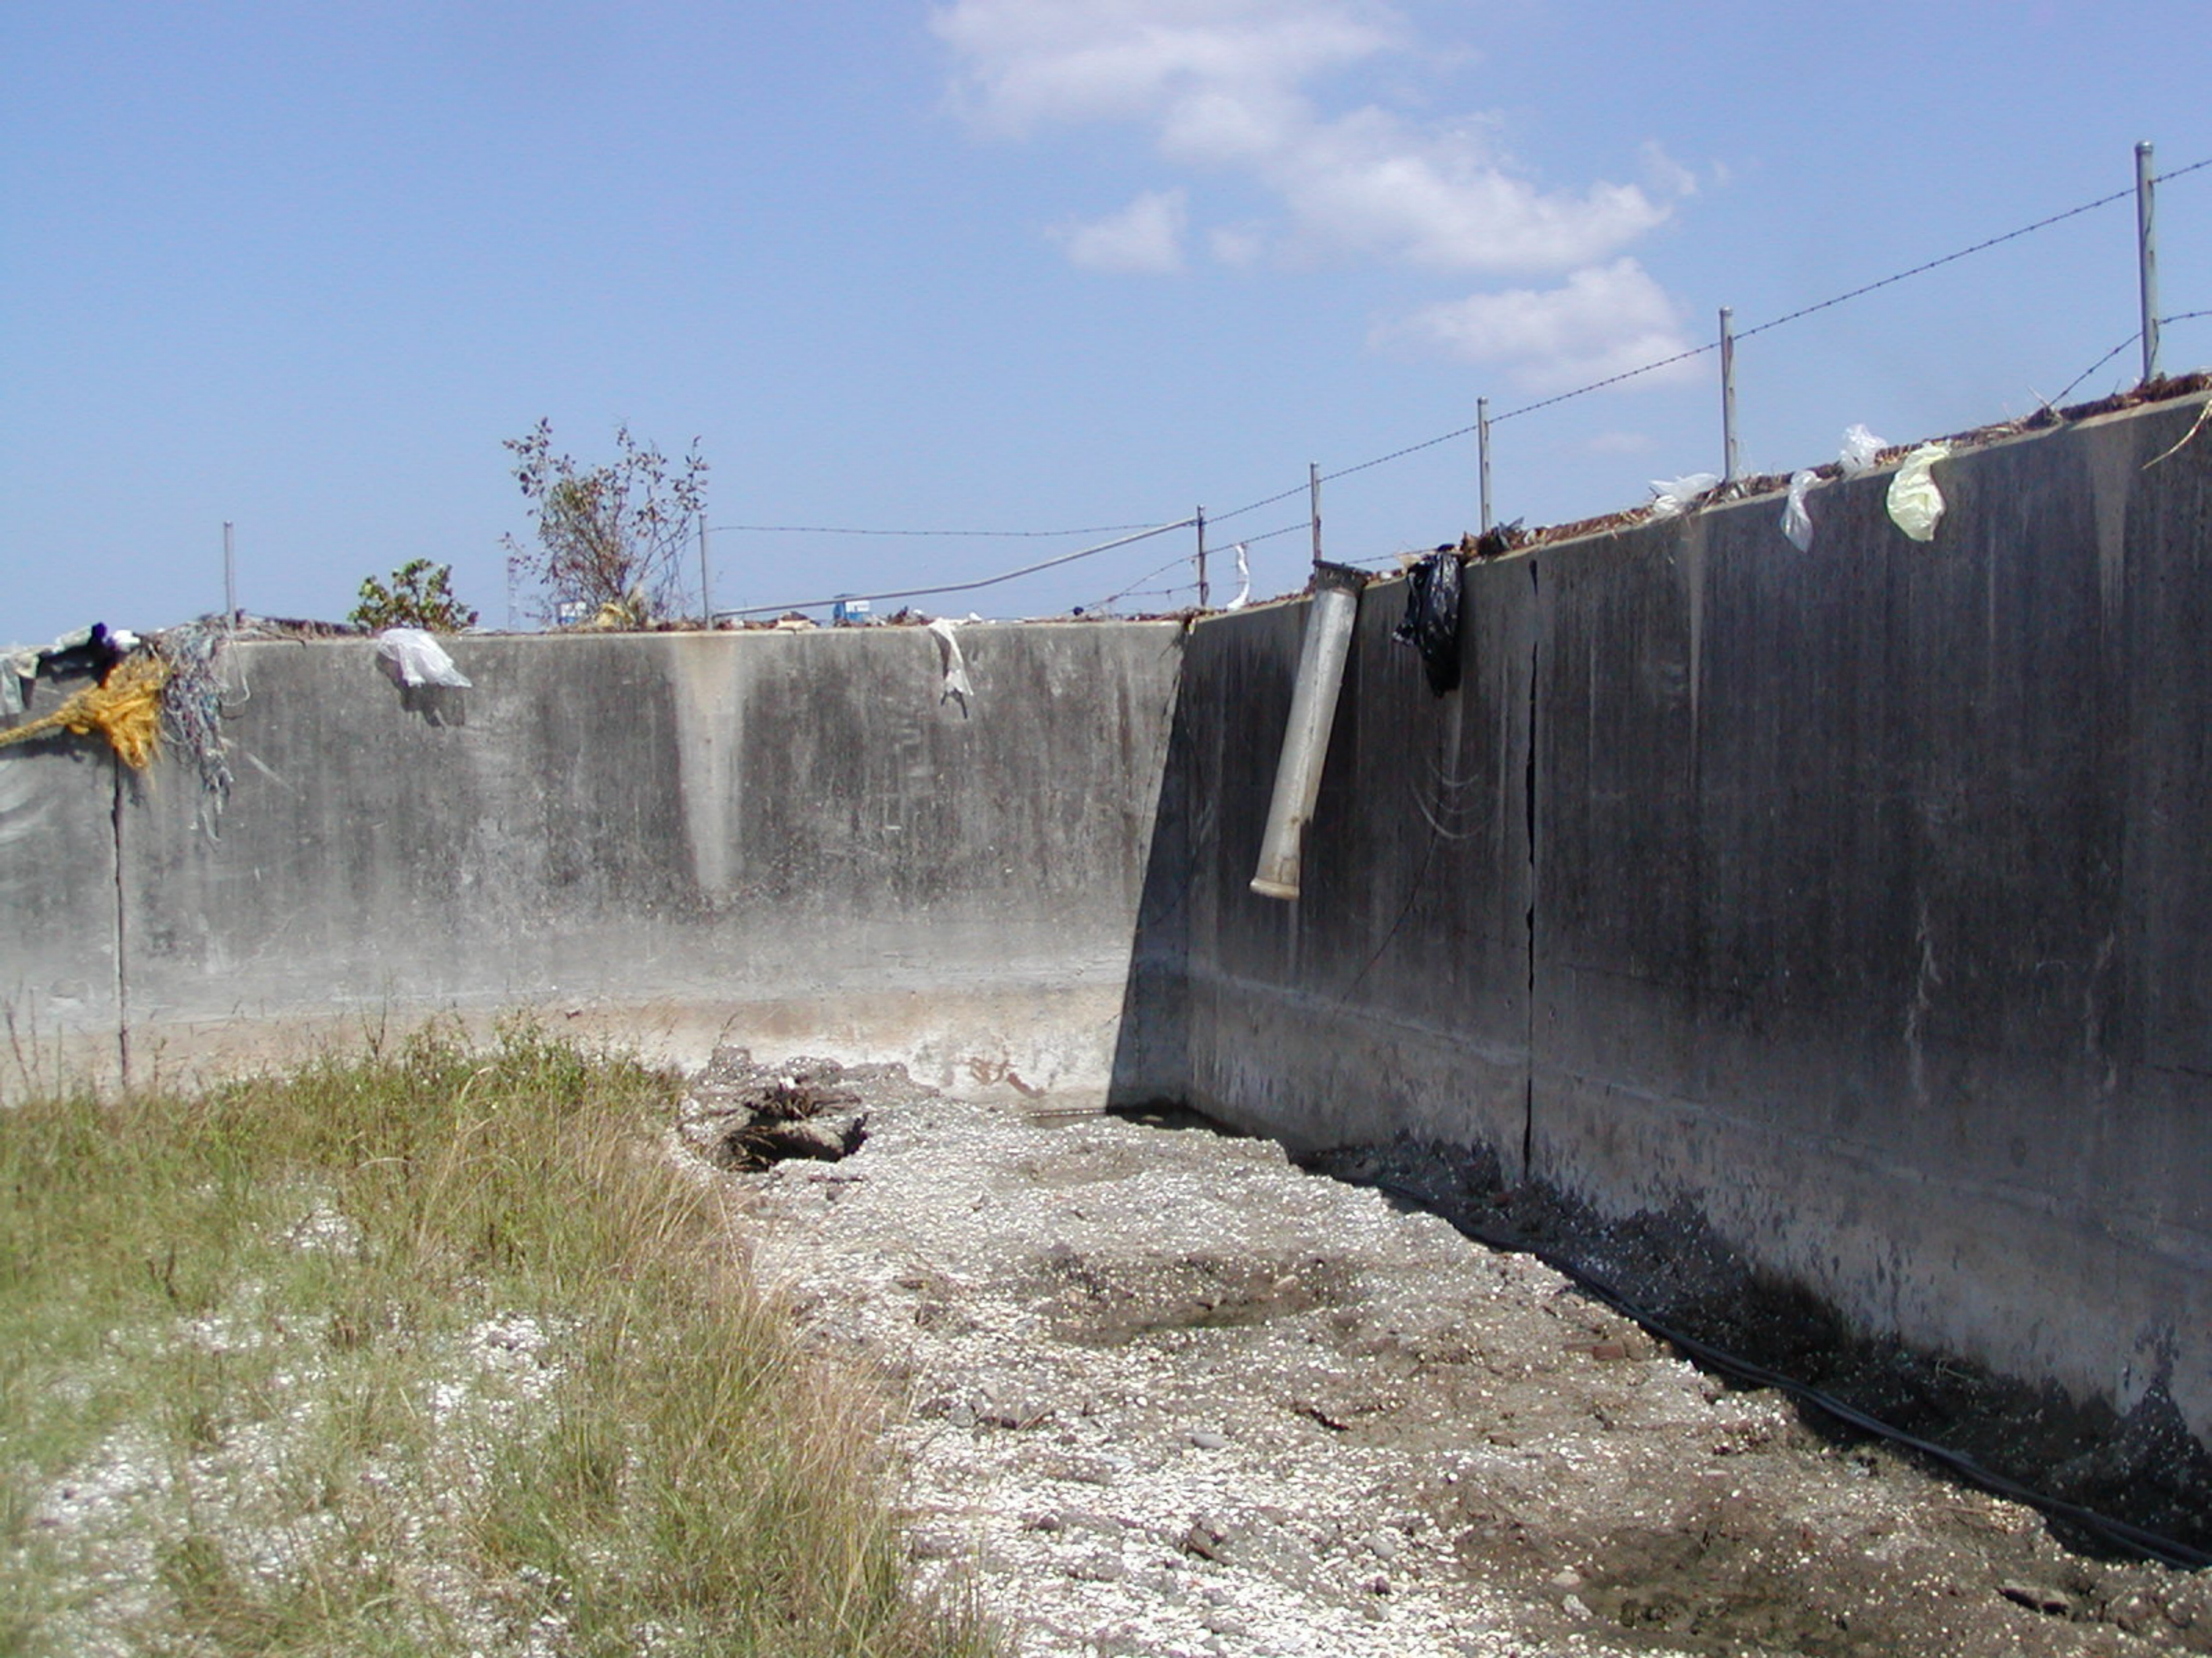
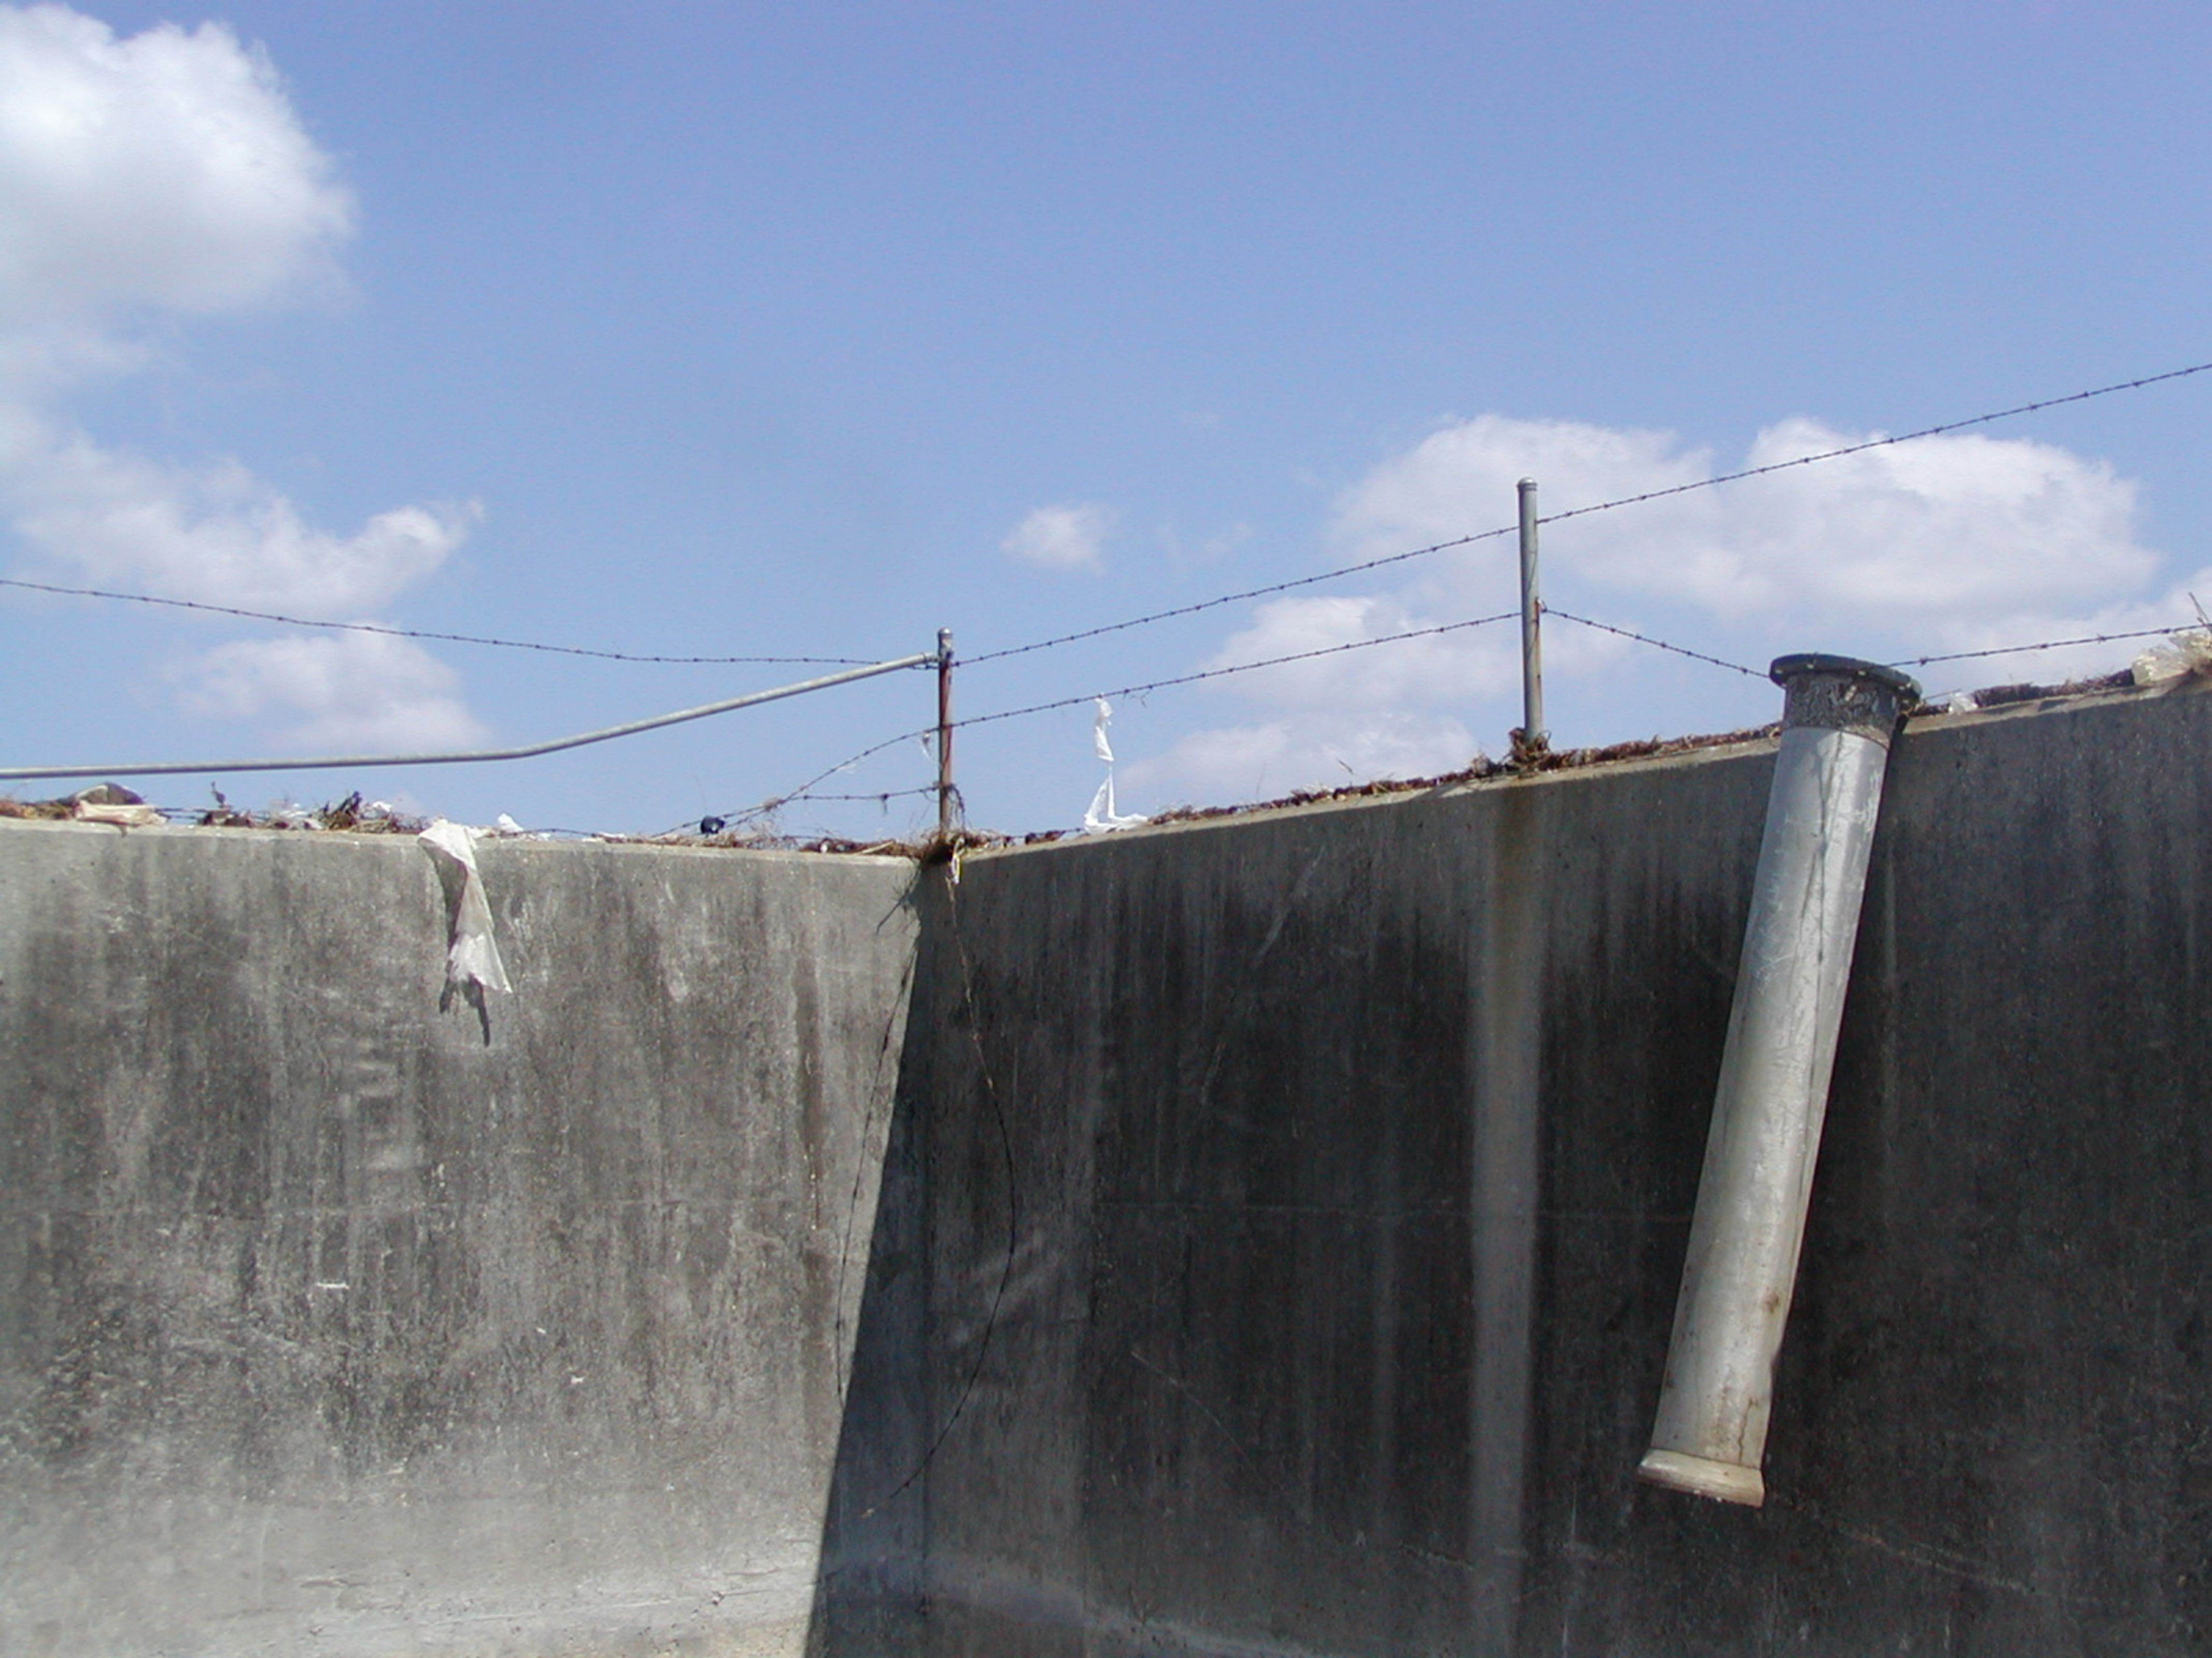
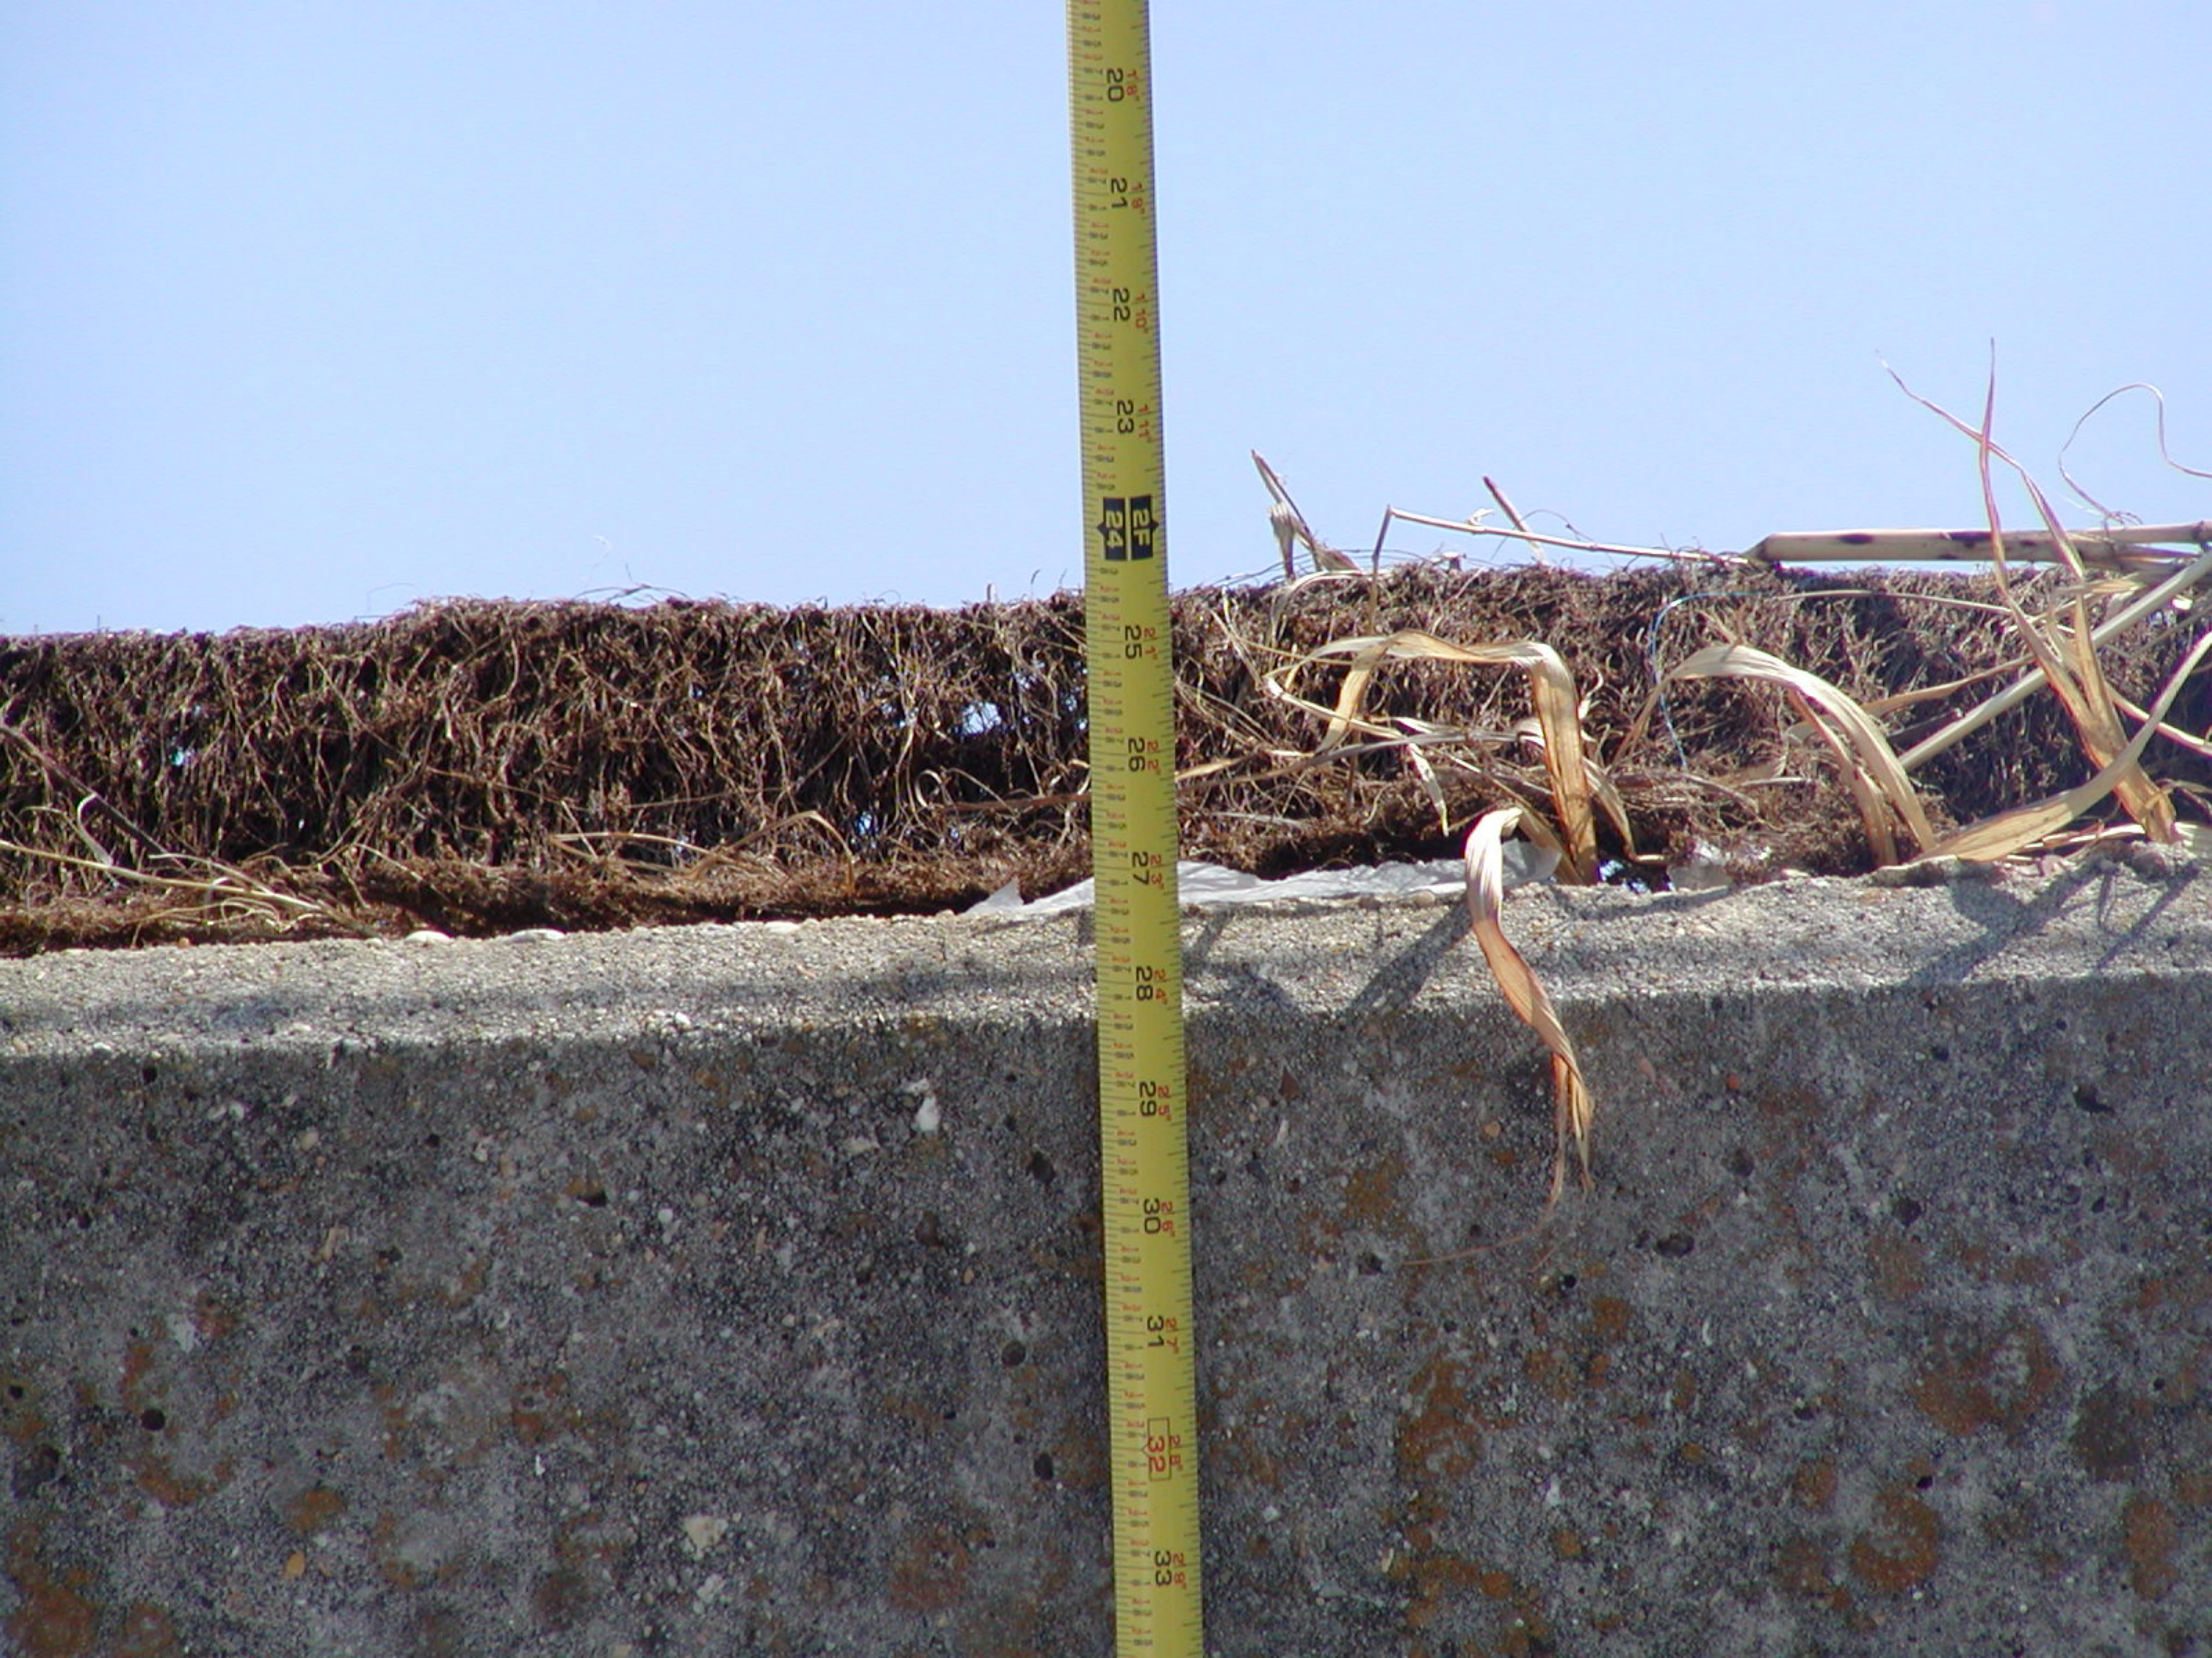
- k. Picture 9270013 thru 18- Looking at scour behind floodwall from ground level at area just north of Claiborne Bridge on west side of IHNC and debris on top of wall. The top of the floodwall had lots of debris on it. The barbwire at 27" above top of floodwall had no debris on it. The barbwire at 18" above top of floodwall had a small amount of debris on it. Same location as pictures 9270007 & 8.
