Subject: Field Notes on New Orleans

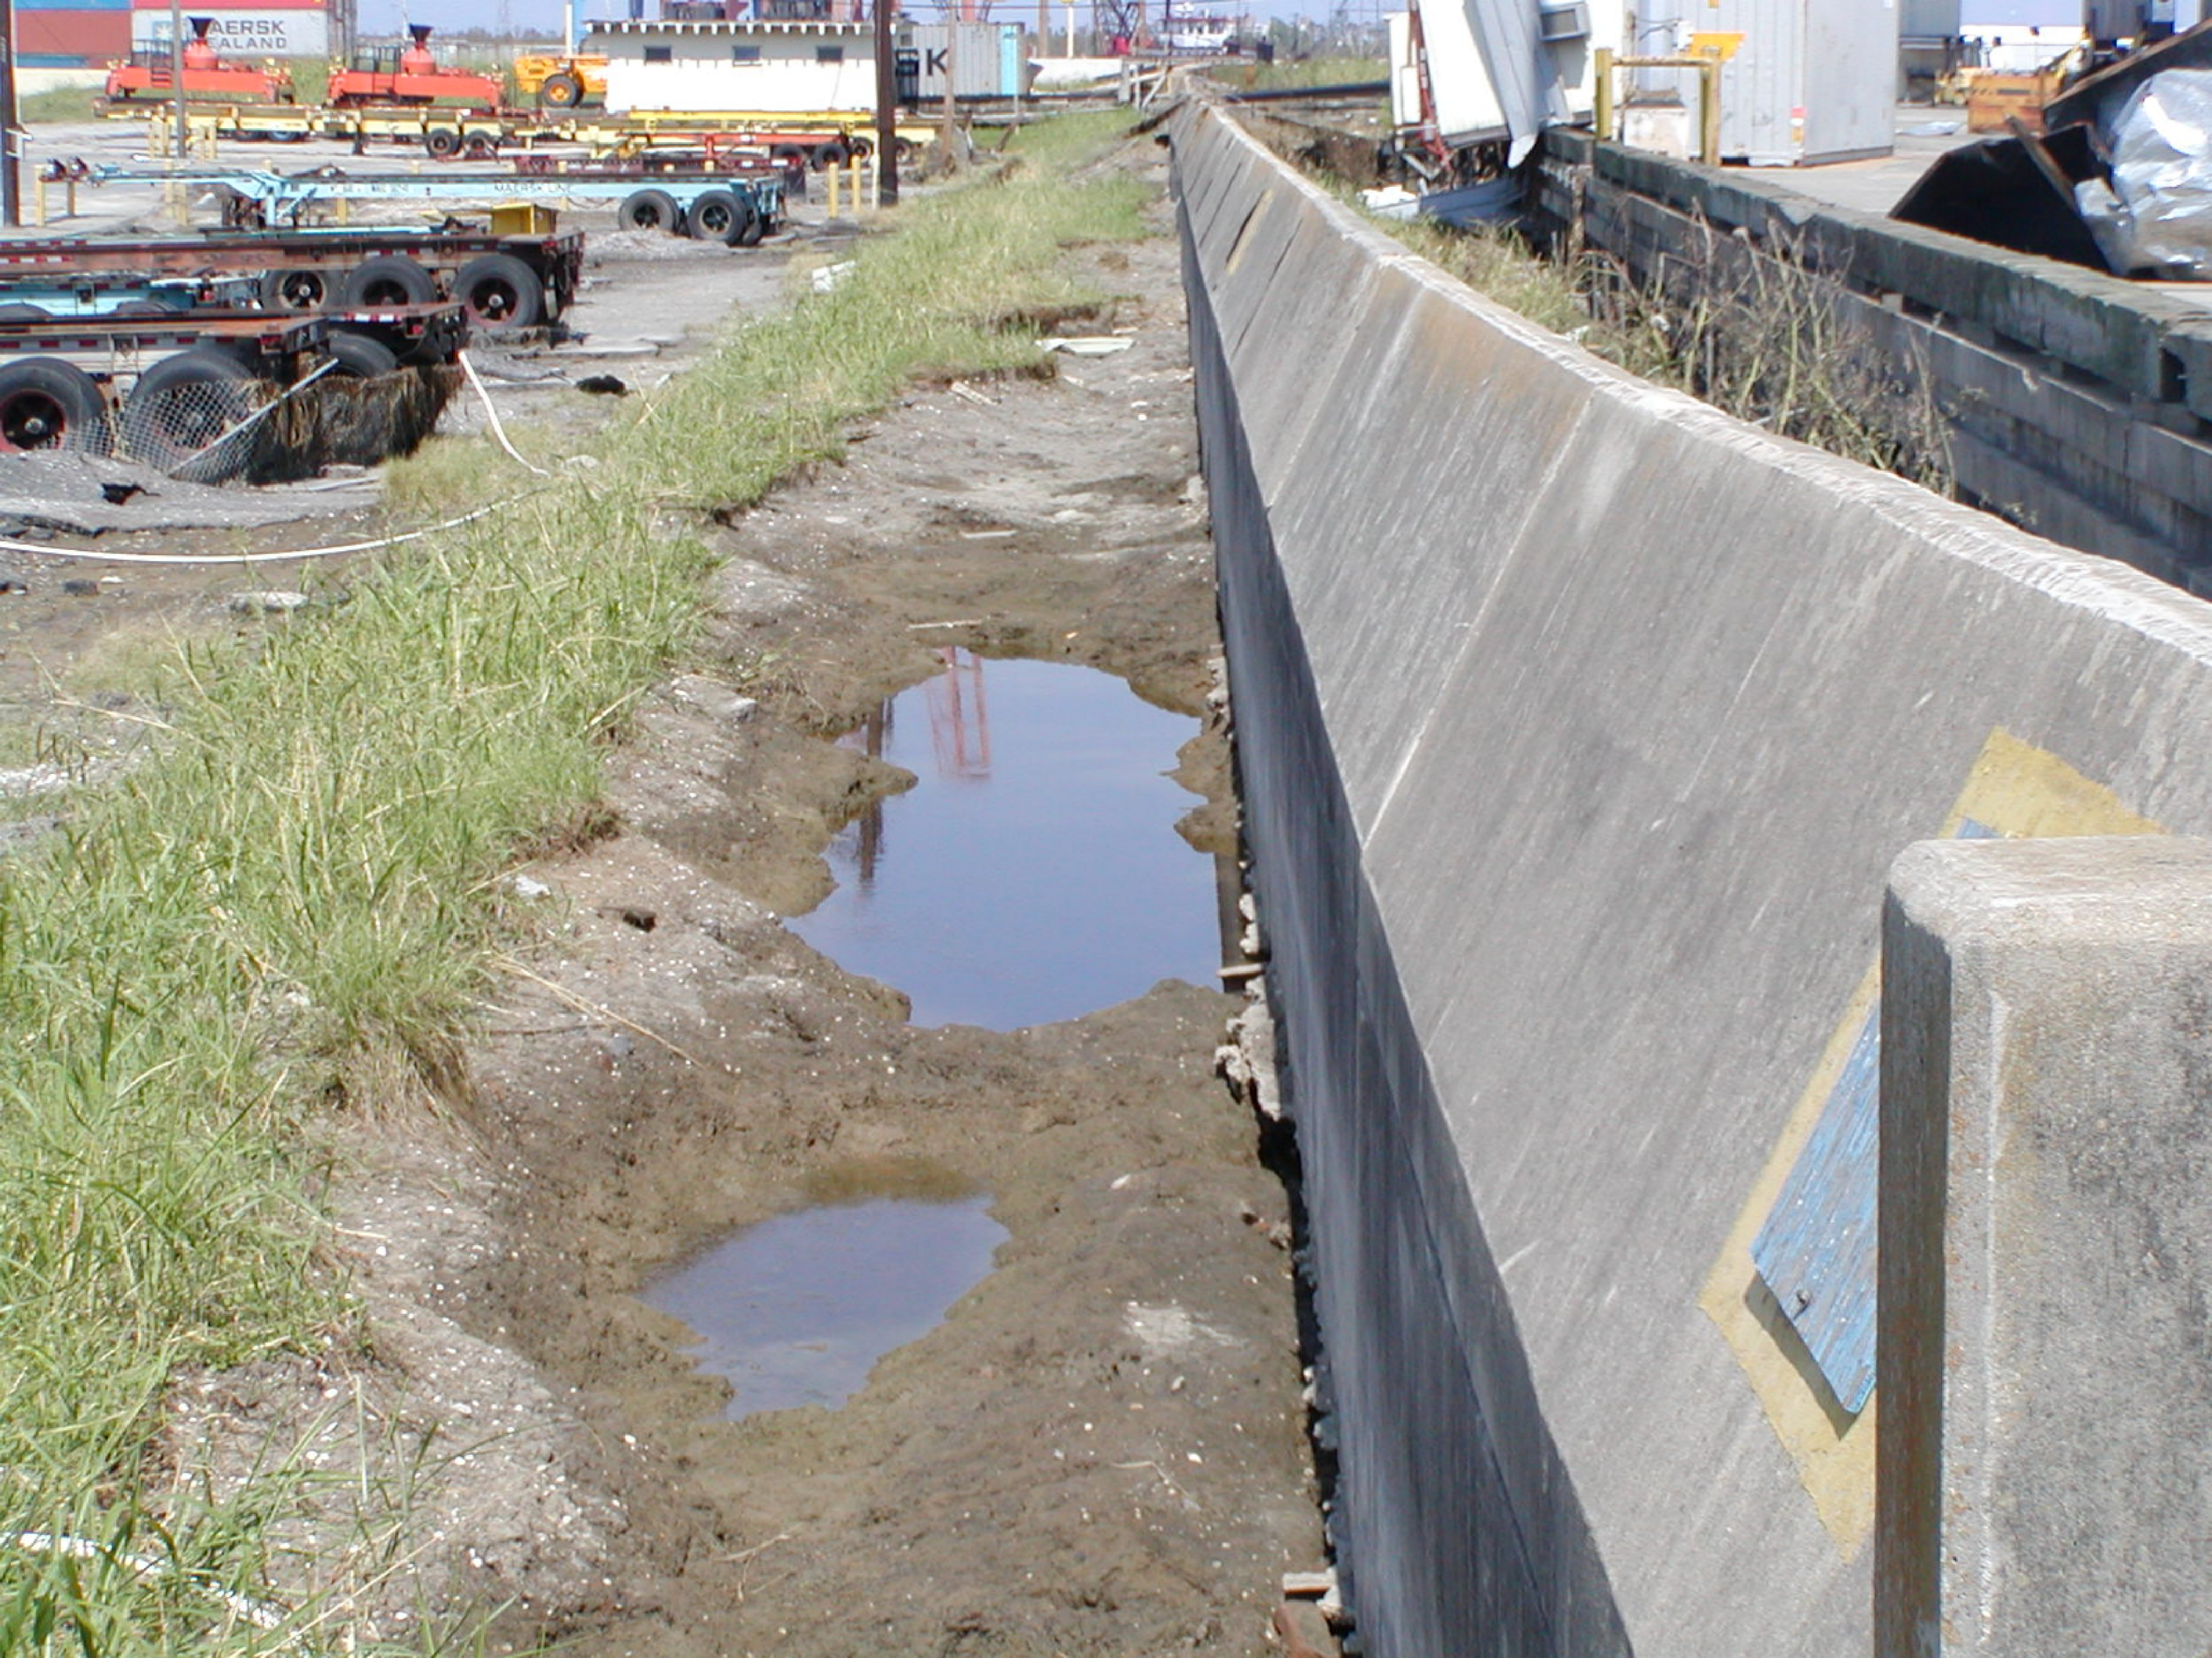
- l. Picture 9270019- Scour behind floodwall at 29.98226, 90.02287. At this location there is a debris high water mark on the fence that is 30" above the floodwall at this location. The team was not certain which floodwall this is because there appears to be multiple lines of protection. This HWM could be on the protected side of the levee and must be checked for location.

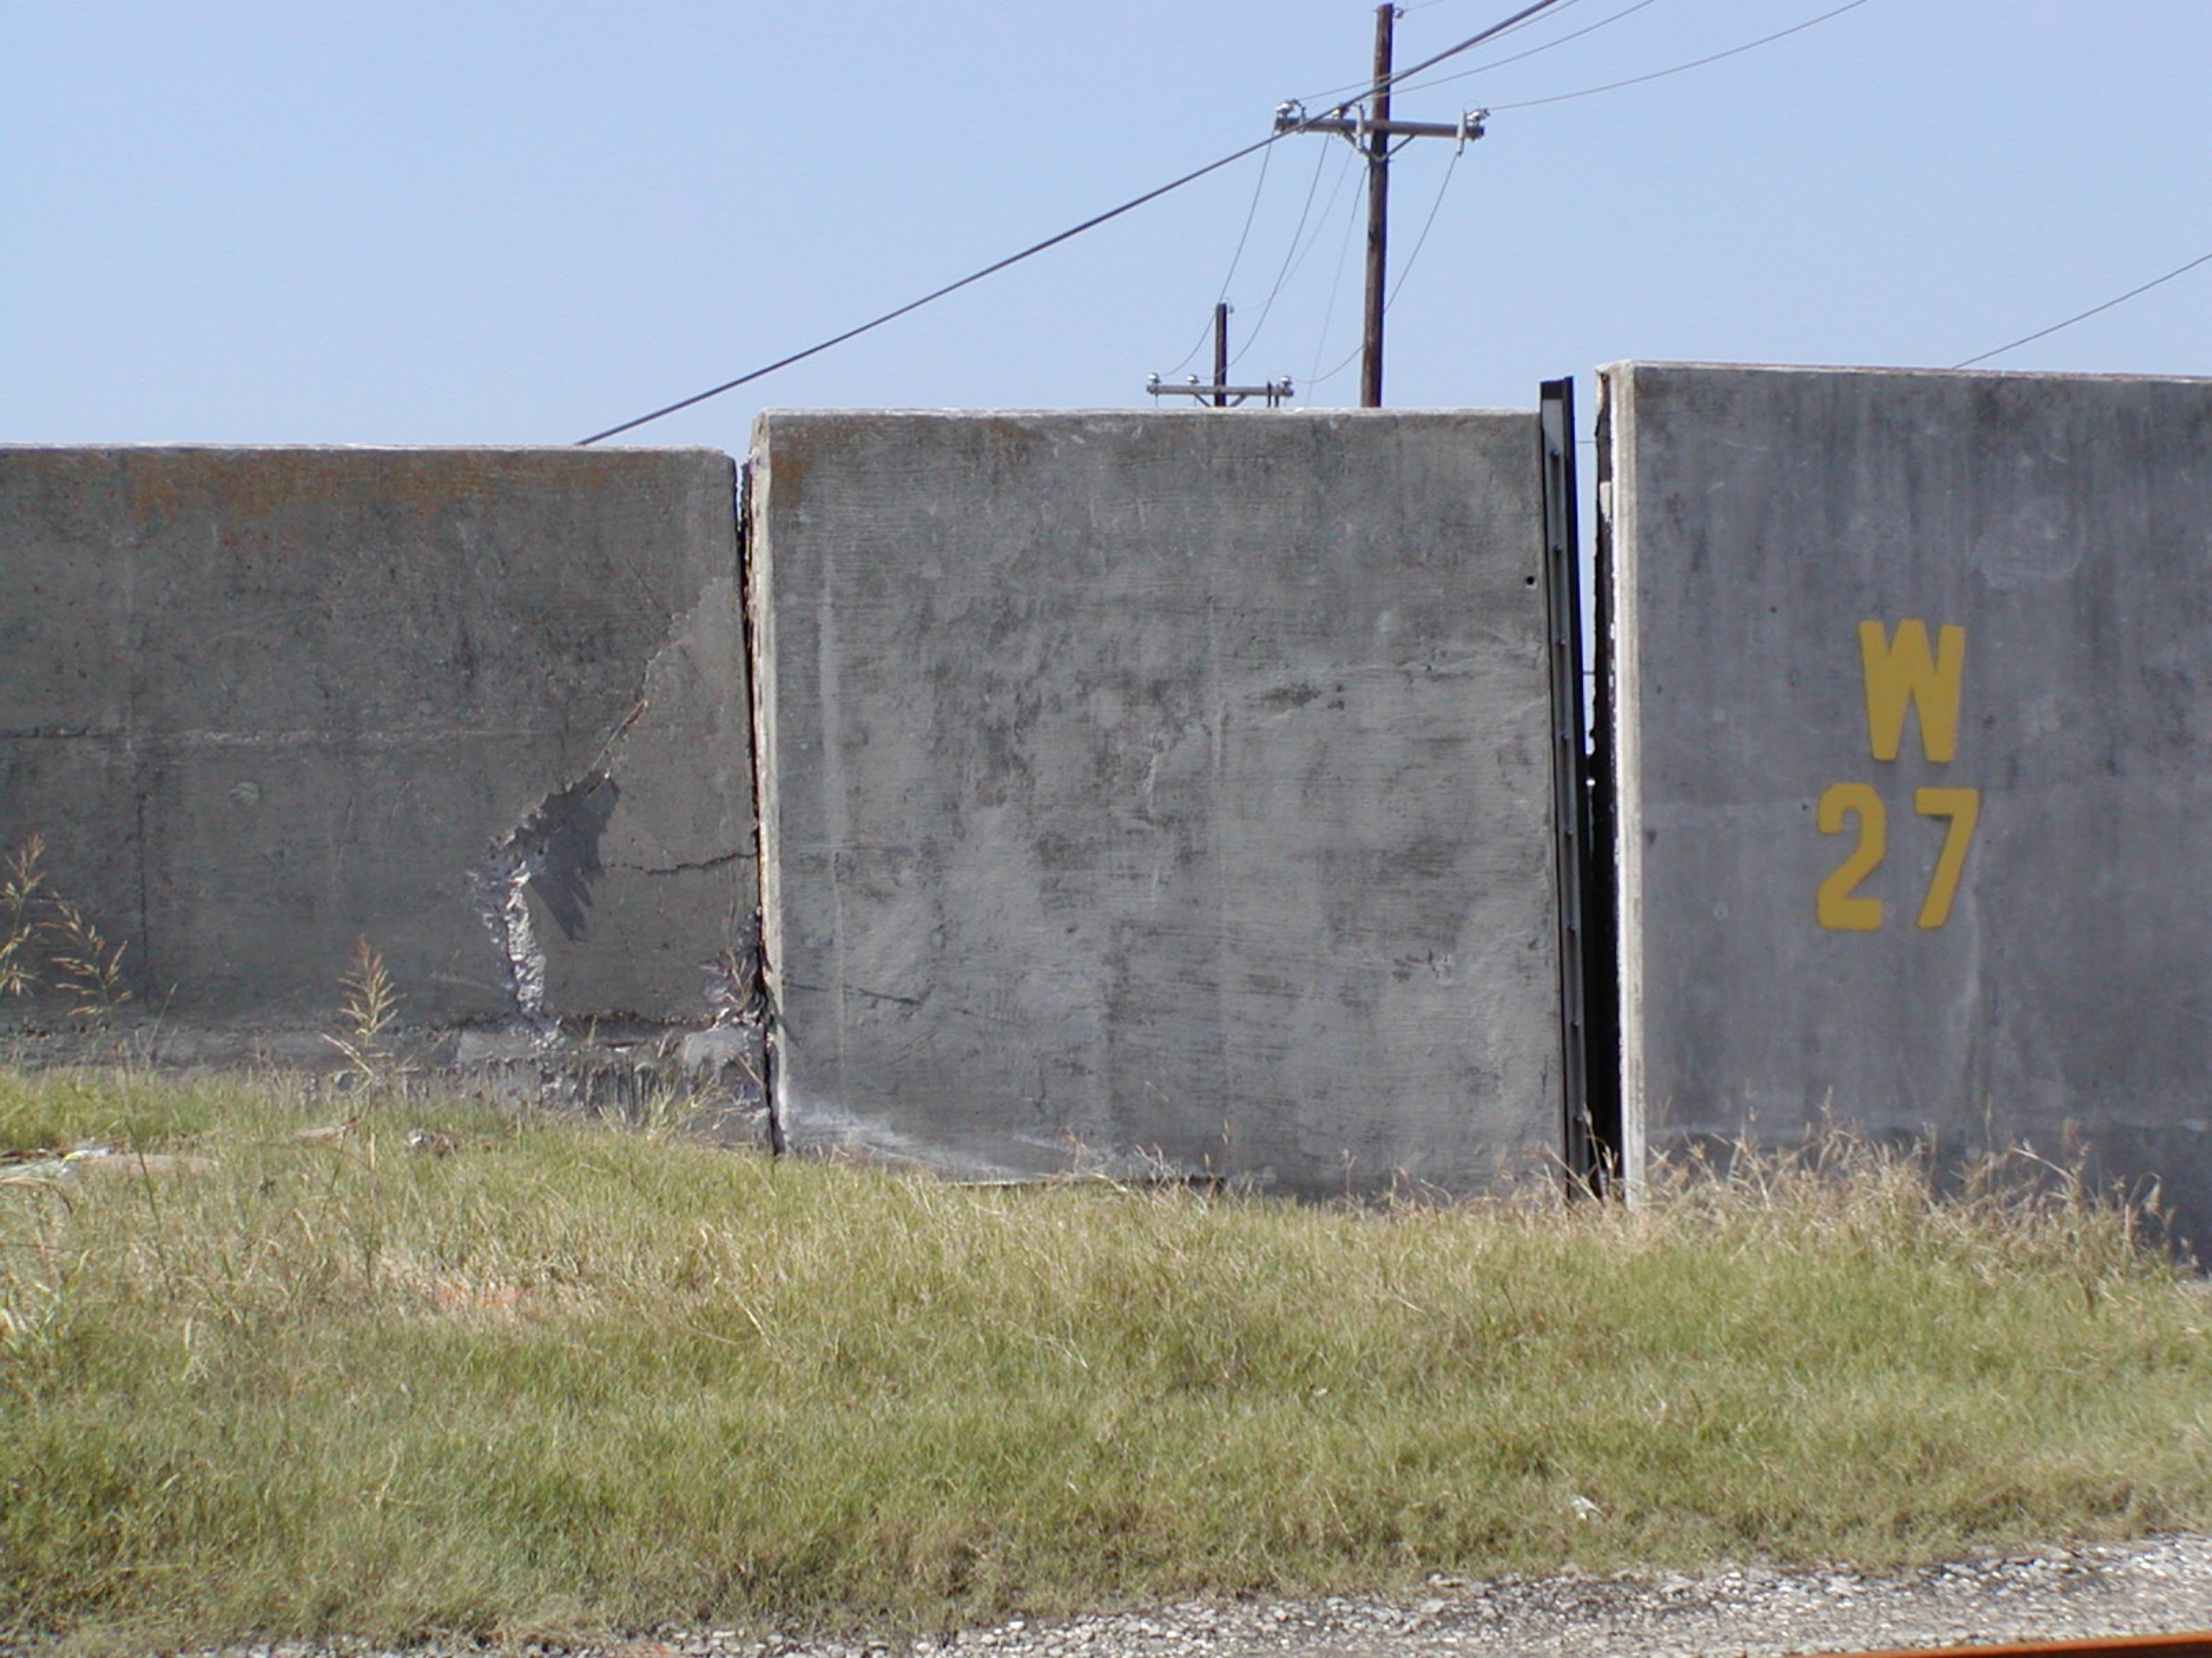
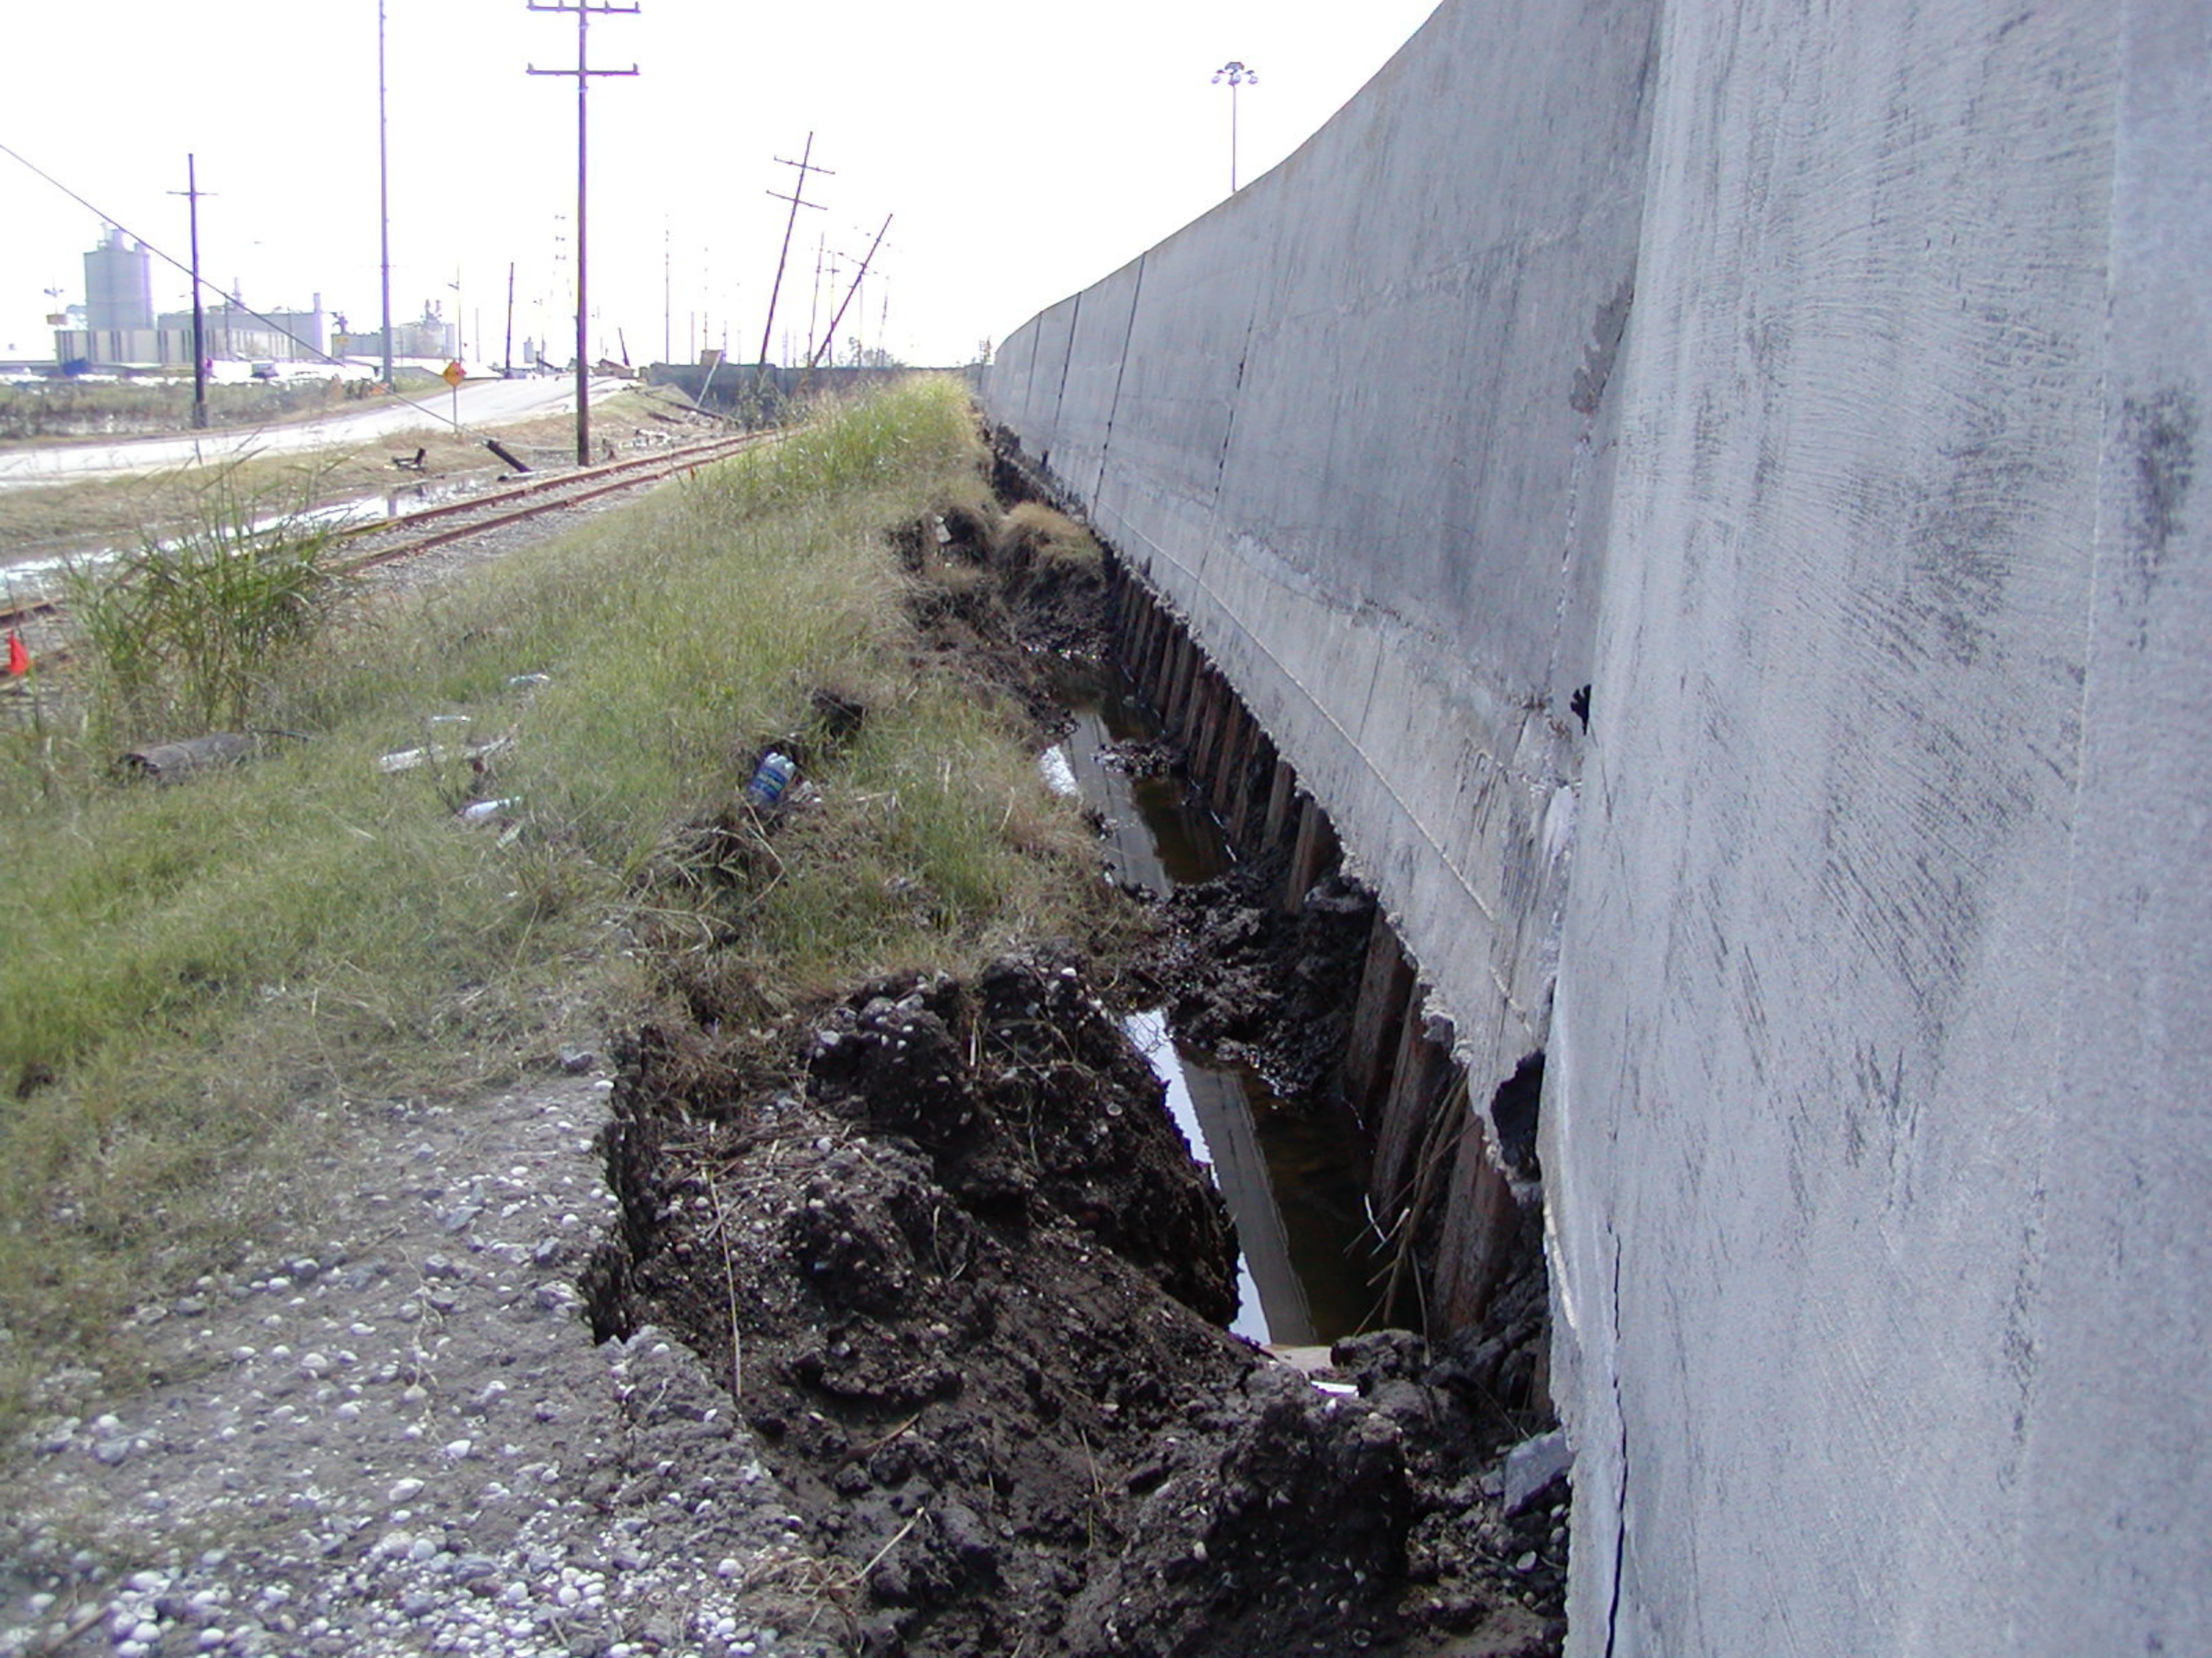
- m. Picture 9270020 & 21- Near one breach on west side of IHNC also in the confusing maze of floodwalls at Sealand/Maersk. Wall leaning and shows exposed sheet pile at base of I-wall. Scour width about 60" at top of scour hole. This is the area near the breach at the corner of the protection floodwall near sealand maersk.

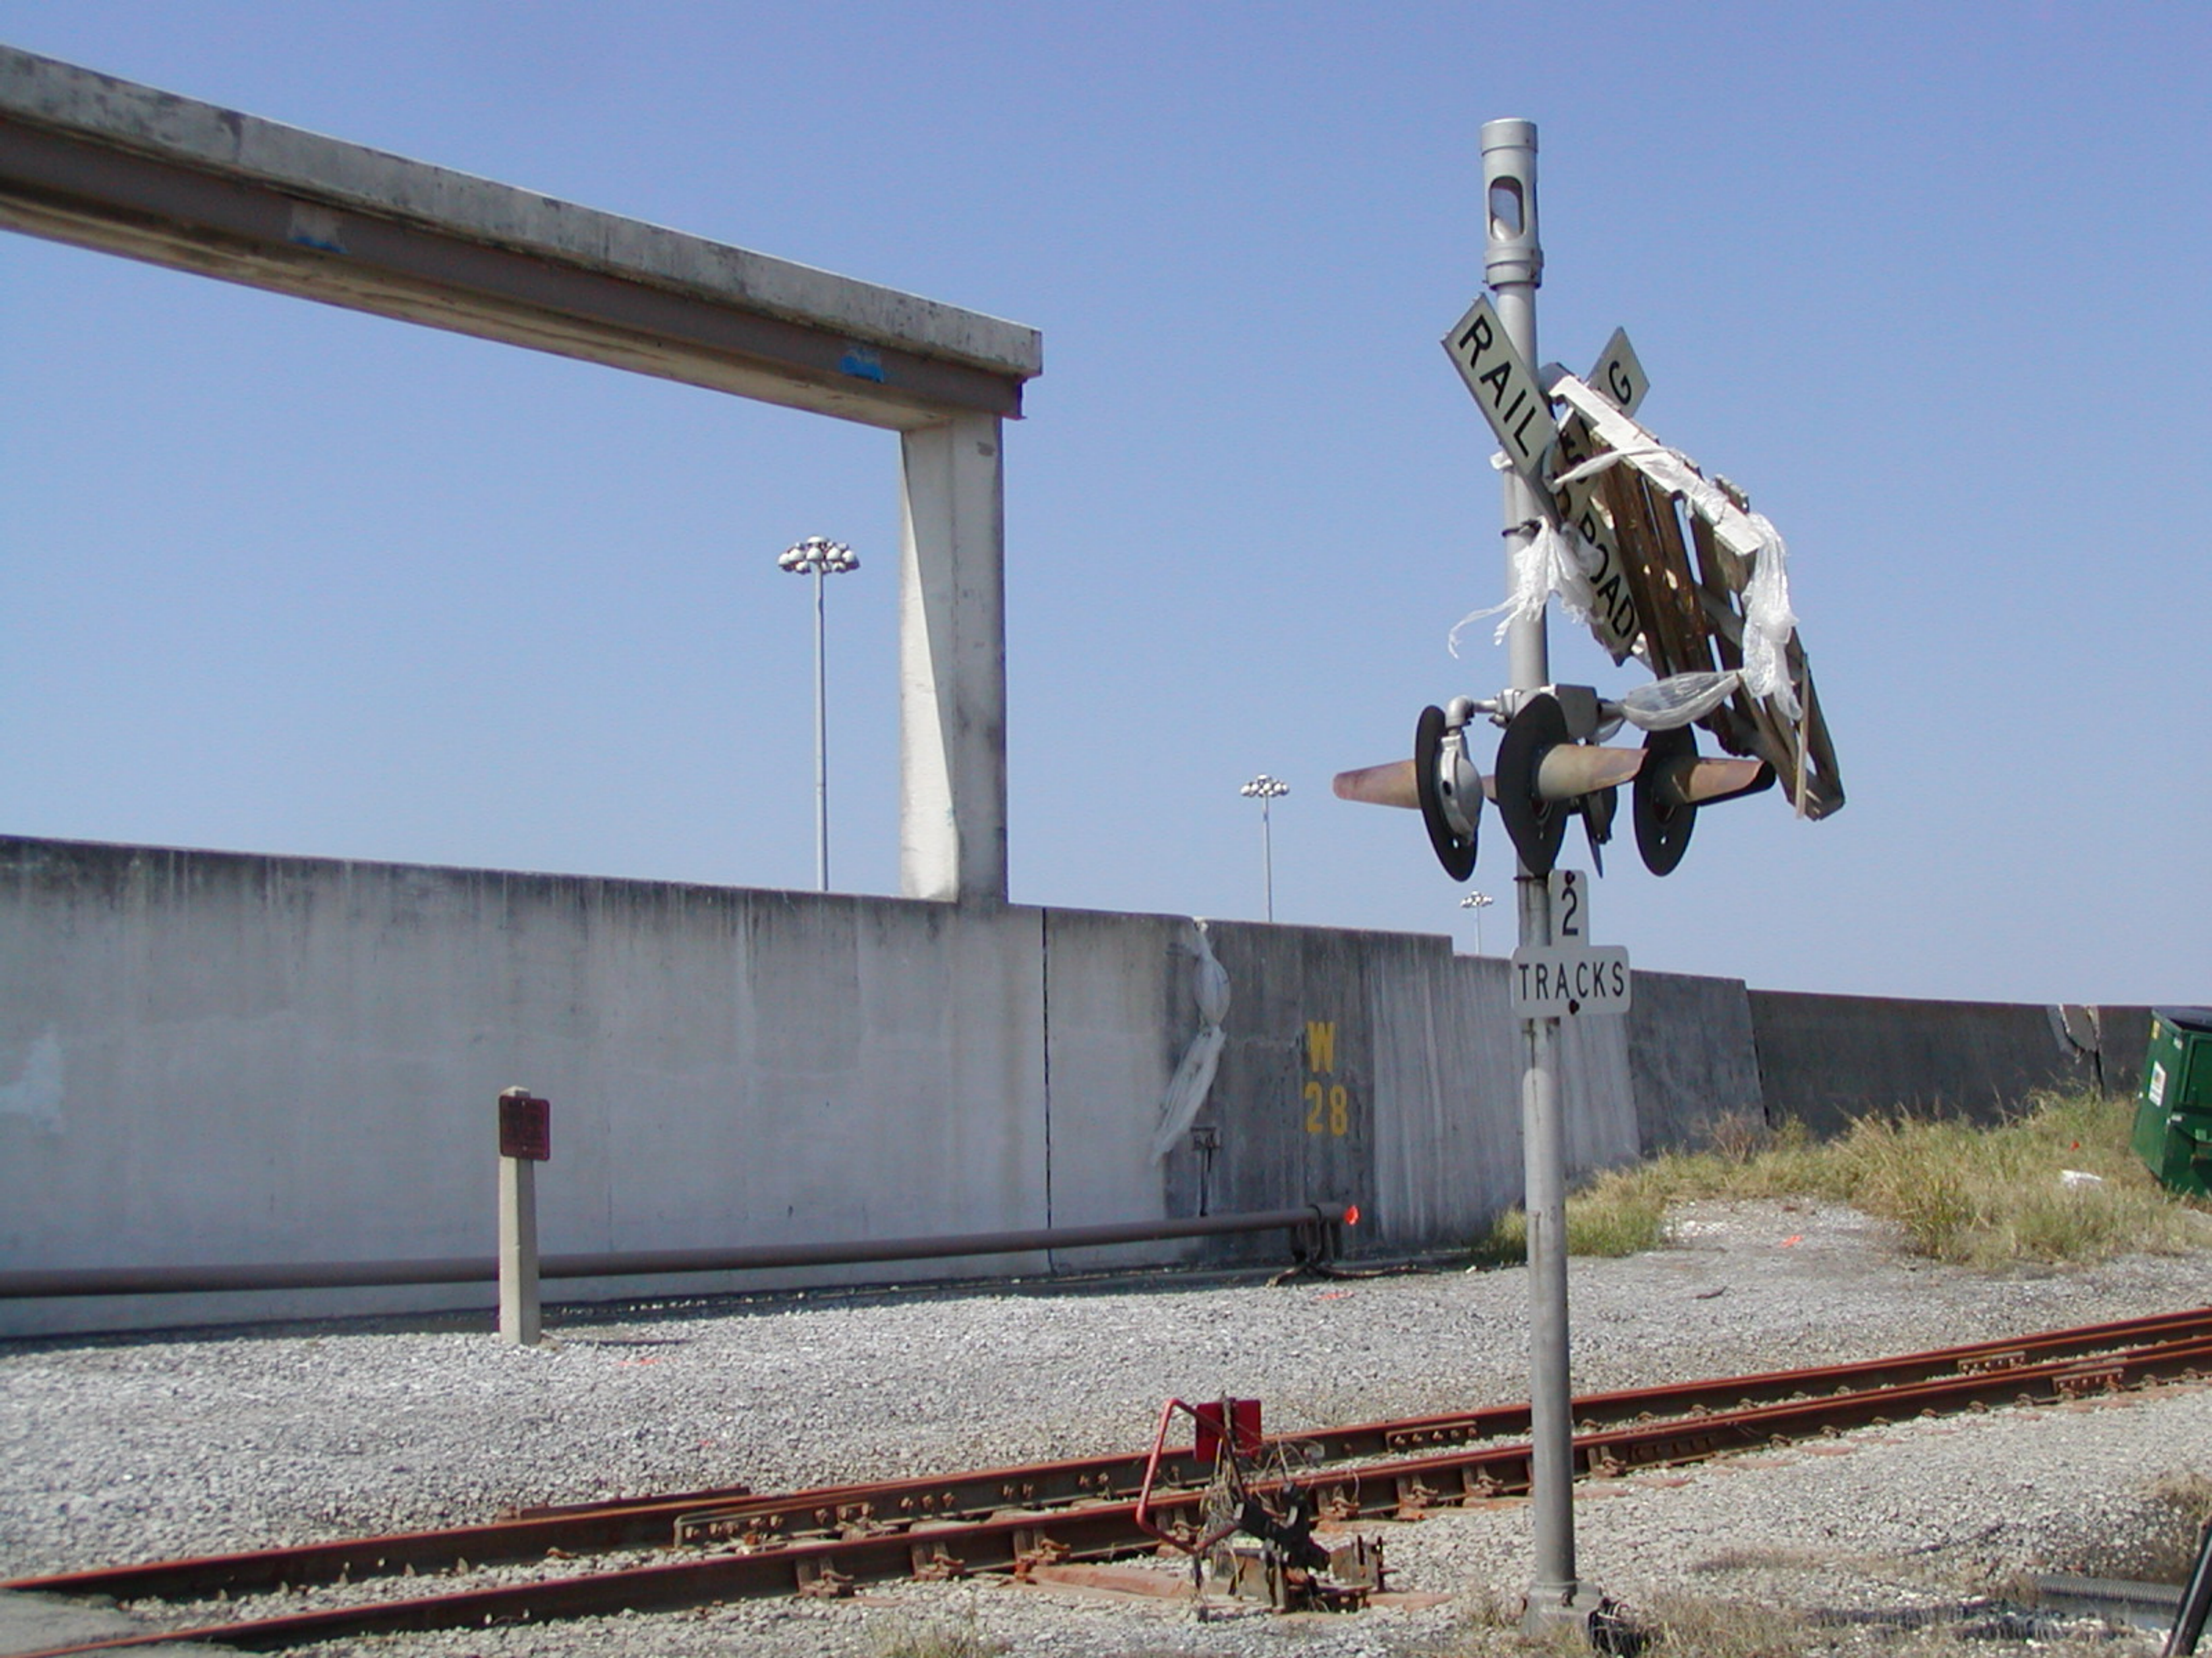
- n. Picture 9270022- Debris on railroad sign near IHNC breach on west side.
  - o. Picture 9270023 thru 25- Southeast breach on IHNC, north end of breach, looking east.

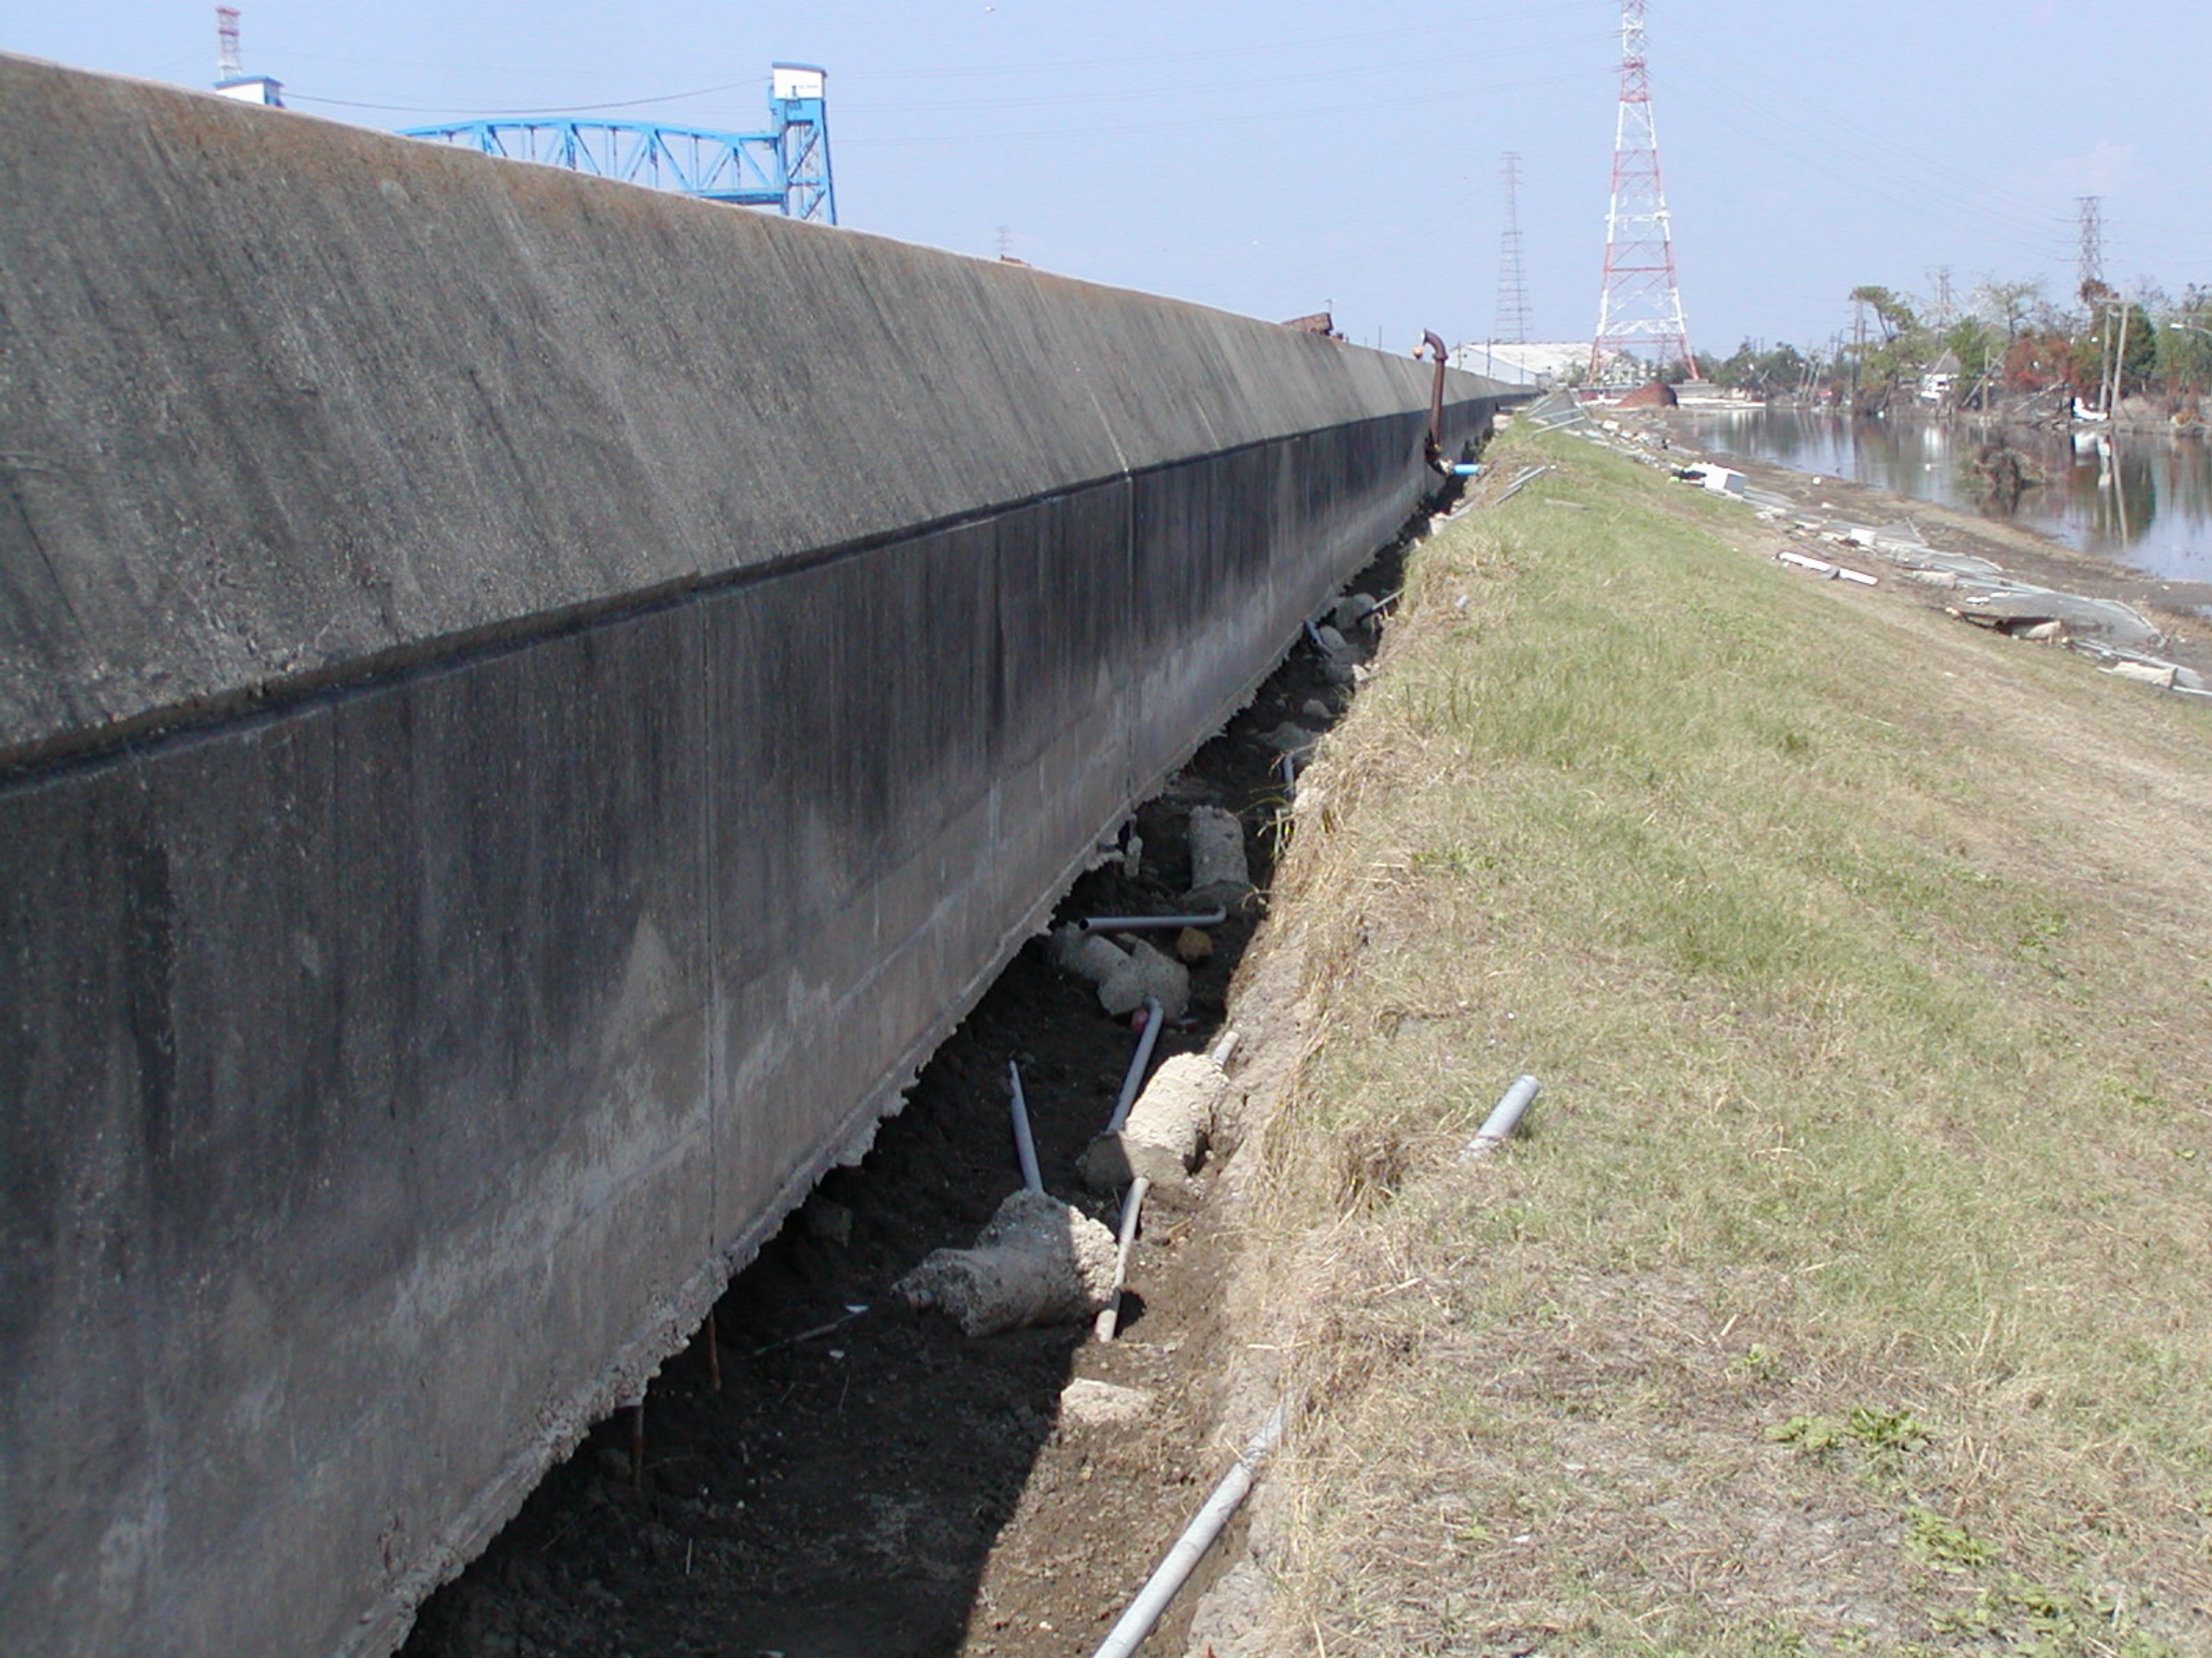
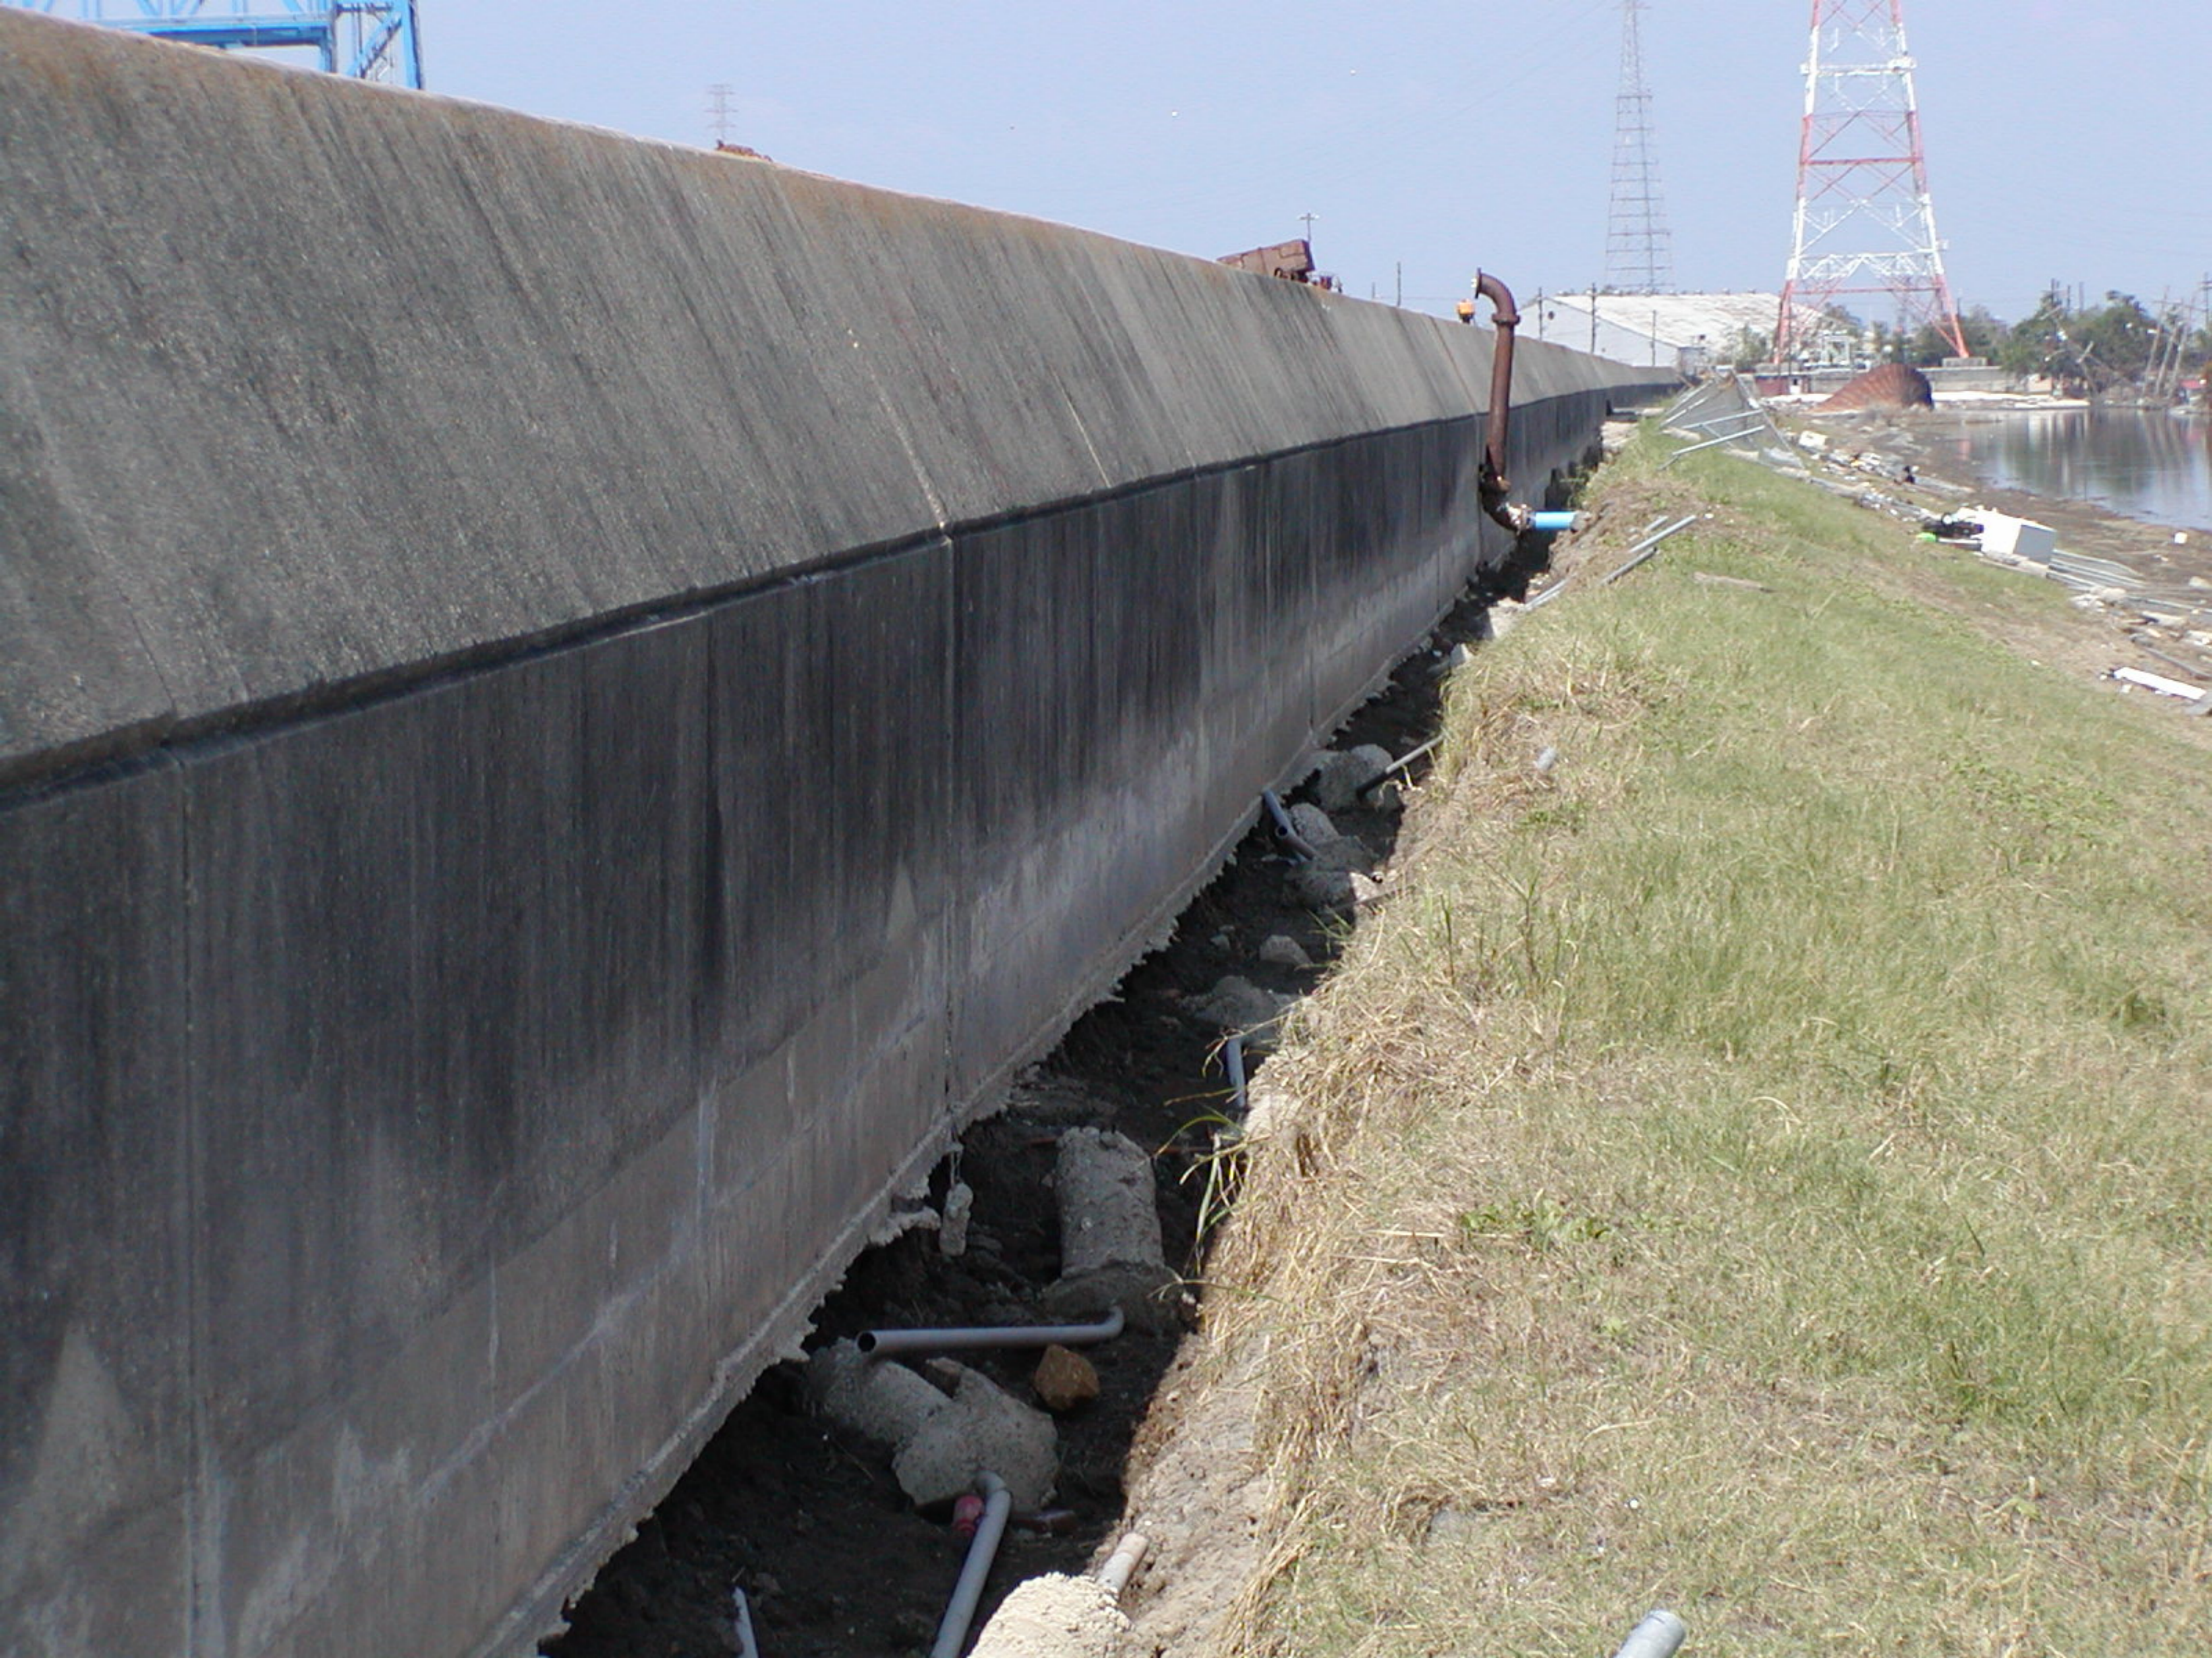
- p. Picture 9270026 & 27- scour behind I-wall at IHNC, east side, south breach, just north of breach. 7 ft vertically from bottom of scour to junction of vertical and sloping section of I-wall. 39' from this junction to top of I-wall. Looking north.
