Subject: Field Notes on New Orleans

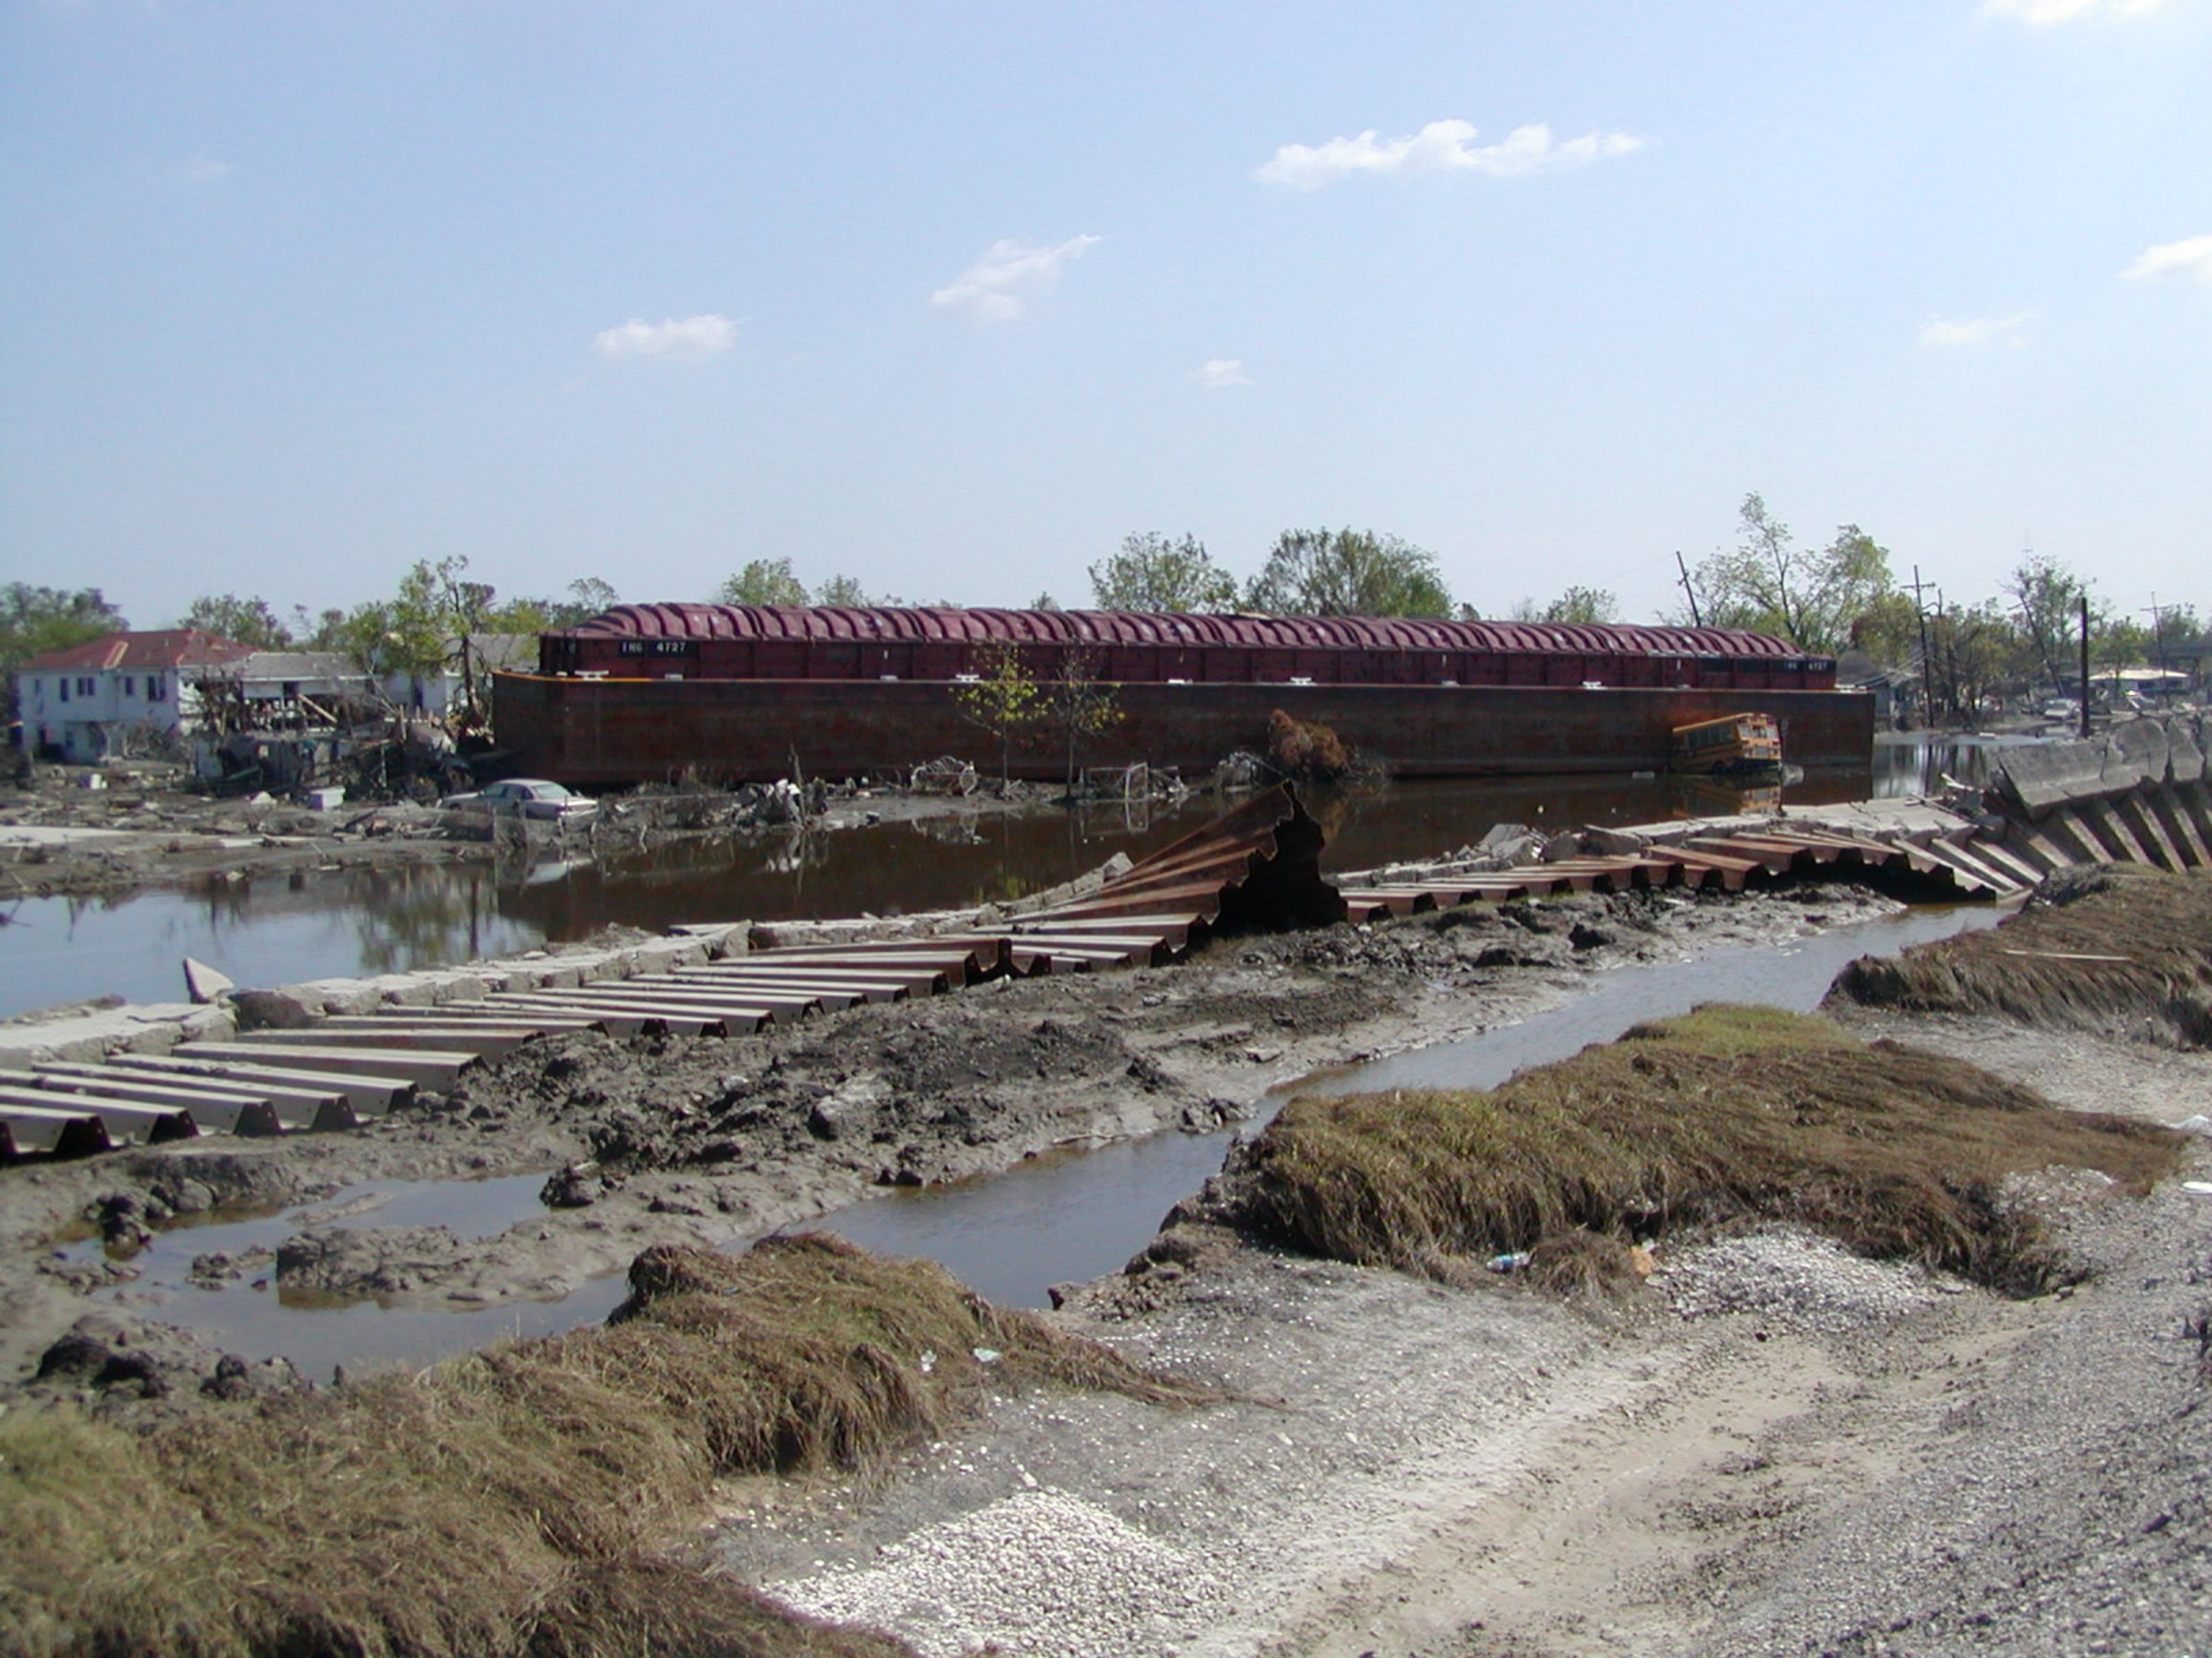
- s. Picture 9270031- IHNC, east side, south breach, looking from breach SE into ninth ward showing failed I-wall near south end of breach. I-wall was about 15 ft of exposed sheet pile and 6 ft of concrete cap.

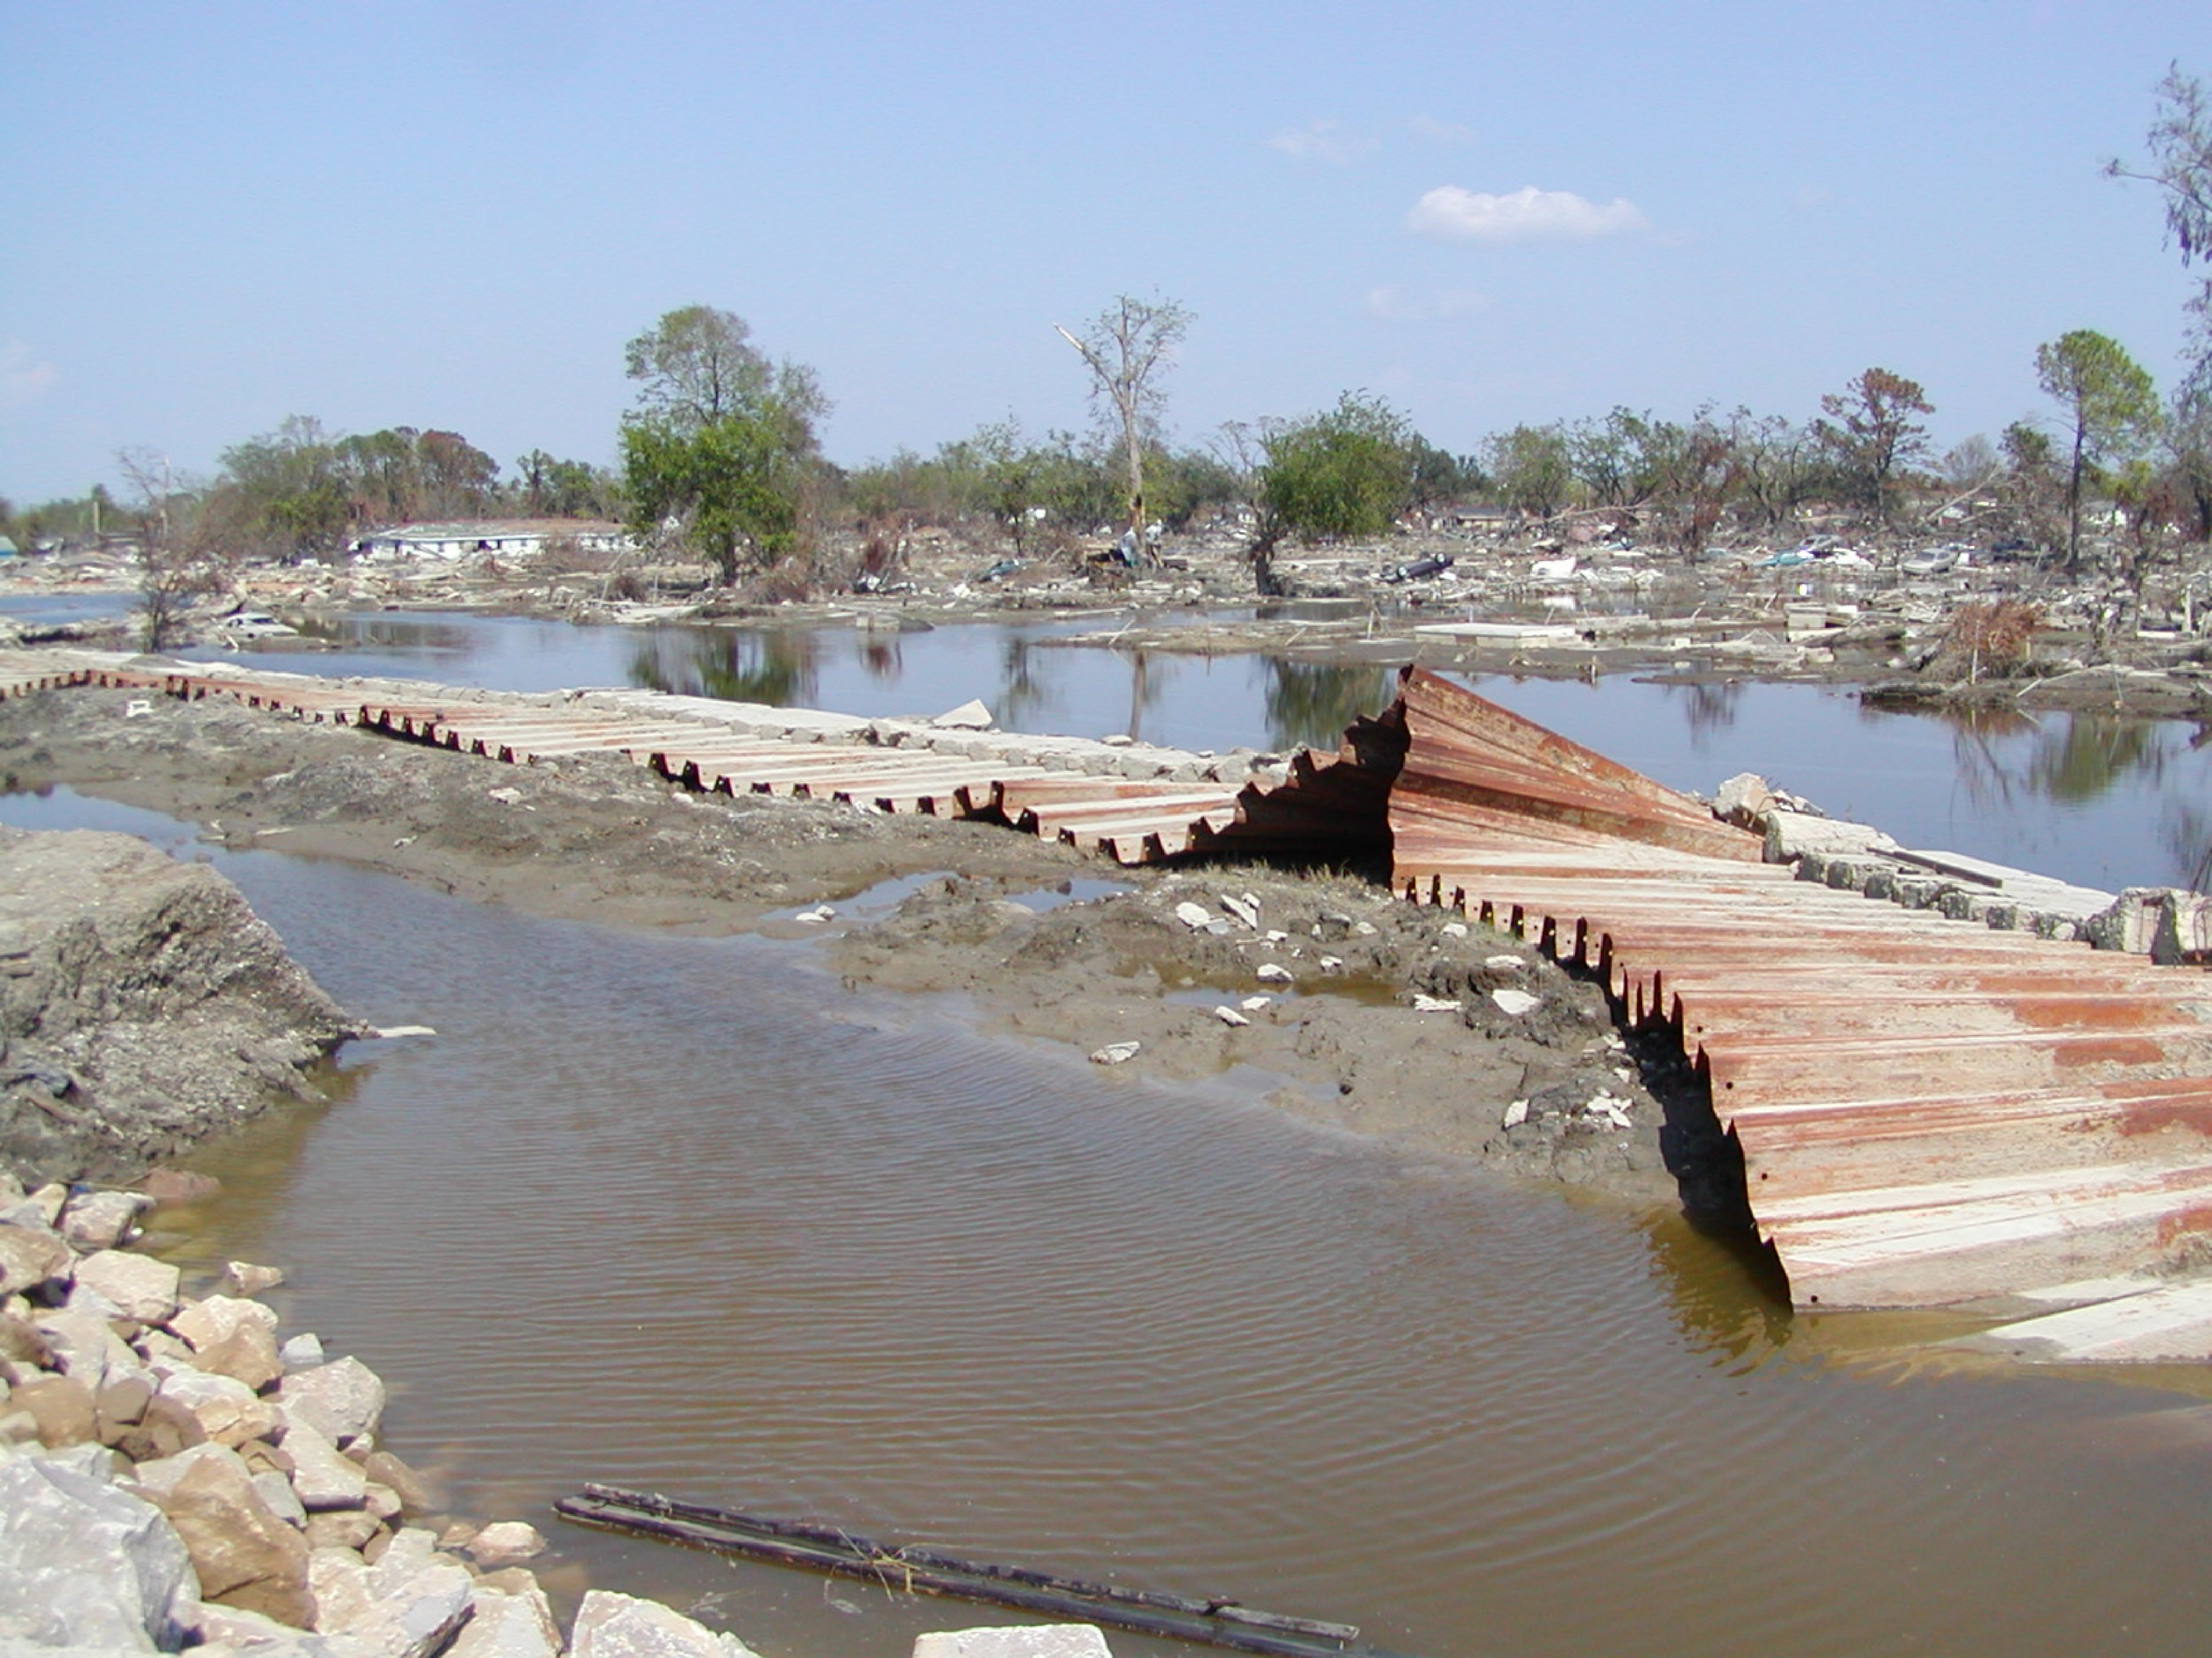
- t. Picture 9270032- IHNC, east side, south breach, looking from breach NE into ninth ward showing failed I-wall near south end of breach.
- u. Picture 9270034- IHNC, east side, south breach, looking east from about 200 ft north of breach into ninth ward.

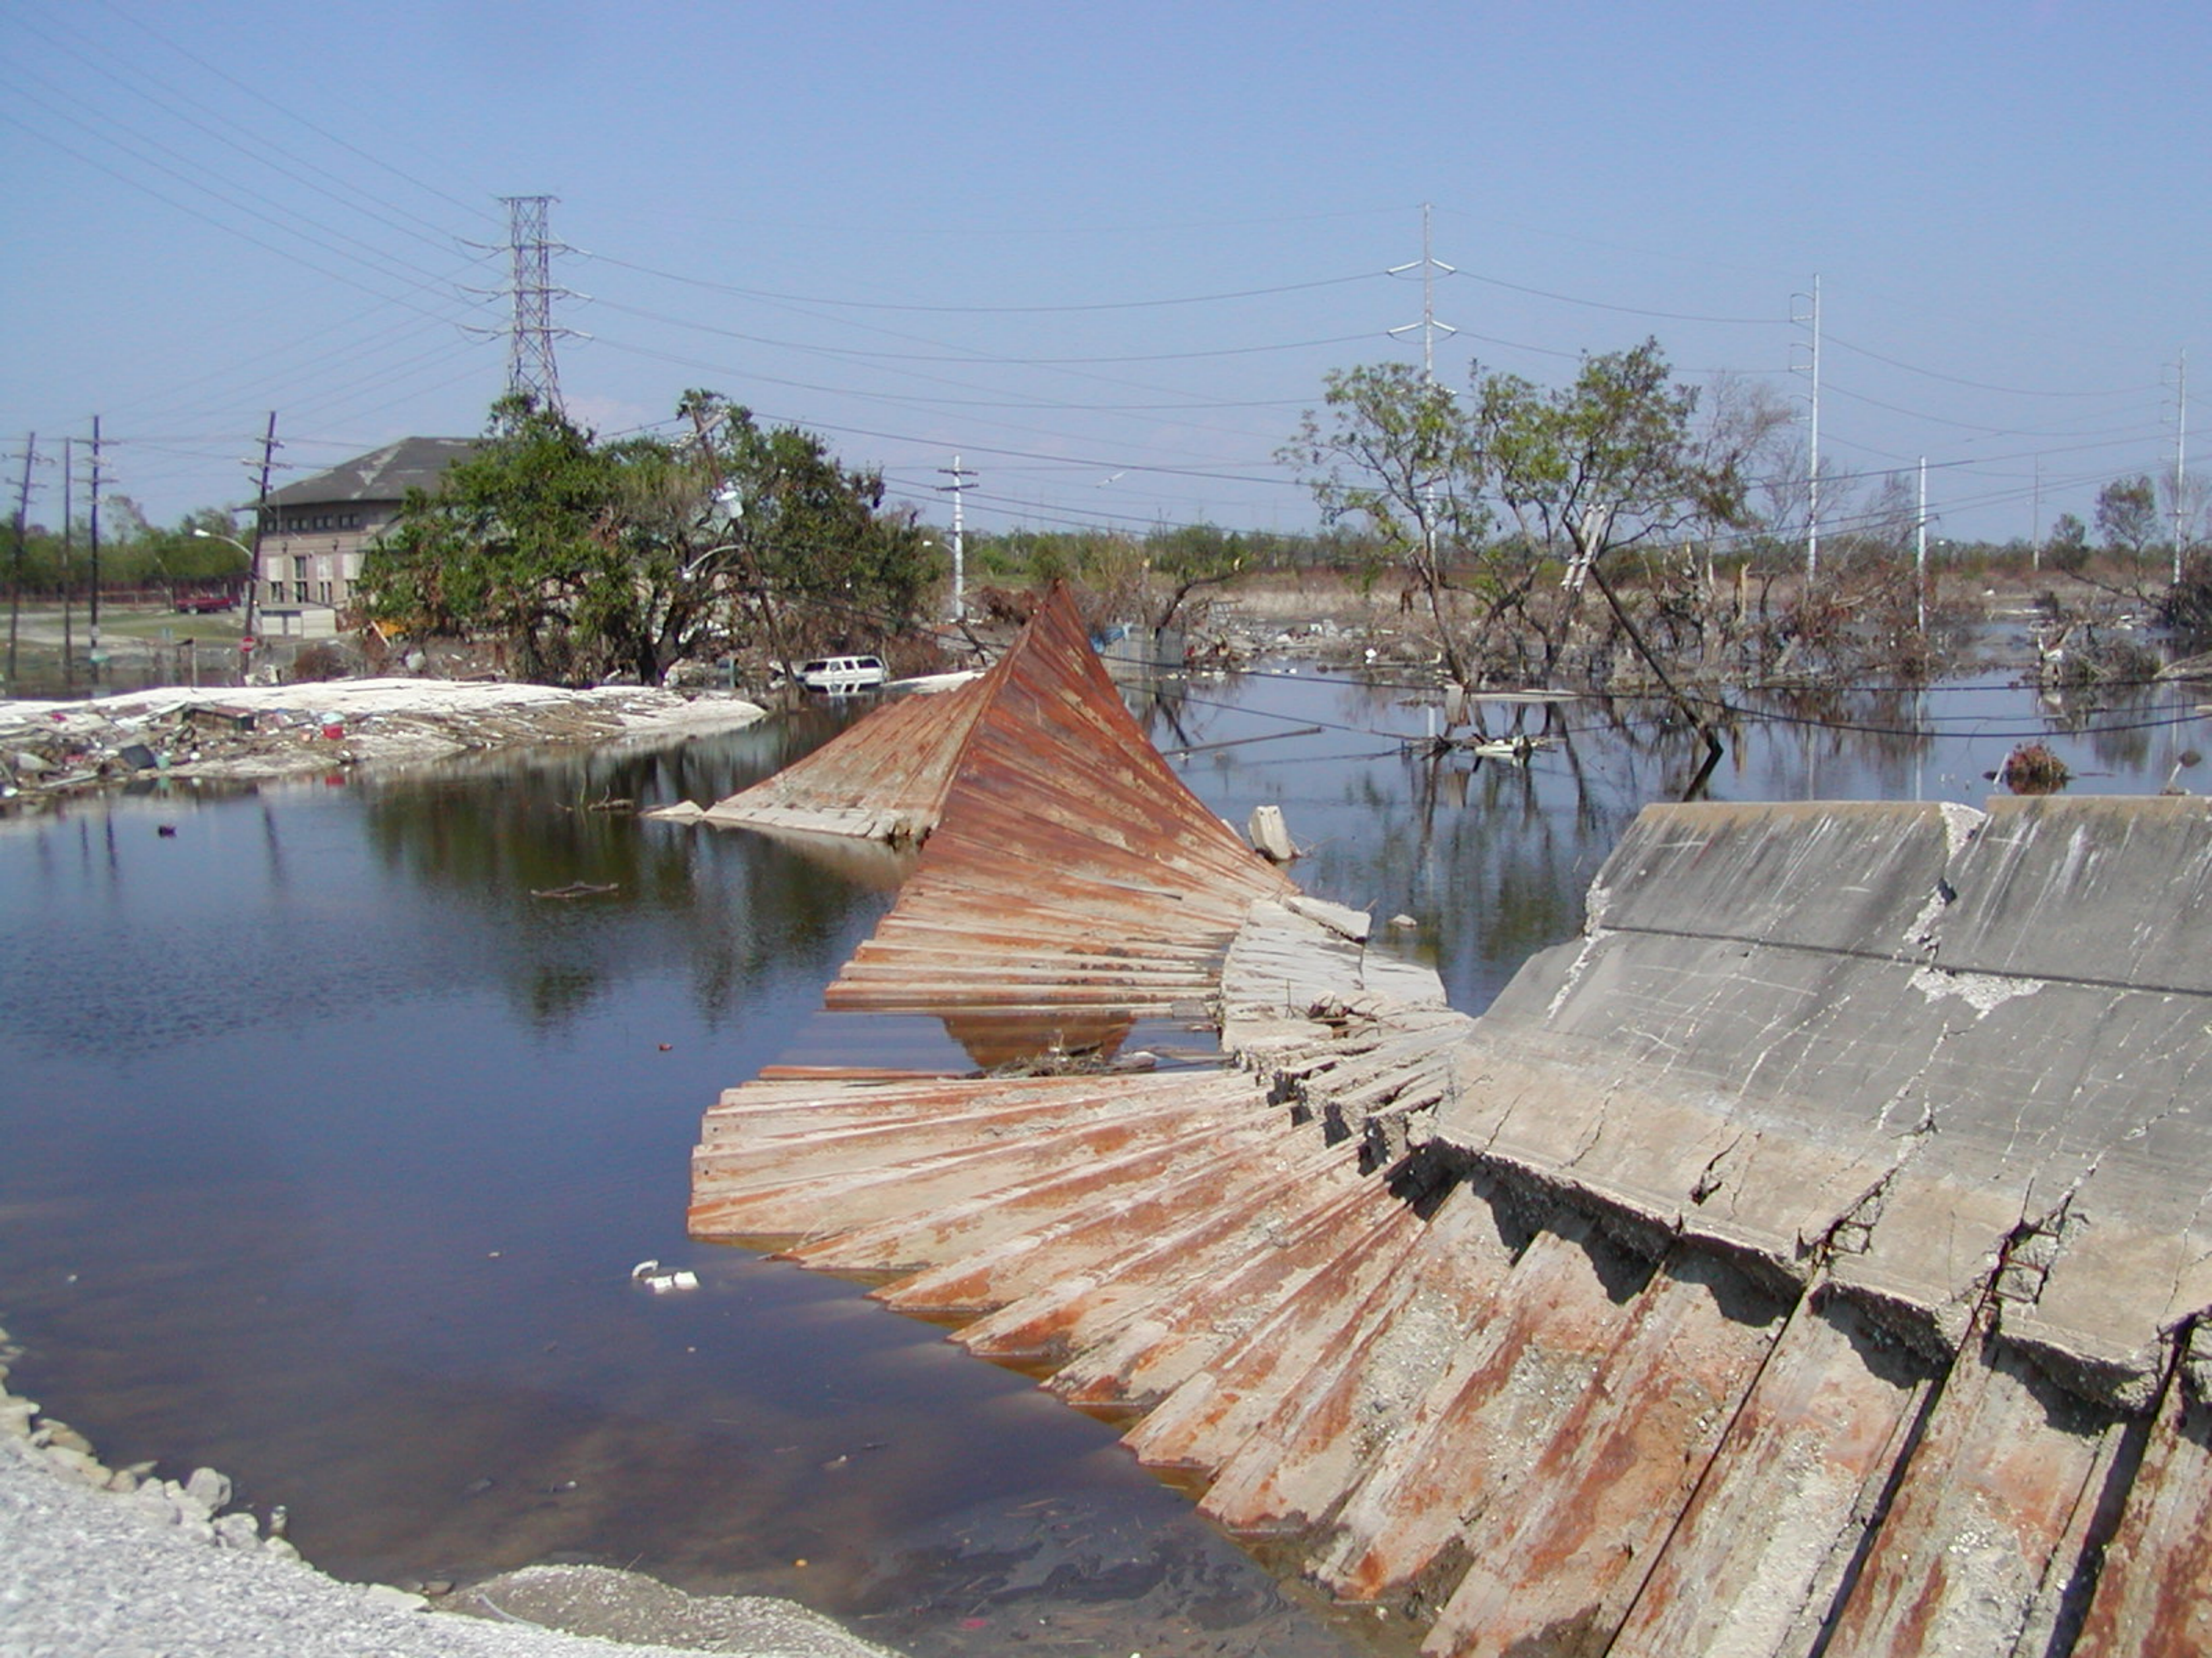
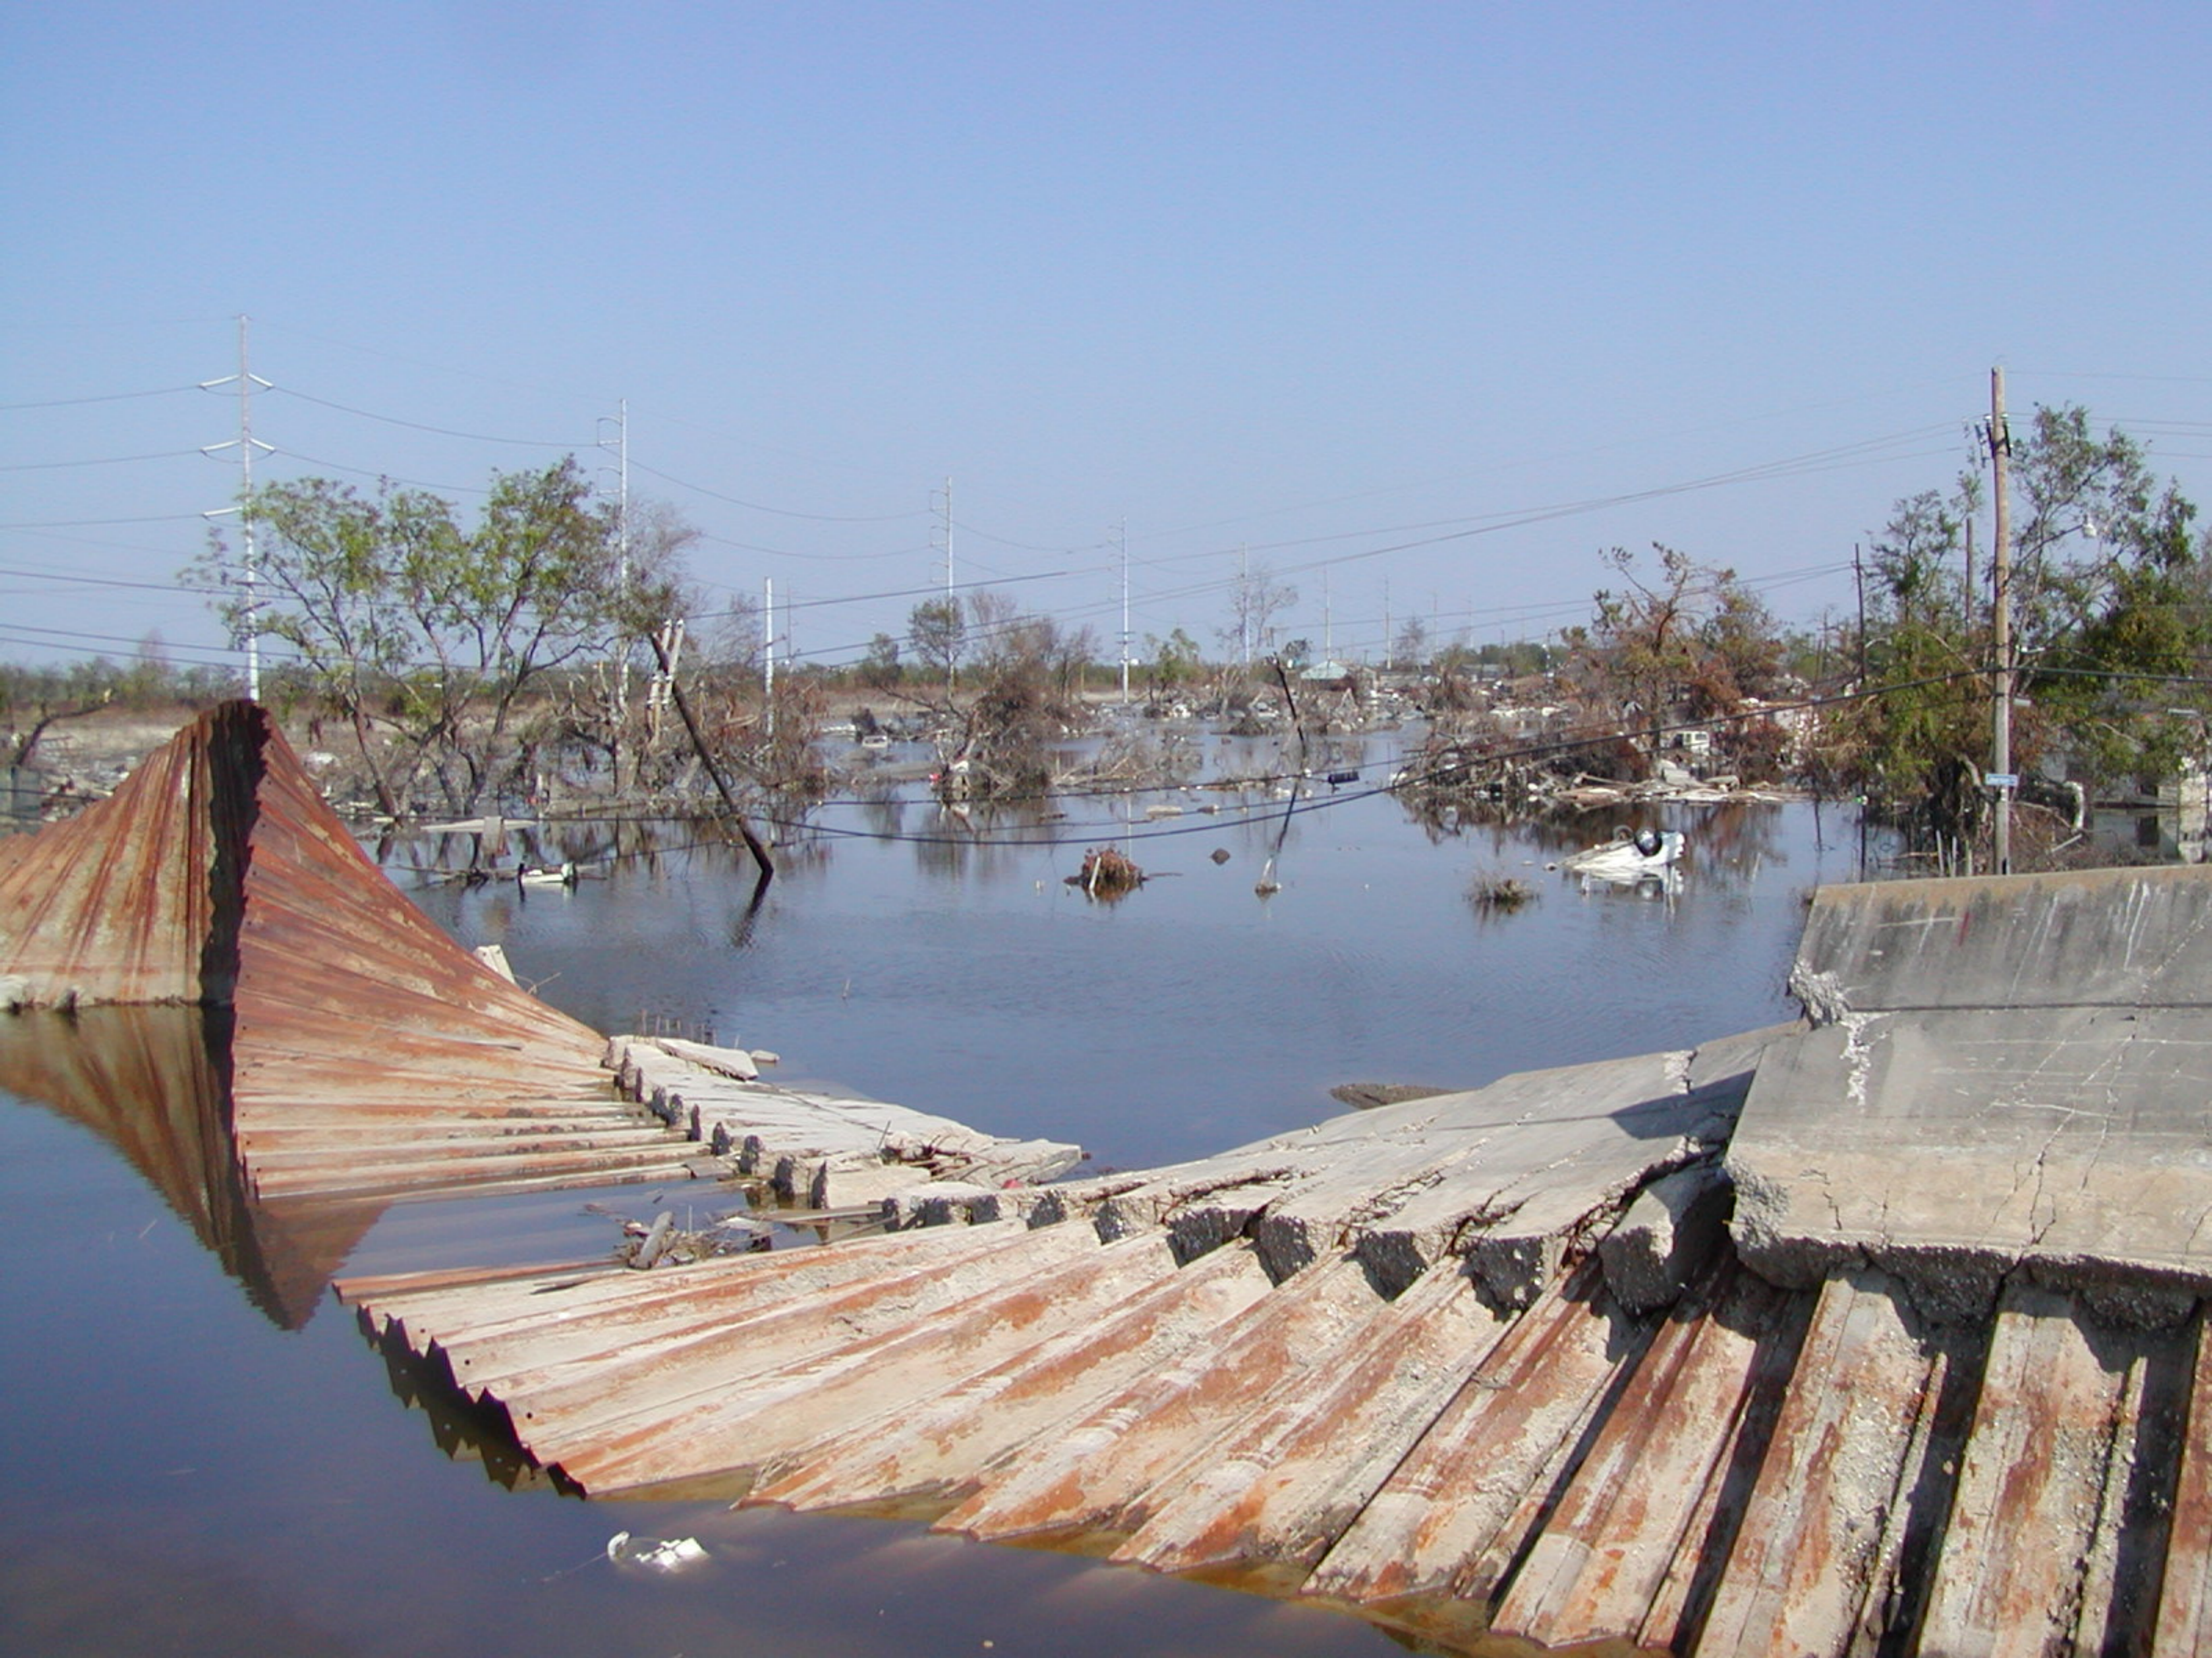
- v. Picture 9270035 & 36- IHNC, east side, north breach, looking east at failed I-wall.
- w. Picture 9270037- Picture of temporary pump station. Several used to augment dewatering effort. Near IHNC, east side, north breach, looking northeast. Near Pump Station OP#5.
