LAKE PONTCHARTRAIN, LOUISIANA AND VICINITY

CHALMETTE AREA PLAN

**BAYOU BIENVENUE
CONTROL STRUCTURE**

PERIODIC INSPECTION REPORT NO. 4

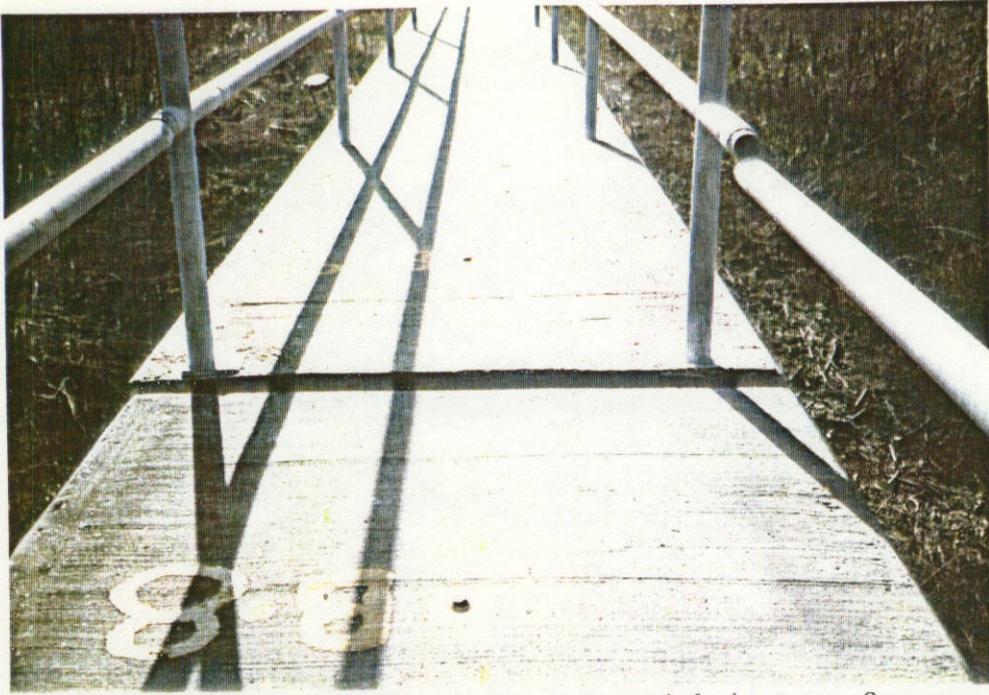
observed between reference marks B8 and B9 on the east floodwall (See Photo 3), and between the structure and east floodwall (See Photo 3), and between the structure and east floodwall. No other differential settlement or alinement problems of the structure and floodwalls were observed during the inspection. The timbers had been removed for painting of the gates, but they were in good condition. After minor repairs they are ready to be reinstalled.

PHOTO 3: Minor differential settlement between reference marks B8 and B9

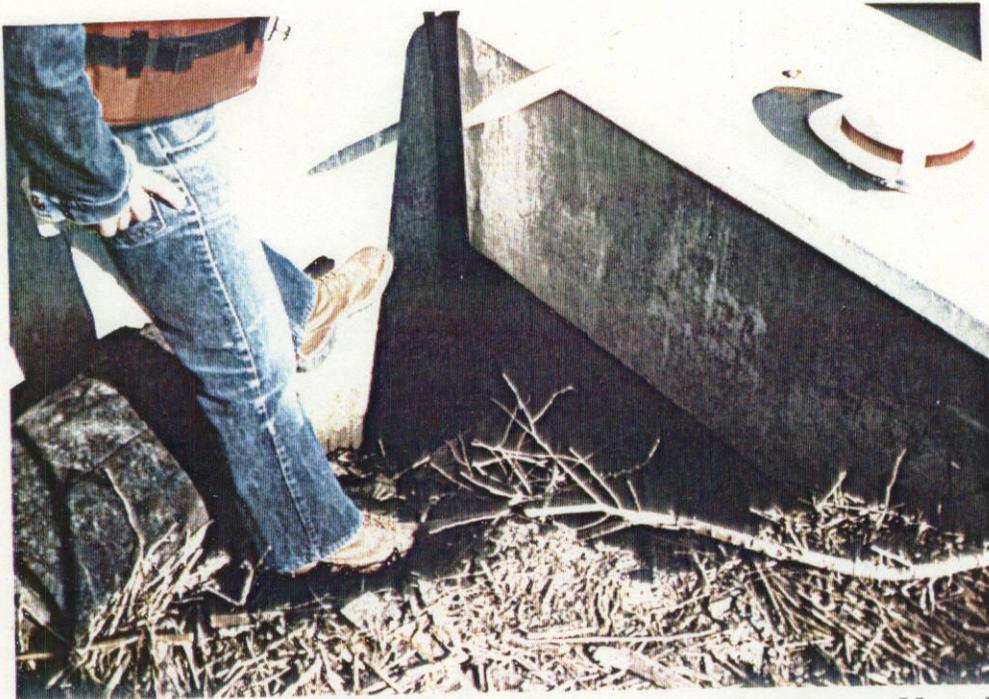
d. Condition of Horizontal and Vertical Joints. The joints between the wingwall and main structure on the southwest side of the structure appeared not to be watertight and soil was washing out of the backfill causing a void in the backfill behind the joint (See Photo 1). A close inspection of all wingwalls revealed that this condition was occurring at all similar joints. Further, the seal between the northwest wingwall and the structure has completely pulled away from the

PHOTO 1: Voids behind the joints between the wing wall and main structure (Typical)

b. In the last periodic inspection report, it was noted that the joint between the wingwall and main structure on the southwest side of the structure appeared not to be watertight and soil was leaching out of the backfill causing a void in the backfill behind the joint. A close inspection of all wingwalls revealed that this condition was occurring at all similar joints. Further, the seal between the northwest wingwall and the structure had completely pulled away from the structure. It was recommended that all joints be repaired and made water-tight and existing voids behind the walls be backfilled.

d. All floodwall and wingwall joints will be repaired and made *watertight. Vegetation will be removed from one of the expansion joints in the northwest floodwall.

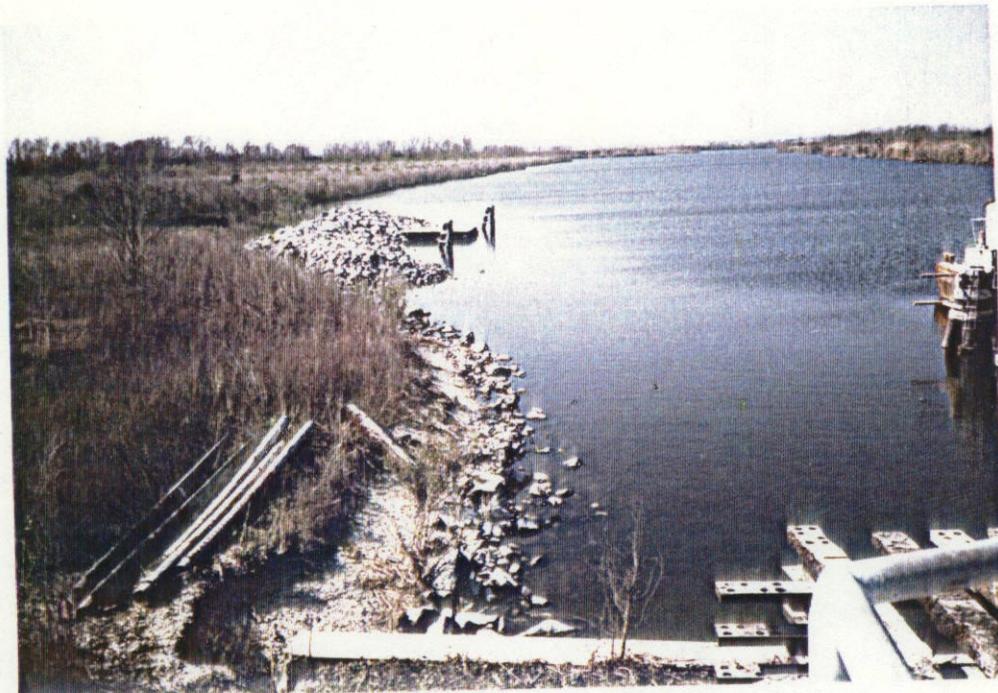
2. Riprap. The riprap is deficient along the banks of the north and south approach channels behind the guidewalls. (See photo 2).

PHOTO 2: Deficient rip-rap

c. As noted in the previous inspection, it was observed that riprap was missing in many areas near the top of the channel slopes and erosion was occurring where riprap was missing. Erosion was also occurring around the outer edges of the wingwalls. It was again recommended that the missing riprap along the upperbank slopes be replaced and additional riprap placed at the outer edges of the wingwalls to prevent further erosion.

*f. Riprap, identical in gradation and blanket thickness to that placed when the structure was originally built, will be replaced in deficient areas near the banks of the north and south approach channels behind the guidewalls.
