LAKE PONTCHARTRAIN, LOUISIANA AND VICINITY

CHALMETTE AREA PLAN

**BAYOU BIENVENUE
CONTROL STRUCTURE**

PERIODIC INSPECTION REPORT NO. 5

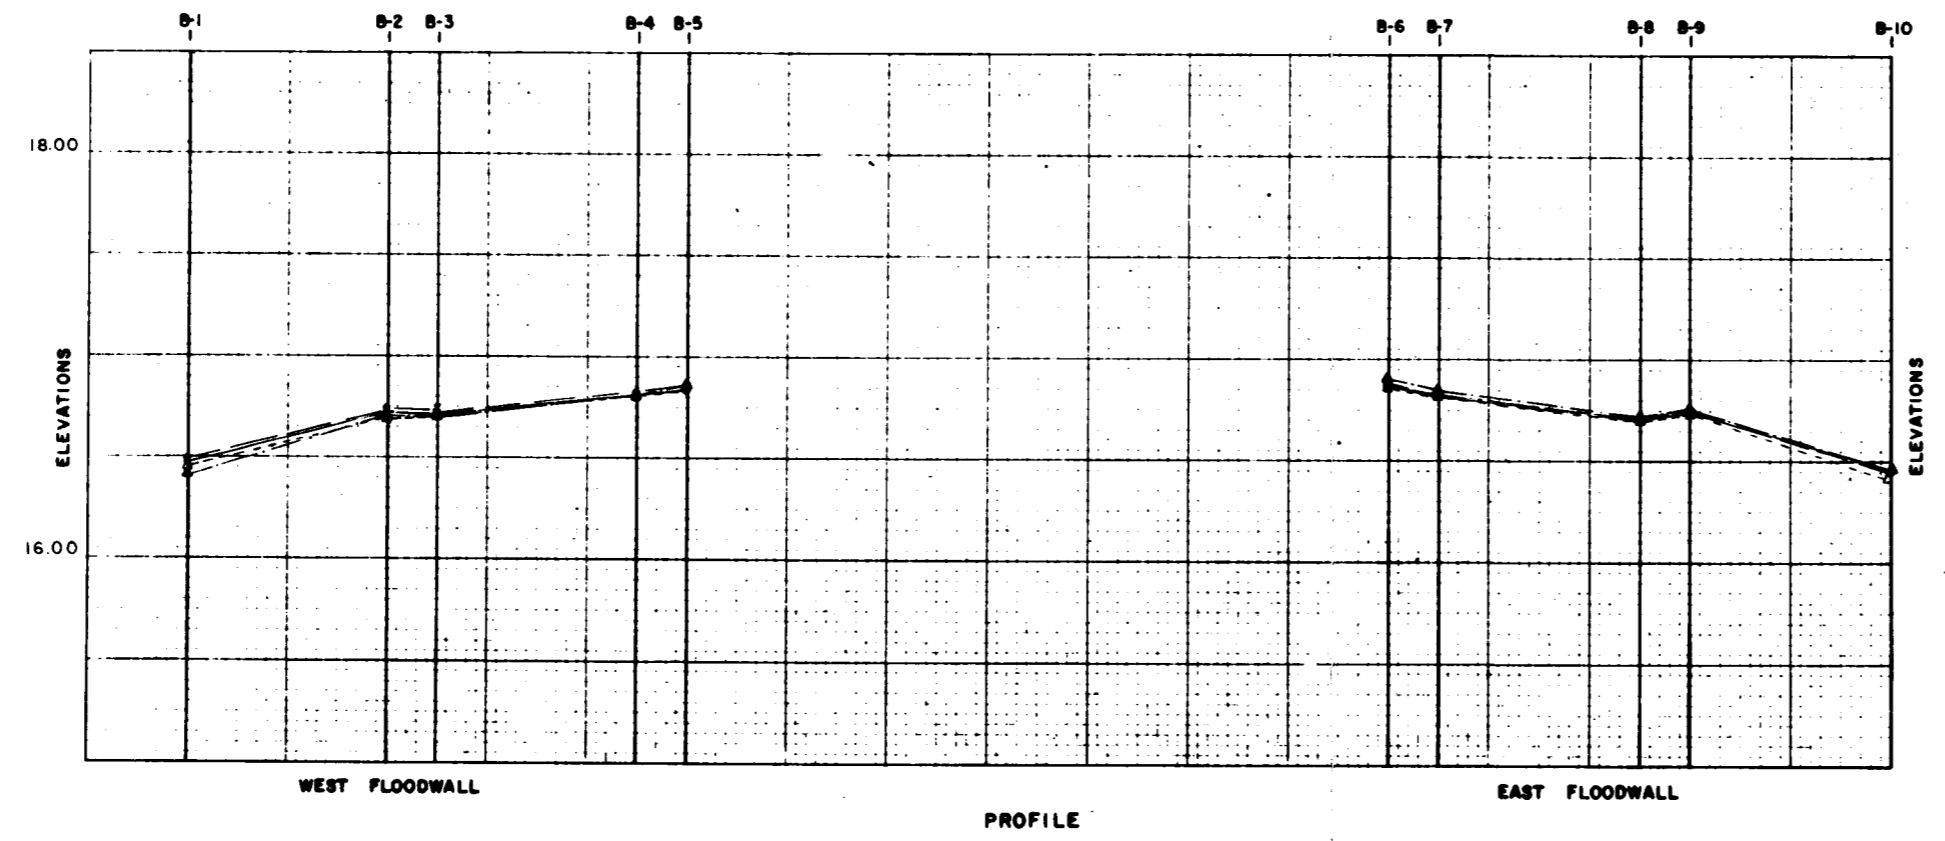
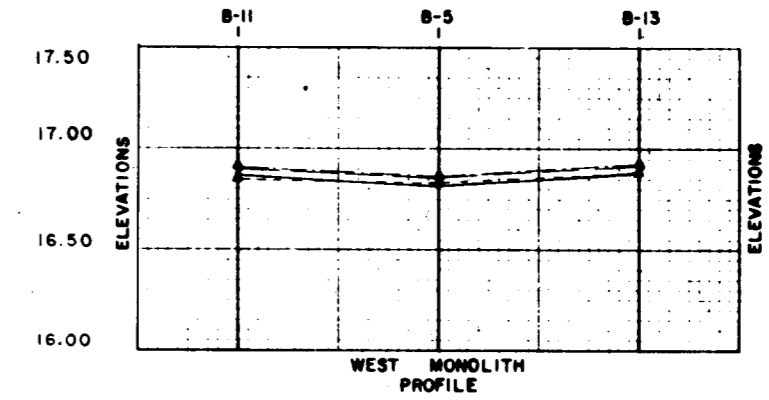
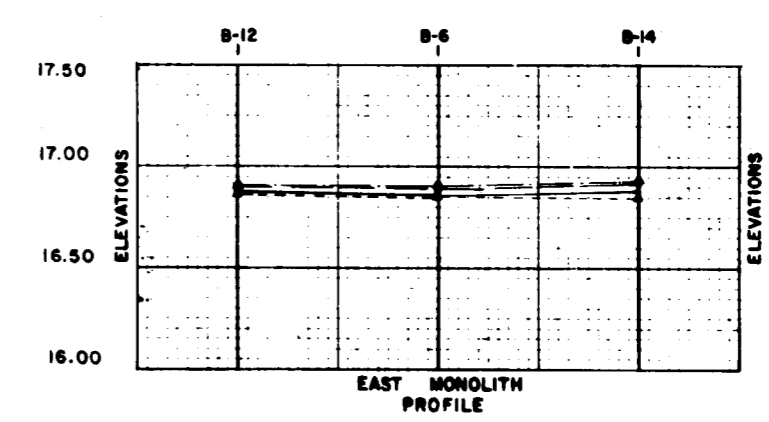
LAKE PONTCHARTRAIN AND VICINITY
 BAYOU BIENVENUE
 PERIODIC INSPECTION
SETTLEMENT REFERENCE MARKS
 PLAN AND PROFILE
 U.S. ARMY ENGINEER DISTRICT, NEW ORLEANS
 CORPS OF ENGINEERS
 FILE NO. H-4-28857

a. Settlement Survey. Present survey, dated 25 February 1988, indicates no unusual settlement or rebound at any point of the structure. (See Plates 2 thru 7).

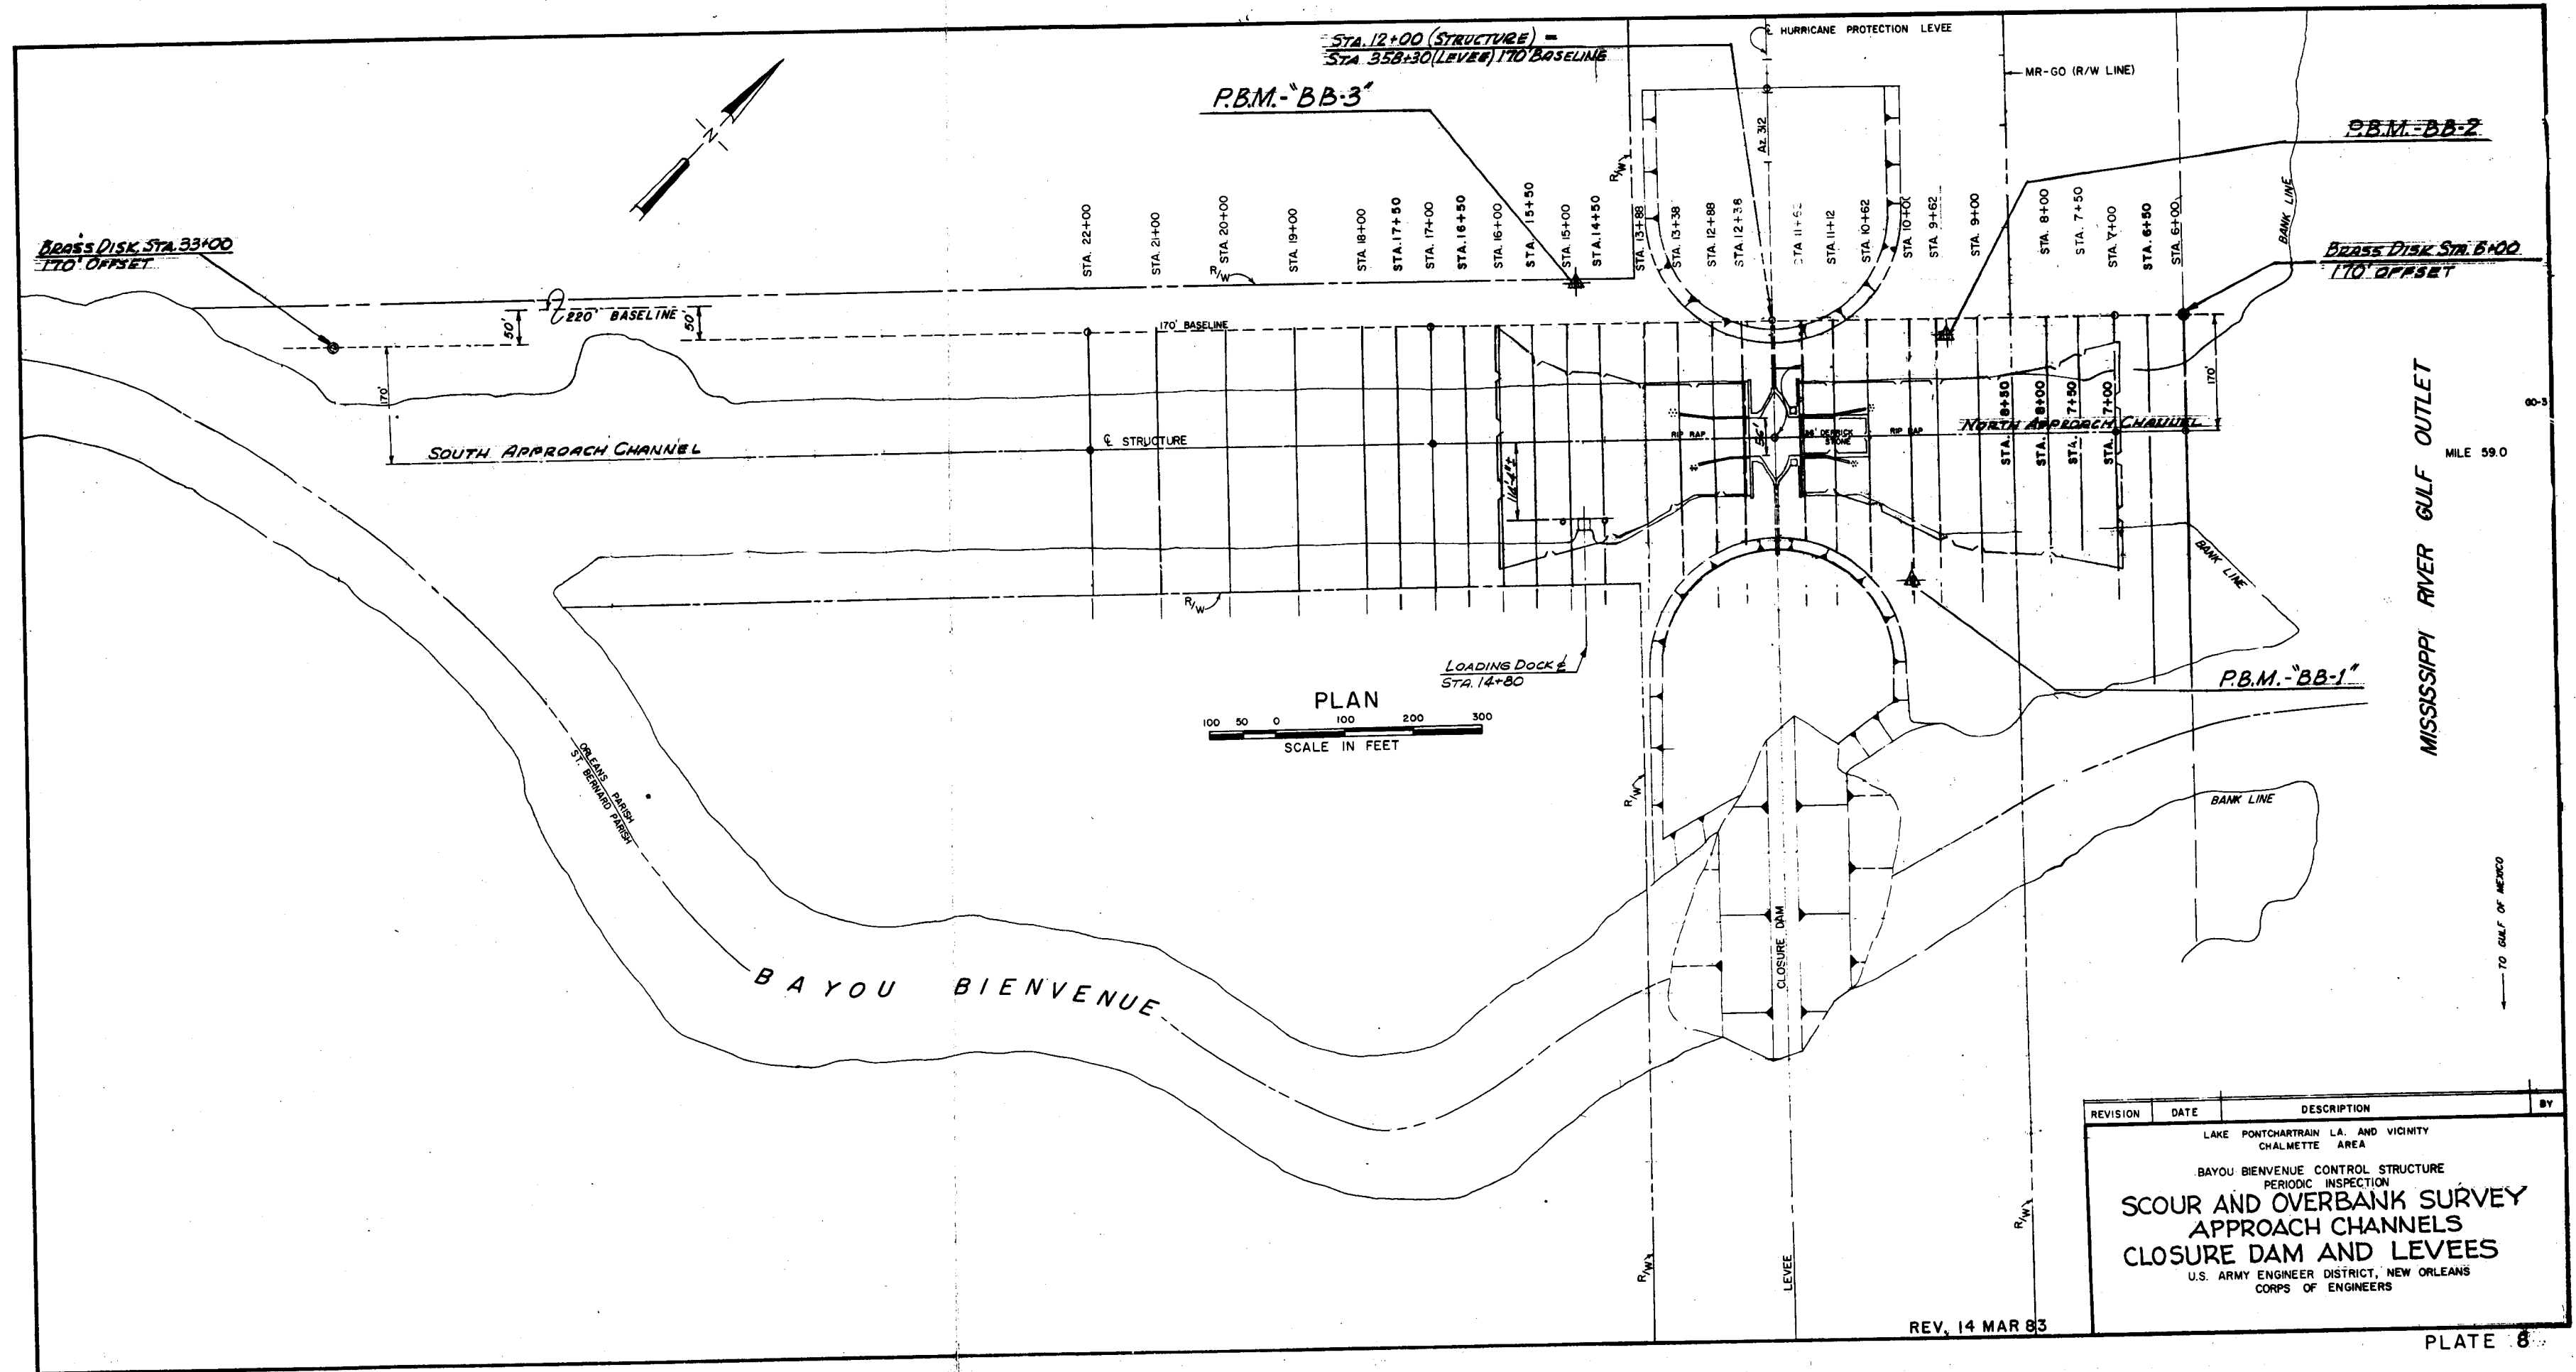
REVISION	DATE	DESCRIPTION	BY
		LAKE PONTCHARTRAIN L.A. AND VICINITY CHALMETTE AREA	
		BAYOU BIENVENUE CONTROL STRUCTURE PERIODIC INSPECTION	
		SCOUR AND OVERBANK SURVEY	
		APPROACH CHANNELS	
		CLOSURE DAM AND LEVEES	
		U.S. ARMY ENGINEER DISTRICT, NEW ORLEANS	
		CORPS OF ENGINEERS

b. Scour. In the north approach channel, scour of about 4 feet is indicated for most of the cross sections. No significant changes are indicated for the remaining sections. Stone movement is evident between Stations 8+00 and 9+00 near the west side of the channel. Appreciable scour has occurred in the south approach channel between Stations 16+00 to 19+50. Scour holes of 6 feet and 9 feet are indicated at Stations 16+50 and 17+00 respectively. This scour is far away and does not

endanger the integrity and safety of the structure at this time. The scour will be monitored very closely in future surveys. (See Plates 8 thru 18).

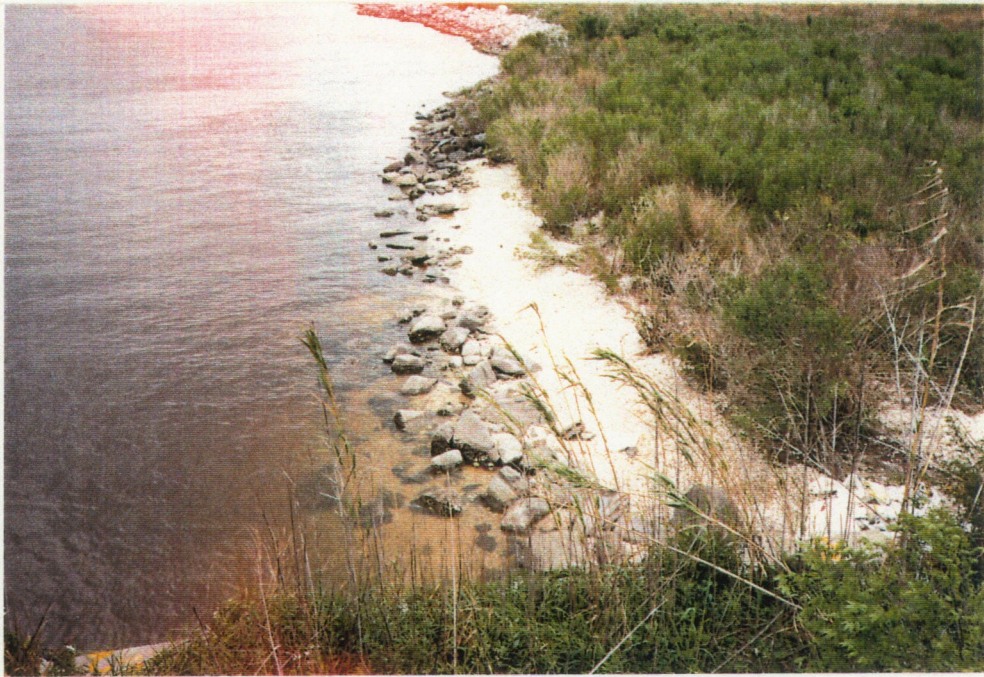
b. Para. 6-02a, page VI-1. Upon further investigation, it
was concluded that no deficiency exists with regard to riprap
design. The riprap has not been replenished since construction
in the early 1970's. Based on a comparison to similar structures
in the area, this lifespan for forebay/tailbay bank protection is
normal. The Orleans Levee Board's schedule for riprap replacement
is uncertain. Although they have started plans and specifications
for the job, the project has been afforded a low priority because
of manpower and fiscal constraints. Since the rock depletion poses
no current threat to the structure, it has been categorized as
routine maintenance, to be accomplished according to maintenance
priorities. The situation will be monitored in the interim period
to assure the safety of the structure.

b. Para 6-02a, page VI-1. Prior to preparation of plans and specifications, you should determine the reason displacement of the riprap protection occurred and then size (blanket thickness and gradation) the replacement stone to ensure that a similar deficiency does not reoccur at this location. The results of this determination should be documented in this report to help ensure that local interests will adequately repair these deficient areas.

- a. The riprap along the banks of the north and south approach channels behind the guidewalls is deficient. See Photo No. 1.
- b. A navigation light on the northeast timber guide was broken.
- c. The ladder attached to the west sector gate was corroded at the tidal zone.
- d. Rust spots were found at the tidal zone on the structural steel members of the east sector gate.
- e. The steel plates attached to the needle girder recesses were corroded.
- f. All staff gages on the structure need to be cleaned and repaired.
- g. The differential settlement between reference marks B8 & B9 has not increased since the last inspection. This was a point of previous concern.
- h. The gates and electrical equipment were in good operating condition.

Photo 1-Deficient Riprap(Typical for the banks along the north and south approach channels)

a. Plans and specifications are being prepared to install riprap along the banks of the north and south approach channels behind the guidewalls. This work is estimated for completion in the 4th Quarter of FY 89.
