**LAKE PONTCHARTRAIN, LOUISIANA & VICINITY
CHALMETTE AREA PLAN**

**BAYOU BIENVENUE CONTROL
STRUCTURE**

PERIODIC INSPECTION REPORT NO. 9

28 APRIL 2004

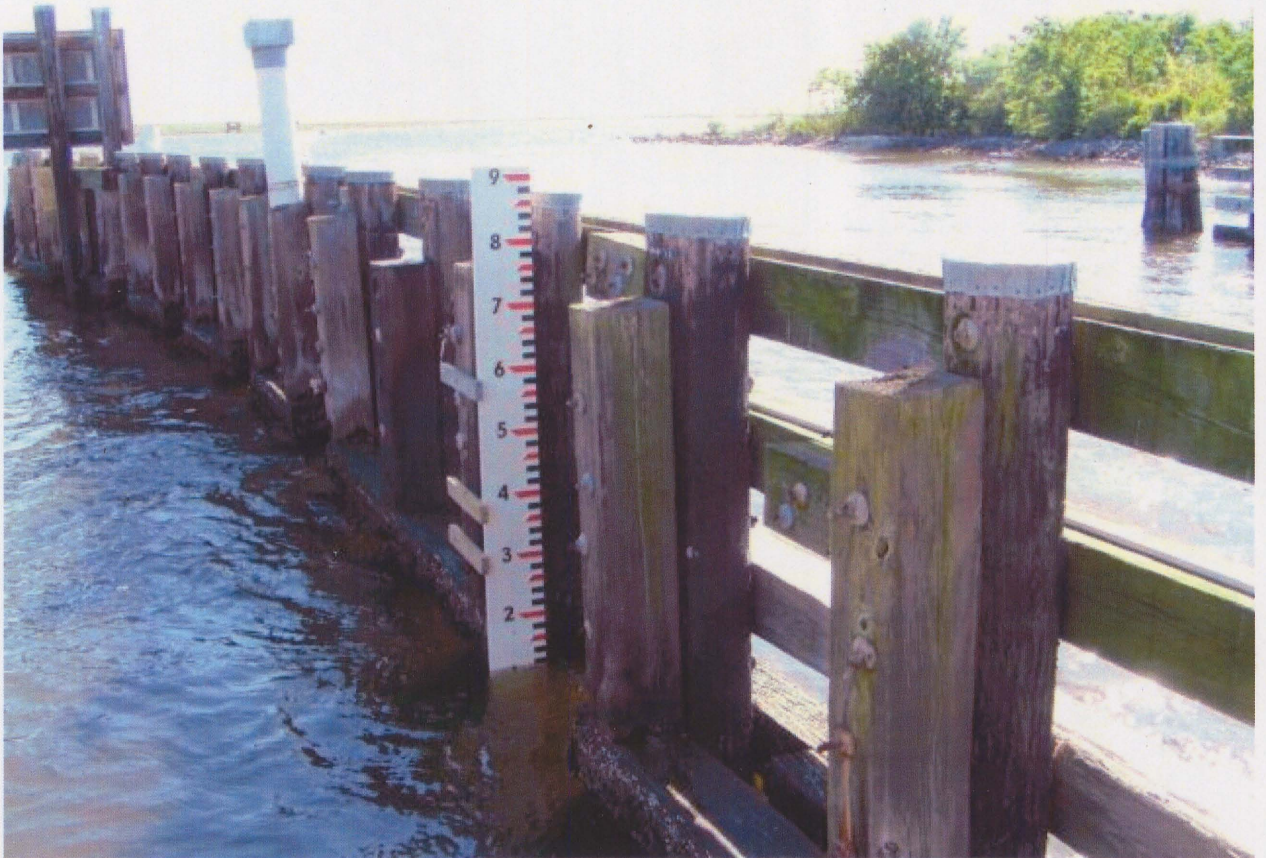
Photo No. 1 – Staff gage (typical condition).

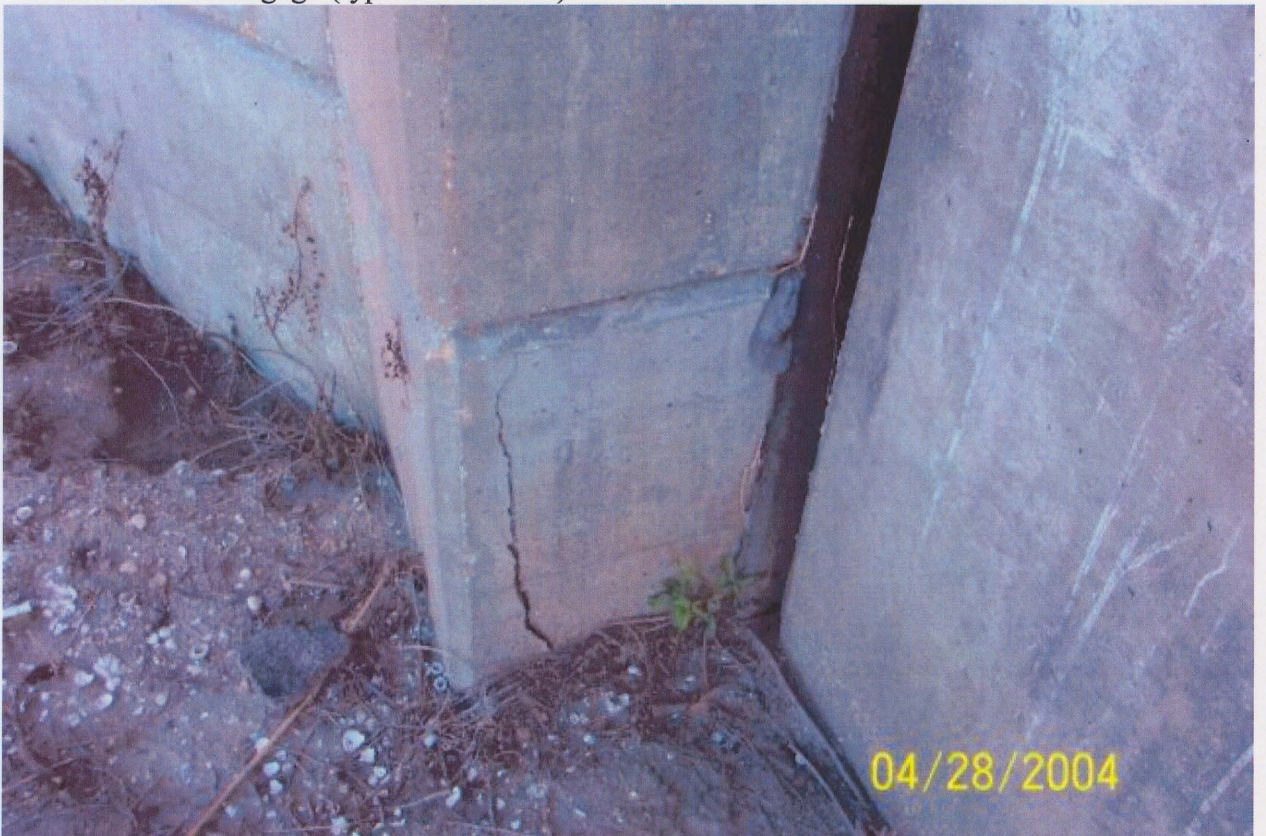
Photo No. 2 – Structural crack noted in the east gate bay monolith, just adjacent to the inverted “T” Floodwall.

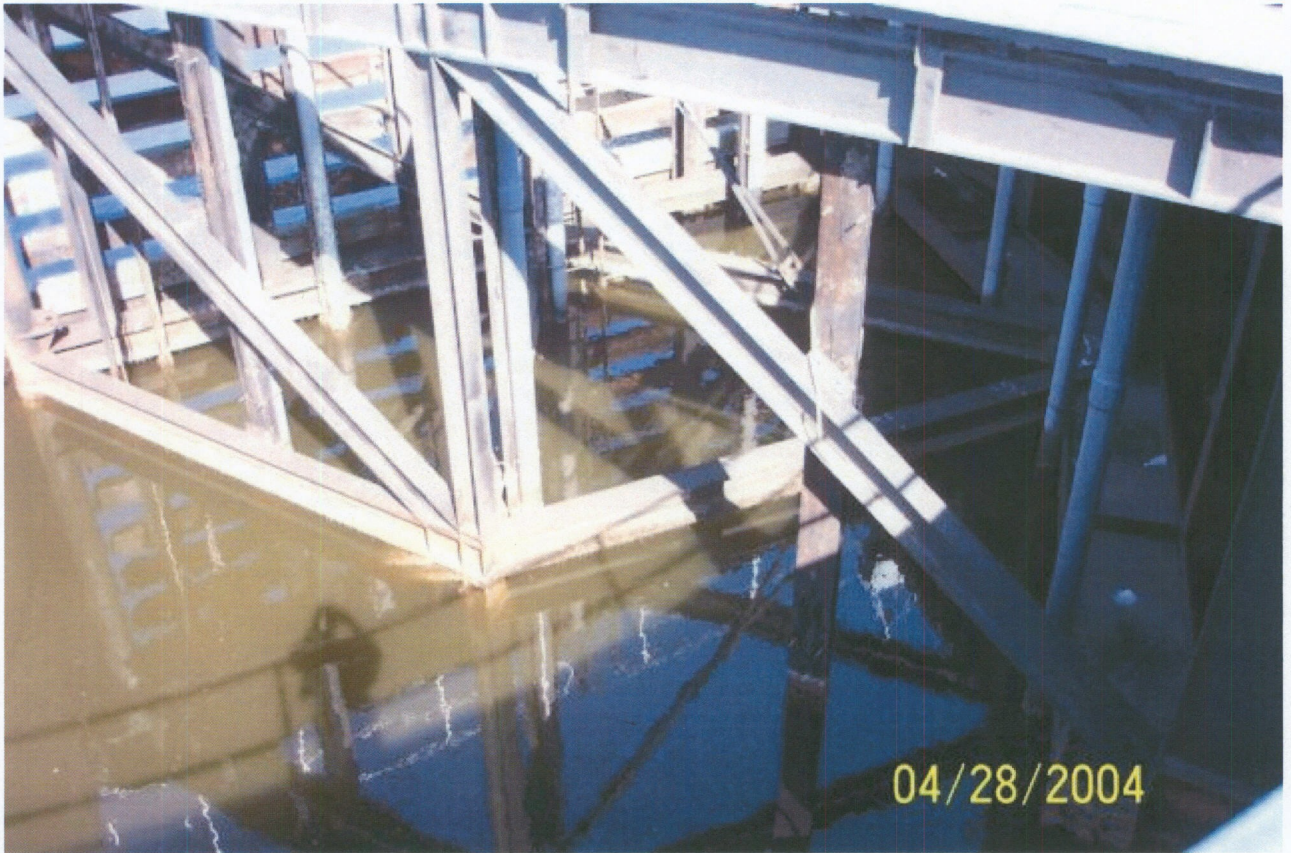
Photo No. 3 – Sector gate members; corrosion at waterline noted.

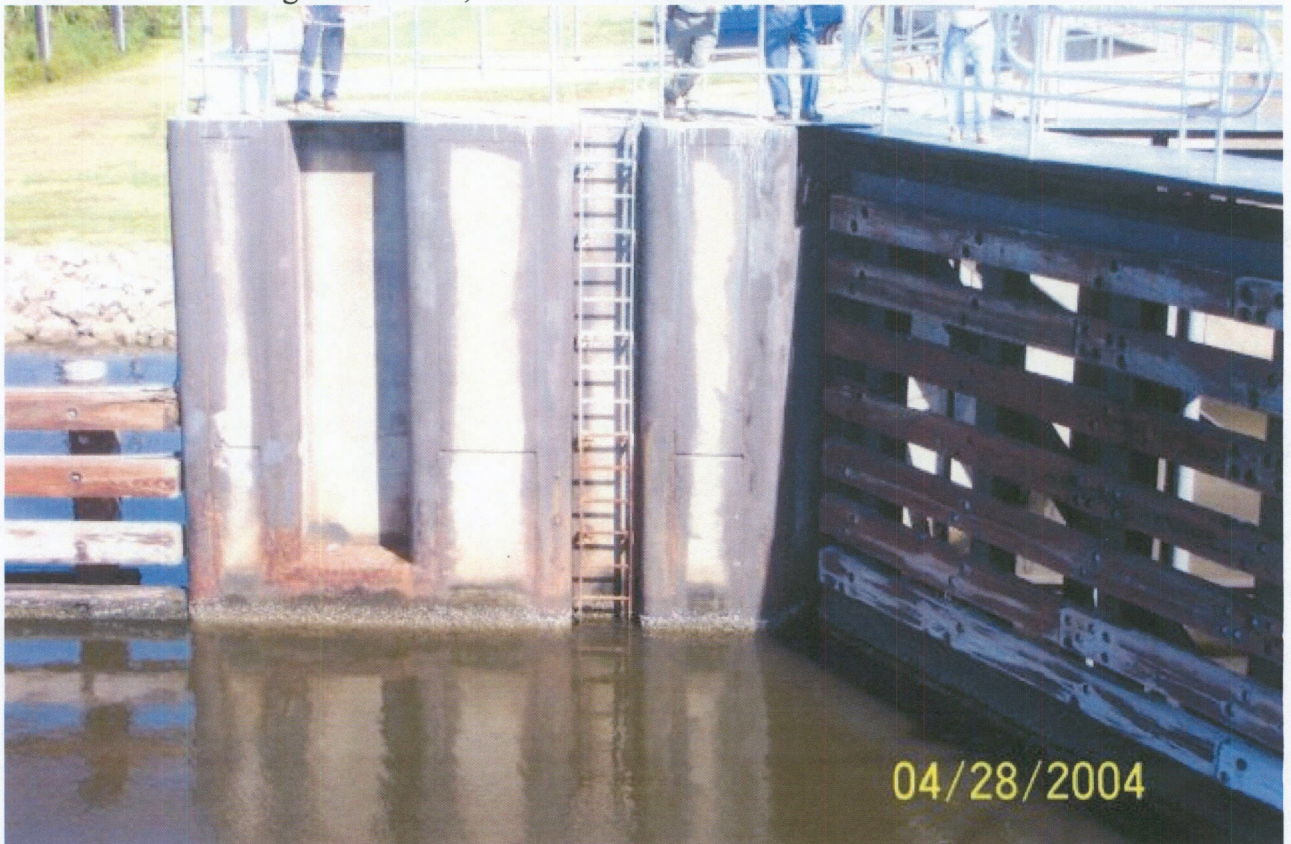
c. Corroded areas on embedded metals above the normal waterline shall be cleaned and painted by March 2000. ***The embedded metals have not been cleaned and repainted based on the results of the inspection (see photo no.4).***

Photo No. 4 – Corrosion of the ladder, corner protection and needle beam recess noted.

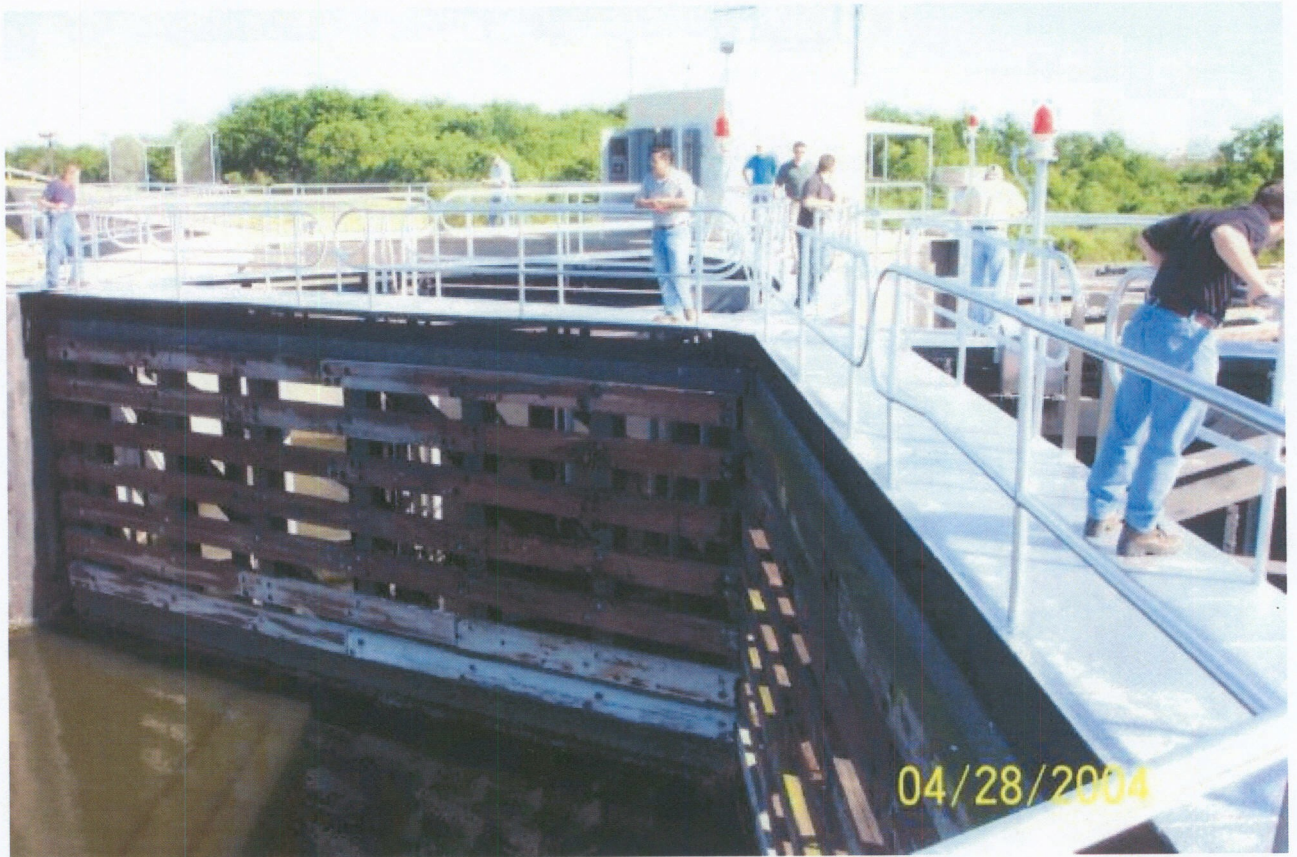
Photo No. 5 – Steel walkways and handrails noted in excellent condition

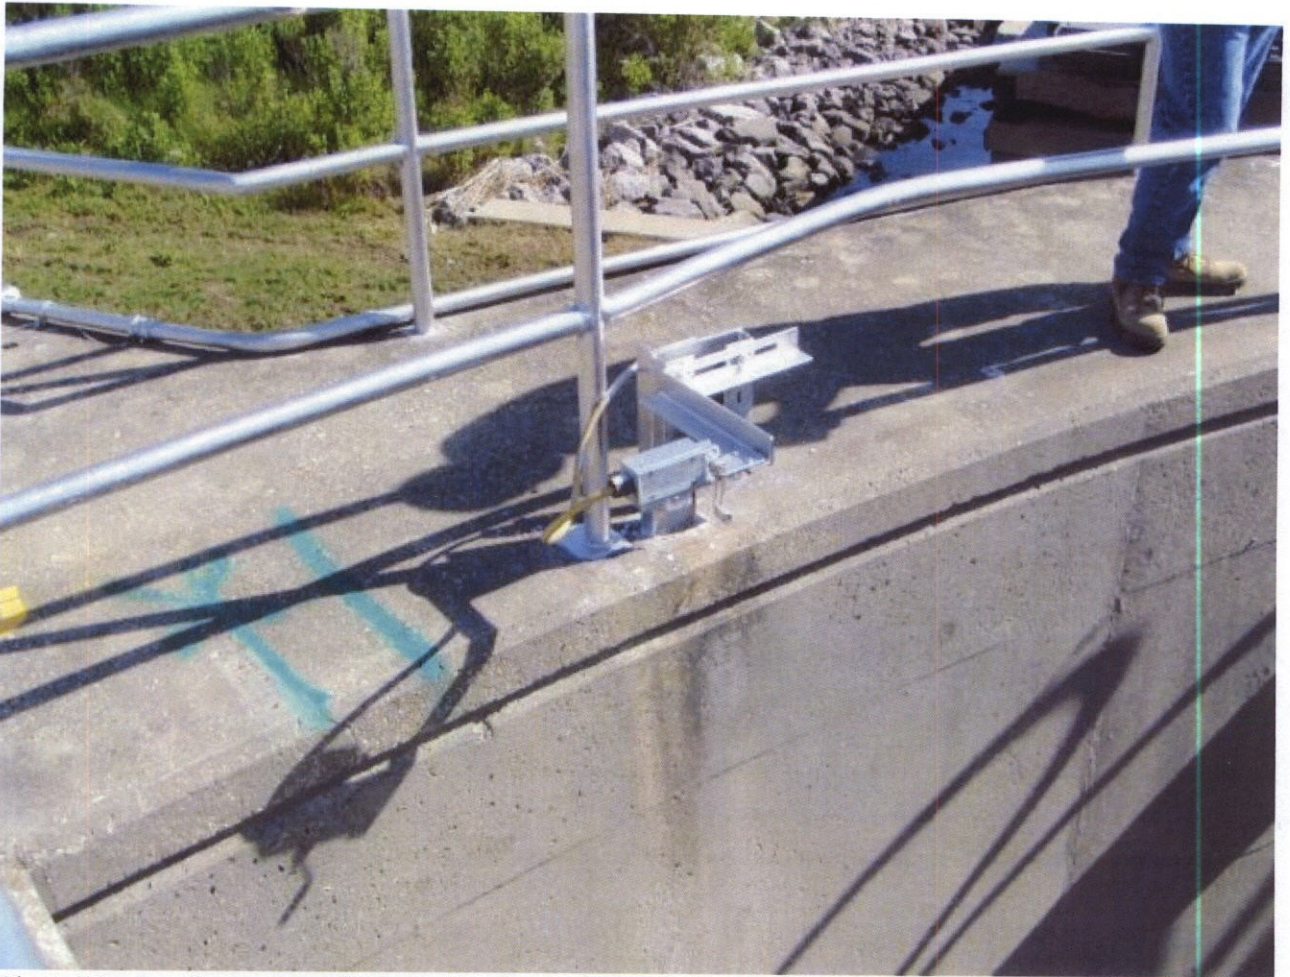
Photo No. 7 - Sector gate limit switch (typical condition).

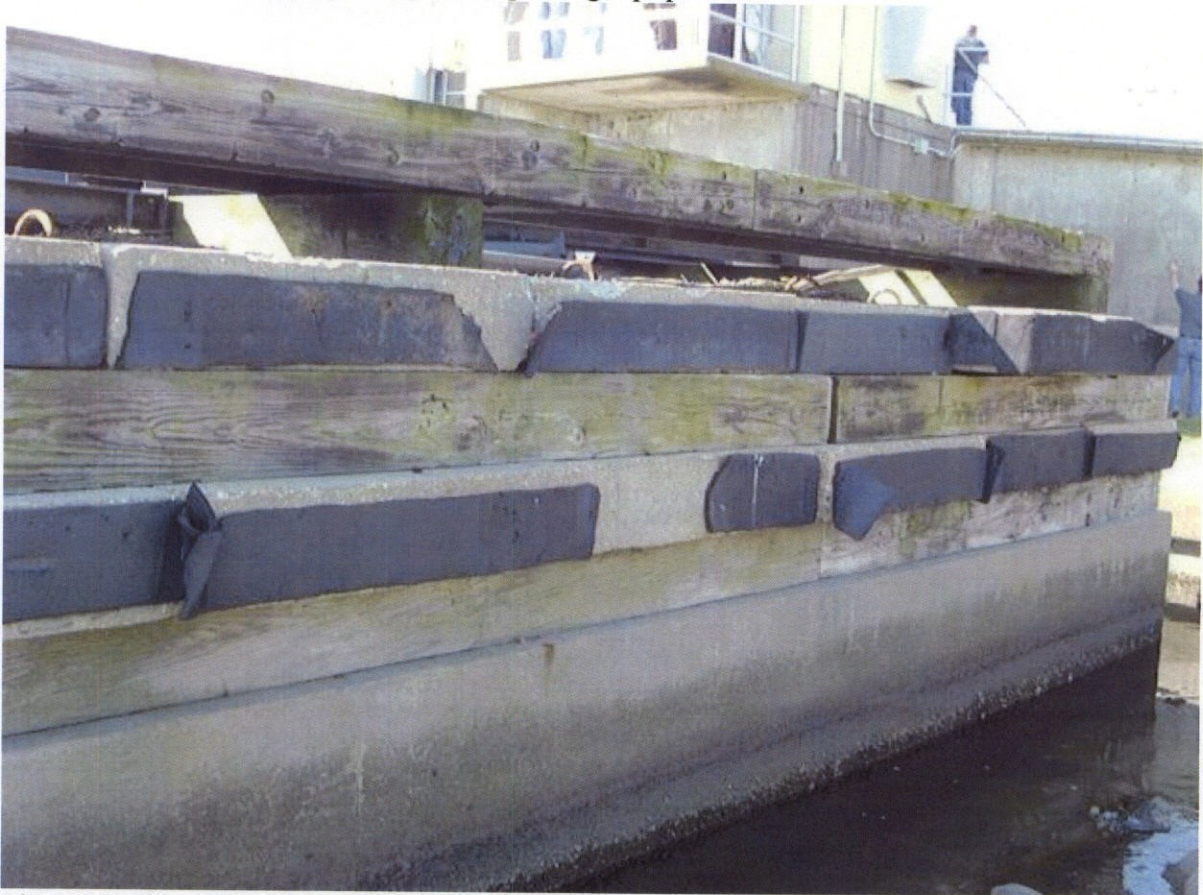
Photo No. 18 – Concrete needles with noted damage to the rubber seals.

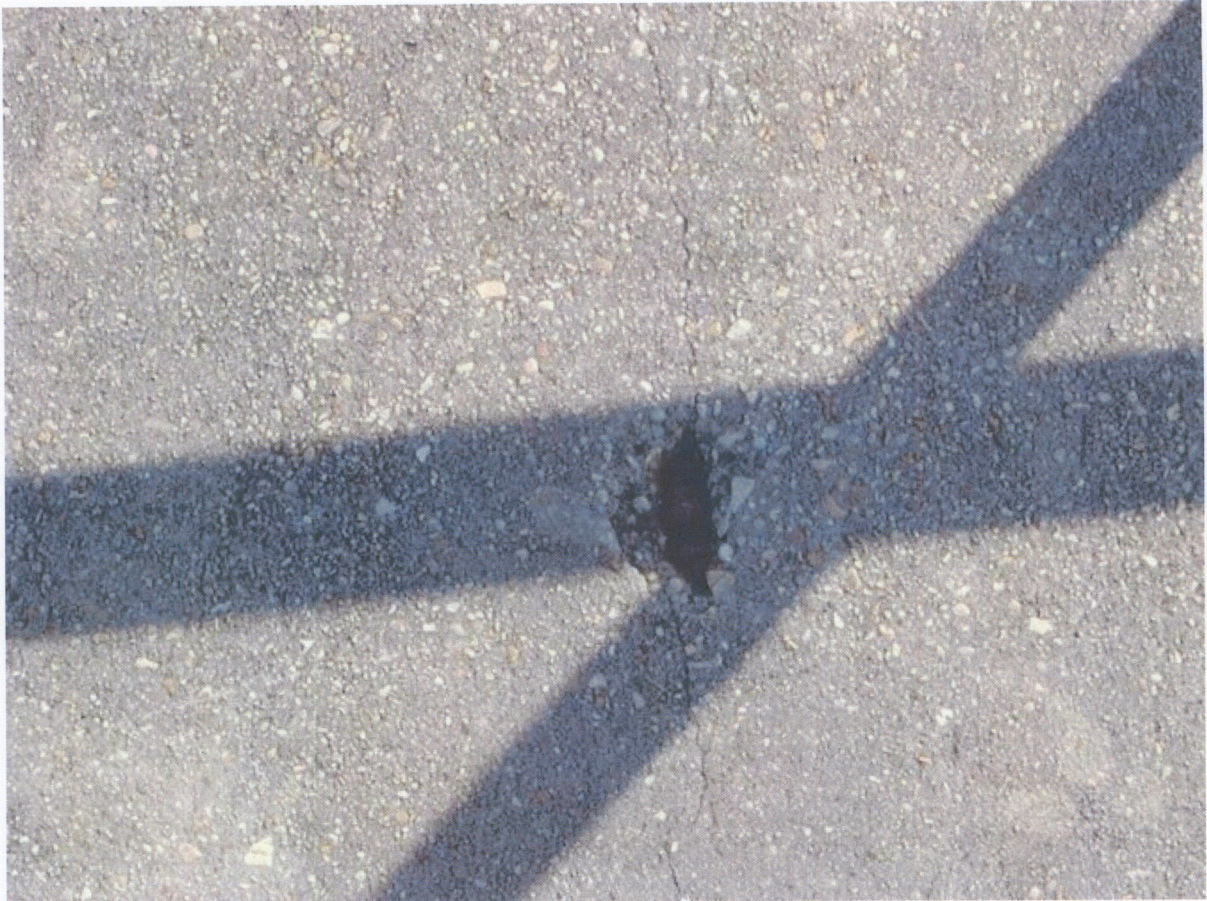
Photo No. 19 - Exposed rebar on the walkway atop the inverted west "T" floodwall.

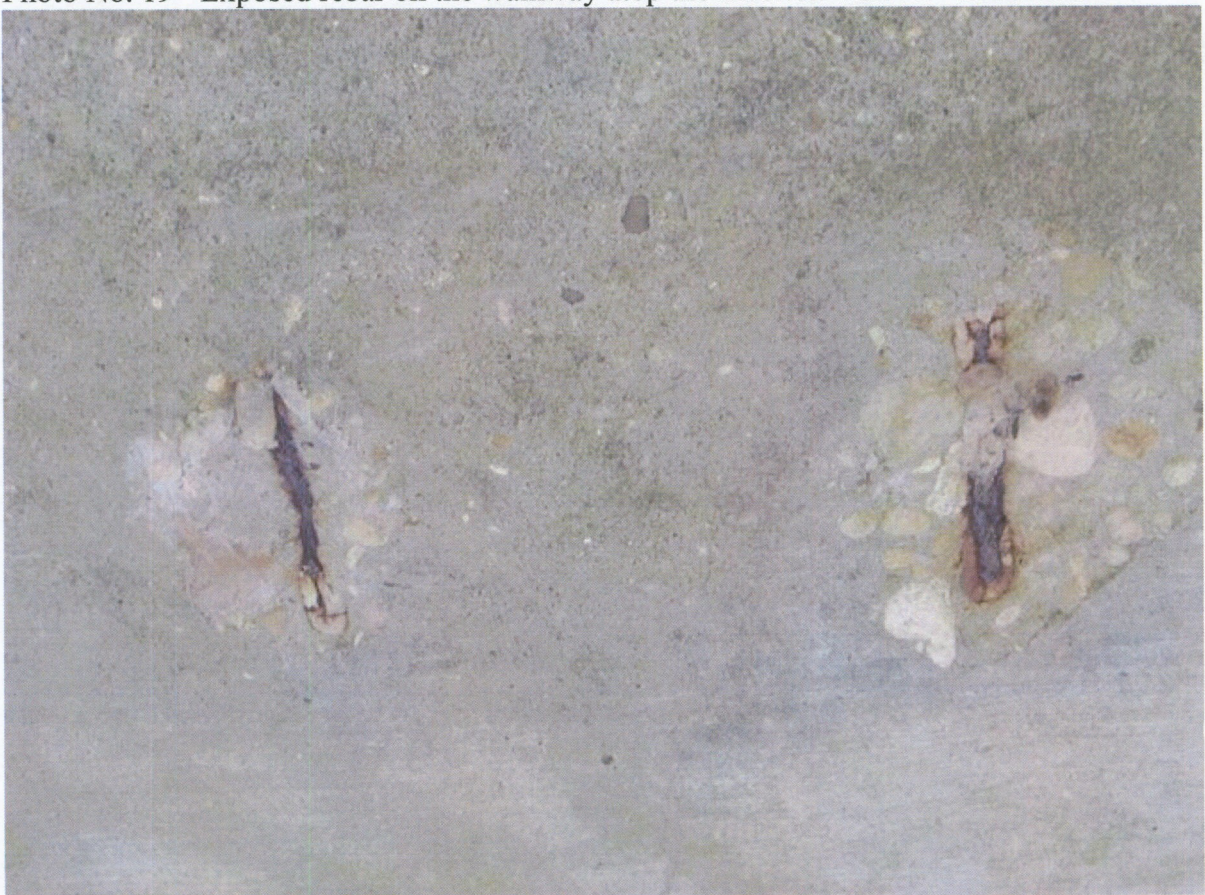
Photo No. 20 – Rebar chair corrosion noted on the inverted west "T" floodwall, flood side.

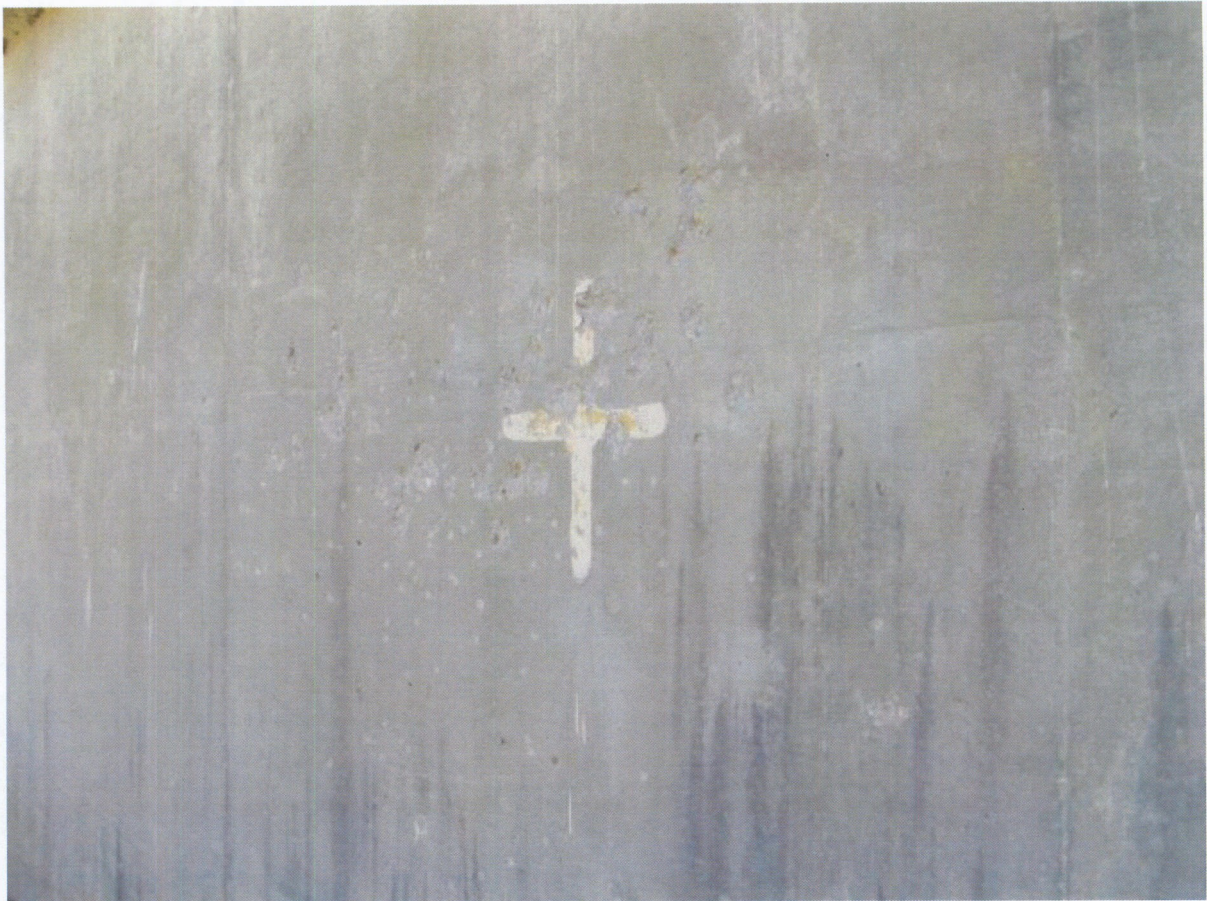
Photo No. 21 – Gunfire damage on the inverted east “T” floodwall, protected side.

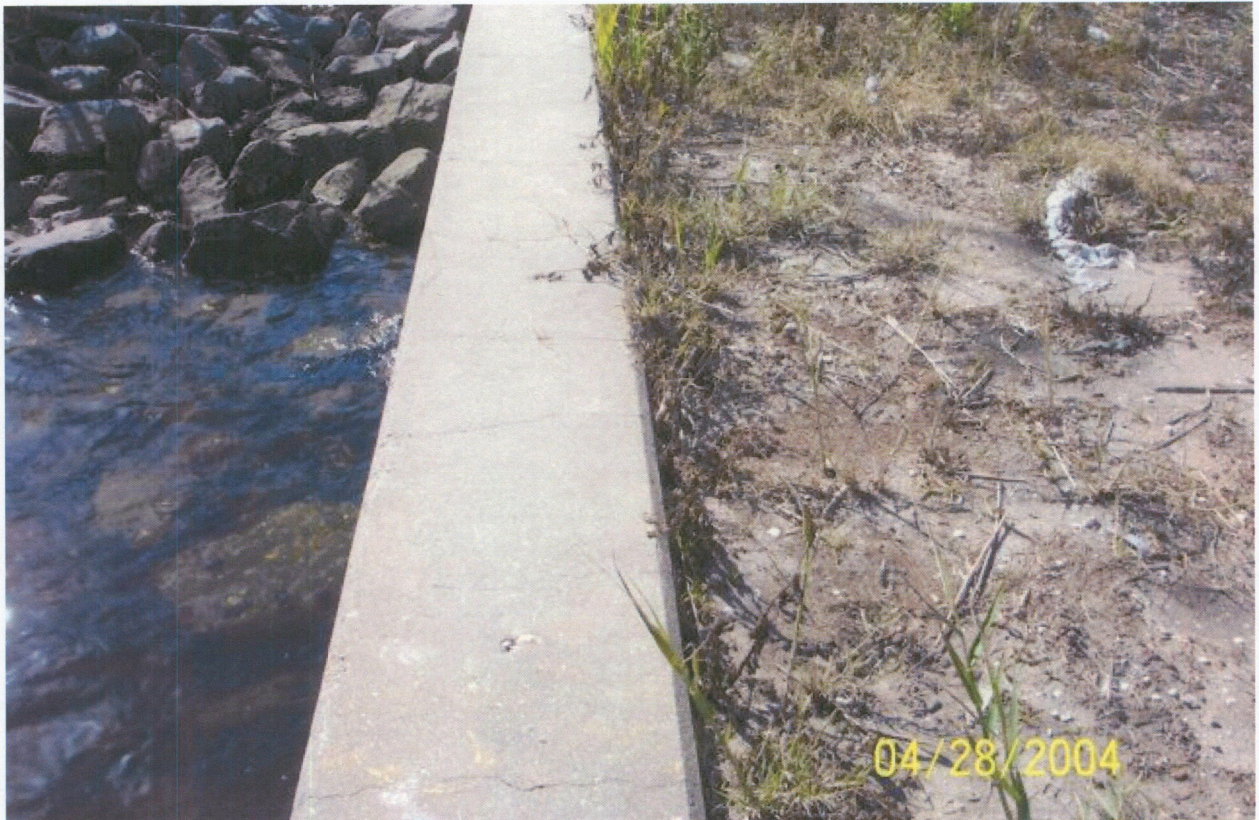
Photo No. 22 – Cracks observed on a wing wall. (Typical).

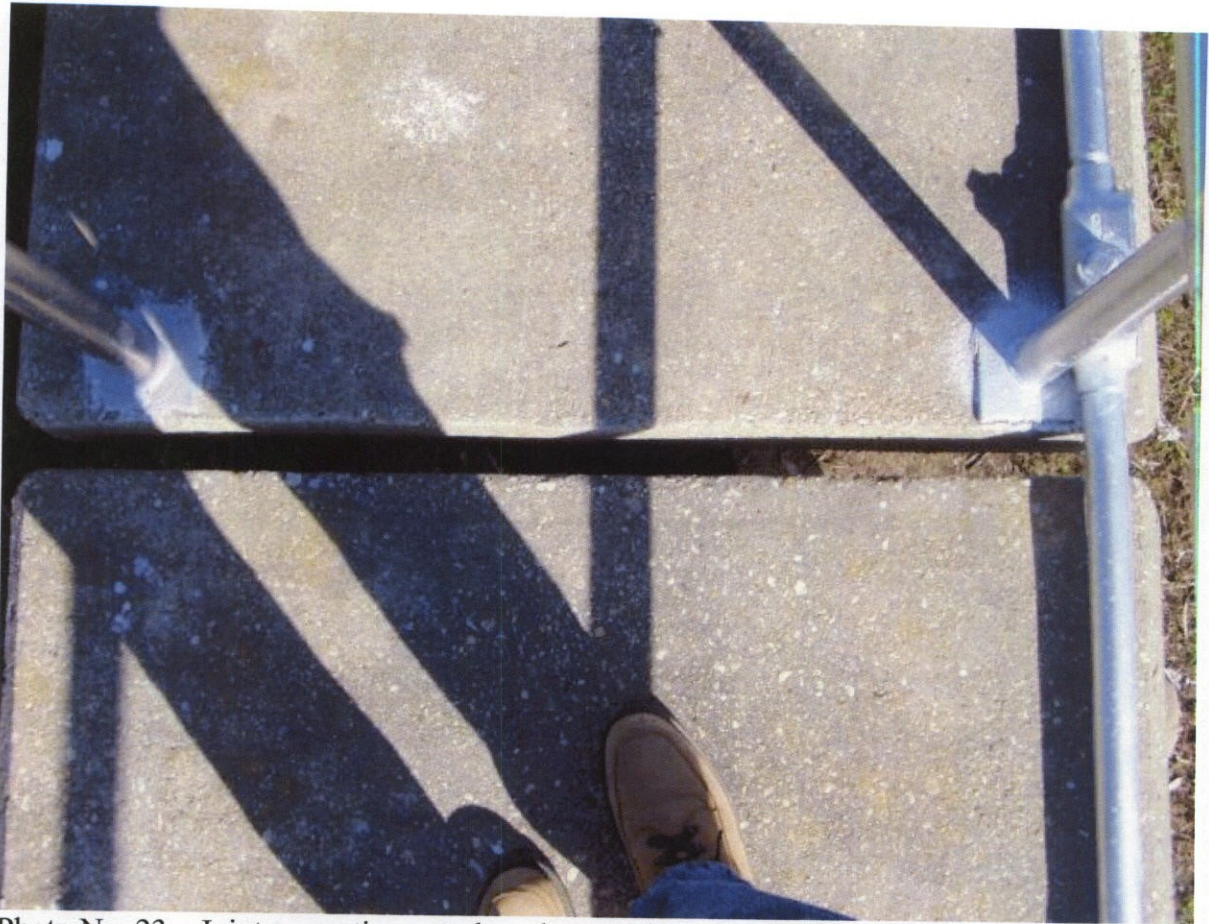
Photo No. 23 – Joint separation noted on the west inverted “T” floodwall.

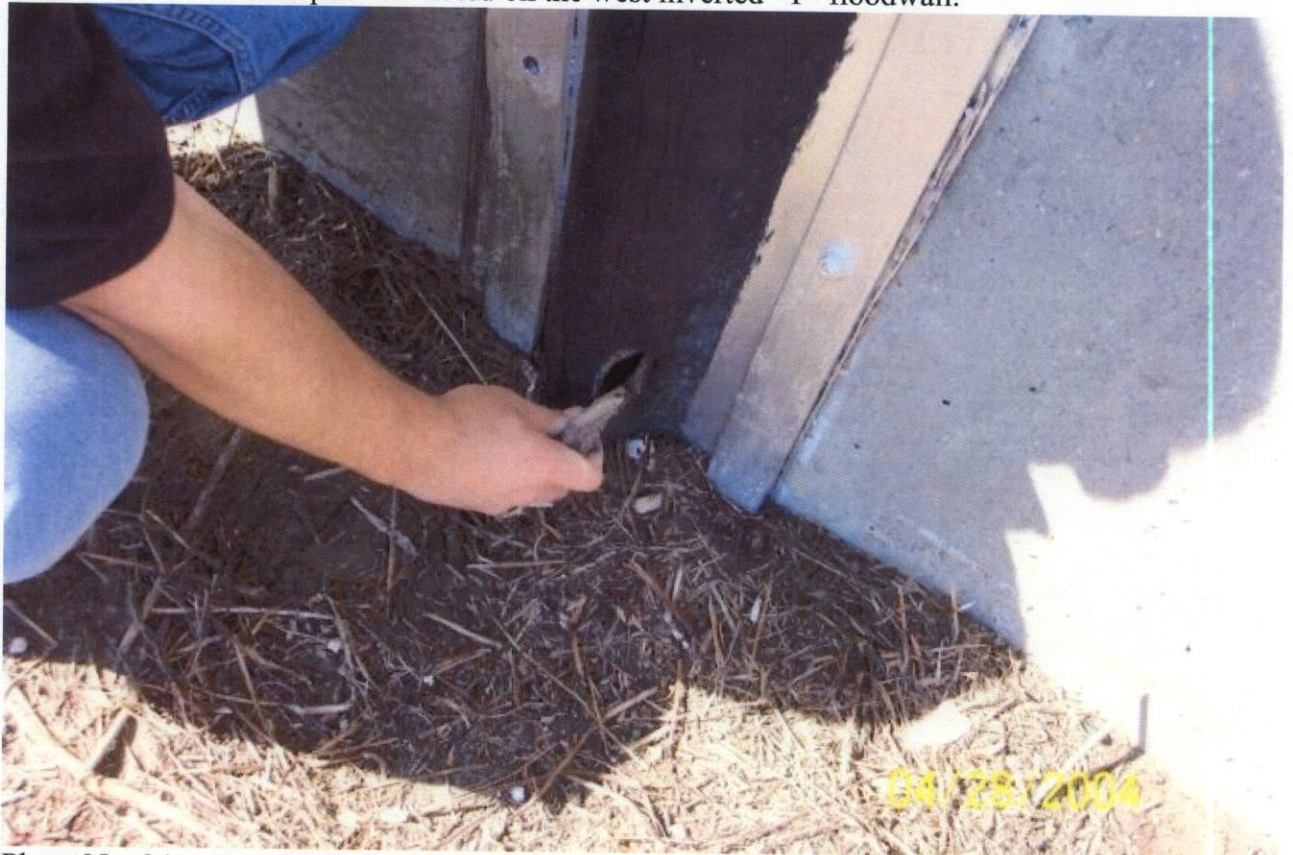
Photo No. 24 – Torn Monolith joint seal.

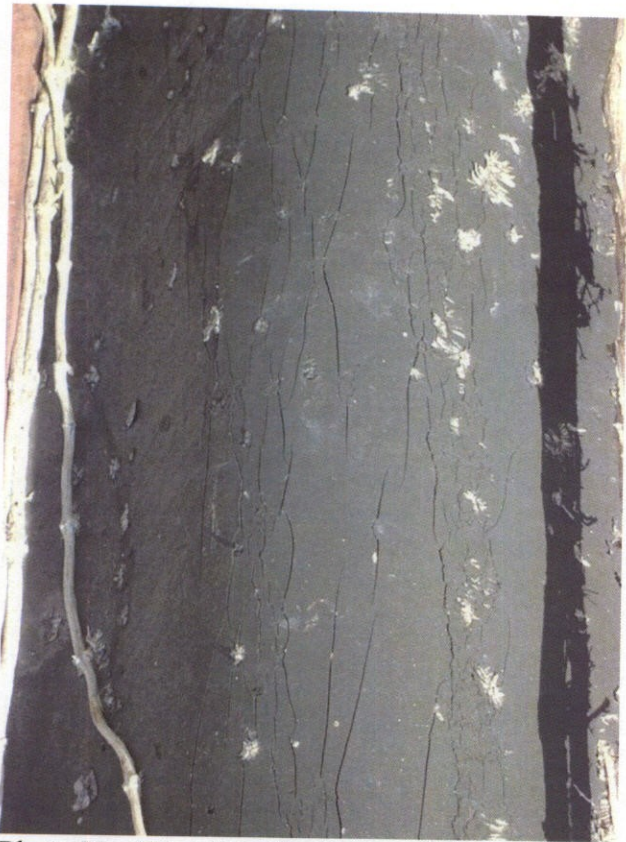
Photo No. 25 – Weathering condition of a monolith joint seal. (Typical).

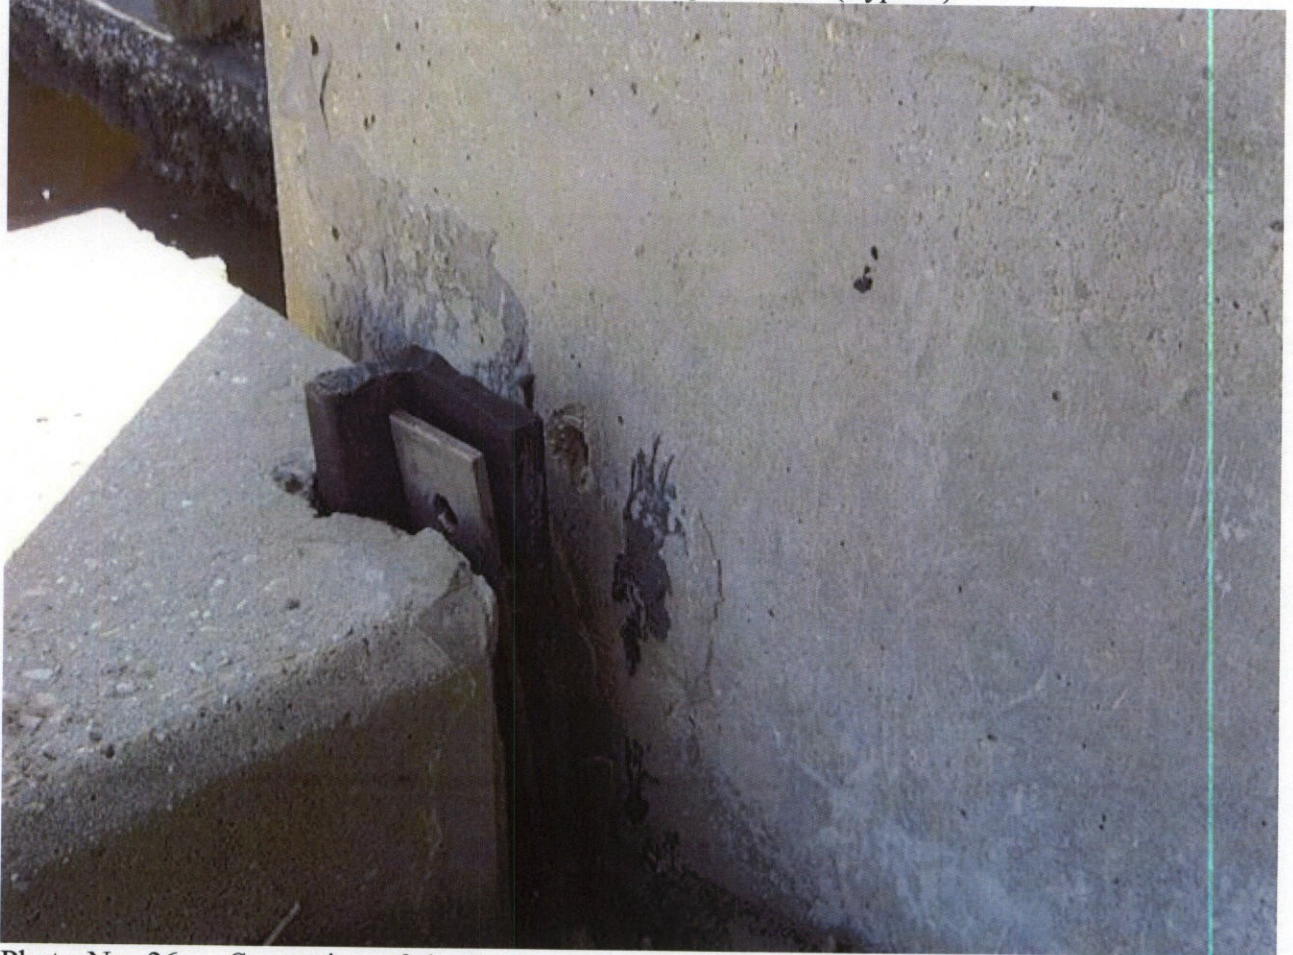
Photo No. 26 – Separation of the L-type waterstop between the west flood side wing wall and structure.

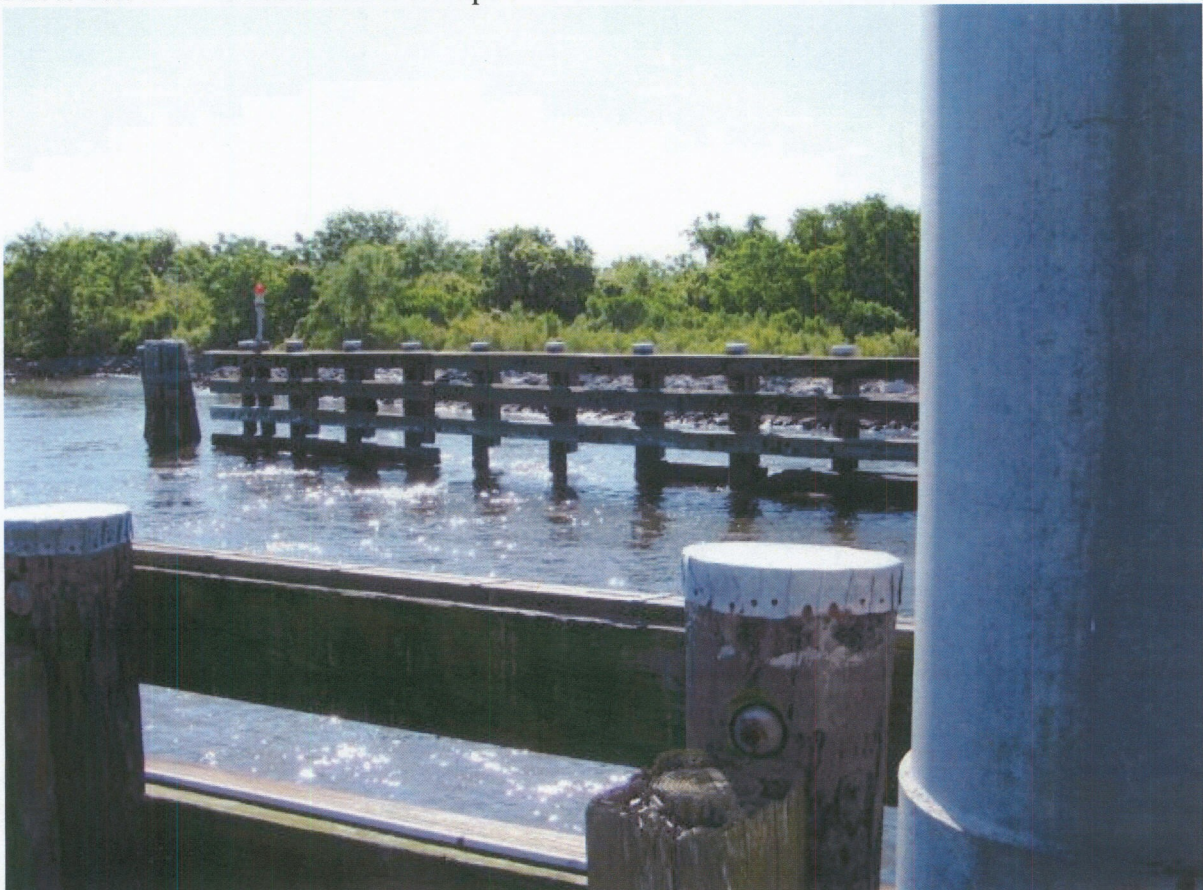
Photo No. 28 – Missing wales noted near the waterline of the northeast guidewall.

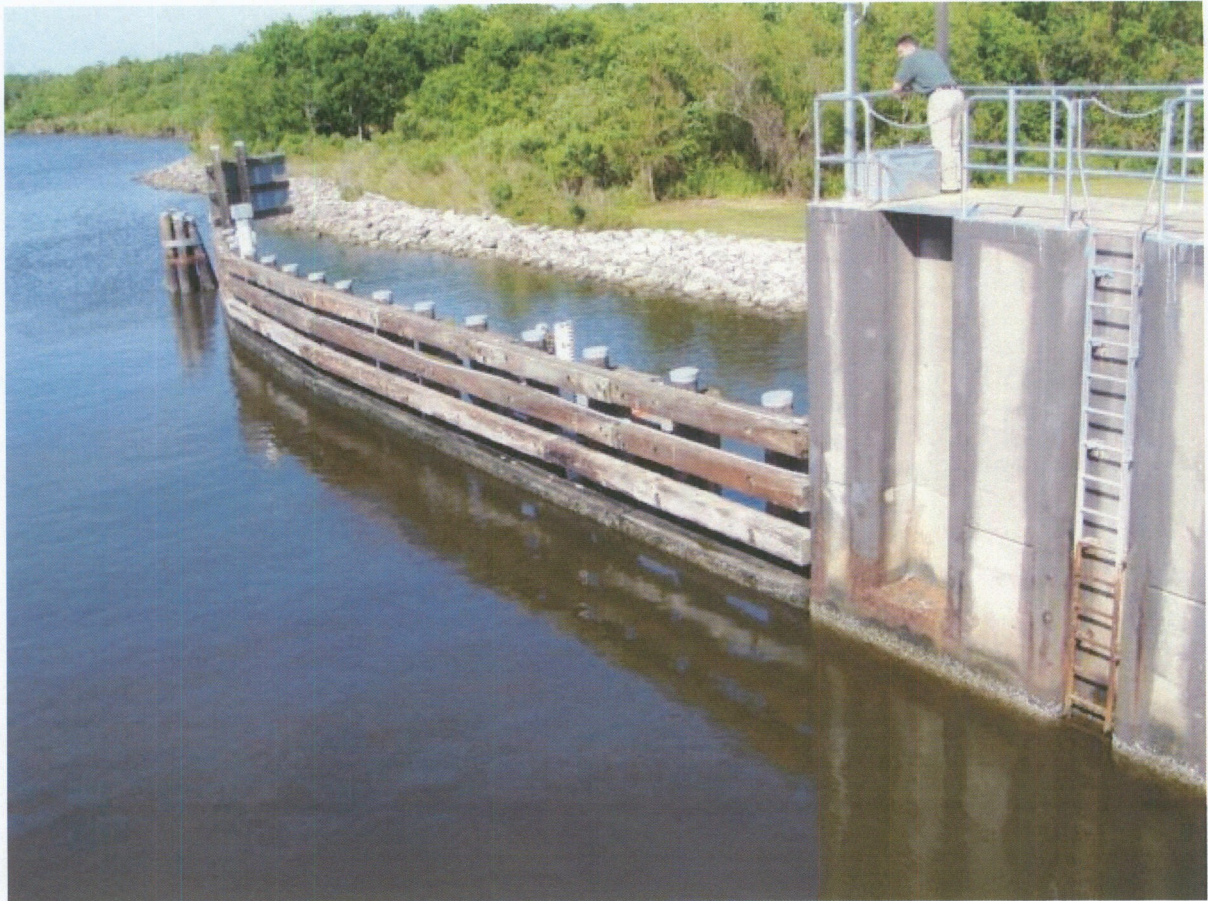
Photo No. 29 – Southwest guidewall noted in good condition.

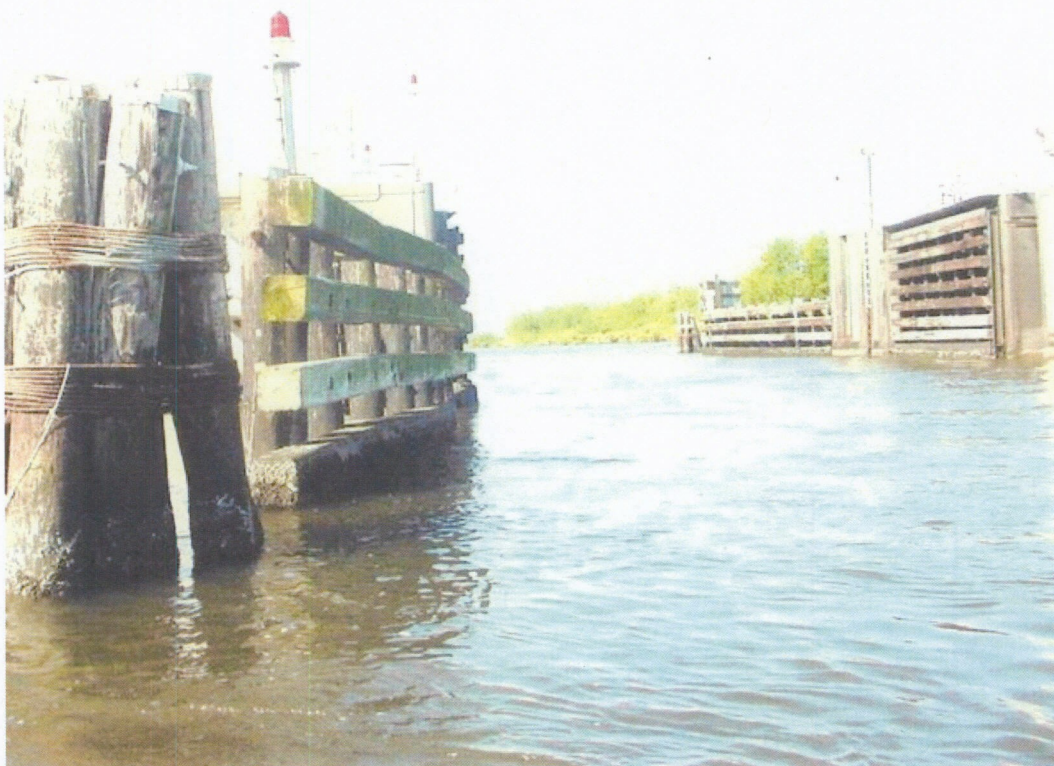
Photo No. 30 – Broken pile noted in the northeast dolphin.

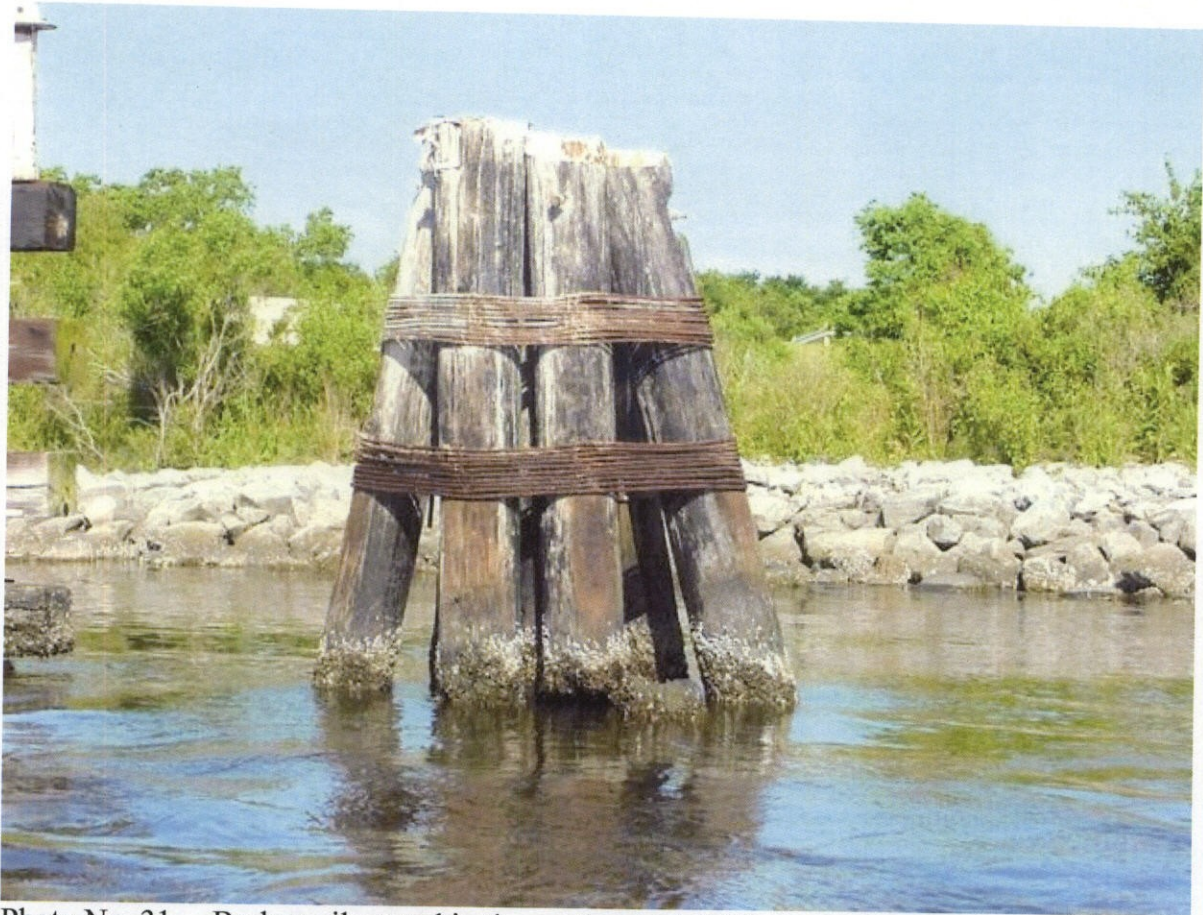
Photo No. 31 – Broken pile noted in the northwest dolphin.

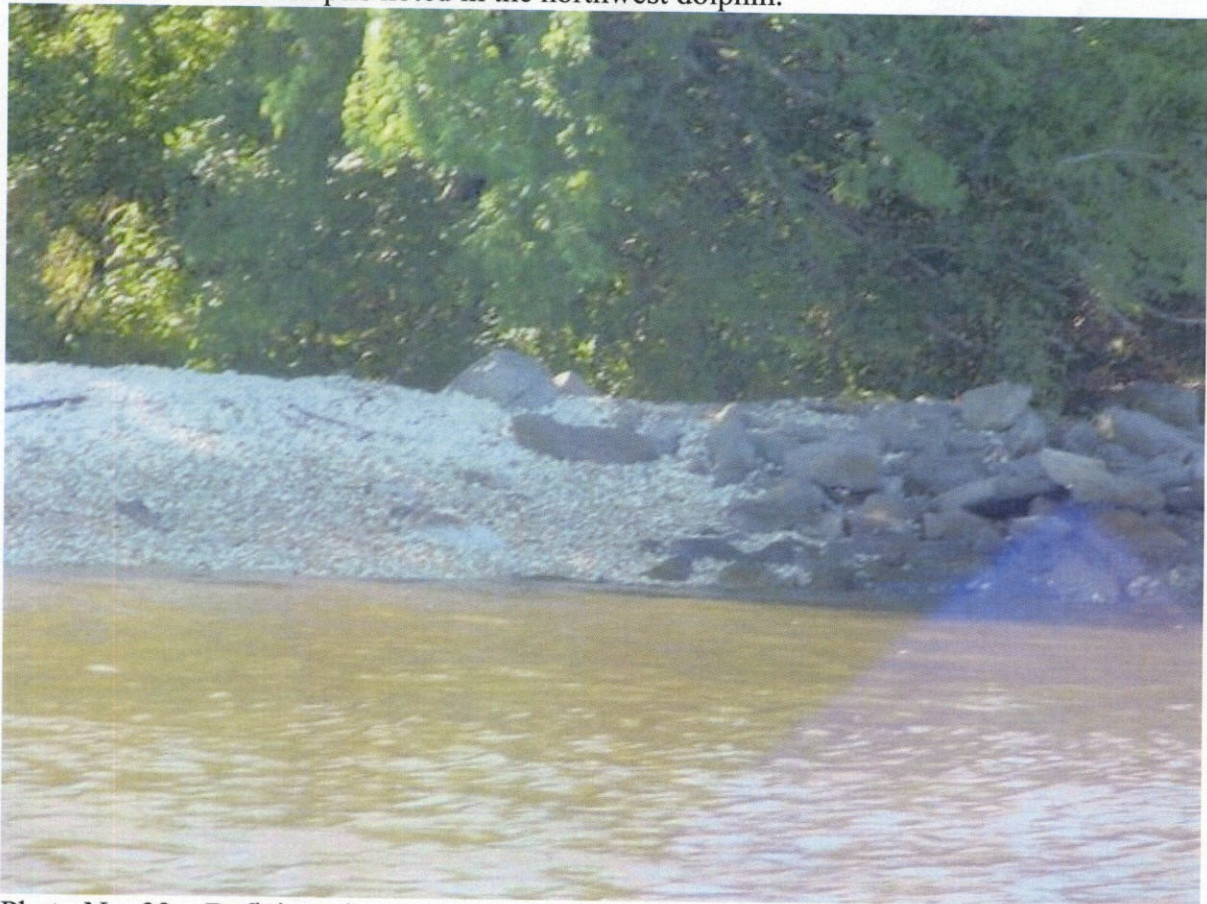
Photo No. 32 – Deficient rip rap slope protection noted on the east channel slope, floodside side of structure.

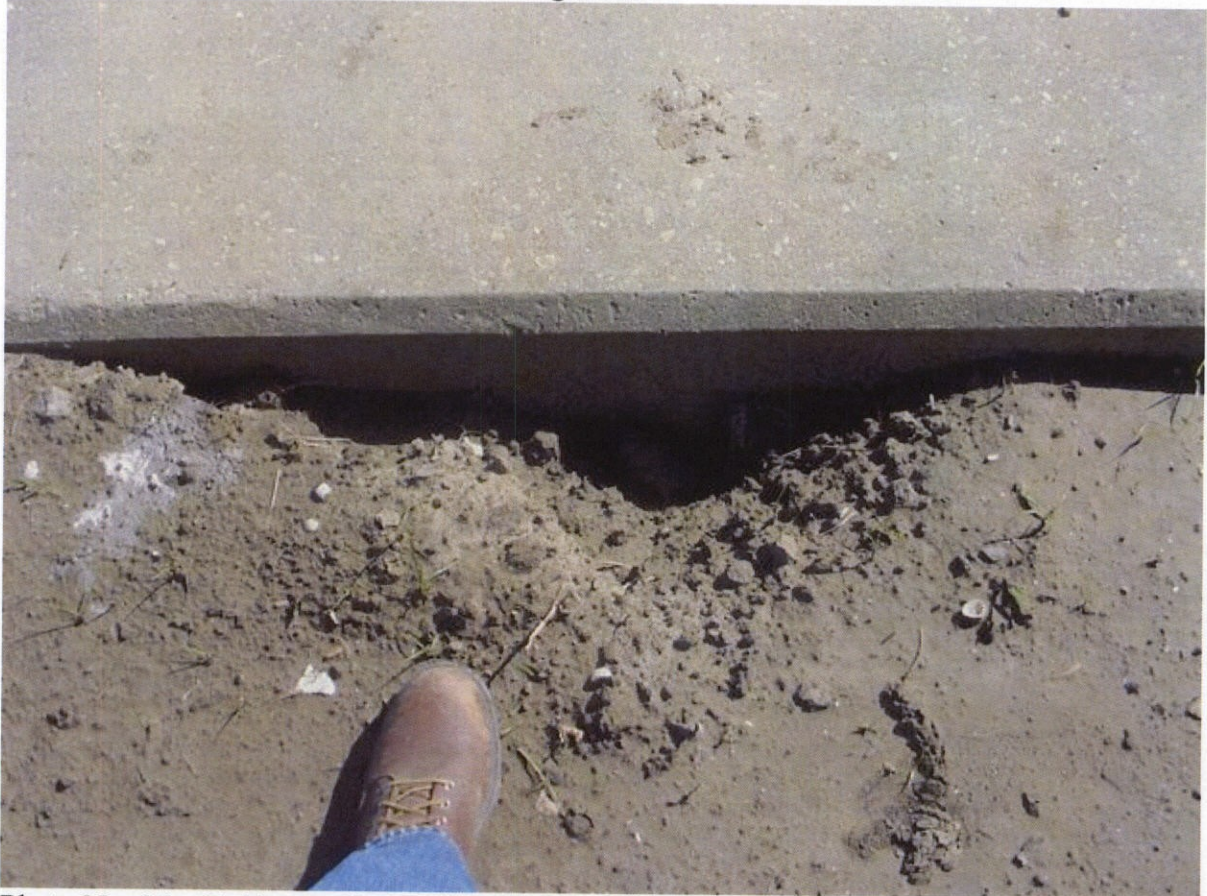
Photo No. 34 – Evidence of material loss noted adjacent to the wing walls.
