**LAKE PONTCHARTRAIN, LOUISIANA & VICINITY
CHALMETTE AREA PLAN**

**BAYOU BIENVENUE CONTROL
STRUCTURE**

PERIODIC INSPECTION REPORT NO. 9

28 APRIL 2004

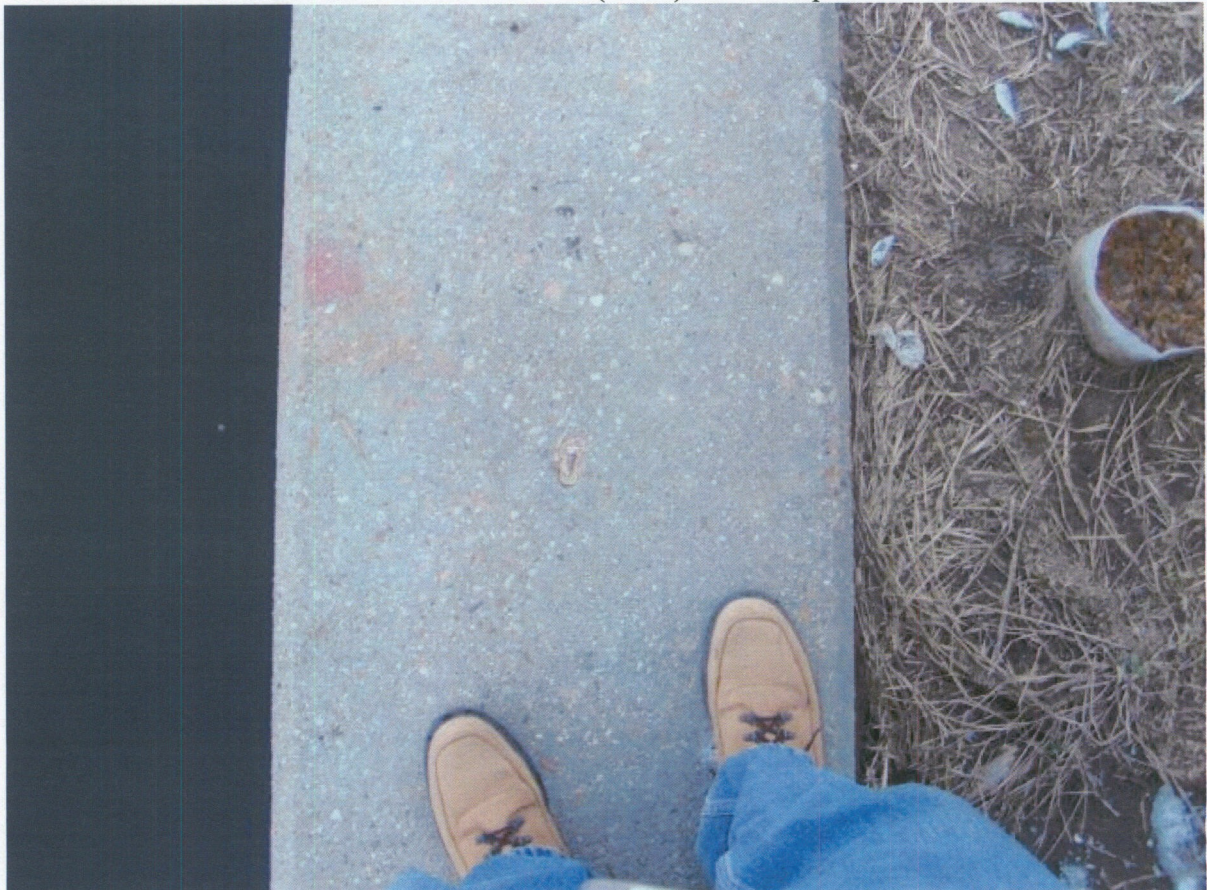
Photo No. 36 – Bent SRM noted on the southwest wing wall.
