**LAKE PONTCHARTRAIN, LOUISIANA AND VICINITY
CHALMETTE AREA PLAN**

**BAYOU DUPRE CONTROL STRUCTURE
PERIODIC INSPECTION REPORT NO. 6**

25 APRIL 1990

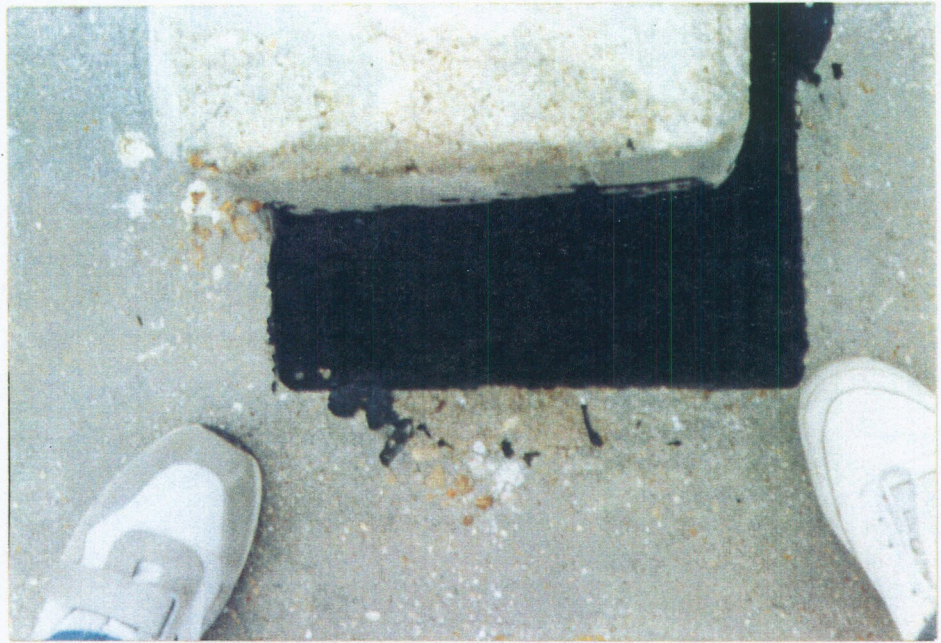
(e) The expansion joint between the "T"-wall and concrete sheet pile wall on the west side of the structure has separated considerably. The sealant is missing and the gap left between T-wall and the I-wall is approximately 6 inches. It is recommended that this gap be covered from the top to prevent the intrusion of debris, animals or injury to humans. See Photo No. 1.

PHOTO 1: JOINT BETWEEN T-WALL AND CONCRETE SHEET PILE WALL ON WEST SIDE. THE SHEET PILE WALL HAS SEPARATED APPROX 6" TO THE WEST. THE TOP SEALANT IS MISSING LEAVING A VERY DEEP AND WIDE OPENING.

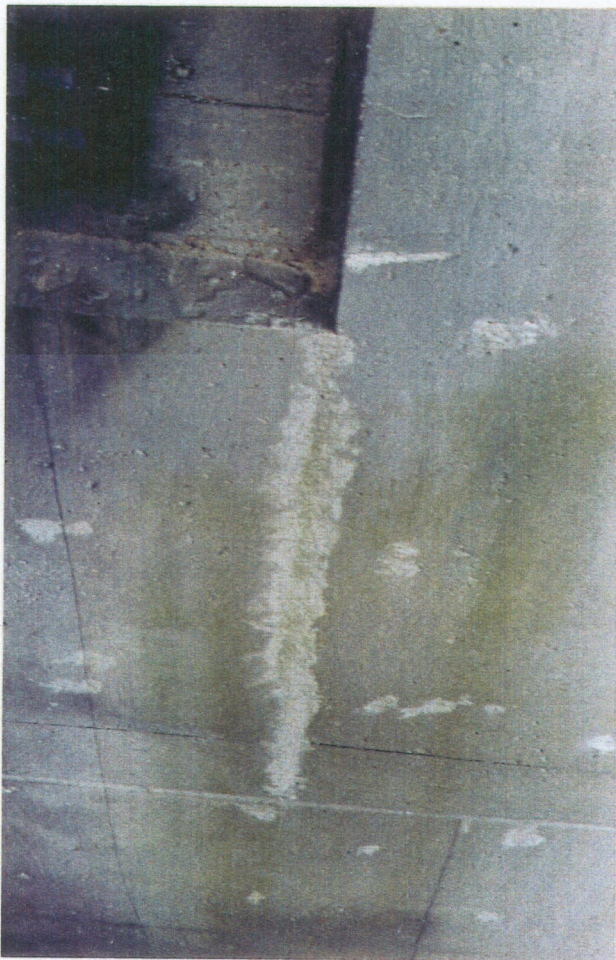
(a) A shrinkage crack with efflorescence was noted at the lower corner of the west gate hinge recess. See Photo No. 2.

PHOTO 2: VERTICAL SHRINKAGE CRACK OFF THE WEST GATE HINGE RECESS. NOTE EFFLORESCENCE.

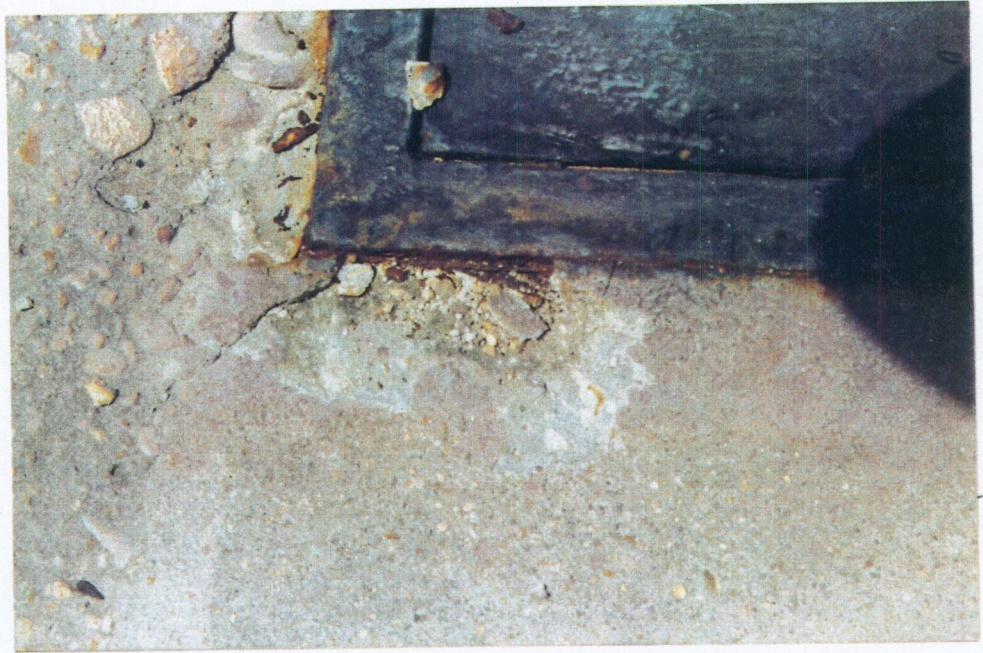
a. Para 6-02a.(3) and Photo No. 3. The rusted portion of the metal hatch should be cleaned and painted and the concrete repaired as required. Continuing to "monitor" the problem will only result in a worse condition in another year or so.

(g) The metal hatch on top of the east gate monolith shows corrosion around its perimeter, causing minor concrete spalling. See Photo No. 3.

PHOTO 3: CORROSION OF METAL HATCH ON TOP OF THE SOUTH END OF THE EAST GATE MONOLITH. NOTE CONCRETE SPALLS DUE TO EXPANSION OF THE METAL.

a. Para. 6-02a.(3) and Photo No. 3. Concur. Para. 6-02a.(3)
has been revised. Three copies of revised page VI-1 are submitted
for your files (see encl 2).

(3) The rusted portion of the metal hatch on top of the east gate monolith (shown in Photo No. 3) will be cleaned and painted and the concrete repaired by LBBLD.

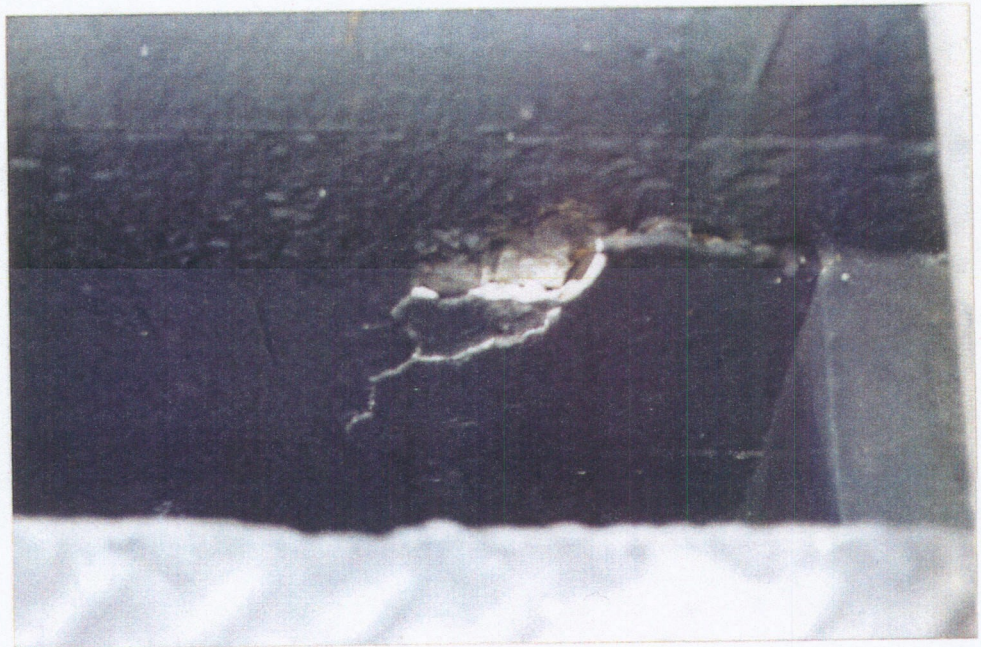
(b) A thin sheet of concrete has separated further off the wall near the east gate hinge. The area was painted black with the same paint used for the gates during the 1987 repairs. The separation has resulted in loss of concrete cover thickness and could eventually lead to corrosion on the reinforcing steel. See Photo No. 4.

PHOTO 4: DELAMINATED CONCRETE NEAR THE EAST GATE HINGE RECESS. THE SHEET OF CONCRETE HAS SEPARATED SINCE INSPECTION NO. 4. NO CORRSION IS EVIDENT.

(2) The thin sheet of concrete which has separated further off the wall near the east gate hinge, will continue to be monitored by LBBLD.

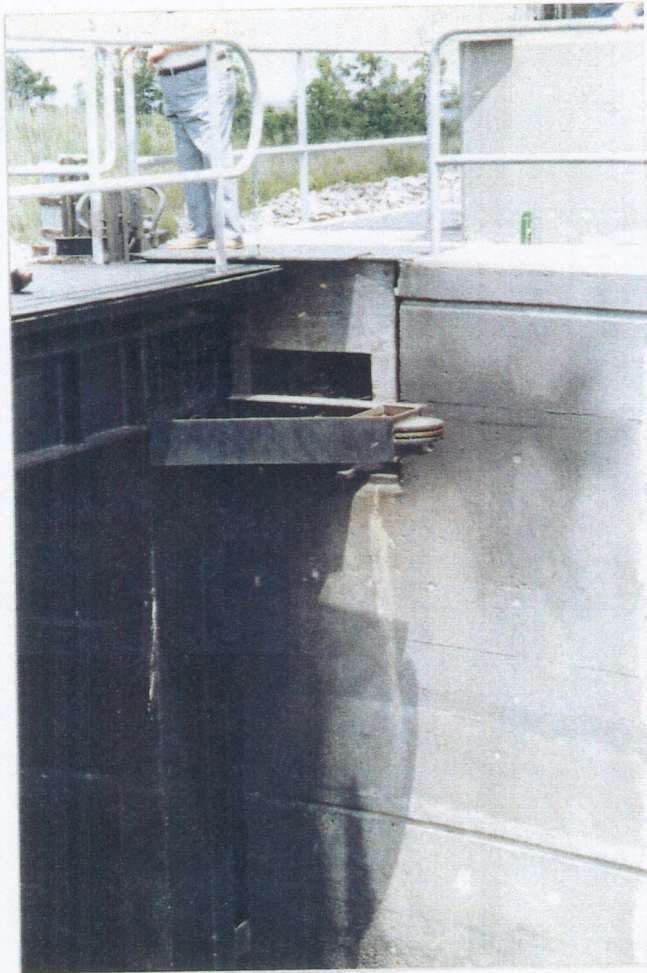
(c) The vertical crack with minor efflorescence was again observed at the cable assembly of the east gate. This shrinkage crack formed soon after the initial concrete placement. The crack appears not to have widened or extended. See Photo No. 5.

PHOTO 5: VERTICAL SHRINKAGE CRACK OFF THE EAST GATE HINGE RECESS. NOTE EFFLORESCENCE. NO APPARENT CHANGE SINCE INSPECTION NO. 4.

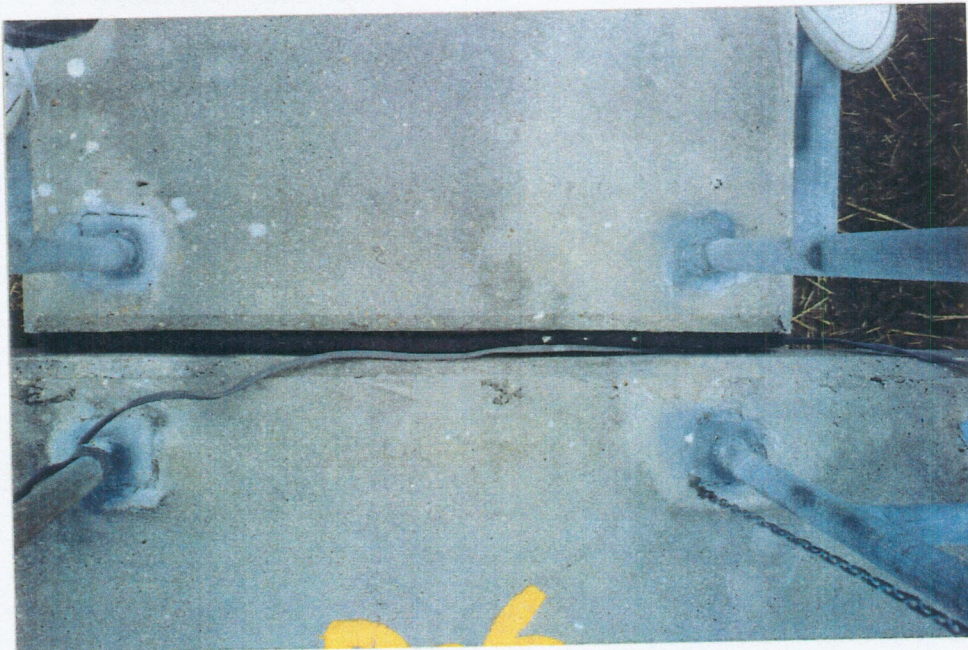
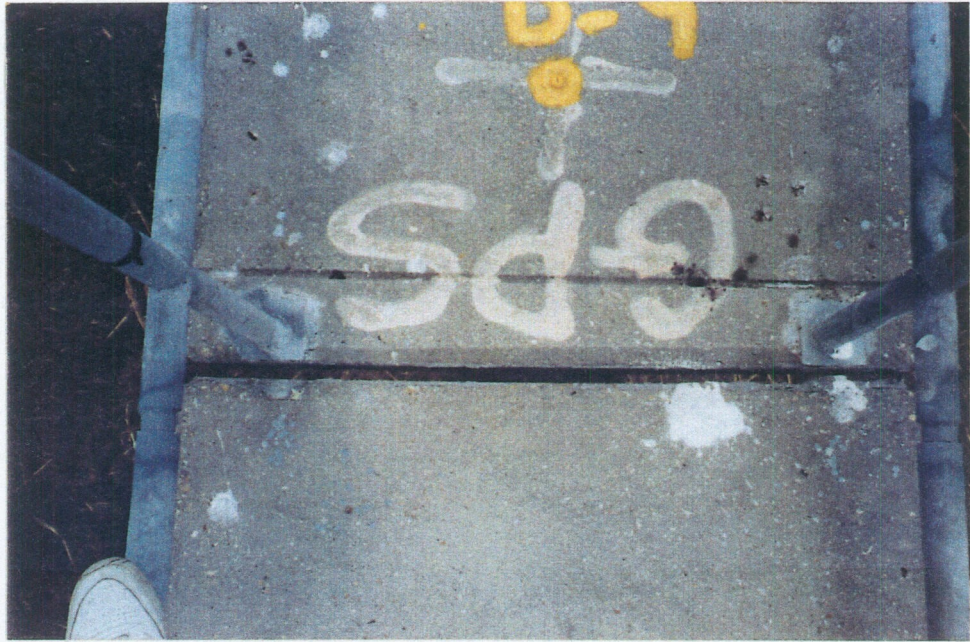
(b) The same conditions noted in Periodic Inspection No. 4 remain at the expansion joints between T-wall monoliths and T-walls and gate monoliths. In the top, the sealant is desiccated and has shrunk and some of it is missing. On the sides, it is also desiccated and shrunken but most of it is still in place. Due to the inaccessibility of the structure and since the joints are free from foreign material, no remedial action is recommended at this time. See Photo No's. 6 and 7.

PHOTO 6: TYPICAL CONDITION OF EXPANSION JOINT BETWEEN THE GATE MONOLITHS AND T-WALLS. FILLER MATERIAL IS DESICCATED AND SHRUNKEN. NO DEBRIS IN JOINTS.

PHOTO 7: TYPICAL CONDITION OF EXPANSION JOINT BETWEEN THE T-WALL MONOLITHS. FILLER MATERIAL IS DESICCATED AND SHRUNKEN, SOME IS MISSING. NO DEBRIS IN JOINTS.

(1) The expansion joints, minor spalls and shrinkage cracks will continue to be monitored by LBBLD.

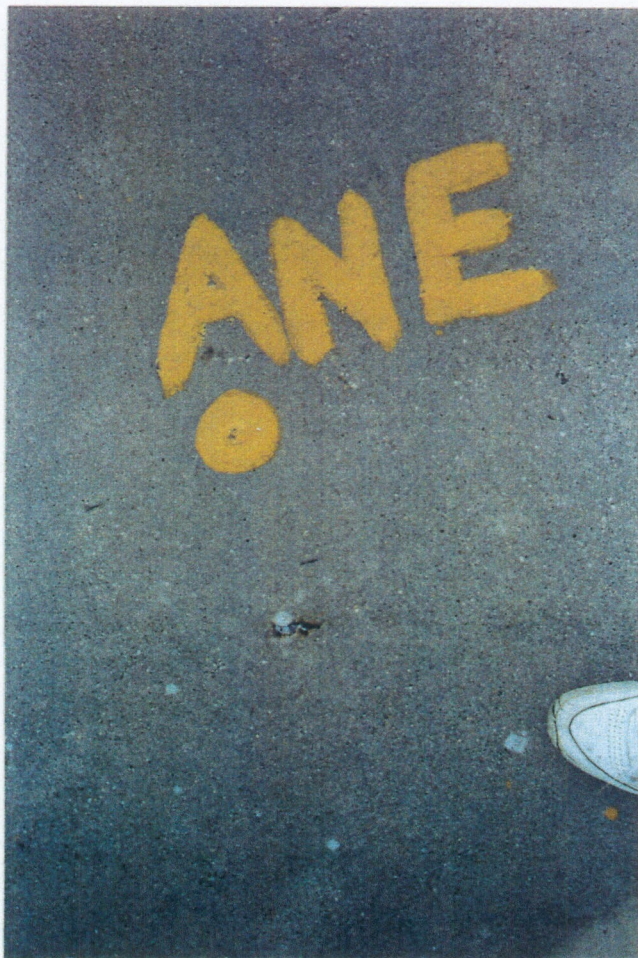
(d) The exposed reinforcing steel near the "A-NE" mark on the east gate monolith, noted during the last periodic inspection, has not worsened or caused any deterioration to the surrounding concrete. See Photo No. 8.

PHOTO 8: EXPOSED PIECE OF METAL ON TOP SURFACE OF EAST GATE MONOLITH. NO CHANGE OR DETRIMENTAL ACTION TO THE CONCRETE SINCE INSPECTION NO. 4.

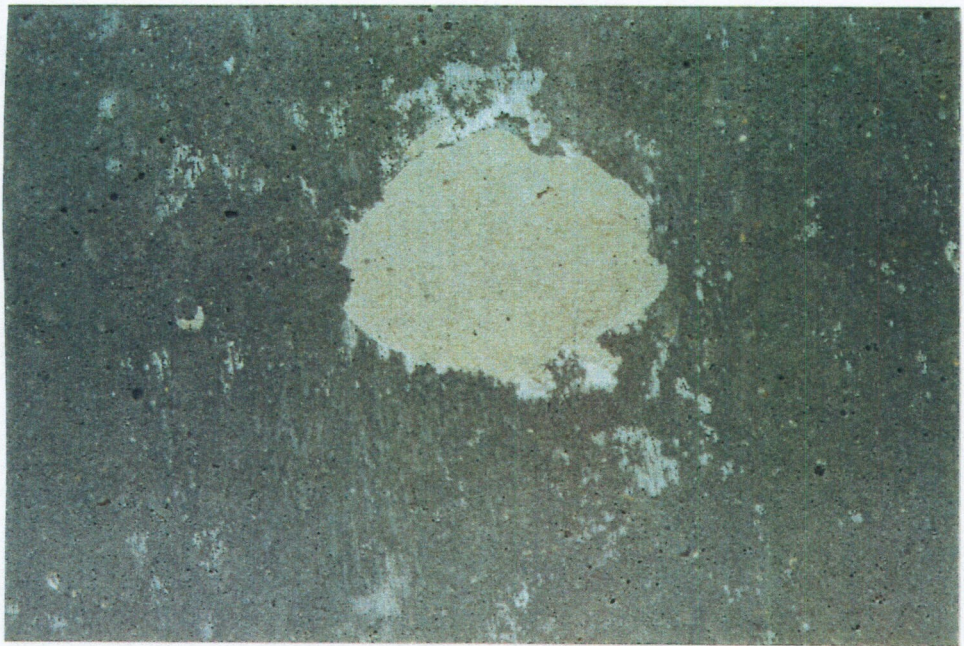
(e) Some tie rod patches on walls appeared to have been repaired; however, others do not show any further deterioration. See Photo No. 9.

PHOTO 9: TIE ROD PATCH THAT WAS APPARENTLY REPAIRED. THE GENERAL CONDITION OF THE PATCHES IS GOOD.

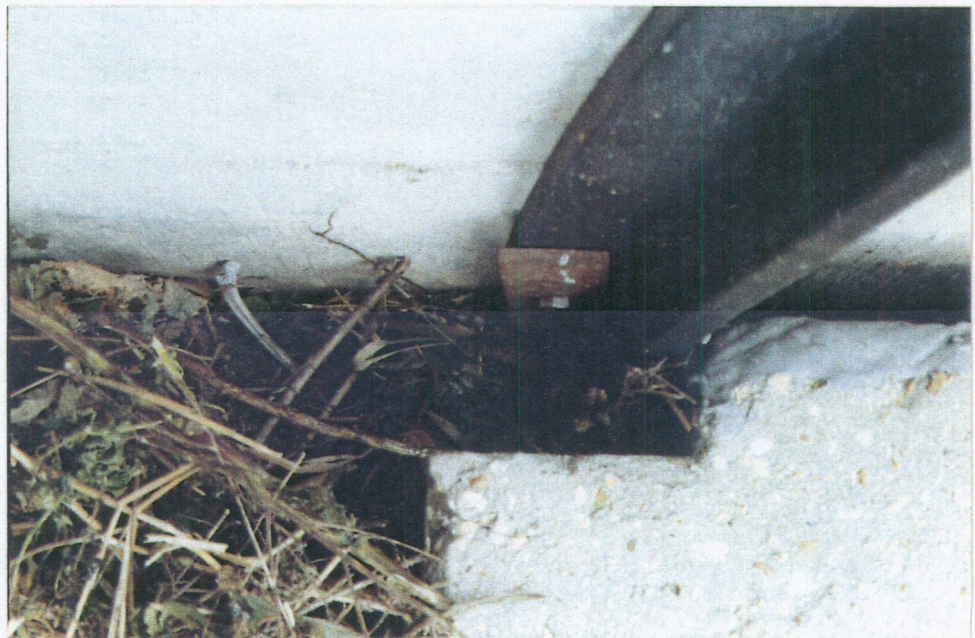
(d) A gap of 1" to 1 1/2" was observed between each of the 4 wingwalls and the structure monolith. The water stop was intact. No evidence of additional soil loss was noticed through the joint between the N-E wingwall and the structure (documented in report

PHOTO 10: L-SHAPE WATERSTOP AT THE GATE MONOLITH AND WINGWALL JOINTS. NO EVIDENCE OF MORE SOIL LOSS THRU JOINTS.

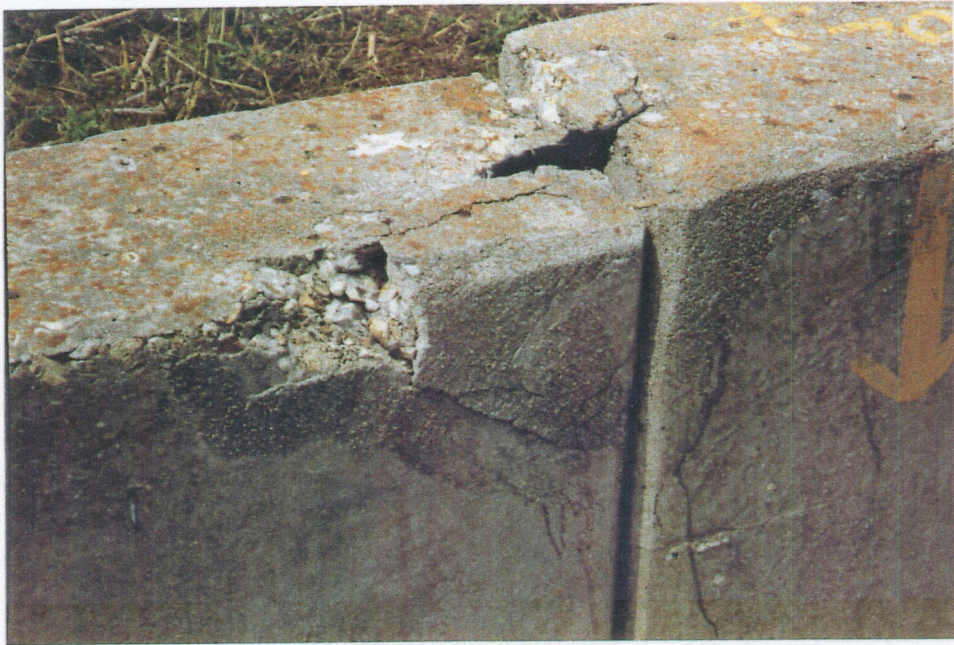
b. Photo No. 11. The spalled area at the joint of the concrete sheet pile should be repaired.

(2) Spalls. No major spalls were observed during the inspection. Minor spalls were noted on the top corners of the concrete sheetpiles due to differential settlement. See Photo No. 11.

PHOTO 11: TYPICAL SPALL AT THE CORNER OF CONCRETE SHEET PILE WALL DUE TO DIFFERENTIAL VERTICAL AND HORIZONTAL MOVEMENT.

b. Photo No. 11. Concur. Para. 6-02a(6) has been added to include
this comment. Three copies of revised page VI-1 are submitted for your
files (see encl 2).

(6) The spalled area at the joint of the concrete sheet pile shown on Photo No. 11, will be repaired by LBBLD.

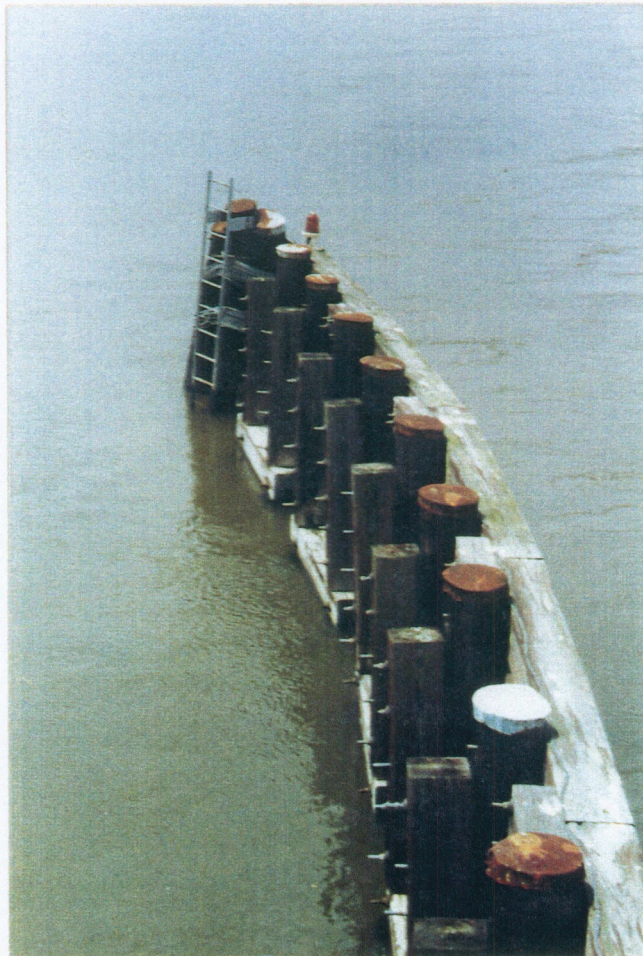
(1) The timber guidewalls are the originals installed in 1972 and are still in good condition. The vertical walers are not capped, but they are in good condition after 18 years in service. The metal caps on the piles are rusted, but appear to still be providing adequate weatherproofing. See Photo No. 12.

PHOTO 12: TIMBER GUIDEWALL WITH RUSTED PILE CAPS AND UNCAPPED WALERS. THE GUIDEWALL HAVE BEEN IN PLACE FOR 18 YEARS AND ARE IN GOOD CONDITION.
