NEW ORLEANS TO VENICE, LOUISIANA

EMPIRE FLOODGATE

PERIODIC INSPECTION REPORT NO. 6

30 JANUARY 1990

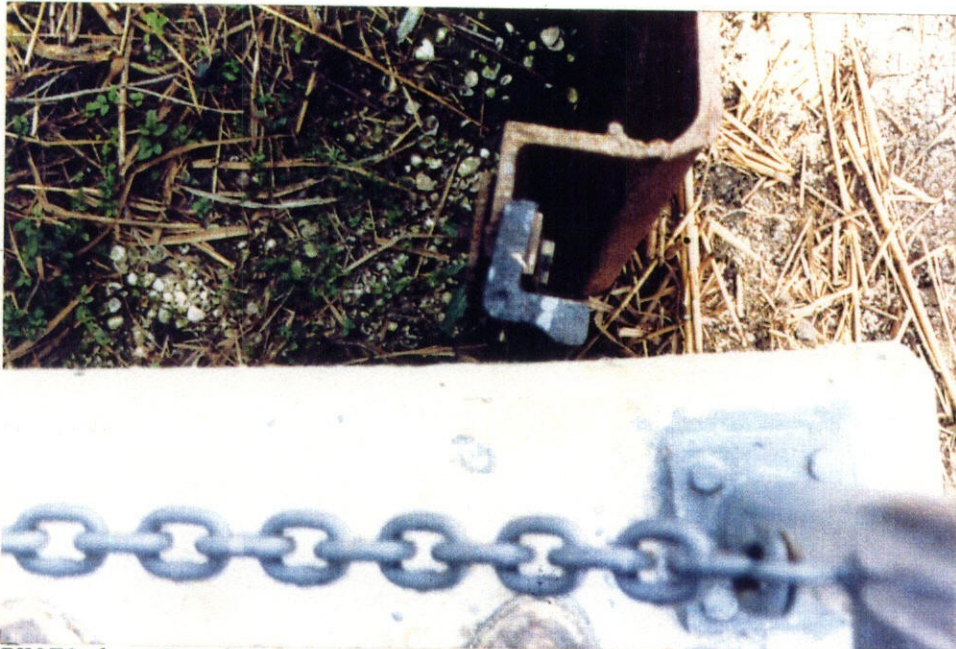
a. Floodwall. Overall, the floodwall was in very good condition. There has been no further separation between the inverted T-wall monoliths and the steel sheet piling beyond what was reported in the previous periodic inspection reports. The L-type waterstops between the sheet piling and the monoliths is still intact and in good condition. A gap of approximately one-half inch was observed between the L-type waterstop that is attached to the sheet piling and the adjacent T-wall monolith on both, the east and west sides of the structure. (See Photo 1).

PHOTO 1 - One-half inch separation between L-Type waterstop and T-Wall monolith

(7) All expansion joints will be sealed with joint sealant.

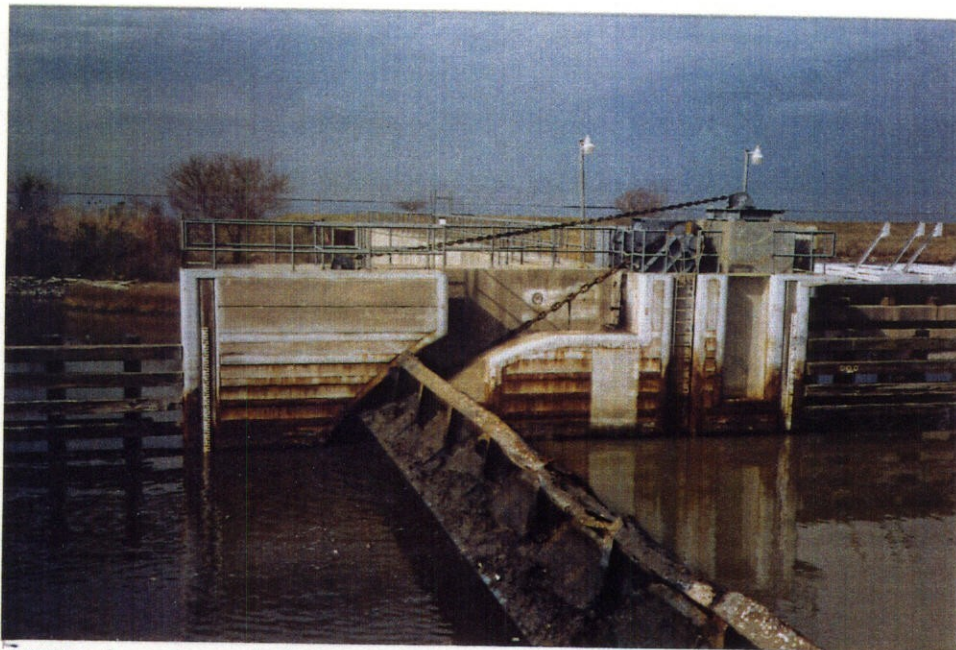
b. Gatebay Monolith. The gatebay concrete was in very good condition. No significant cracks, spalled concrete areas nor exposed reinforcing steel was observed. Minor spalls are noted in paragraphs d and h(3). Water was again observed flowing from a two-inch hole in the North wall of the counterweight recess shaft on the East half of the structure. However, the inspection team was informed that the hole was placed intentionally in order to drain water ponding in the shaft caused by the continual blockage of the original drain hole by silt. The original drain hole is at elevation -12.0, while the silt in the channel is only maintained to elevation -9.0. The protective wall armor, corner plates, and ladders on each of the channel walls contained a large amount of corrosion. (See Photo 2).

PHOTO 2 - Corroded protective wall armor, corner plate, ladder and damaged flap gate

c. Embedded Metals. Wall armor and corner protection plates in the splash zone are severely corroded. These items will be sandblasted and painted when the structure is dewatered.

(1) The damaged gate skin plate and channel beam will be repaired.

(3) The corroded protective wall armors and ladders will be cleaned and painted.

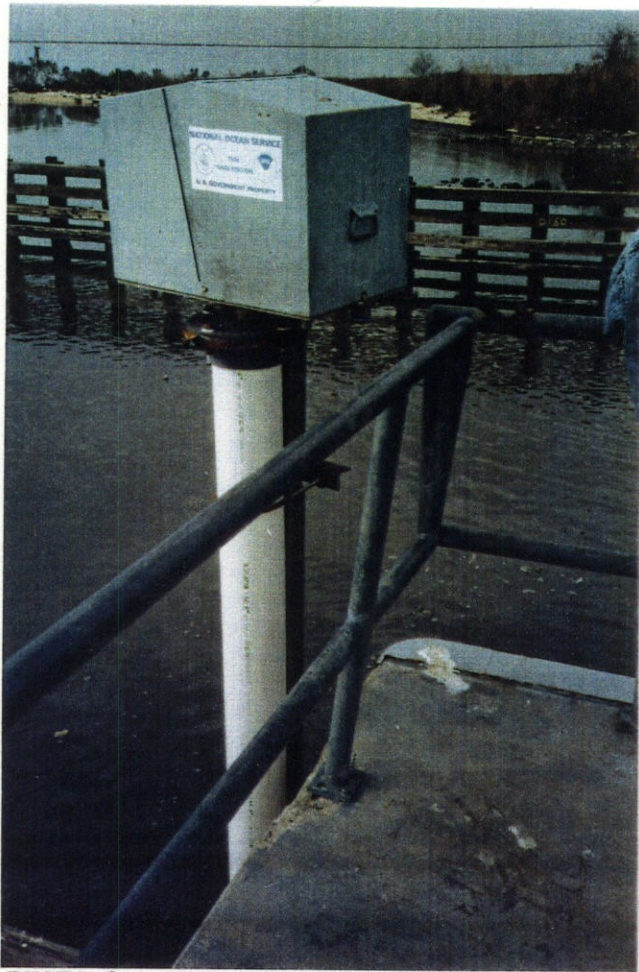
d. Handrails. Overall, the handrails were in good condition. On the east half of the structure, the south handrail had apparently been hit and was bent slightly towards the north. The impact caused the concrete around the handrail anchor bolts to spall on the top of the south face of the structure. (See Photo 3). Even though the handrailing was bent, it was still securely attached. No exposed reinforcing bars were observed in the spalled areas. On the west half of the structure, adjacent to and on the north side of the channel ladders, the two-foot section of the handrailing did not have any anchor bolts and the railing was loose.

PHOTO 3 - Damaged concrete and bent south handrail on the east half of structure

(1) Damaged handrails and concrete spalls will be repaired.

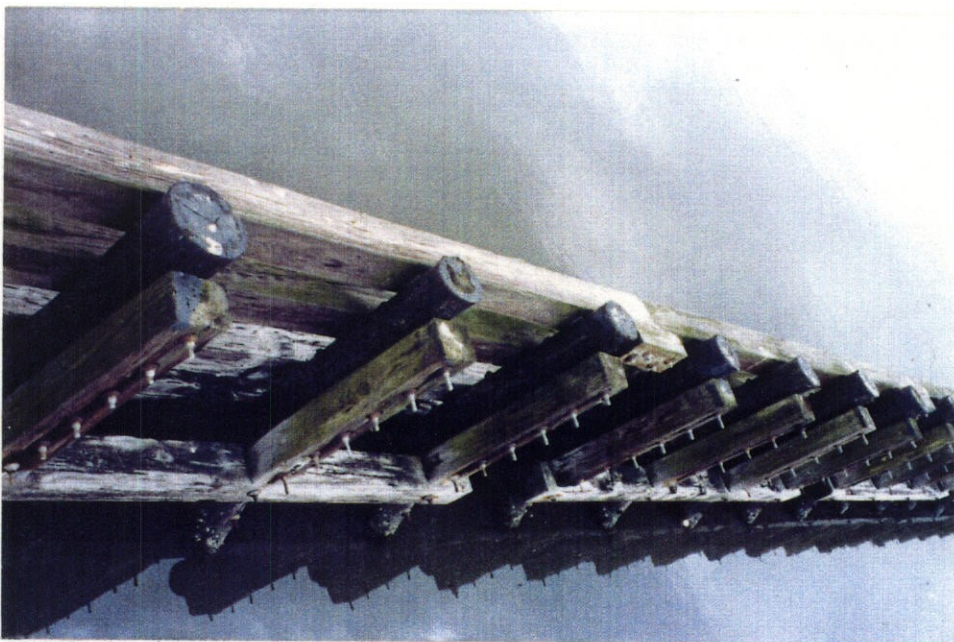
e. Approach Channels. The general condition of the timber guide walls, fenders and dolphins were excellent. Almost all the timber piles and vertical wales need to be capped. (See Photo 4).

PHOTO 4 - Uncapped timber piles

(5) Timber piles and vertical wales will be capped.

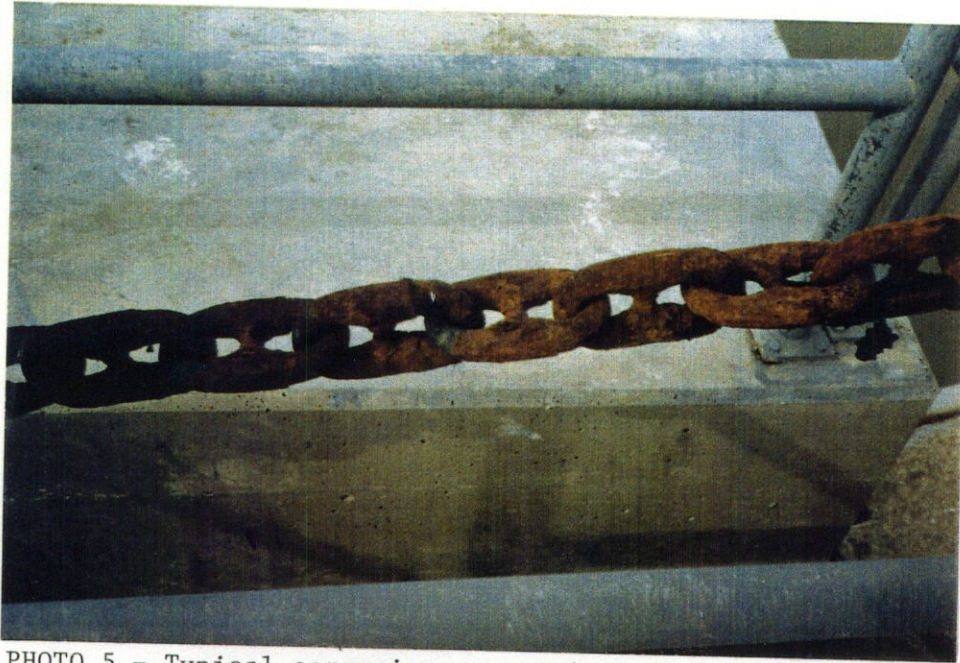
1. Hoist Chains and Counterweight Chains. Several links in the splash zone were severely corroded. (See photo 5). In the past year some links in the hoist chain have broken while lifting the gate. Failure of these links was due to corrosion. The sections of hoist chains and counterweight chains in the splash zone should be replaced prior to dewatering the structure.

PHOTO 5 - Typical corrosion on sections of hoist and counterweight chains in the splash zone

b. Hoist Chains and Counterweight Chains. In the past year some links in the hoist chain have broken while lifting the gate (see photos at encl 2). The links that broke were located either in the splash zone or under water near the mudline. The links were severely corroded and had experienced considerable elongation prior to failure. The chain was repaired with special replacement links which are commonly used in anchor chain applications. The hoist chains and counterweight chains should be replaced when the structure is dewatered.

(6) The sections of corroded hoist chains and counterweight chains, in the splash zone, will be replaced.
