Clearwater Dam Consensus Report

External Peer Review of DSAC-1 Projects

June 9, 2008

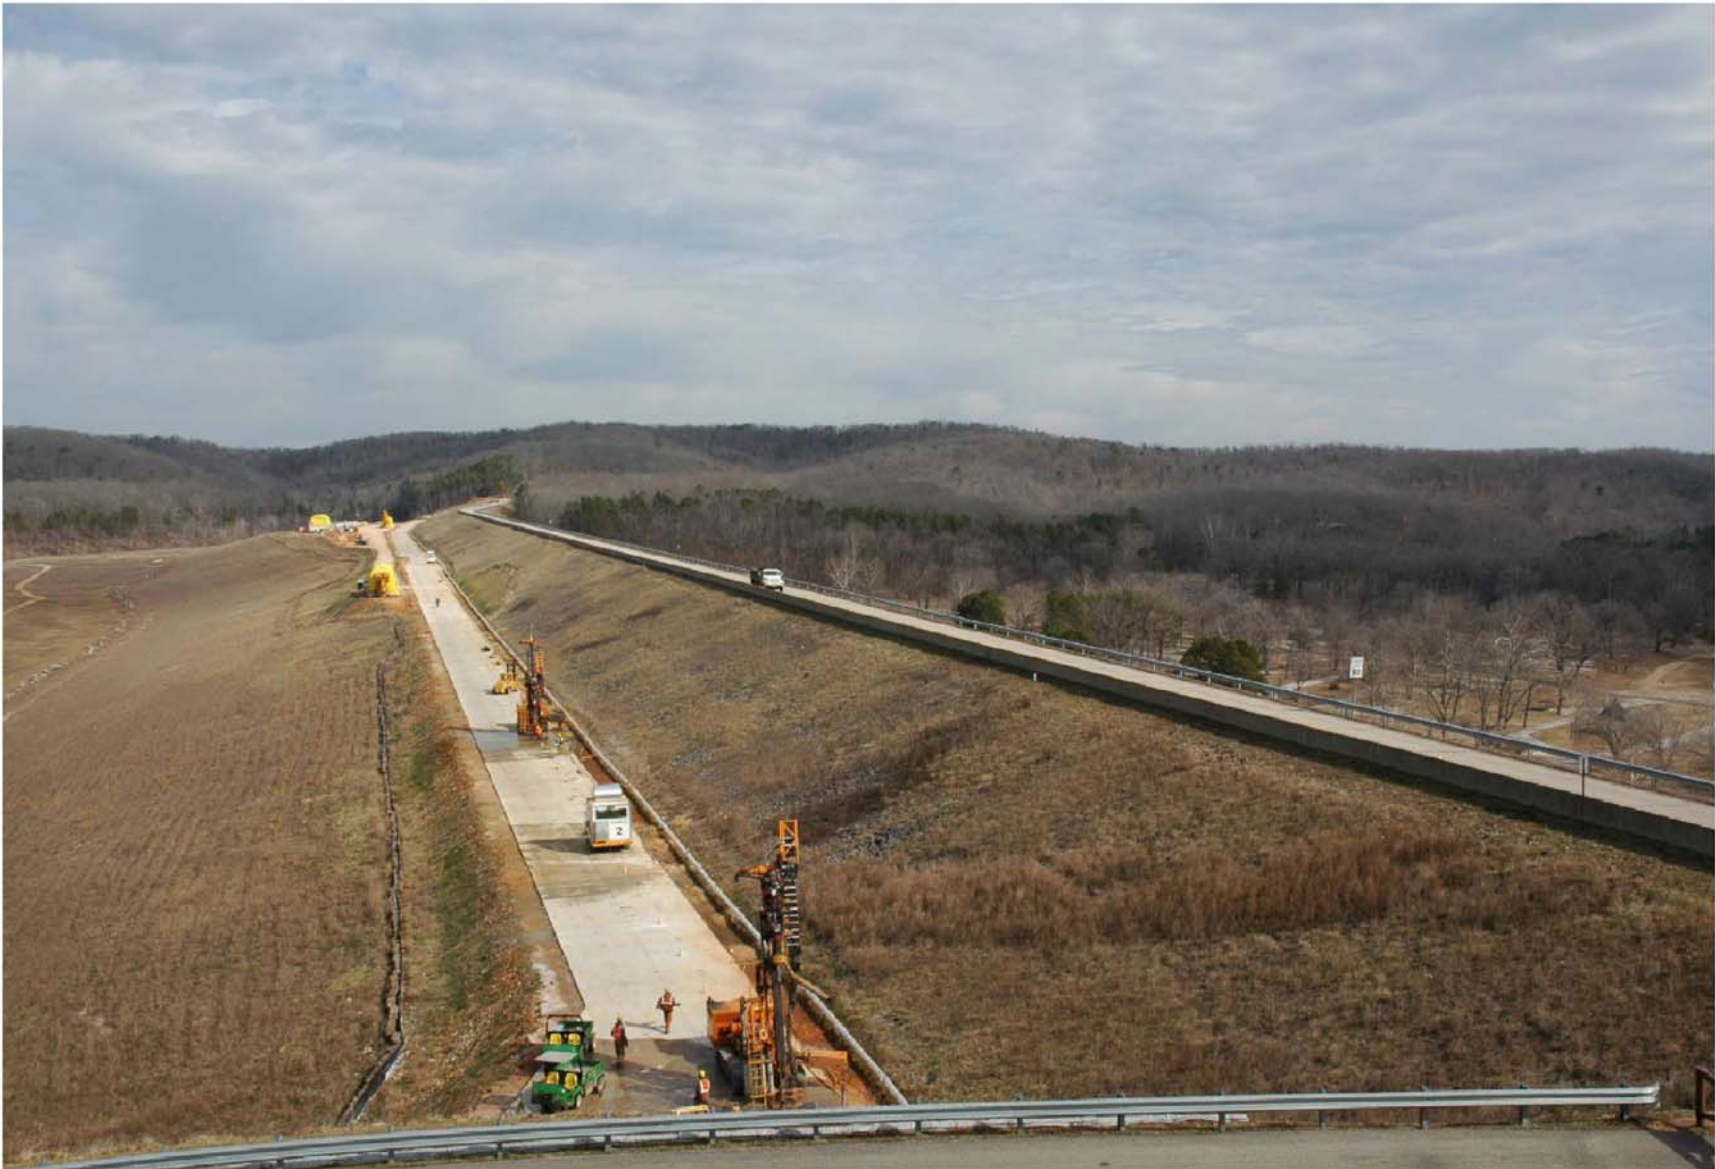
Figure 8. Parapet Wall and Berm

- **Erosion of Embankment Toe, Surface and Crest:** This condition would occur when the pool levels reach near the crest of the dam. The parapet wall could be undermined by wave action, which may allow flow over the crest that could eventually lead to failure of the dam if the pool remains high long enough.

- **Embankment – Erosion.** It is anticipated that modest winds will likely topple or overtop some part of the parapet wall during pool levels that may be reached at or near the PMF. A failure of a small portion of the parapet wall could lead to a complete breach of the embankment.

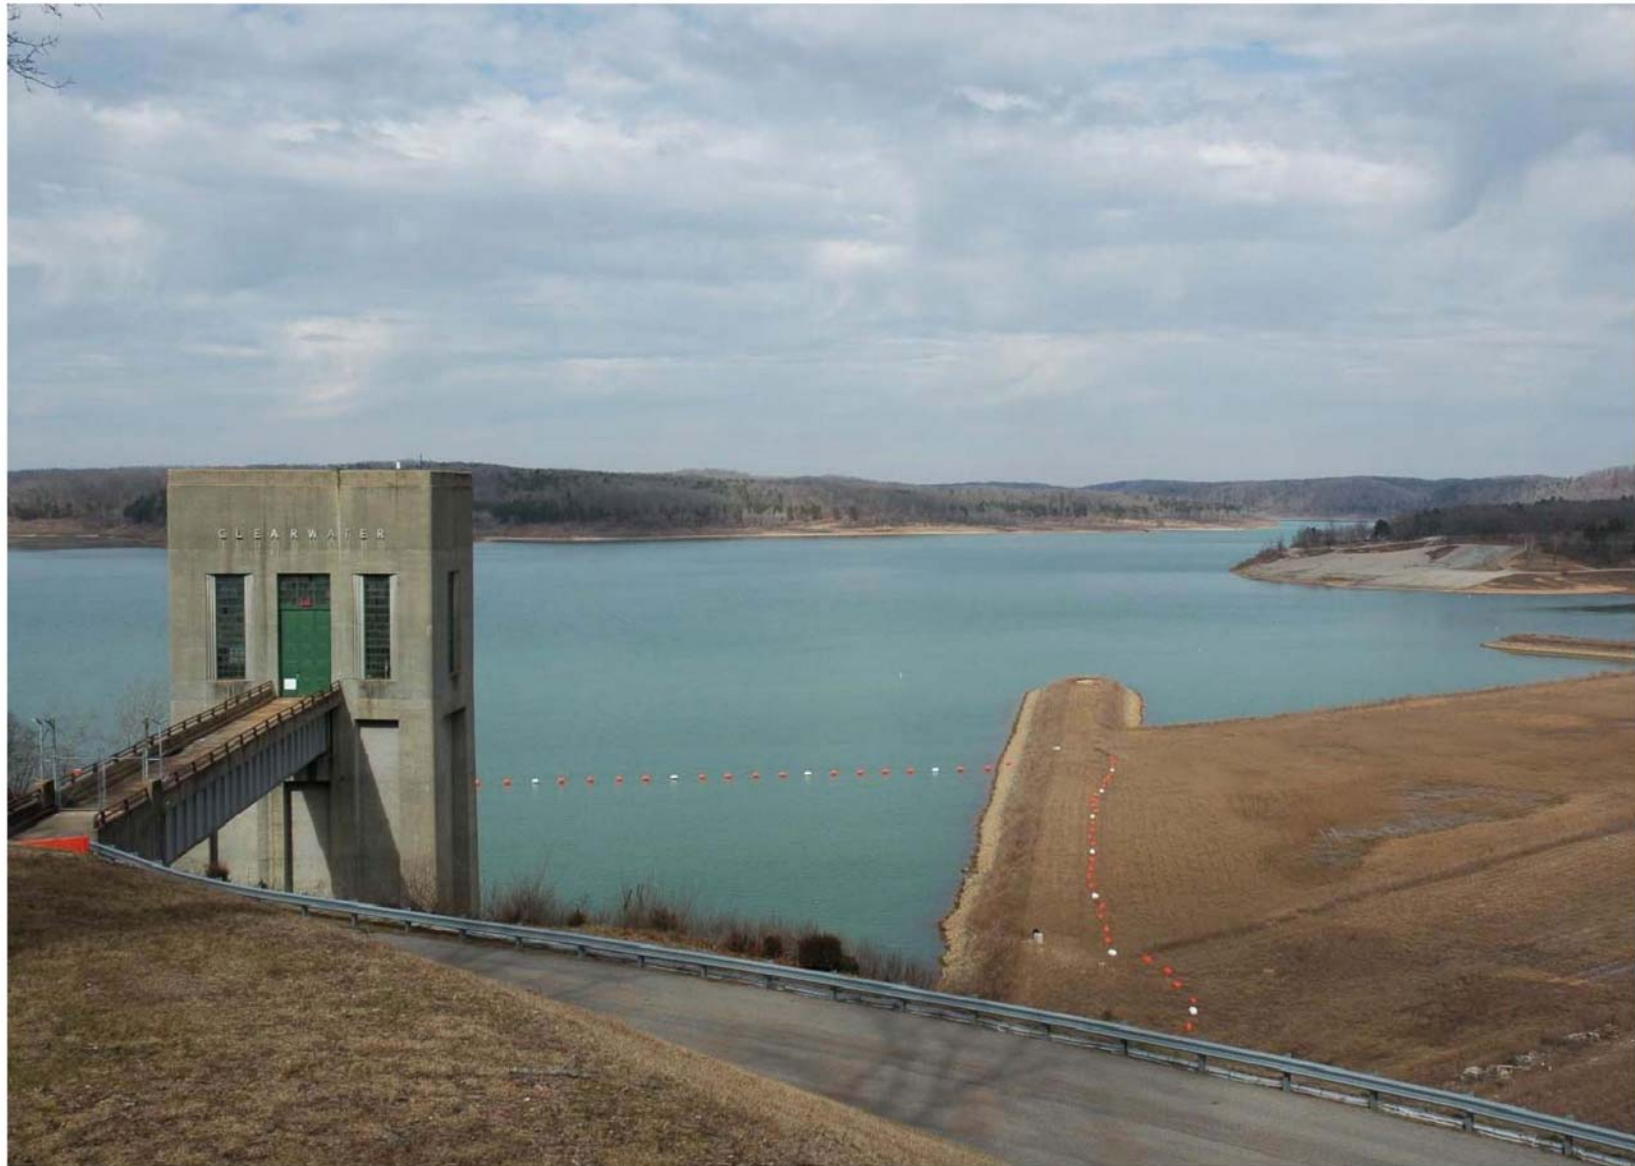
Figure 9. Low Level Outlet Control Tower

- **Low Level Outlet Controls:** Earthquake loads could cause failure of the tower housing the controls for the outlet works or make them inoperable. The operability of the controls should be assessed under varying earthquake loading conditions.

Repair the access to the controls in the intake tower for the discharge tunnel so that they are operable during high pool levels.

7.2.3.4 Improve access to the outlet works controls so that they can be accessed during high pool levels.

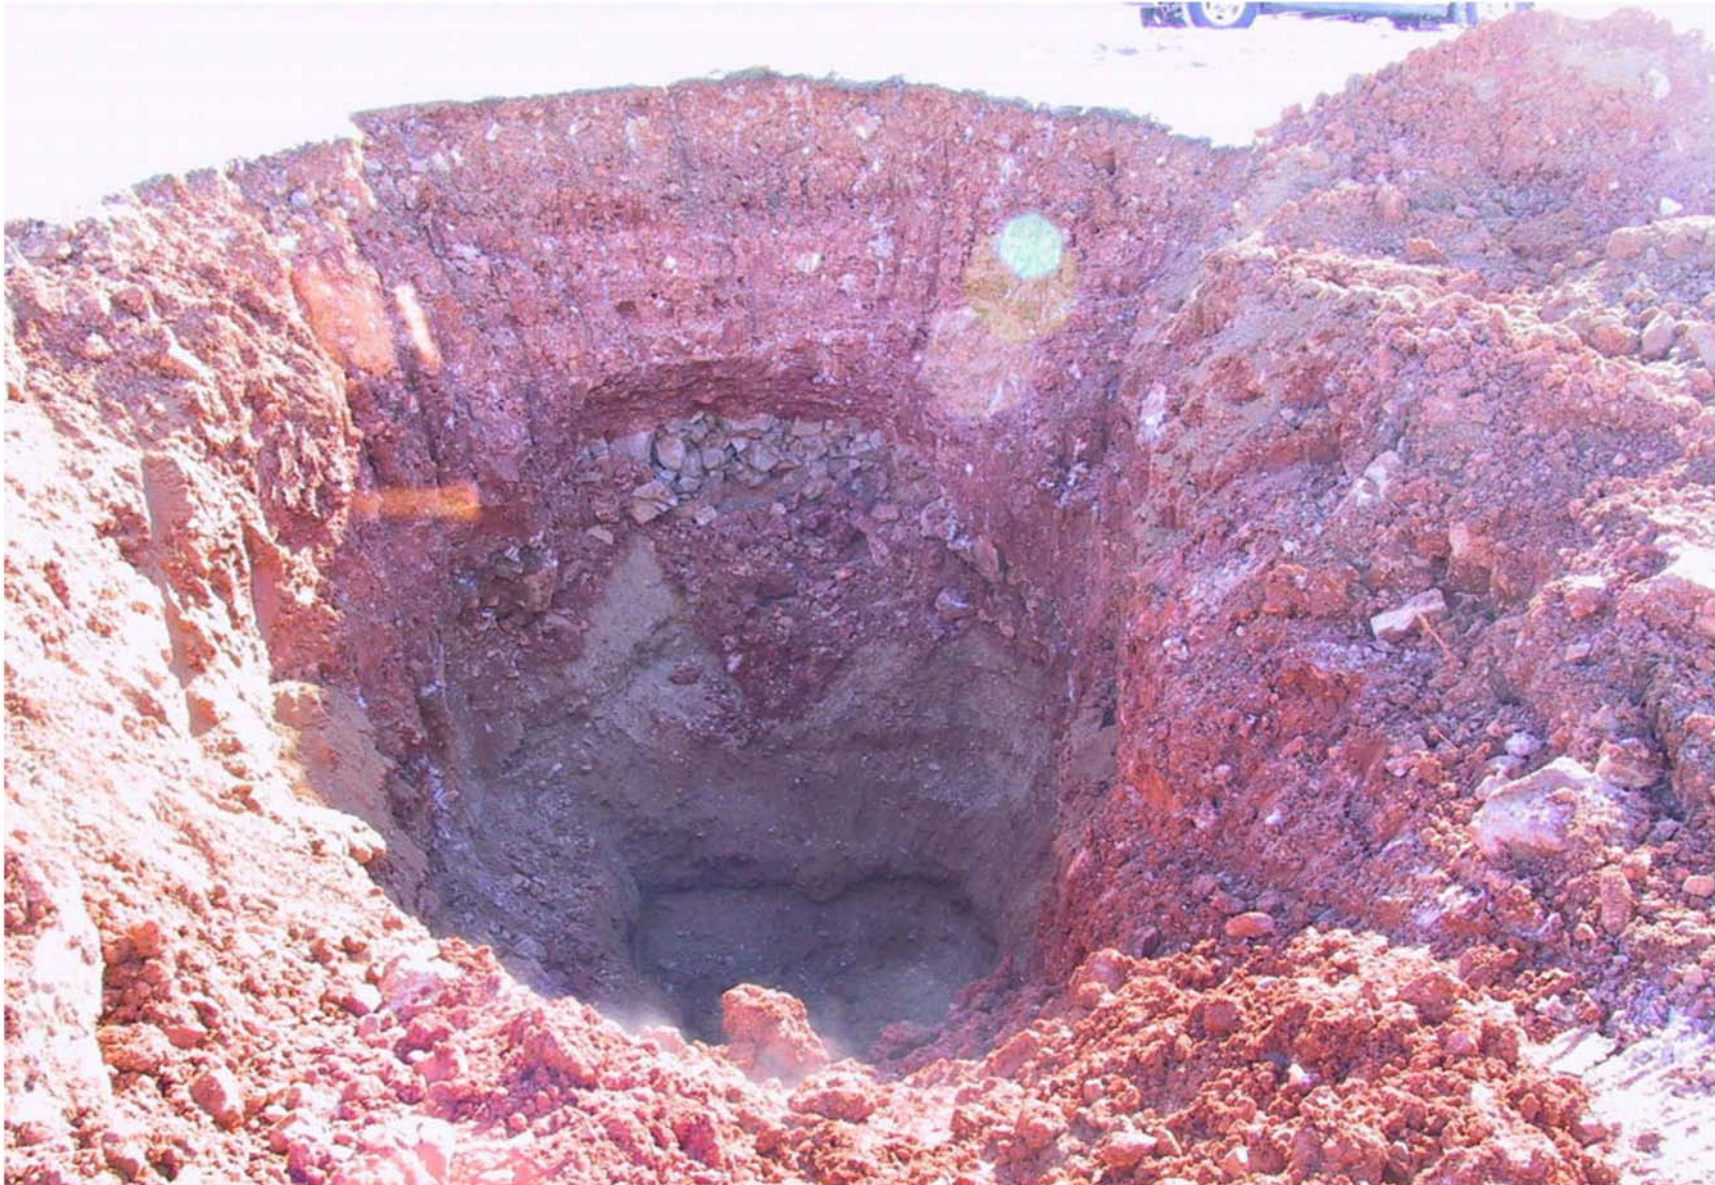
Figure 11. Sinkhole After Excavation

A sinkhole was first observed in January 2003 on the upstream slope at about El. 573, which is above the record pool level, but just below the top of the seepage berm placed in 1988. The hole was near the top of the clay seepage berm and was about 10 feet in diameter and 8 to 10 feet deep. A photograph is shown on Figure 11 of the bottom of the sinkhole after excavation to a depth of 25 feet. At the bottom, the sink hole is about 2 feet in diameter and is filled with the material from above. Figure 12 shows the location of the sinkhole superimposed on two wide joints in the Karst that were found during construction of the cutoff trench. Openings through

The sinkhole that was first observed in January 2003 was excavated to a depth of 25 feet and filled with compacted soil. The Panel considers that erosion of Karst features is continuing at other locations in the foundation of the dam at the interface with the base of the embankment resulting in the loss of support that could cause additional sinkholes.

A partial piping failure has occurred, which caused a sinkhole high and near the center of the main dam. The sinkhole probably developed over a long period of time, although it was first observed on January 15, 2003 after the pool of record that occurred on May 20, 2002. This sinkhole has been repaired.

Repairs were made by filling the sinkhole with compacted clayey fill. The Panel observed the repaired area during the site visit.

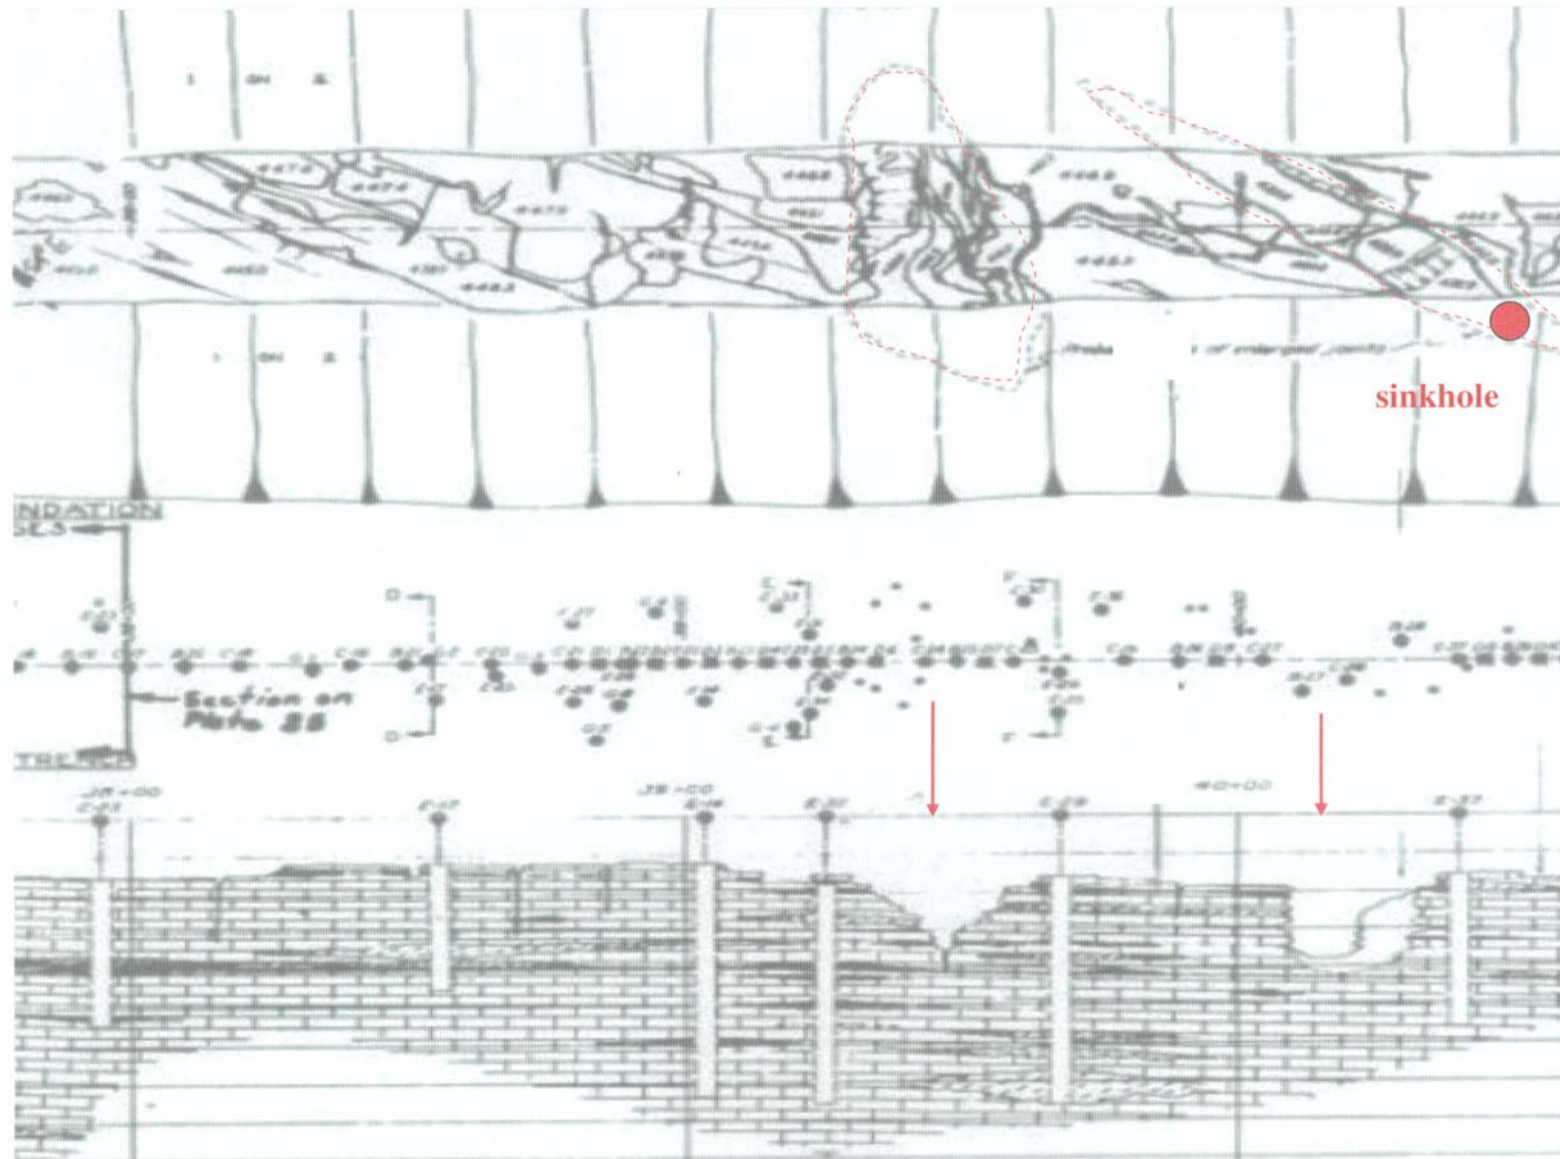
Figure 12. Sinkhole Location Plan

During this exploration and grouting program, a cavity about 15 feet wide and about 90 feet in height was found near the location of the sinkhole first observed in January, 2003. The top of the cavity is about 30 feet below the top of rock. Rounded stones covered with what appeared to be residual soil were found near the bottom of the cavity. It is likely that they entered the cavity from soils in the alluvium on top of the bedrock during the current exploration program.

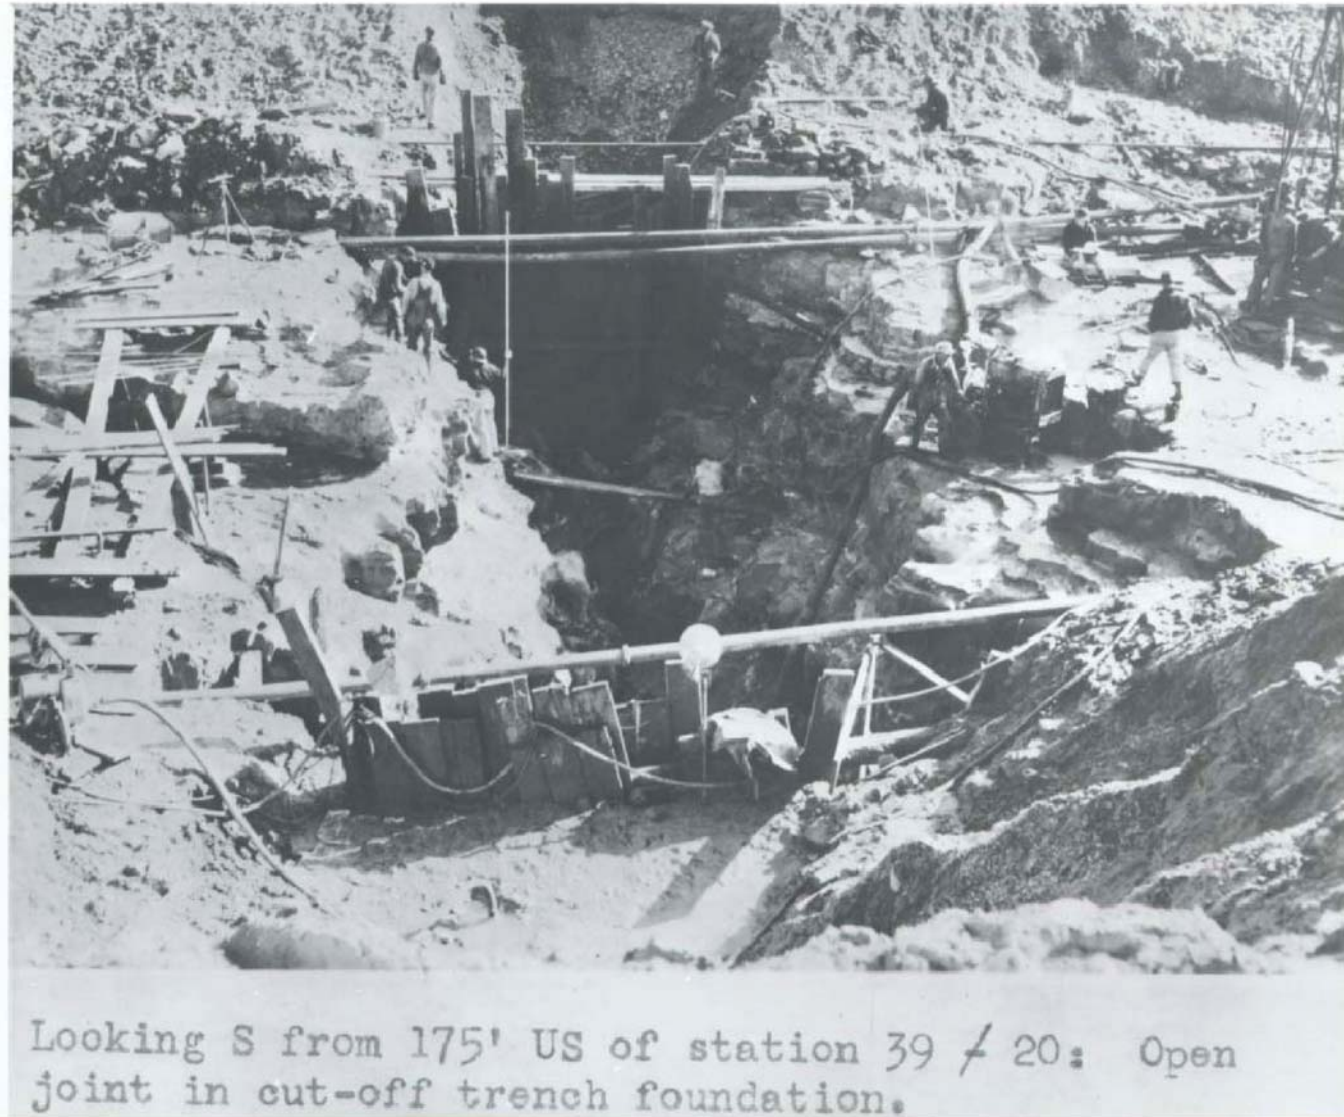
Figure 13. Joint at Sta. 39+20

During construction of the core cutoff trench, two wide joints were found in the bedrock and were treated. The bottom of the core trench was cleaned of loose materials. The soils in the joints were removed and replaced with concrete. Some areas were filled with dental concrete. A concrete slab exists on top of the cleaned bedrock from about Sta. 40+00 to 53+00. The entire core trench extends from Sta. 34+00 to 53+50.

Looking S from 175' US of station 39 / 20: Open joint in cut-off trench foundation.

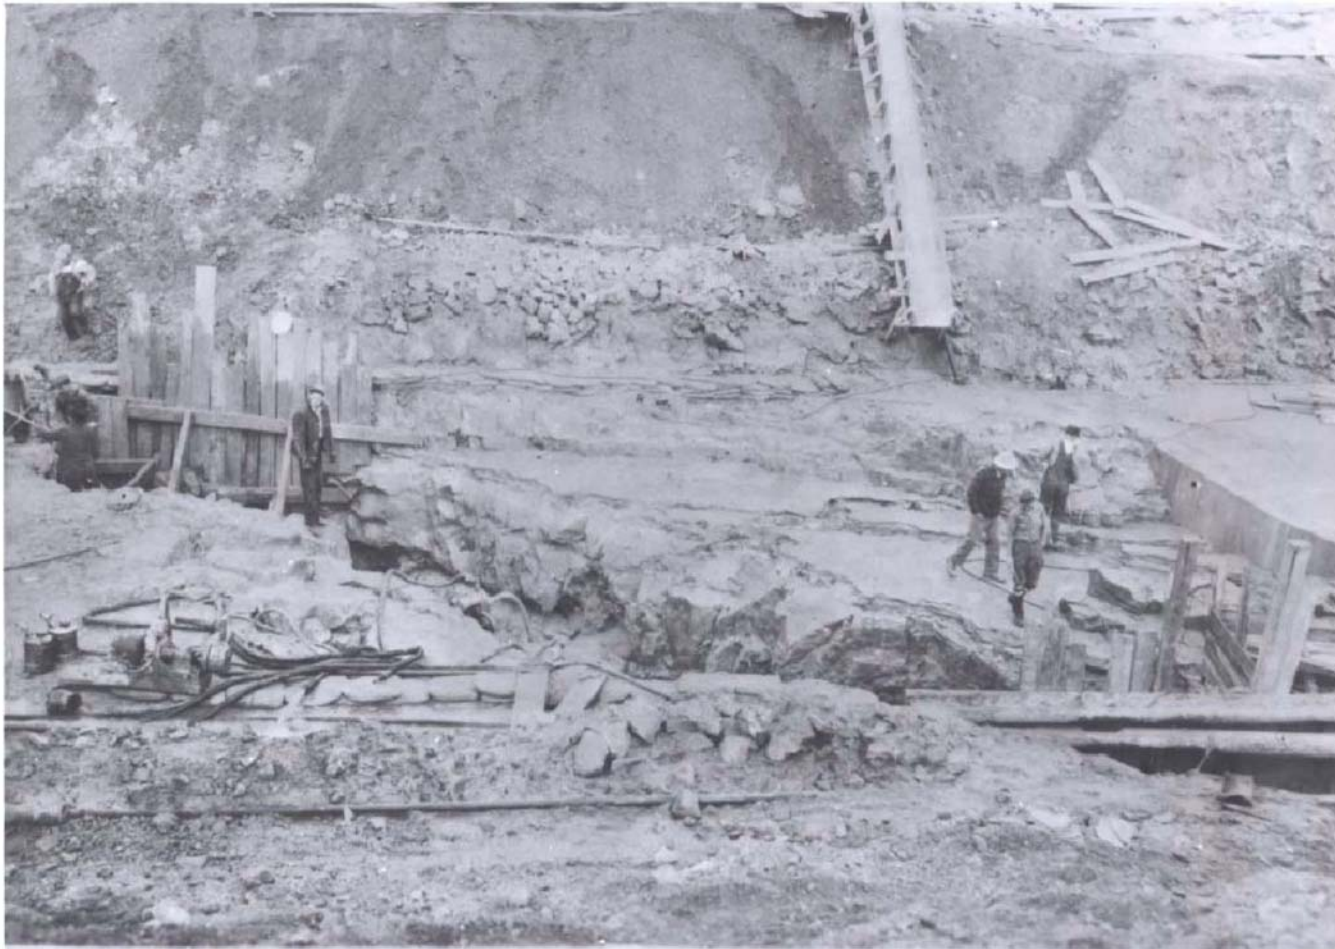
Figure 14. Joint at Sta. 40+15

Looking NW from 35' U.S. of station 40 / 15: Open joint in cut-off trench foundation.

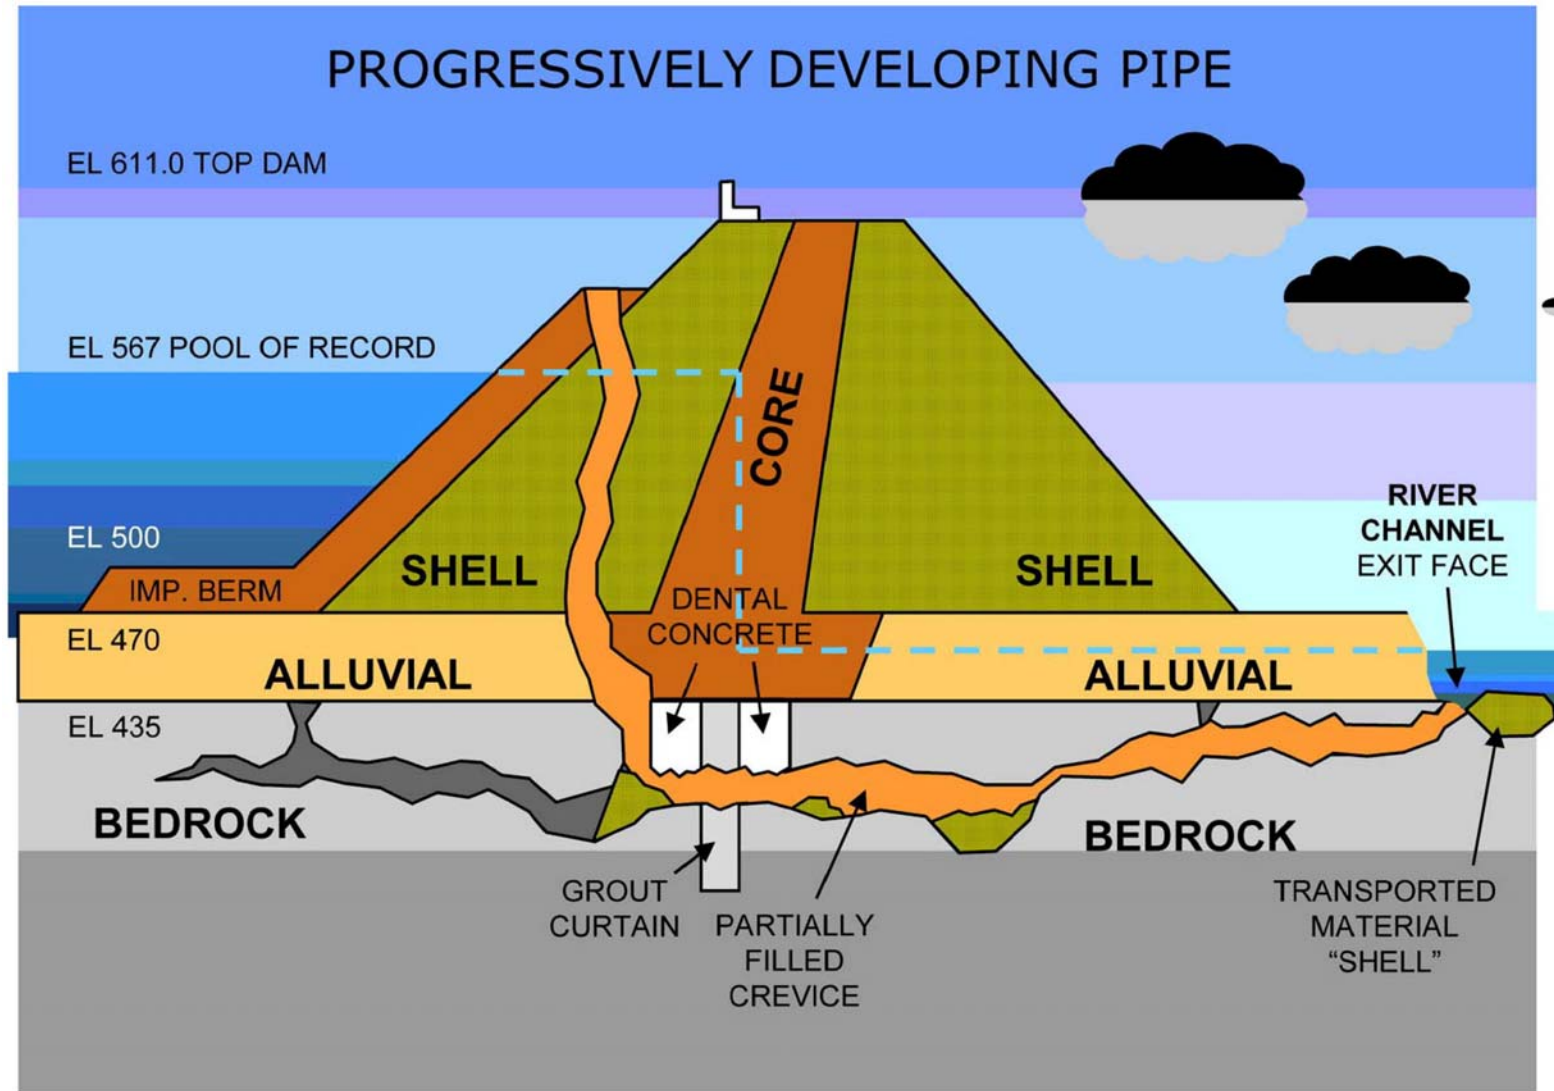
Figure 15. Schematic Section through Sinkhole

It is the Panel's judgment that the upstream seepage blanket and berm probably caused a small reduction of the gradients in the upstream shell. Although slightly reduced, these gradients can carry soil from the alluvium and the upstream shell into openings in the bedrock under the alluvium. This process is likely to have caused the sinkhole that was first observed in 2003.

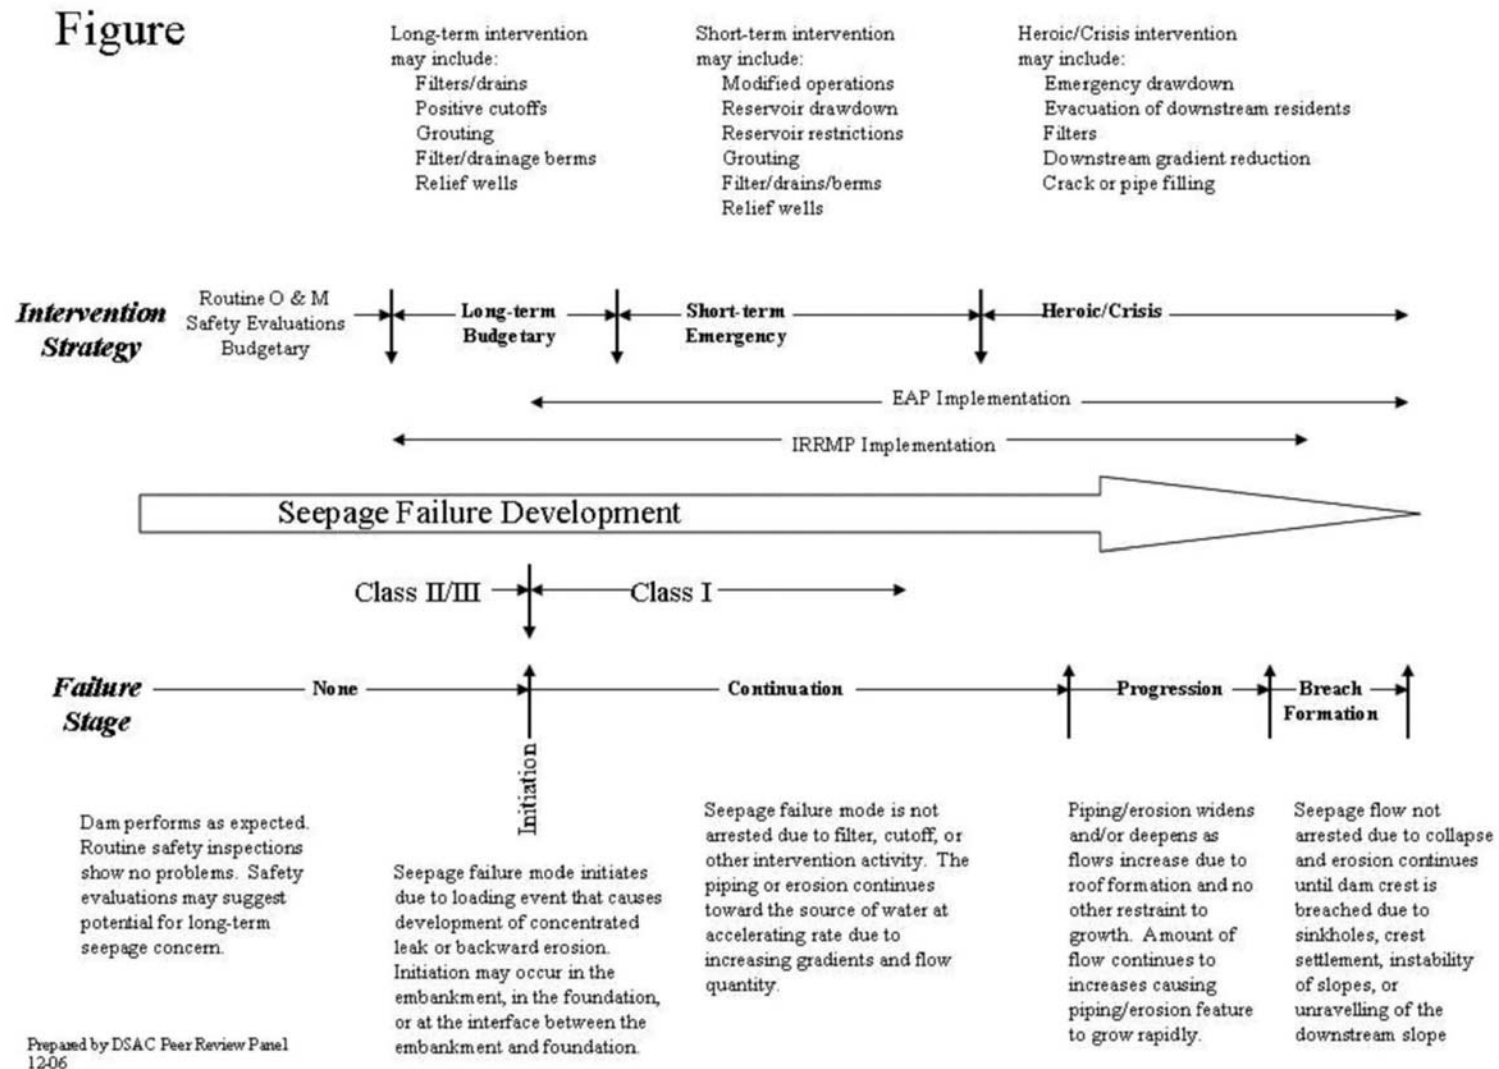
Figure 16. General Continuum to Failure

The Panel has developed a graphical depiction of a seepage failure mode continuum and has presented this depiction in a separate memorandum (DSAC Peer Review Panel, December 14, 2006). The failure continuum on Figure 16 summarizes four stages of failure development and three corresponding intervention strategy categories as seepage characteristics progress along the continuum. The various modes of failure are described in Section 5.0.

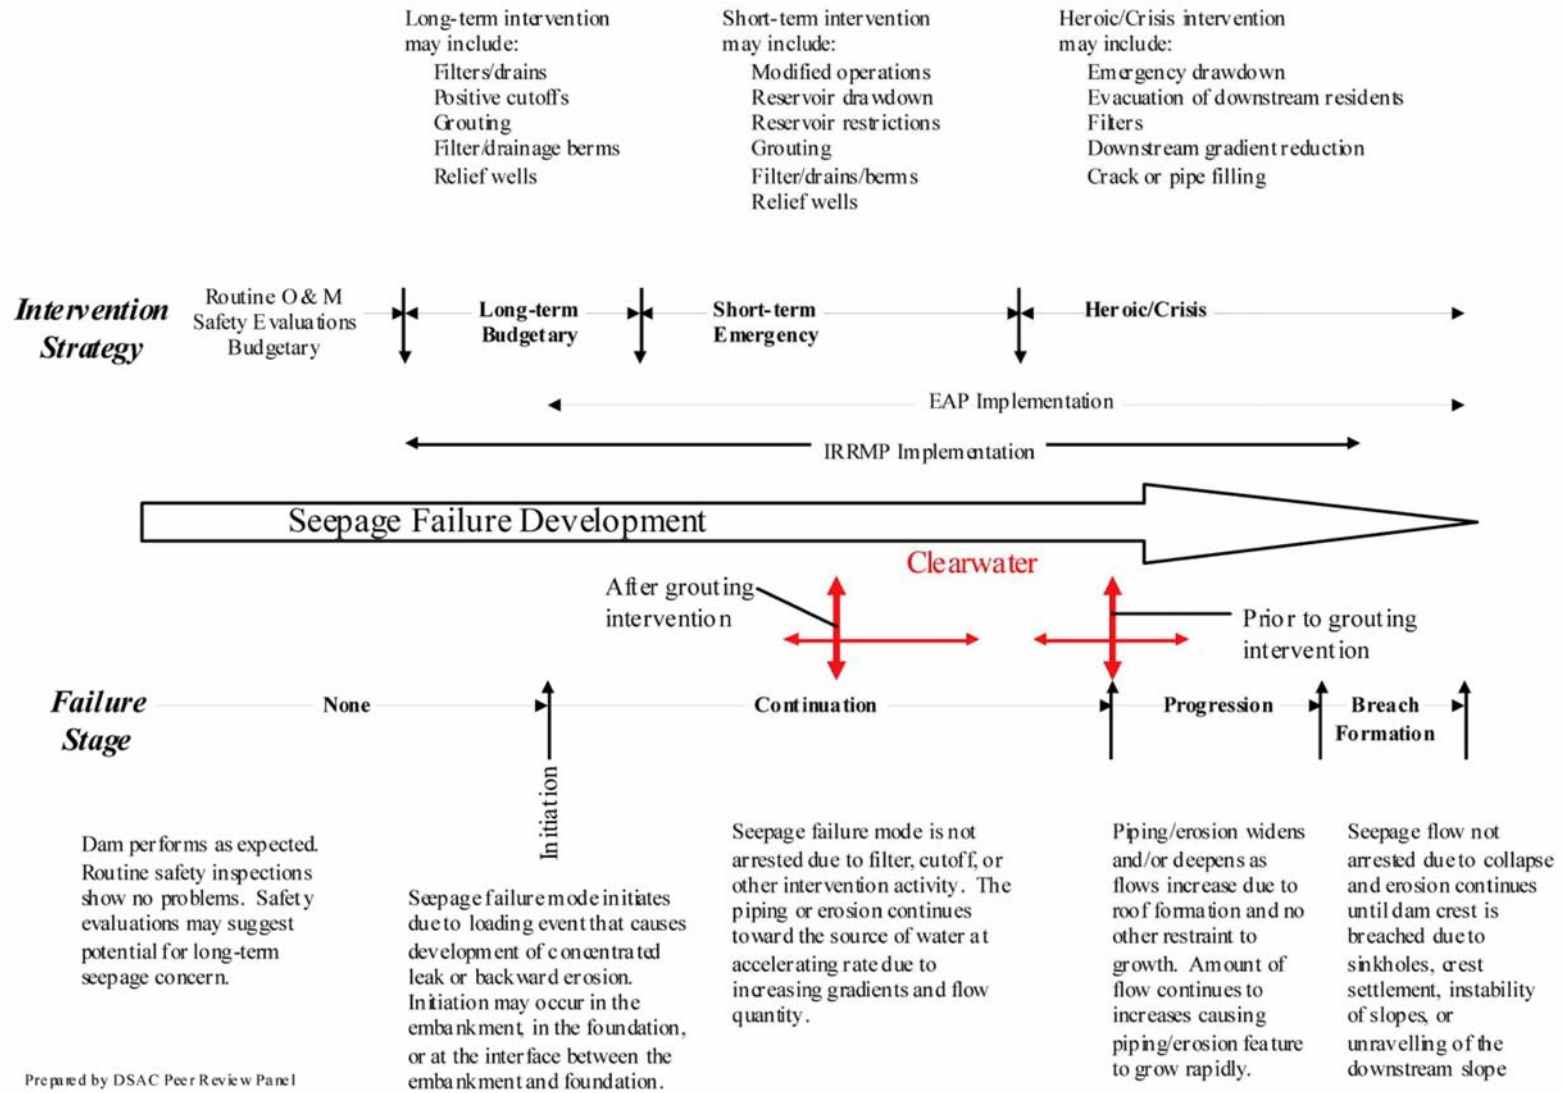
Figure 17. Clearwater Continuum to Failure

The Panel's assessment of the safety of this dam is shown along the Failure Continuum on Figure 17. Our assessment, as shown in this diagram, indicates that a seepage-related failure mode has initiated. Appearance of the sinkhole on the upstream slope of the dam indicates that the continuation phase has been completed and that the dam is entering the progression stage toward failure. During the progression stage the rate of seepage and piping and the corresponding rate of deterioration will significantly increase whenever the pool rises. The heavy red arrow on the right shows that the dam is susceptible to a seepage failure unless remedial measures are taken.

Therefore, the Panel finds that the dam is well into the continuation phase on the continuum to failure. In some locations under the shells, there may be un-observable progression of piping occurring at a slow rate under normal pool elevations. High pool levels will increase the erosion rate at any such locations in proportion to the increase in gradients.

Upon completion of the planned remedial measures for the seepage and piping failure mode, the probability of a seepage and piping failure will be decreased and the life of the dam will be increased. The red arrow to the left on the Failure Continuum is the Panel's current estimate of the improvement. However, instrumentation will be installed in the dam to better judge the actual improvement.
