**LAKE PONTCHARTRAIN, LOUISIANA AND VICINITY**

**BAYOU BIENVENUE CONTROL STRUCTURE**

**PERIODIC INSPECTION REPORT NO.7**

**30 MARCH 1994**

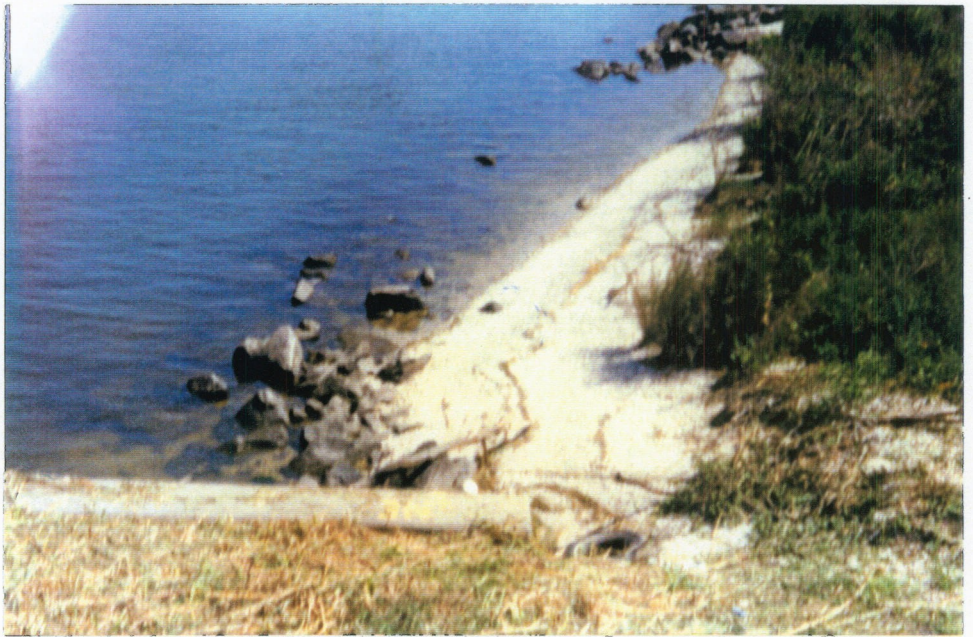
(See Photo 1)

a. Riprap has not been replaced in deficient areas near the banks of the north and south approach channels behind the guidewalls.

g. Riprap is deficient along the banks of the north and **south approach** channels behind the guidewalls.

PHOTO 1 - Deficient Rip-Rap along banks of the north and south approach channels (Typical)

a. Deficient riprap, rusting steel members, termite infested timbers and missing timbers will be replaced or repaired by contract forces.

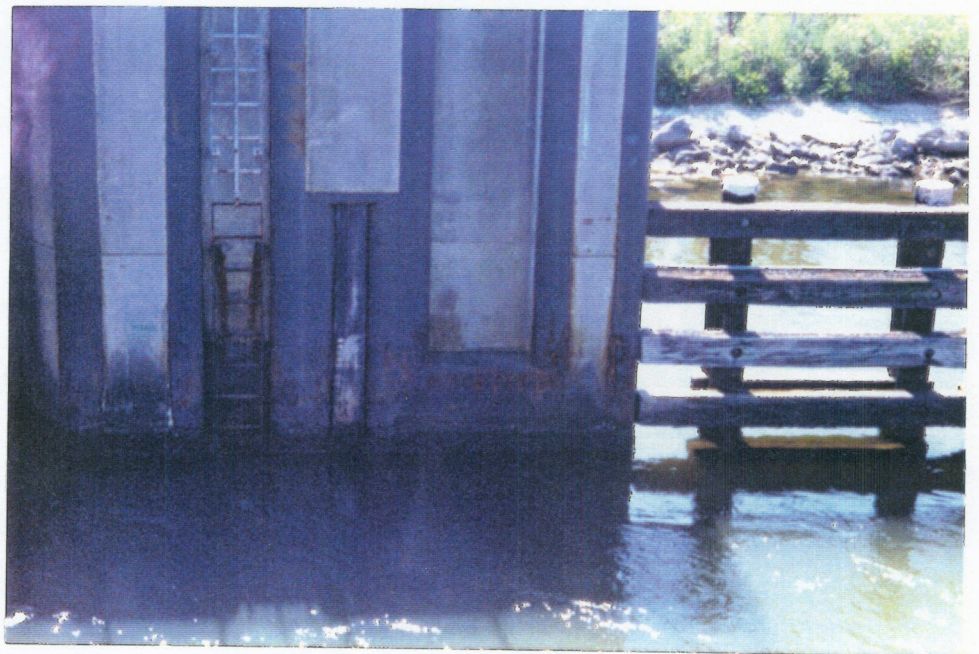
h. Rusting steel members, ladders, corner plates and metal pile caps need repair. (See Photos 2 & 3).

PHOTO 2 - Rusting steel members

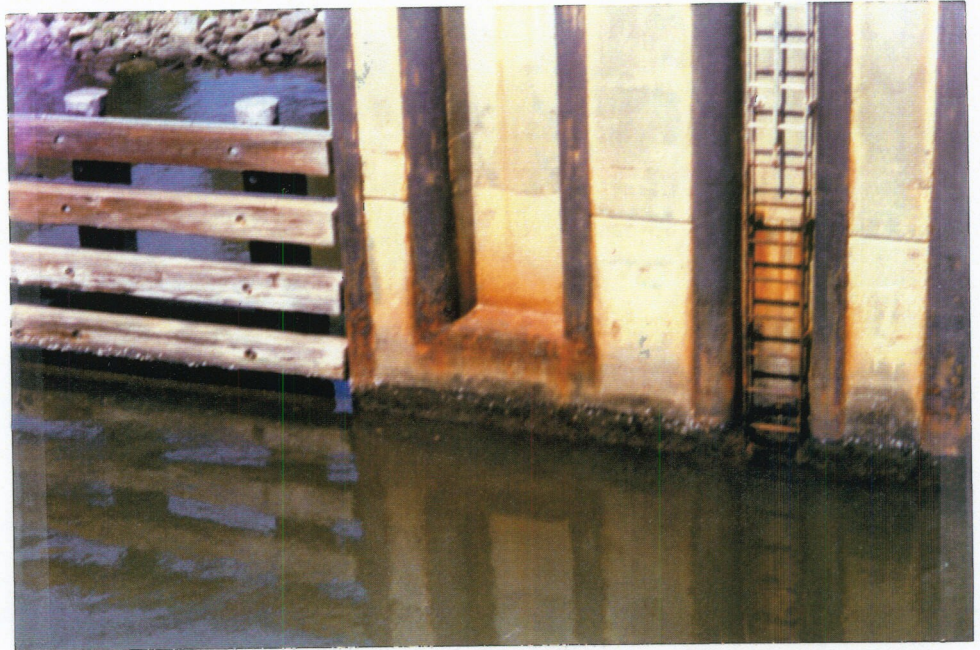
PHOTO 3 - Rusting Steel Members

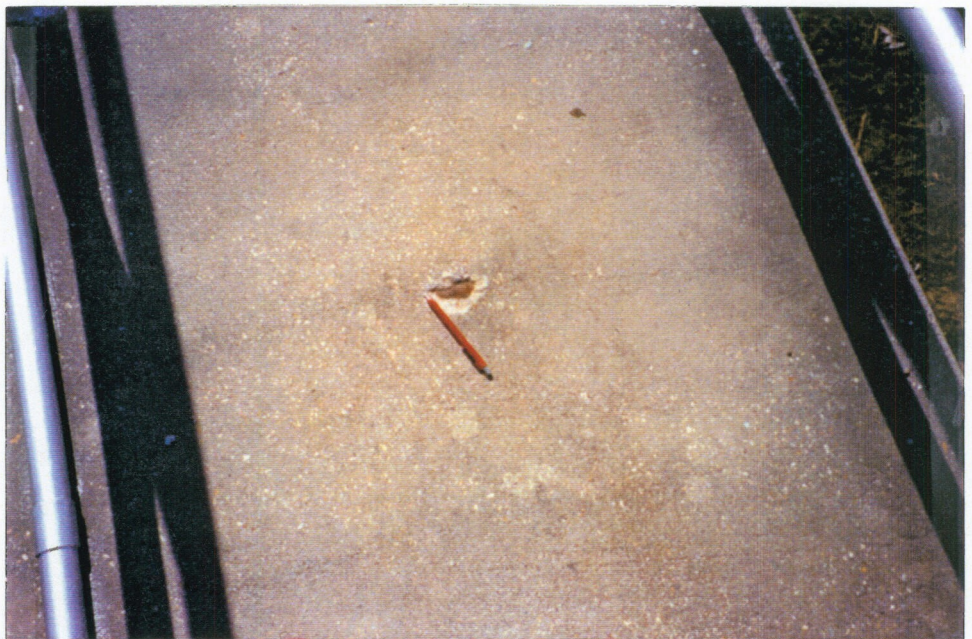
j. There were no significant changes in the condition of the concrete since the last inspection. There were small spalls as shown in **Photos 4 & 5**.

PHOTO 4 - Small spall with exposed rebar on the west side by monolith B-2

c. Small concrete spalls and the depression behind the wingwall at the northwest corner of the structure will be monitored in future periodic inspections for further deterioration.

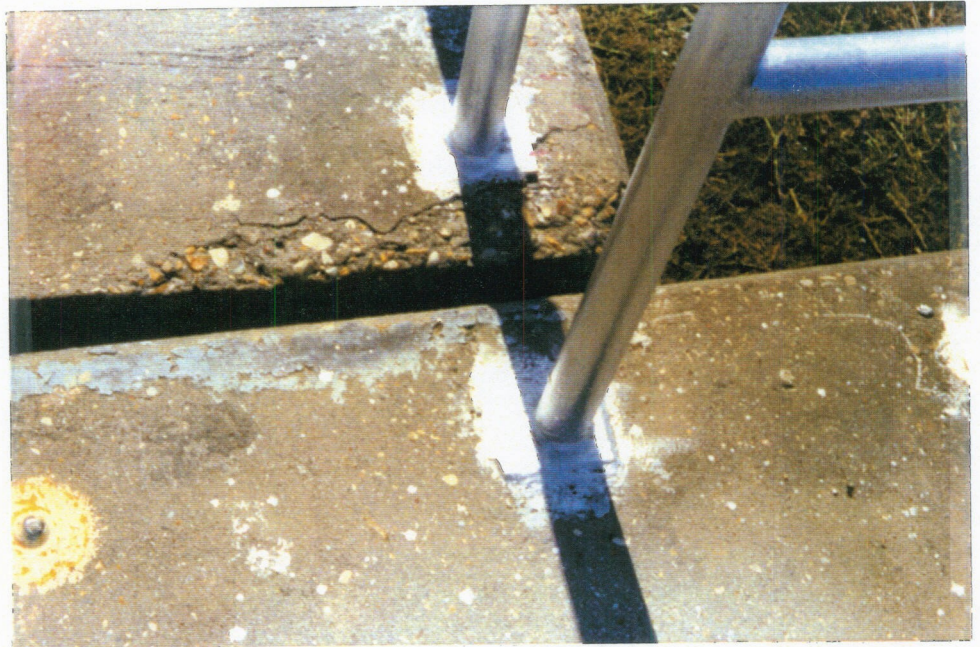
PHOTO 5 - Typical small spalls at the joints  
on the east side

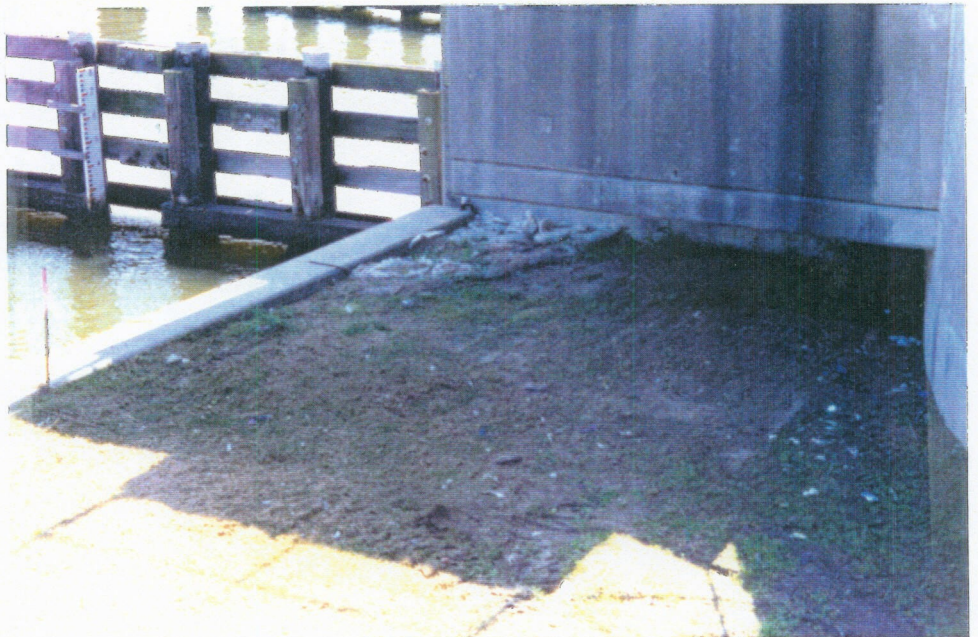
(See Photo 6)

k. A depression, which had been filled with sandbags, was noted behind the wingwall at the northwest corner of the structure. Site personnel stated that this depression was apparently caused by material migrating through the joint at the wingwall/gatebay interface. The sandbags had been placed in the depression about three years ago and no appreciable movement had been noted since. This condition does not apparently pose any immediate threat to the structure. Site personnel will continue to monitor this area for change.

PHOTO 6 - Depression filled with sandbags  
behind wingwall at northwest corner  
of structure

c. **Geotechnical Observations.** A depression which had been filled with sandbags was noted behind the wingwall at the northwest corner of the structure (see photo). Site personnel informed us that this depression was apparently caused by material migrating through the joint at the wingwall/gatebay interface. The sandbags had been placed in the depression about three years ago and no appreciable movement had been noted since. This condition does not apparently pose any immediate threat to the structure. Site personnel will continue to monitor this area for change.
