LAKE PONTCHARTRAIN, LOUISIANA AND VICINITY

CHALMETTE AREA PLAN

BAYOU DUPRE
CONTROL STRUCTURE

PERIODIC INSPECTION REPORT NO. 2

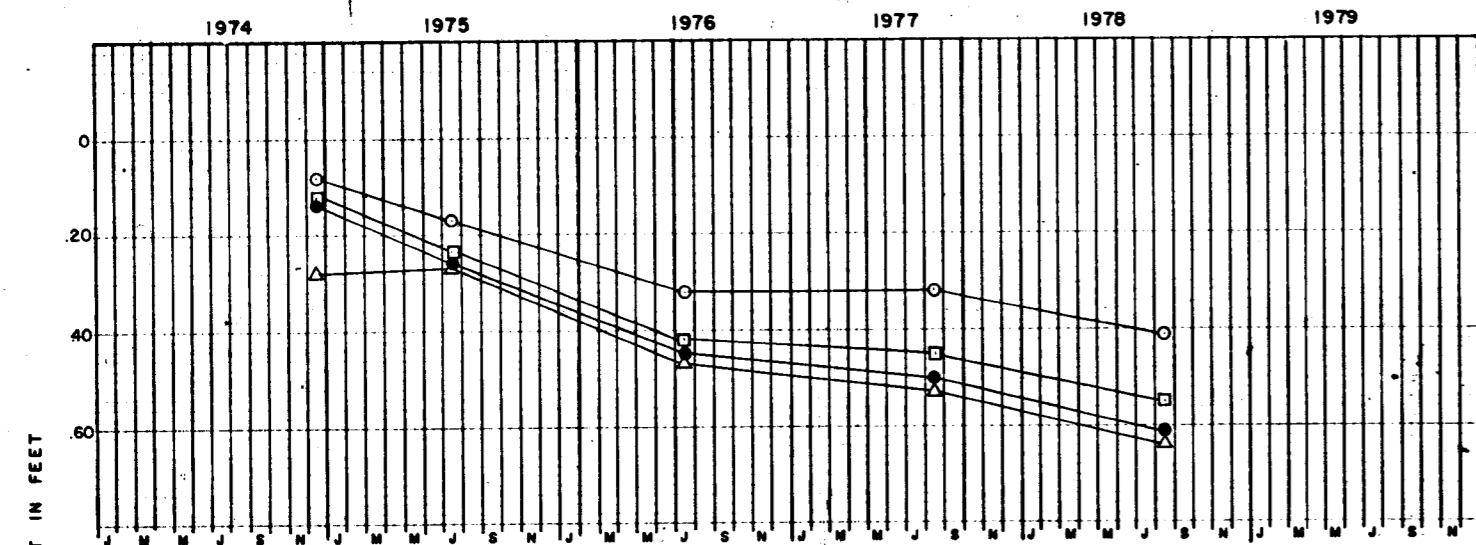
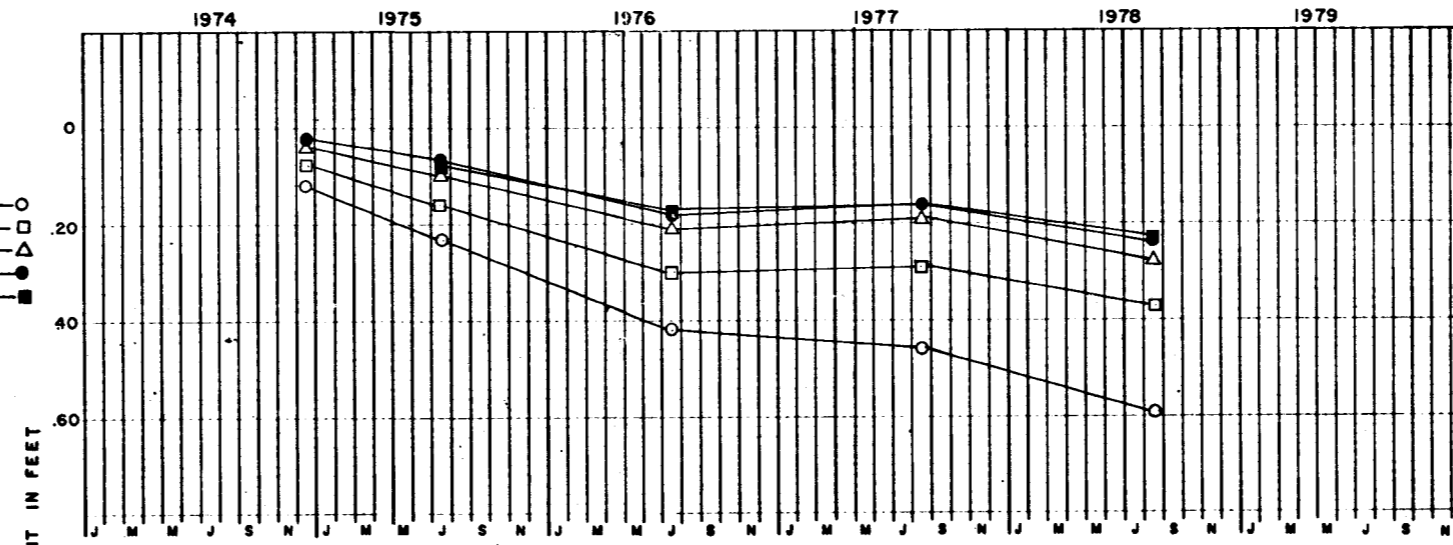
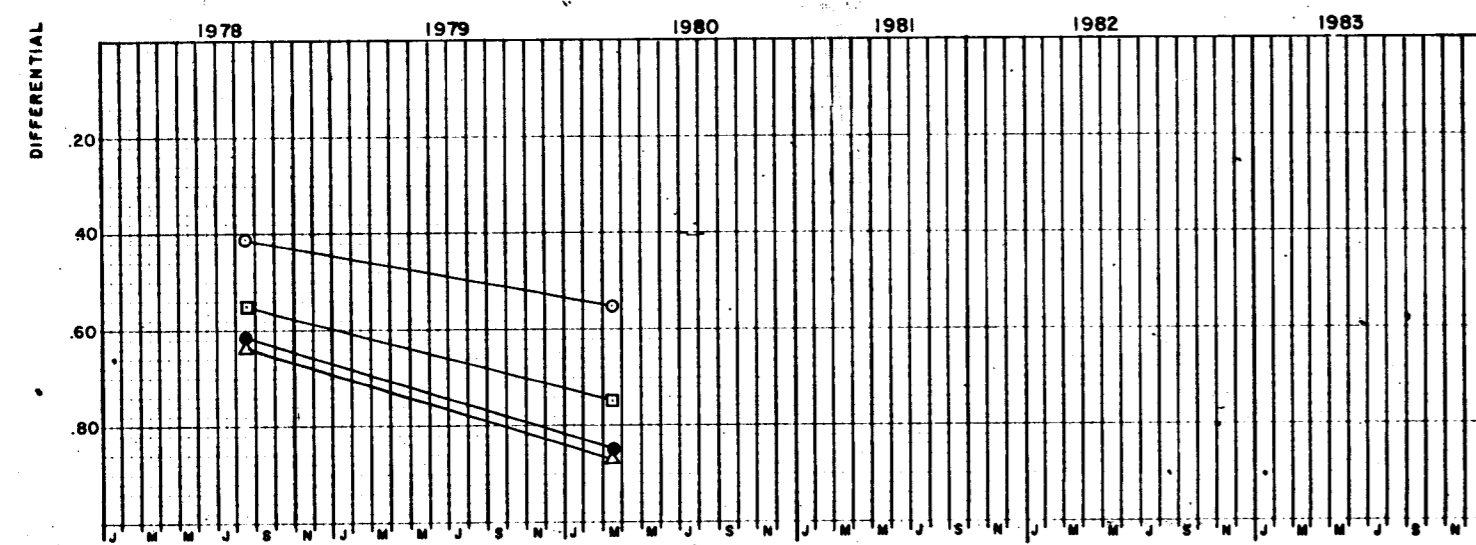
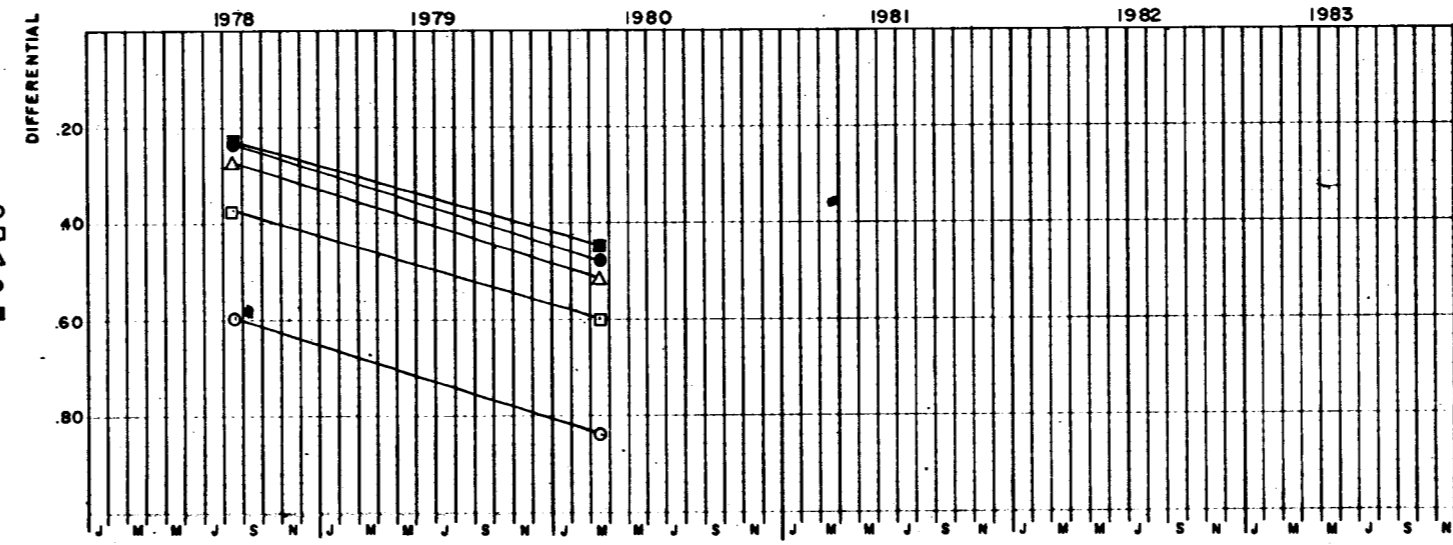
SETTLEMENT REFERENCE MARKS
DIFFERENTIAL SETTLEMENT CHART

(1) Settlement data on Plate 6 indicate that the east concrete-sheetpile wall has settled from 0.6 to 0.9 ft since it was constructed. The rate and magnitude of settlement and the significance of this settlement should be discussed in para 4-03a. In this regard, time-settlement plots of the reference marks on this wall should also be included in this report.

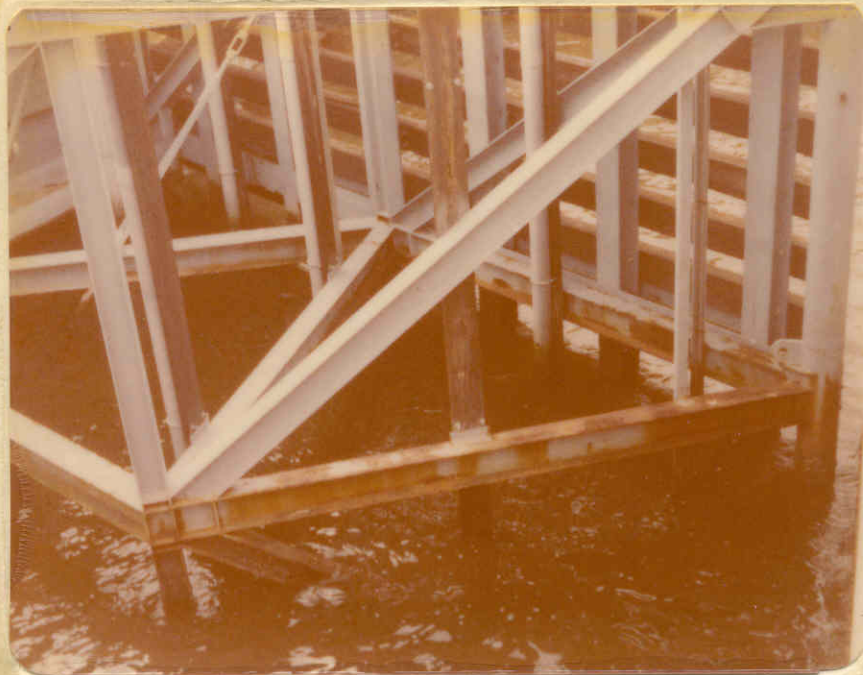
3. Condition of Paint. Good, only the area of tidal fluctuation is heavily corroded.

4. Corrosion. Severe corrosion was found in the area of tidal fluctuation. All exposed metal surfaces are corroded. This condition is normal to marine structures since no effective cathodic protection can be provided to this area (See Photo 1).

PHOTOGRAPH NO. 1 - Rust Corrosion on
Structural Steel
Members of Sector Gate.

- a. ✓ Repair the two pile bents on the N.W. guidewall.
- b. ✓ Replace lost riprap along the bank in the north approach.
- c. ~~Shot blast~~ and paint the corroded structural steel members of the sector gates. This work should be scheduled during a period of low tide. Structural steel members below the water line should be scheduled for repair and painting during next dewatering period.
- d. Adjust the alternator belt on the diesel engine for the generator.
- e. Replace burned out indicator lights on the control panel.
- f. Adjust the loose coupling on the electric motor on the #1 side.

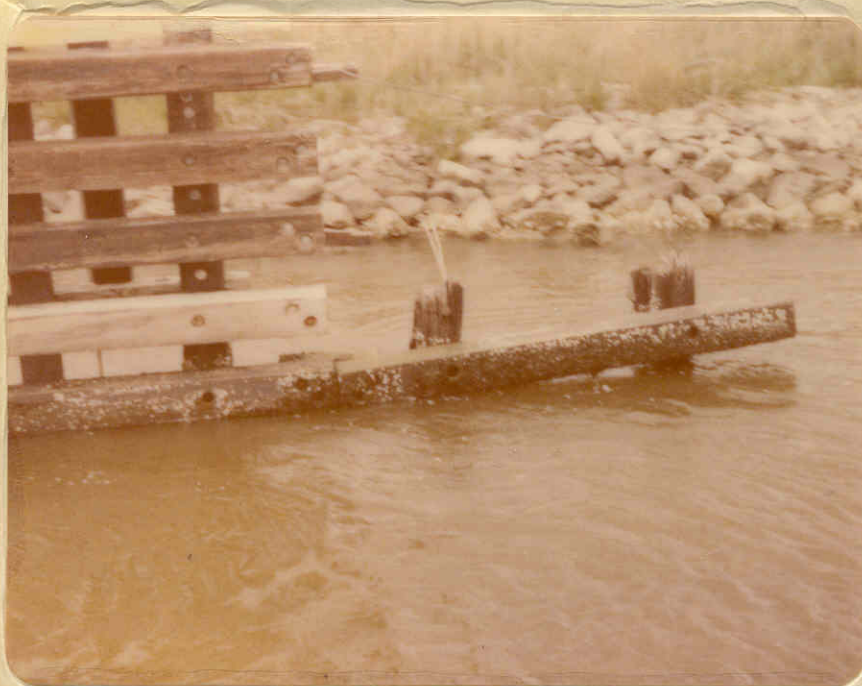
3-01 Maintenance and Operating Problem. The N.W. timber guidewall toward the MR-GO has been damaged near the end, but the Lake Borgne Levee Board knows who was responsible and is working on restitution.

c. Guide Walls and Fenders General Condition of Timber and Connections. The first two pile bents on the N.W. guide wall are damaged above the waterline (Photo 2). Damage was caused by barge collision (The Lake Borgne Levee Board is fully aware of this problem).

PHOTOGRAPH NO. 2 - Damaged pile bents on
the N.W. Guide Wall.

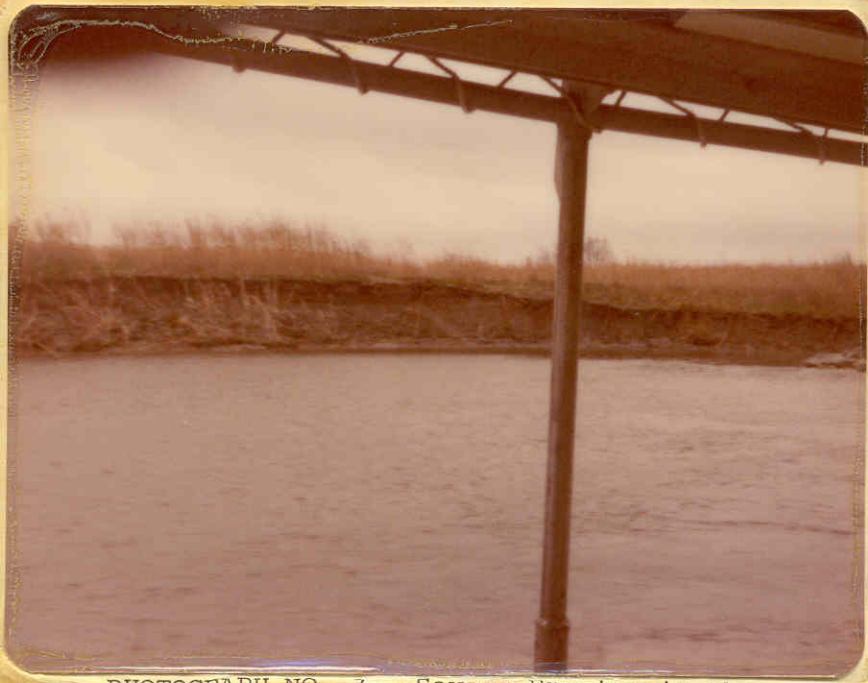
e. Foundations. Observations made during the inspection of the structure indicate that the north approach channel is continuing to scour and thus eroding the bankline (Photo 3). Refer to Section IV, 4-03c for detailed analysis of scour.

PHOTOGRAPH NO. 3 - Severe Erosion in the
west bank on the north
approach channel.

6-02 Proposed Remedial Actions. Plans and specifications to repair the scour/erosion damage in the vicinity of the Bayou Dupre structure are presently being prepared. A construction contract is scheduled for award in September 1980. Also, the following remedial actions should be scheduled during the current year:
