LAKE PONTCHARTRAIN, LOUISIANA AND VICINITY

BAYOU DUPRE  
CONTROL STRUCTURE

PERIODIC INSPECTION REPORT NO. 3

DECEMBER 1983

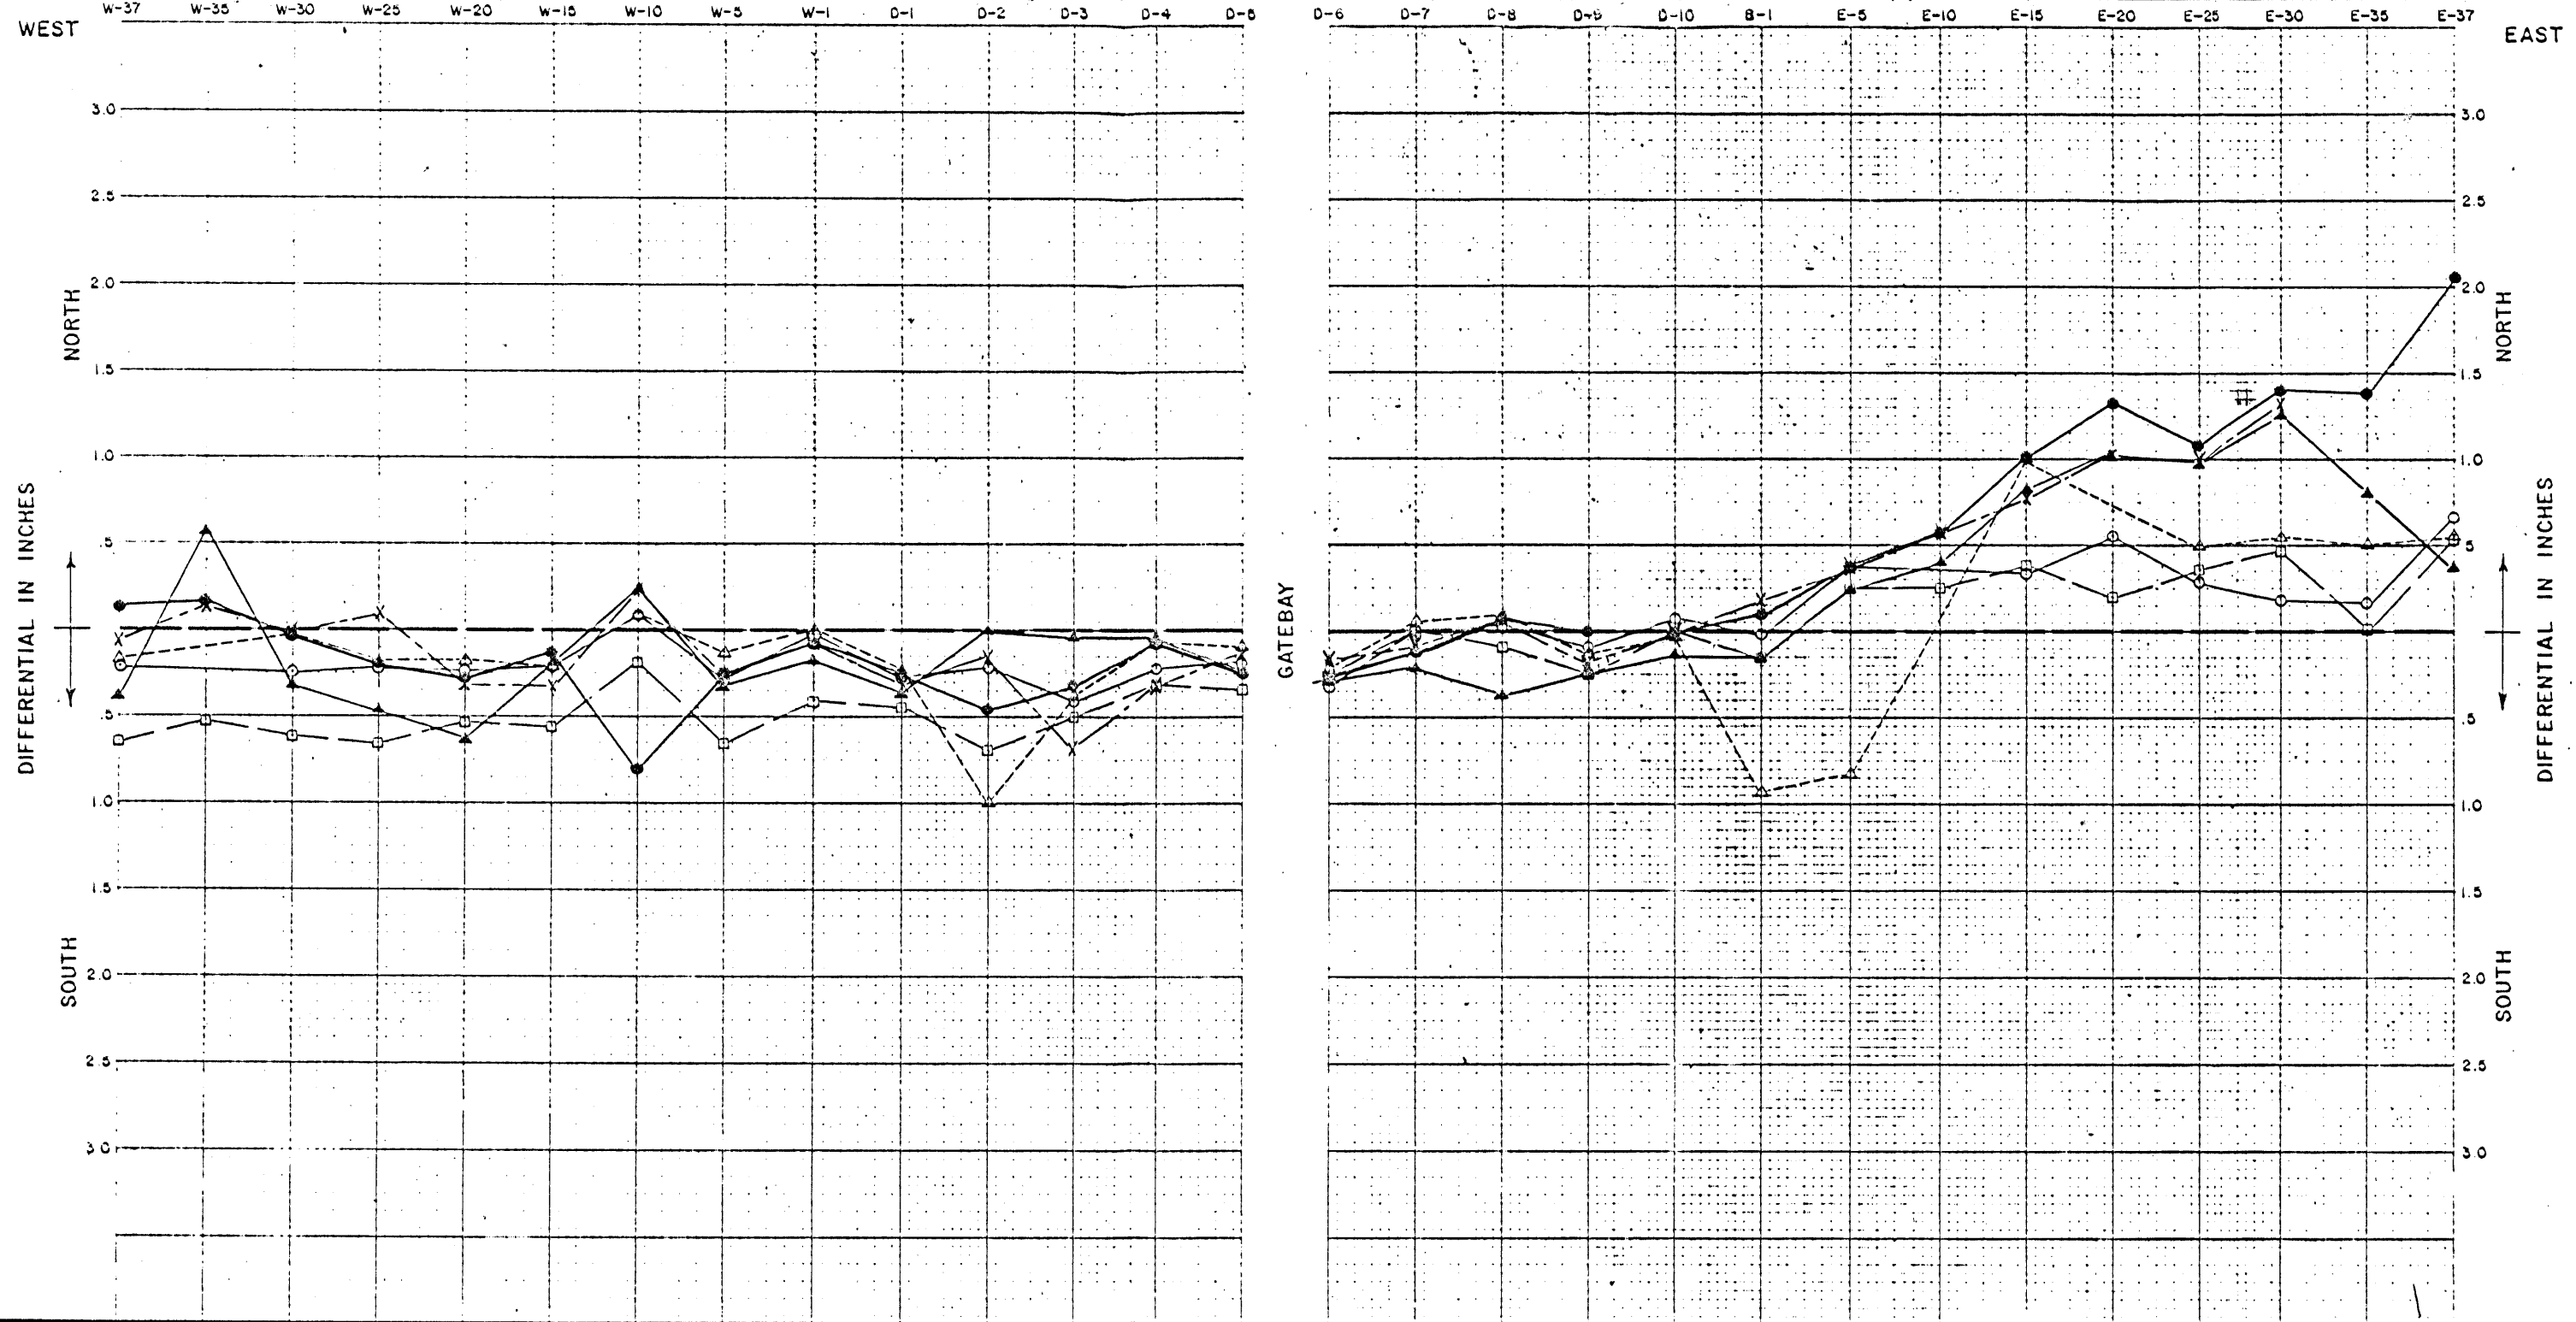
PL-9  
FILE NO. H-4-26855

\* .8 and 1.0" movement was, in fact, erroneous, see plate 9.

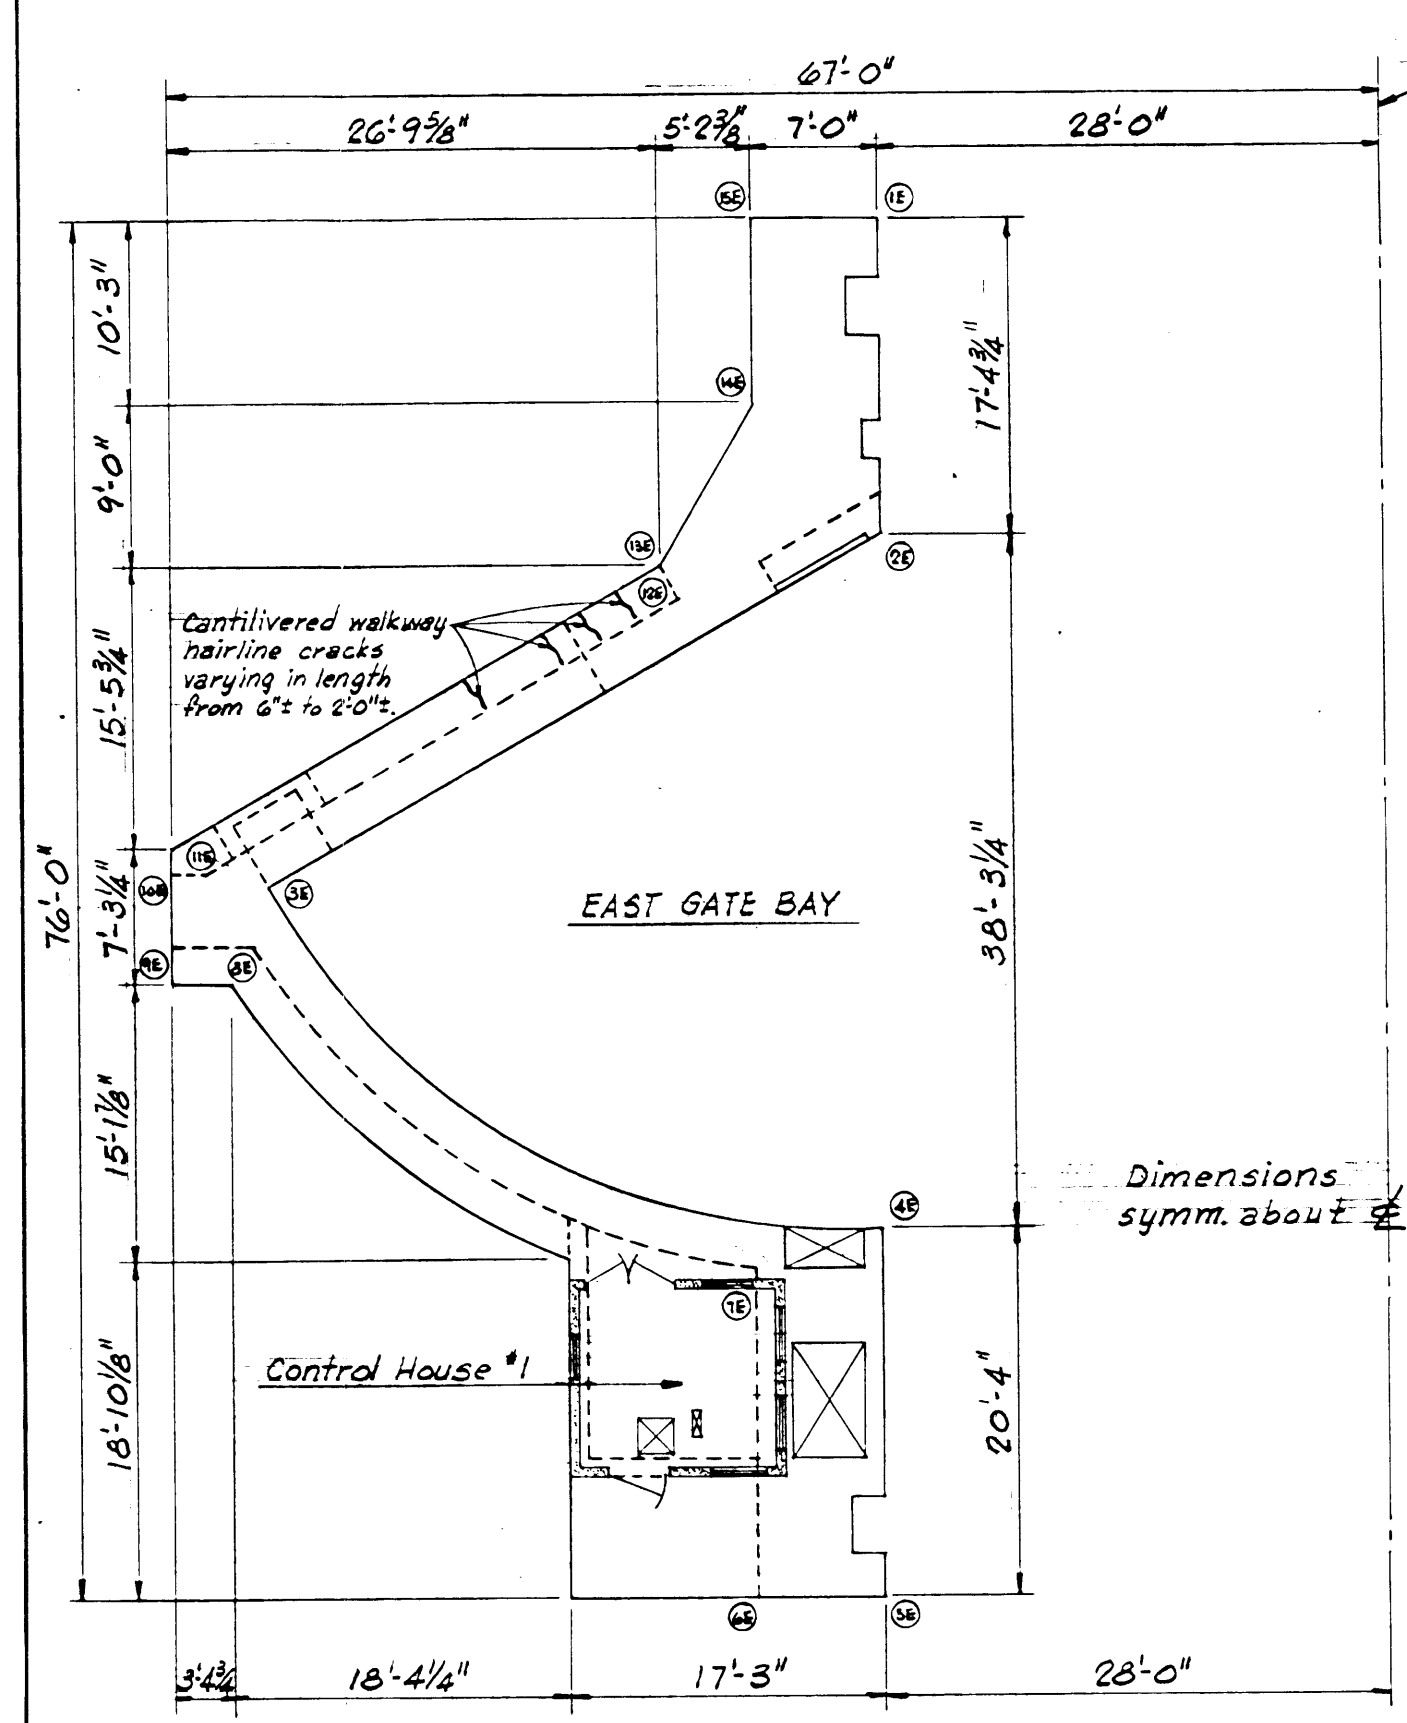
Cantilivered walkway hairline cracks varying in length from 6"± to 2'-0"±.

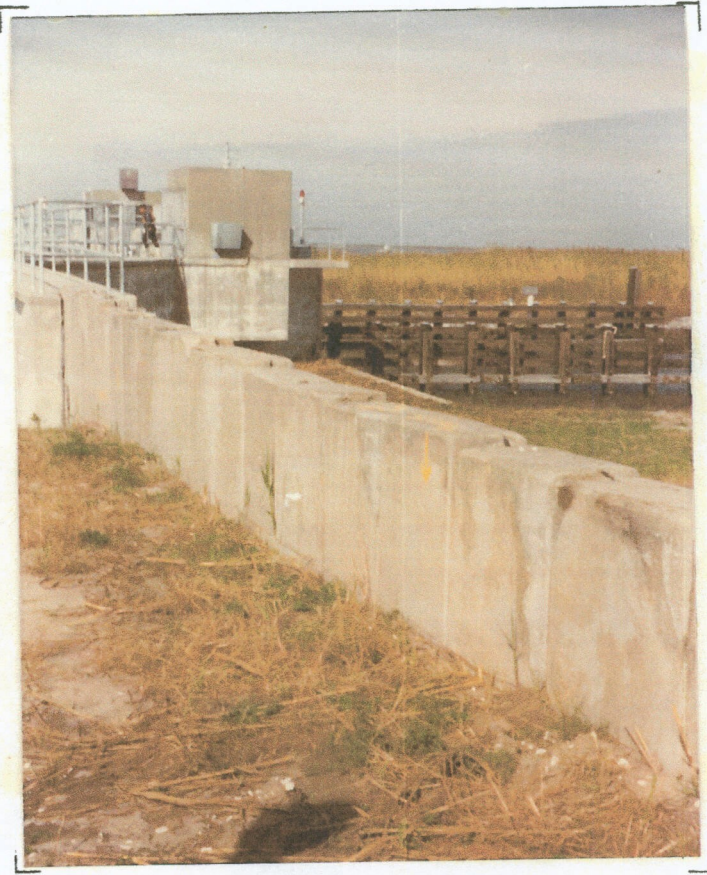
(4) Condition of Horizontal and Vertical Joints. There is no evidence of slippage or separation of joints either on the main structure or the adjacent T-walls. The concrete sheet pile walls adjacent to the T-walls have experienced some differential settlement between piles, but with no apparent separation of the joints. See Photo Nos. 1 and 2. There was some separation of the joint where the concrete sheet pile wall ties into the west T-wall.

Photo No. 1, Para. 5-03, a(4) -  
Differential Settlement

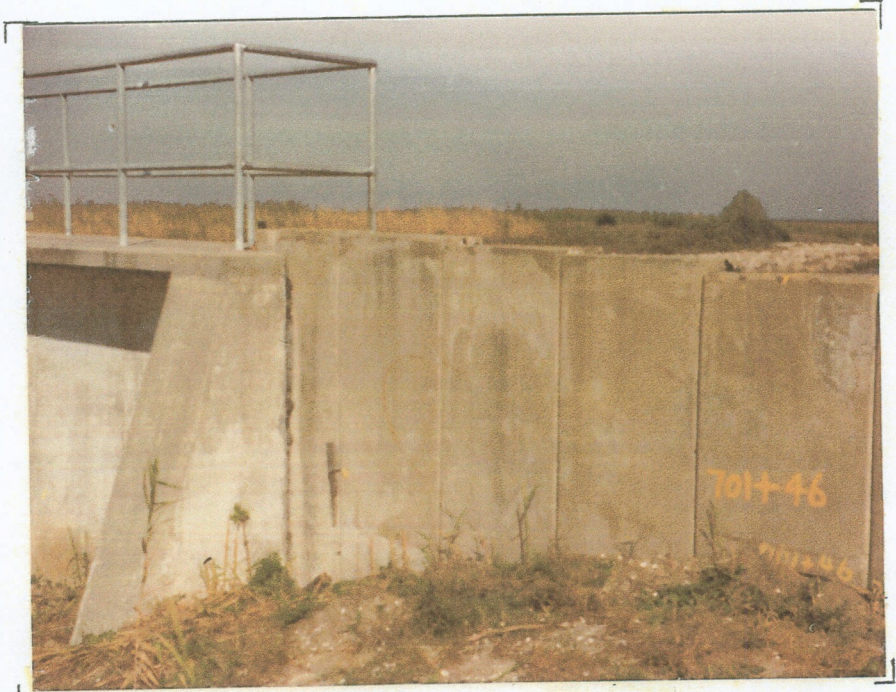
Photo No. 2, Para. 5-03, a(4) - Closeup of Above  
View

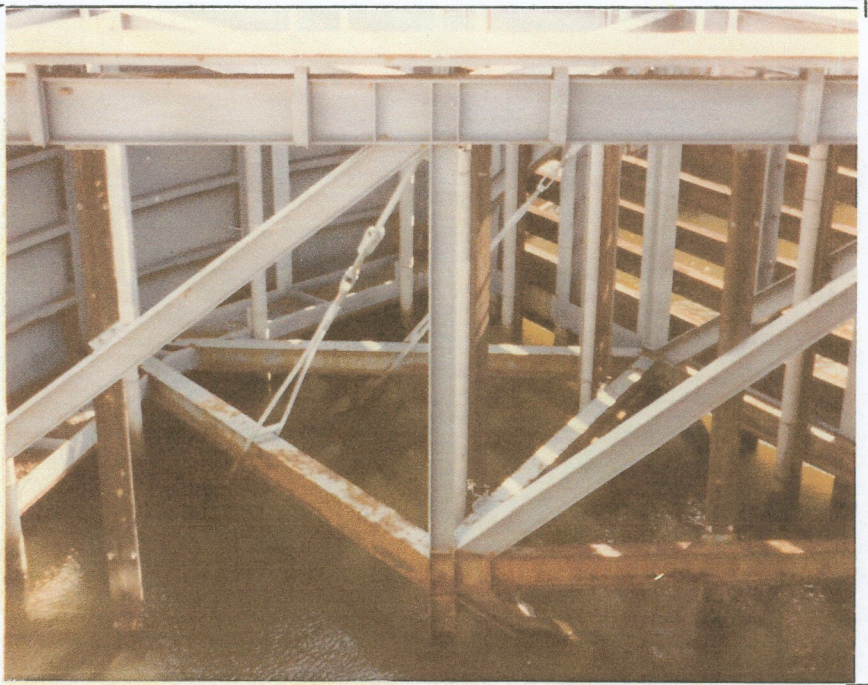
(4) Corrosion. Only general light corrosion under light oxide scale was observed in the area of tidal fluctuation at the time of this inspection and no plans were discussed with the Levee Board to repair it; however, any progress should be noted closely at subsequent inspections in case it should impair the structural integrity of the gates. Refer to Photo Nos. 3 and 4.

Photo No. 3, Para. 5-03, b(4) - East Sector Gate Corrosion

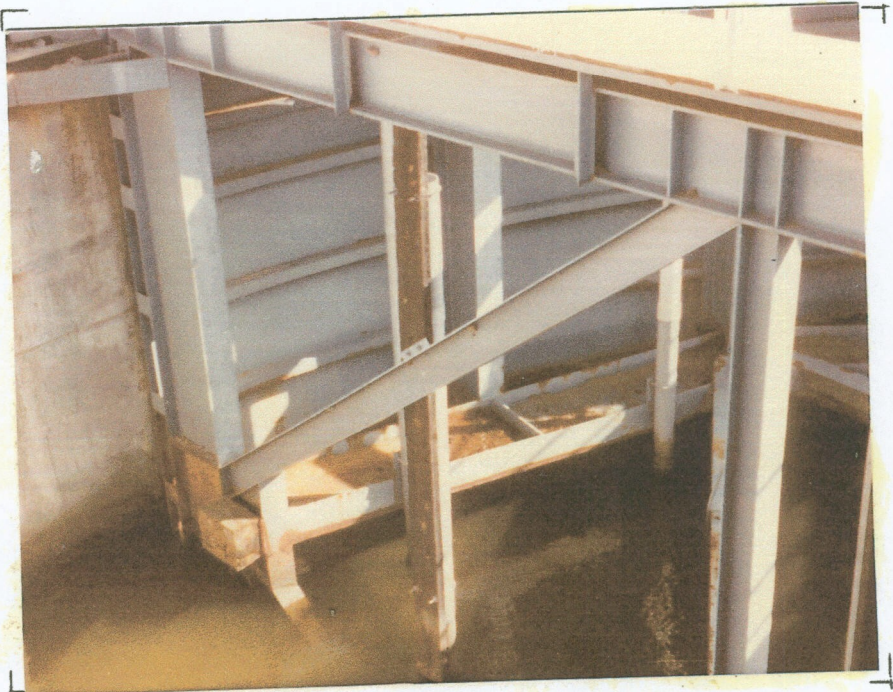
Photo No. 4, Para. 5-03, b(4) - West Sector Gate Corrosion
