NEW ORLEANS TO VENICE, LOUISIANA

EMPIRE FLOODGATE

PERIODIC INSPECTION REPORT NO. 5

29 January 1987

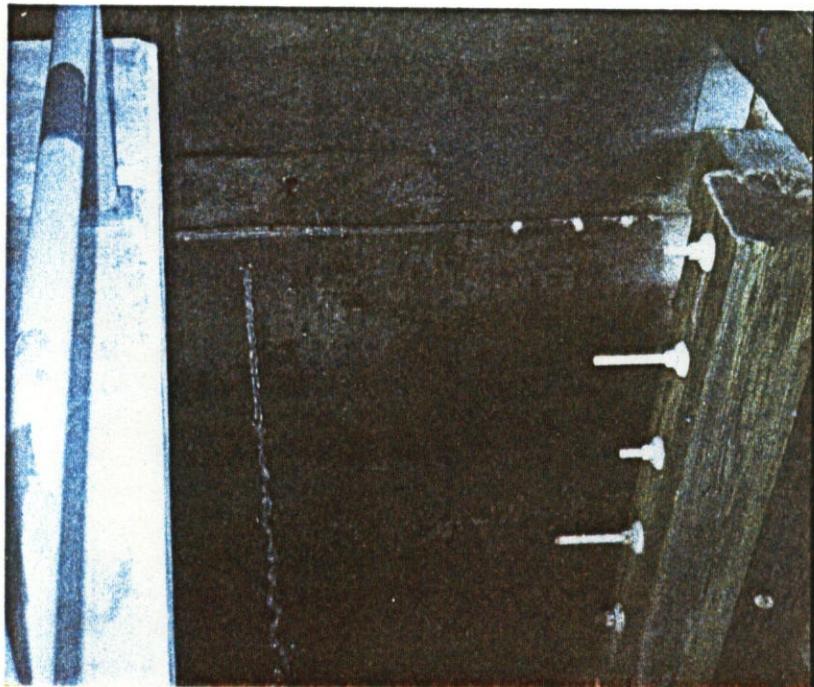
b. Gatebay Monolith. The condition of the concrete in the gatebay monolith was also in very good condition. No significant cracks, spalled concrete areas nor exposed reinforcing steel was observed. A small hole through the North wall of the counterweight recess shaft on the East side of the structure with water flowing through it was observed (See Photo No. 1). The location of the hole was approximately 6" below the chamfered joint elevation. A large amount of corrosion was evident on the protective wall armour and also on the ladders on each side of the channel walls (See Photo No. 2).

Photo No. 1: Small Hole in counter weight recess shaft

f. The small hole in the counter weight recess shaft will be repaired.

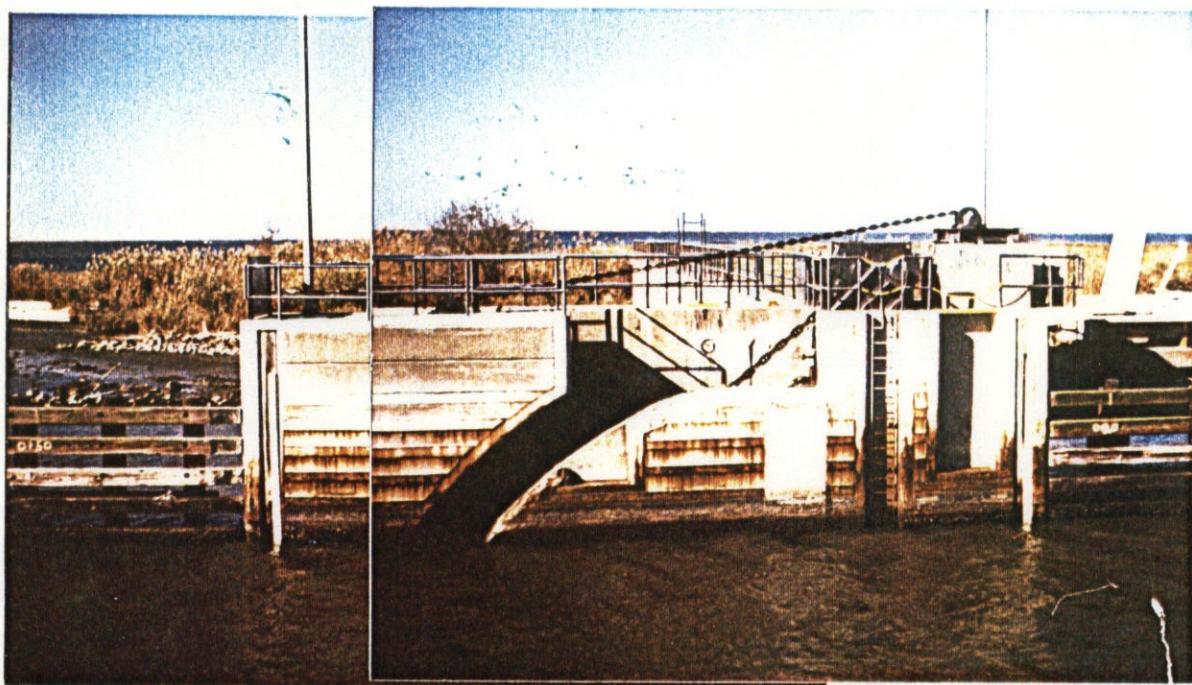
Photo No. 2: Corrosion on protective wall armour and ladder
(Typical)

c. The corroded protective wall armours and ladders, will be cleaned and painted.

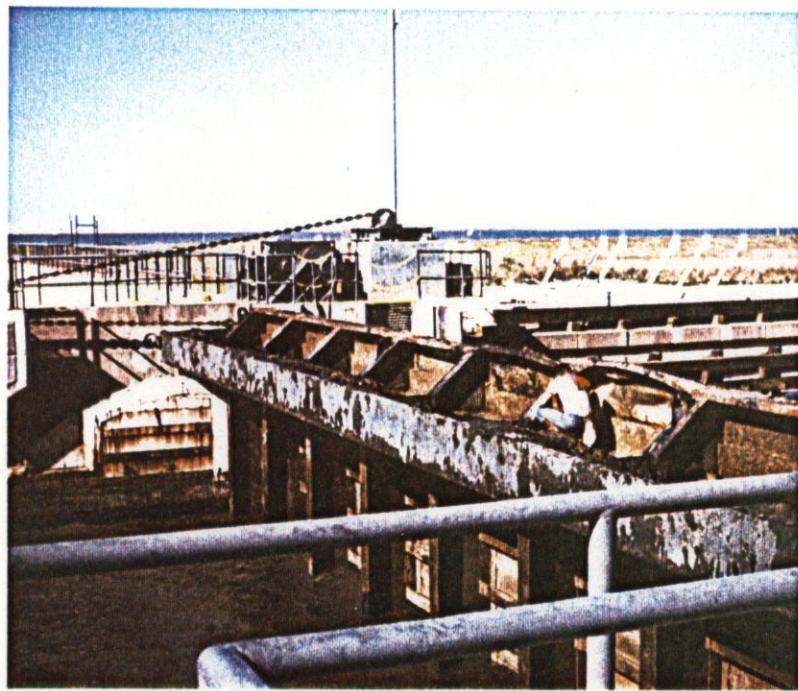
c. Flap Gate. The flap gate was raised to the closed position (See Photo No. 3). The operation of the gate was satisfactory. The paint on both sides of the gate appeared to be in fairly good condition. Extremely large amounts of soil deposits had collected on the gate while in the open position. After the gate was in the fully closed position, there was still a substantial amount of soil remaining on the walkway with smaller deposits remaining on the skin plate of the gate. Adjacent to and on the North side of the gate in its closed position the soil deposits sloped down and away from the water surface into the channel. Moderate damage to the skin plate and channel beam across the top of the gate was observed on the three central interior spans (See Photo No. 4). A portion of this damage occurred prior to Periodic Inspection No. 4 and has not yet been repaired. However, the majority of the damage has taken place since the previous periodic inspection. The damage to the flap gate does not in any way adversely affect the operation of the floodgate. The damage to the gate occurred as a result of its failure to properly seat when in the fully opened position due to a silt build-up underneath it. With the gate in this "partially open" position, the gate is susceptible to being hit by some of the larger vessels that pass through the floodgate.

Photo No. 3: Flap gate in closed position

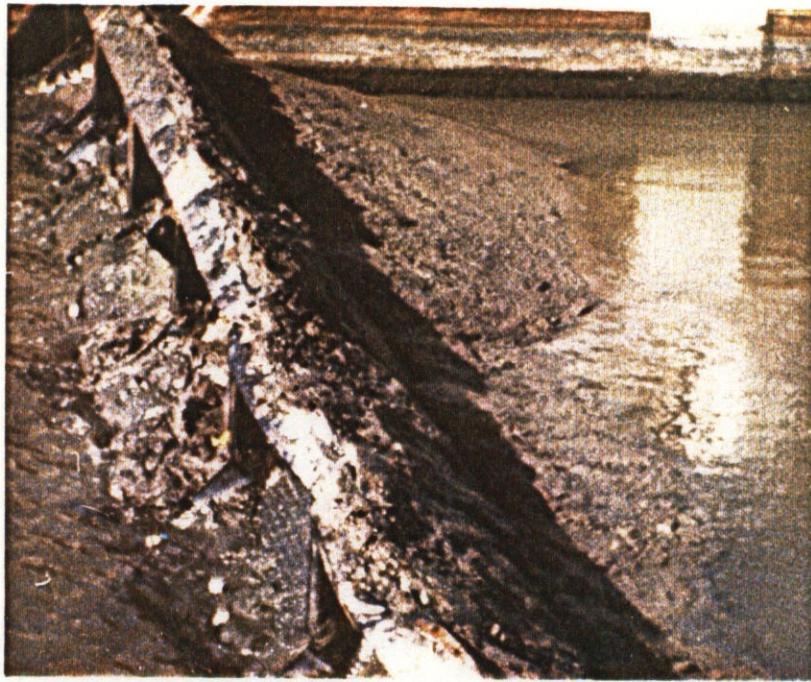
Photo No. 4: Damaged flap gate

a. The damaged gate skin plate and channel beam will be repaired.

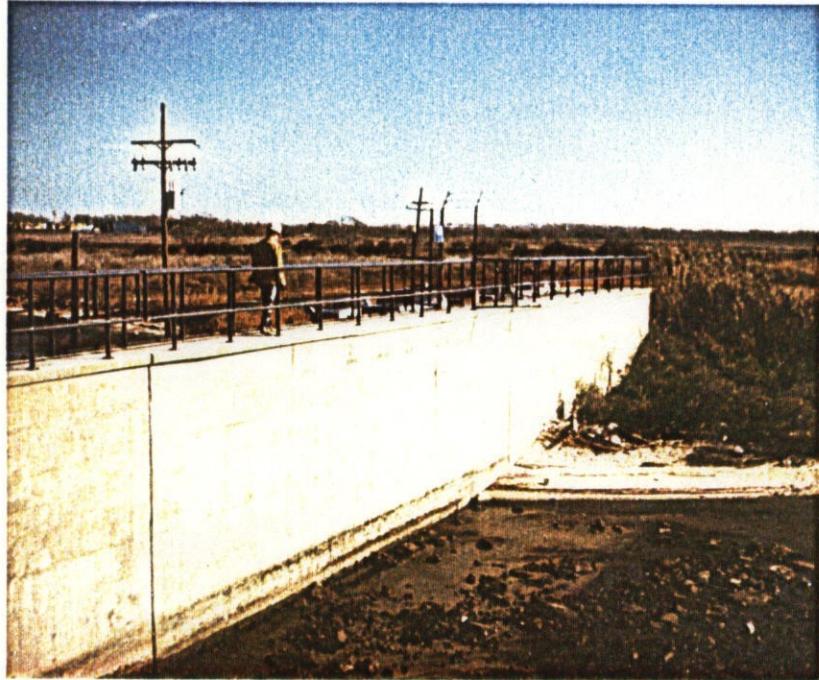
b. Riprap is deficient all around the structure (See Photo No. 5). According to the plans there are areas near the T-Walls, sheet pile, levees and shoreline that require riprap up to elevation +8.00 feet and that seems not to be the case.

Photo No. 5: Deficient riprap (Typical)

*b. A 24-inch layer of No. 2 riprap stone will be replaced at the breakwater dike on the southwest bank and the east side of the north and south approach channels.
