HURRICANE PROTECTION

EMPIRE FLOODGATE

PERIODIC INSPECTION REPORT NO. 8

17 JANUARY 1996

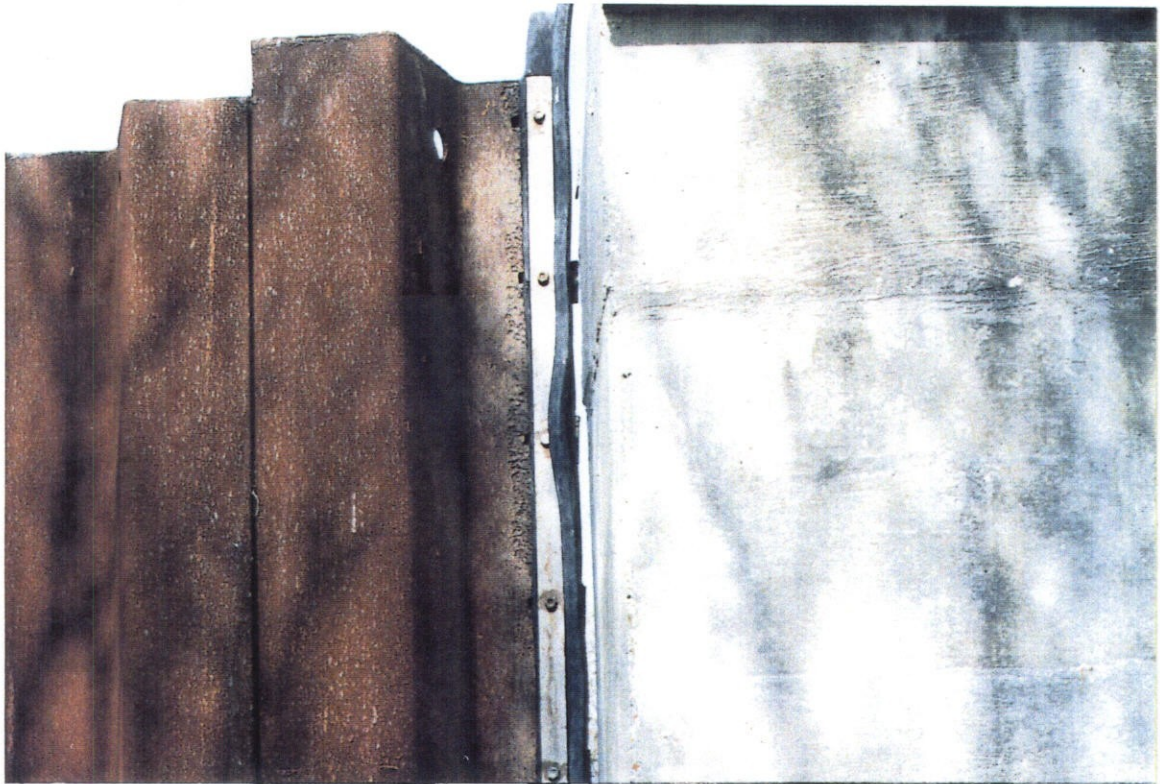
PHOTO NO. 2 - JOINT BETWEEN FLOODWALL MONOLITH T-4L AND
THE WEST SIDE SHEET PILE FLOODWALL
SHOWING THE GAP BETWEEN THE L TYPE SEAL
AND MONOLITH T-4L.

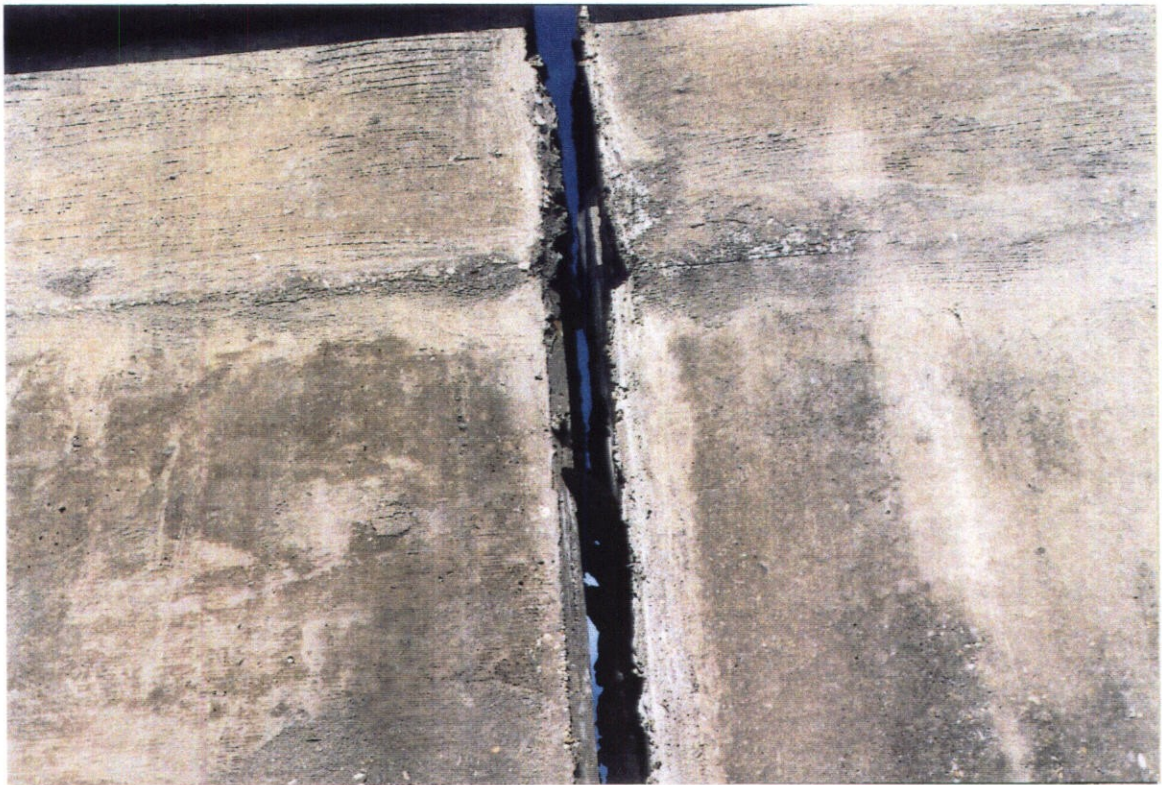
PHOTO NO. 3 - JOINT BETWEEN FLOODWALL MONOLITHS T-3L AND T-4L. NOTE TORN WATERSTOP.

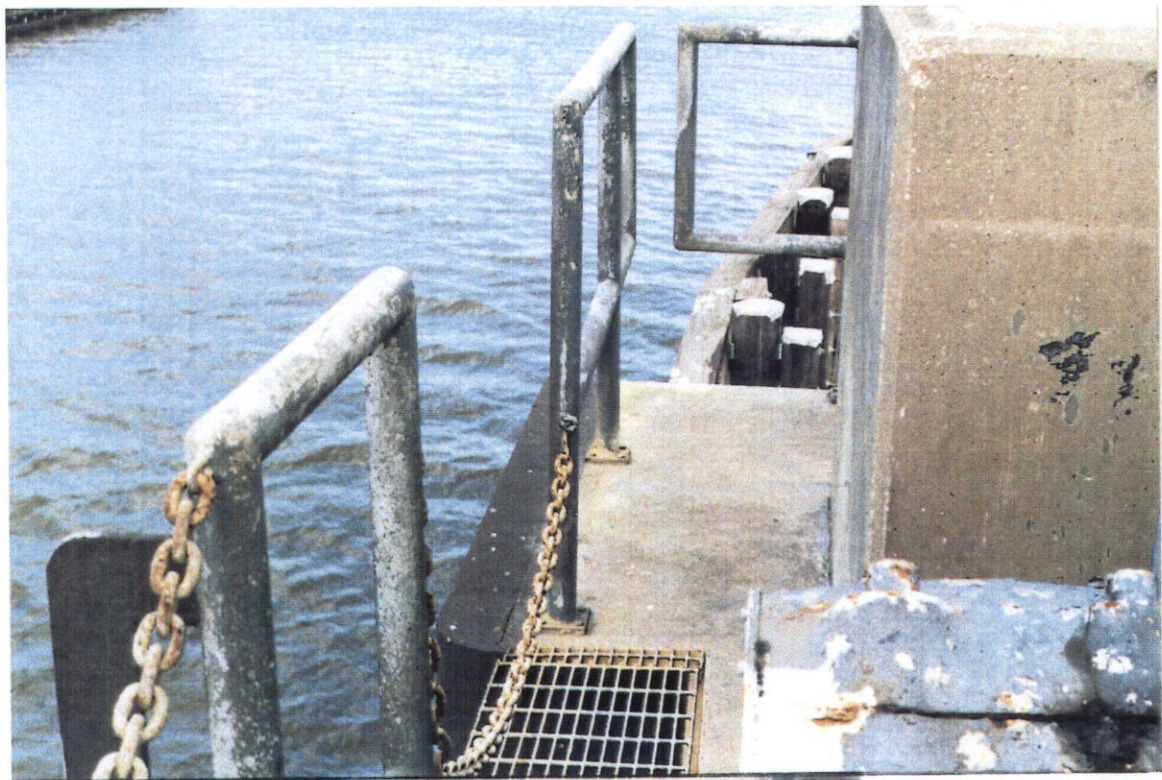
PHOTO NO. 4 - VIEW SHOWING DETERIORATED PAINT ON HANDRAIL AND MISSING EYE FOR CONNECTING THE SAFETY CHAIN.

b. Reinstallation of the missing hand railing safety chains is not addressed in Section VI. This is a small, but very important item in the area of safety. The New Orleans District should ensure that the chains are replaced.

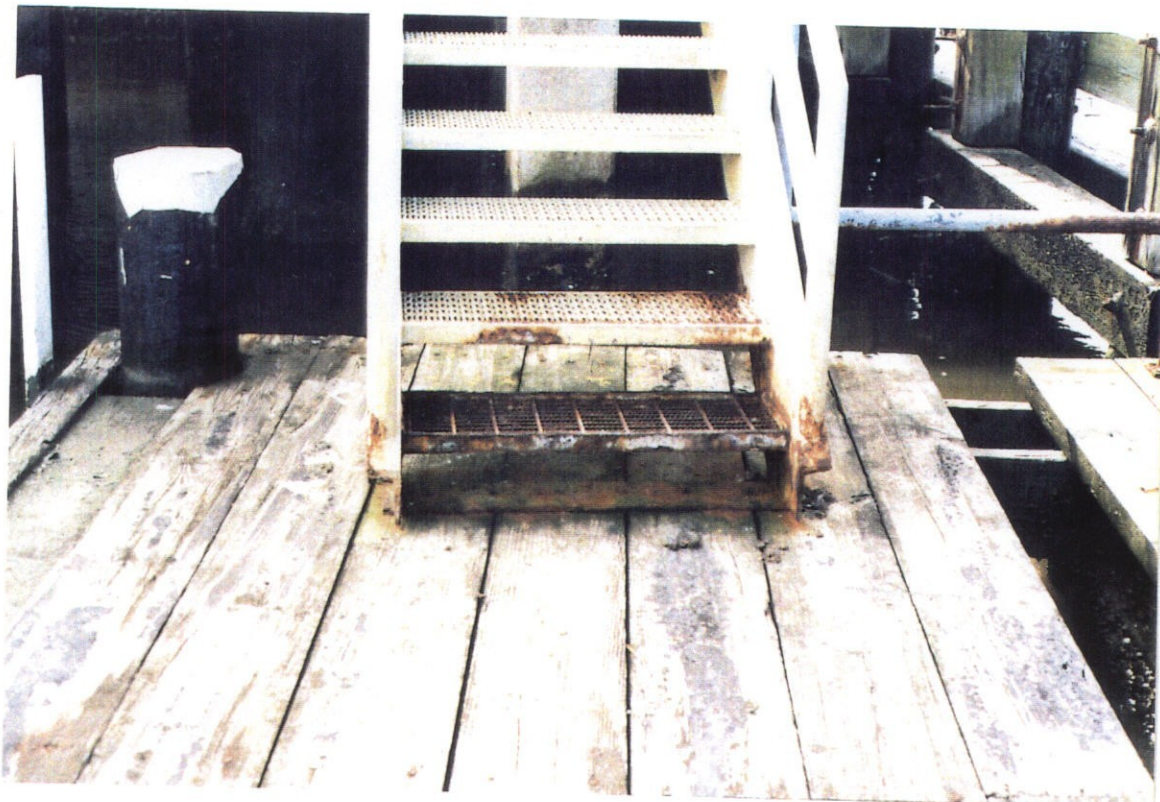
PHOTO NO. 5 - BADLY CORRODED BOTTOM TREAD AND ATTACHMENT PLATE ON STAIRWAY TO BOAT DOCK. NOTE MISSING DECK BOARD.

6. Paragraph 6-02z, page VI-6. The referenced paragraph mentions only one deck board to be replaced on the boat dock. All of the deck boards should be thoroughly inspected and replaced as required, as well as the timber girders below the deck.

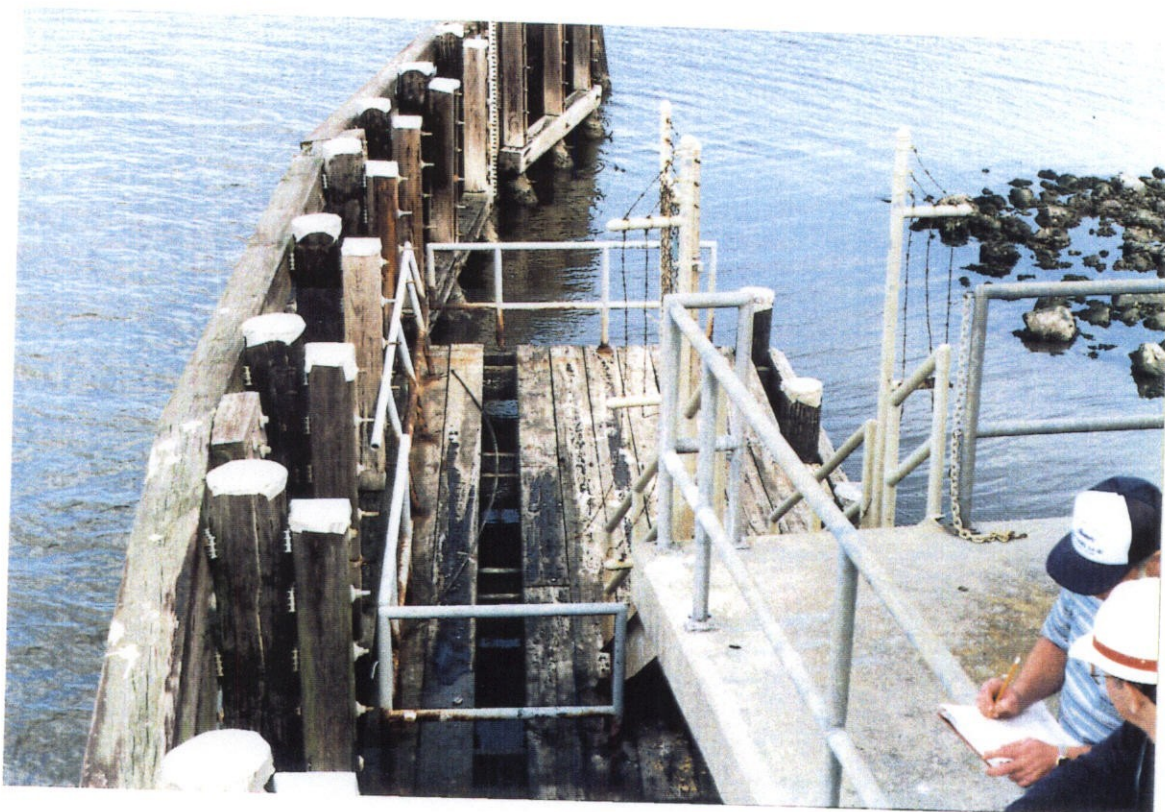
PHOTO NO. 6 - BADLY DETERIORATED HANDRAILS ON THE BOAT DOCK.

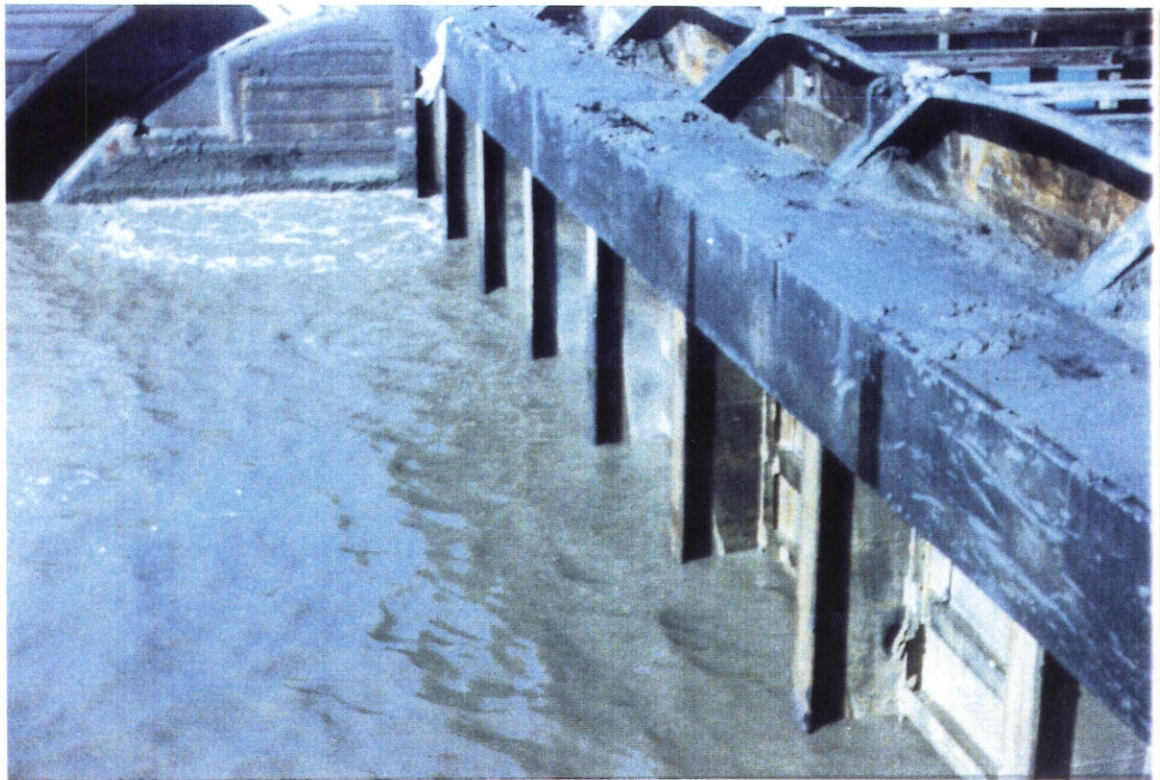
Safety: Because of silt accumulation in the gate recess area, the gate does not fully open (lowered into the sill seat) after the gate has been closed without significant effort (dredging and cleaning of the gate recess). The gate protrudes above the chamber floor 2 feet to 3 feet on average (El -12 to El -11) in its open position. There is concern that the gate may be sitting up higher than this on some occasions. The top of the gate has been hit on a number of occasions with only minor gate damage occurring to date. It appears only the top member has been damaged. The top member was repaired during the last dewatering in 1991. Since then, it appears the gate has been hit at least four times based on a photo taken 2 Feb 97. Also of safety concern is if one of these deep draft vessels strike the gate while taking harbor from an approaching hurricane and damage the gate such that it can not be closed. This problem should be corrected. Requiring the locals to bring out a dredge to clean the gate recess each time they close the gate is impractical and appears to be more than normal maintenance. Removal of silt from the gate recess by a dredge is an appreciable expense, and results in the structure being closed to navigation an appreciable length of time. A more proficient system needs to be developed to assist the locals in performing readiness checks.

PHOTO NO. 7 - VIEW LOOKING WEST AT UNDERSIDE OF THE GATE. GATE IS IN THE FULLY CLOSED POSITION. NOTE LINES ON VERTICAL MEMBERS MADE BY SILT LINE WHEN THE GATE WAS OPEN (LOWERED INTO ITS RECESS).

6. Other Concerns: Based on the following, we will recommend to the project manager that a study be conducted to investigate alternative means of removing the silt from the recess to facilitate fully opening the gate.

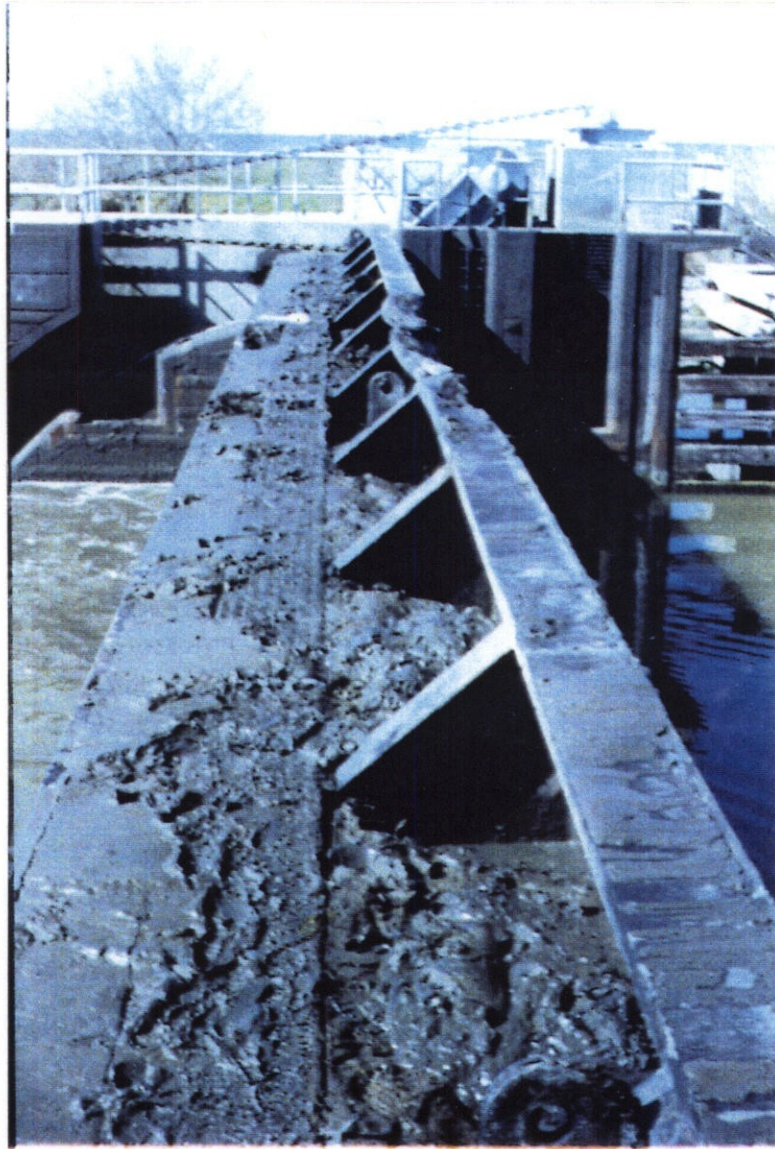
PHOTO NO. 9 - VIEW LOOKING WEST SHOWING DAMAGE TO THE TOP OF THE GATE. NOTE SILT ON TOP OF GATE.

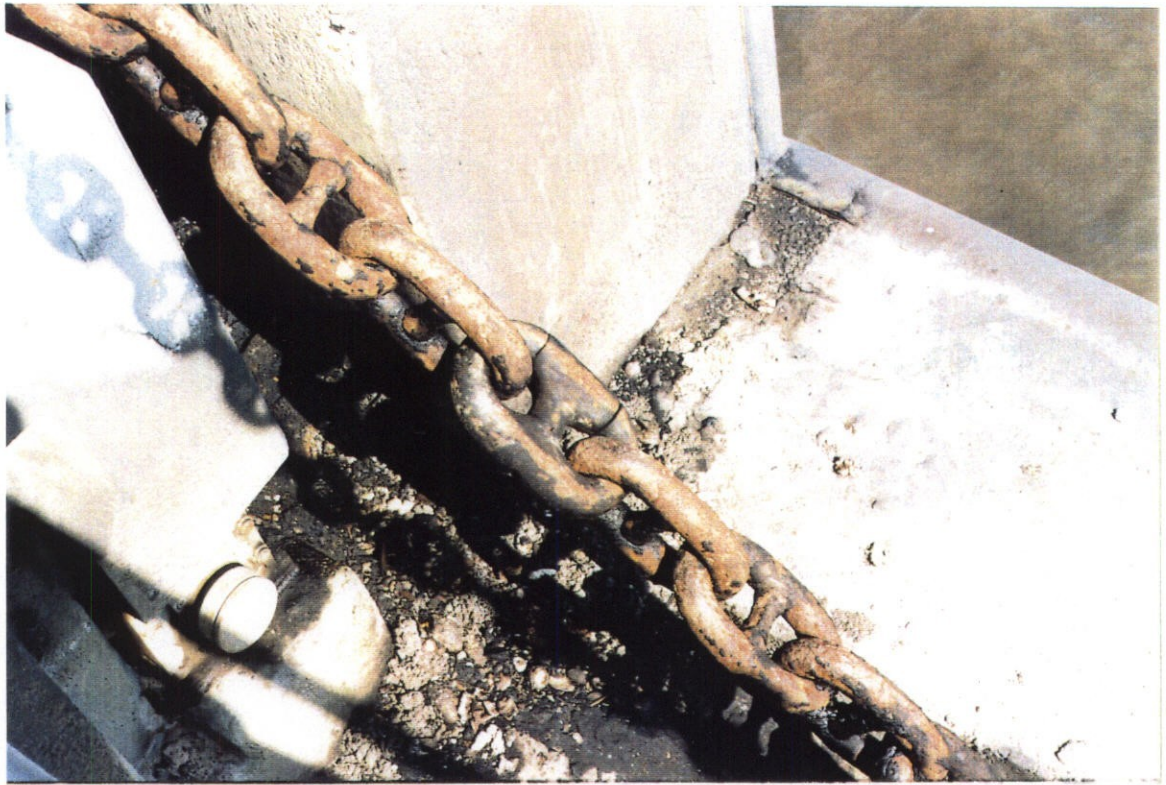
PHOTO NO. 12 - WEST SIDE HOIST CHAIN. NOTE CORROSION AND CONNECTING LINK INSTALLED TO REPLACE A FAILED LINK.

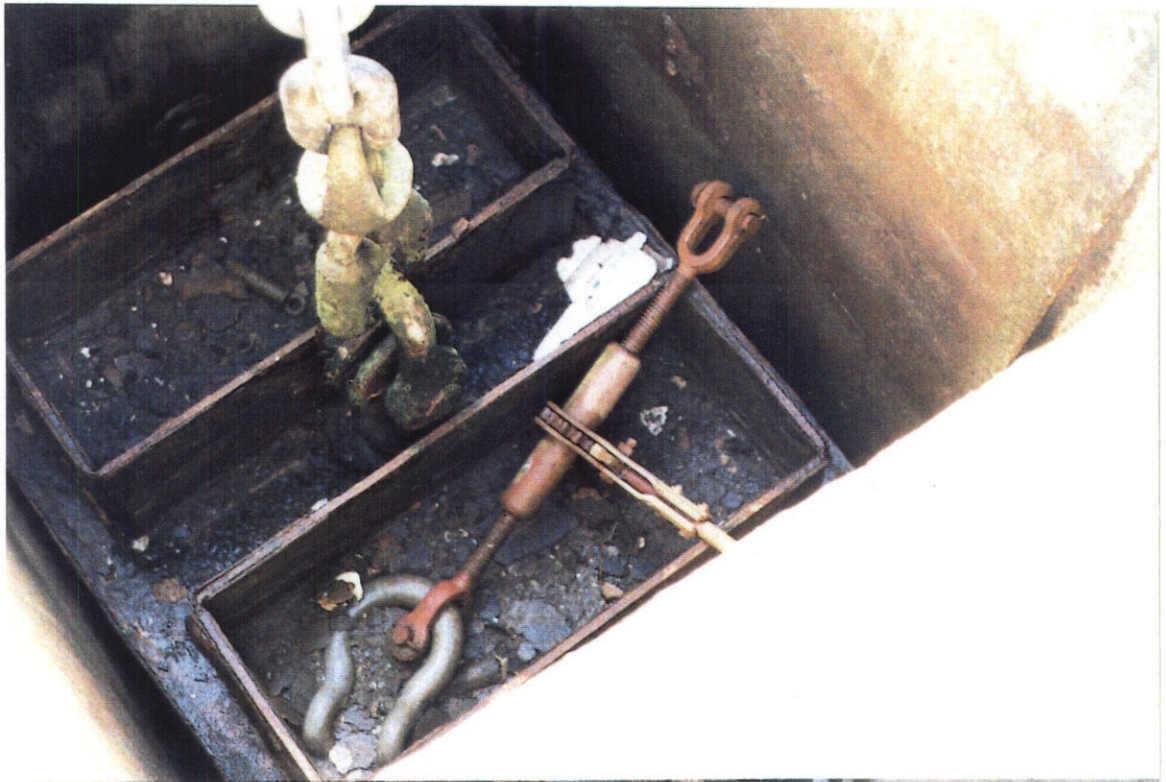
PHOTO NO. 13 - TOP OF WEST SIDE COUNTERWEIGHT. NOTE DISCONNECT LOAD BINDER RATCHET LYING ON TOP OF THE COUNTERWEIGHT.

b. As the first quarter of FY 97 is almost over, the decision concerning whether to hang the counterweights from the chain or the ratchet jacks should have been made by now. You should furnish this information in your response. It should be noted that the intent of the original design was that the counterweights be suspended from the ratchet jacks at all times. It is recognized that releasing the counterweight from the ratchet jack is accomplished with some minor amount of effort, however, this operation is required only when landfall of a hurricane is predicted for that area and the gate is being prepared for operation, or once every 3 years for the periodic inspection of the structure. It should be noted that on at least one previous occasion the counterweight chain broke and one of the counterweights did in fact fall to the bottom of the counterweight well. Proper operation and maintenance of the counterweights should be given high priority.

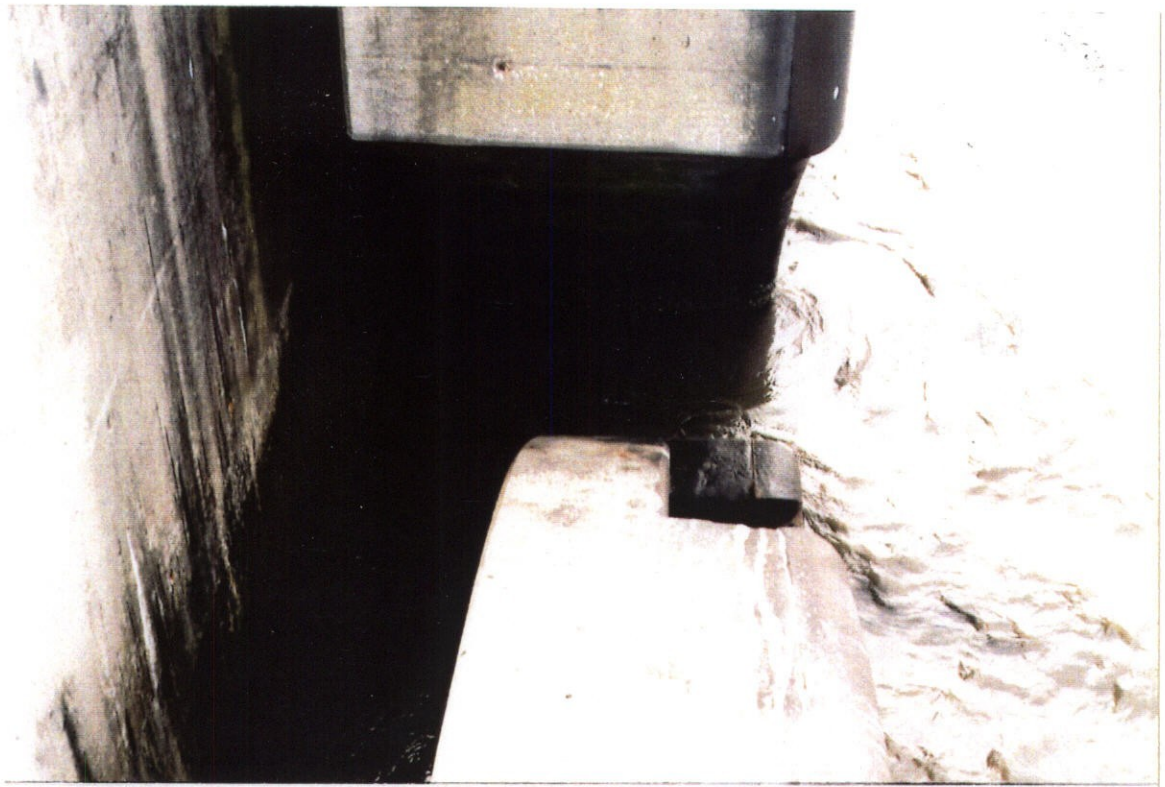
PHOTO NO. 14 - TURBULENCE AT EAST SIDE GATE SLOT DURING PERIODIC INSPECTION ON 17 JANUARY 1996. TURBULENCE IS A RESULT OF OPERATION OF THE GATE RECESS FLUSHING SYSTEM. GATE IS RAISED FROM FULLY OPEN ABOUT 2-FEET.

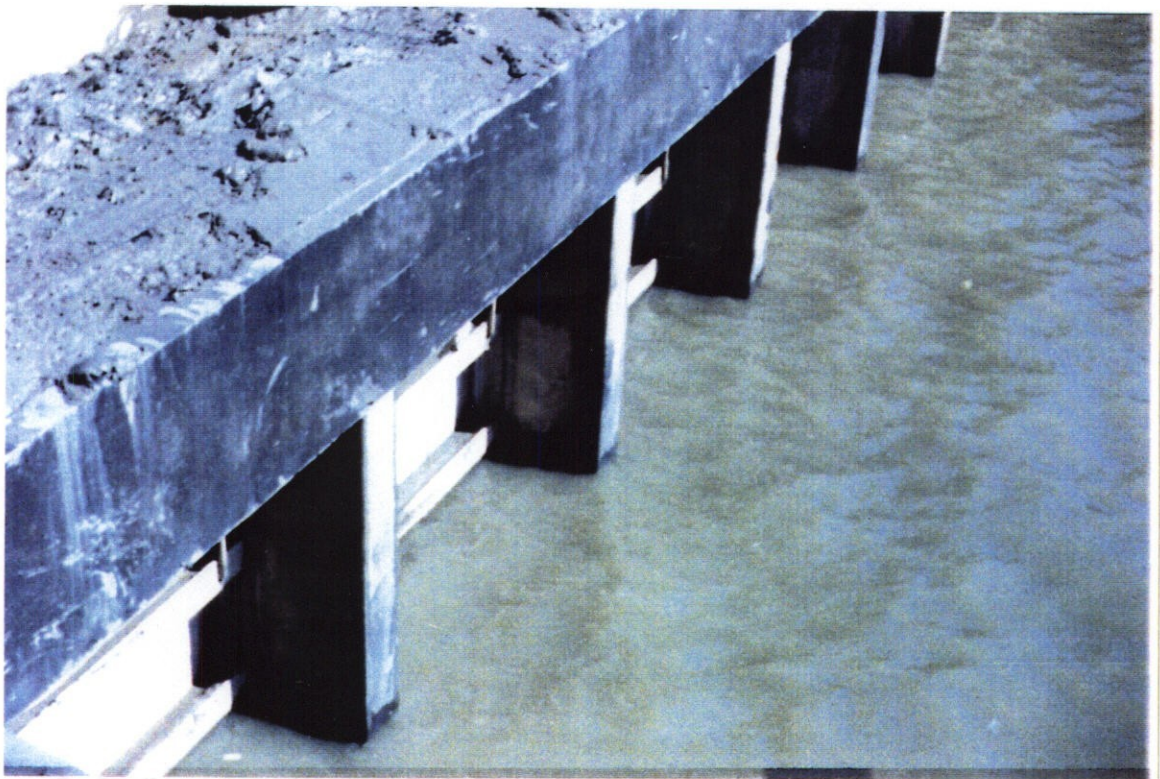
PHOTO NO. 15 - VIEW SHOWING SLIGHT AMOUNT OF TURBULENCE FROM GATE RECESS FLUSHING SYSTEM WITH GATE FULLY CLOSED (RAISED) DURING THE SUPPLEMENTAL GATE INSPECTION ON 13 FEBRUARY 1996.

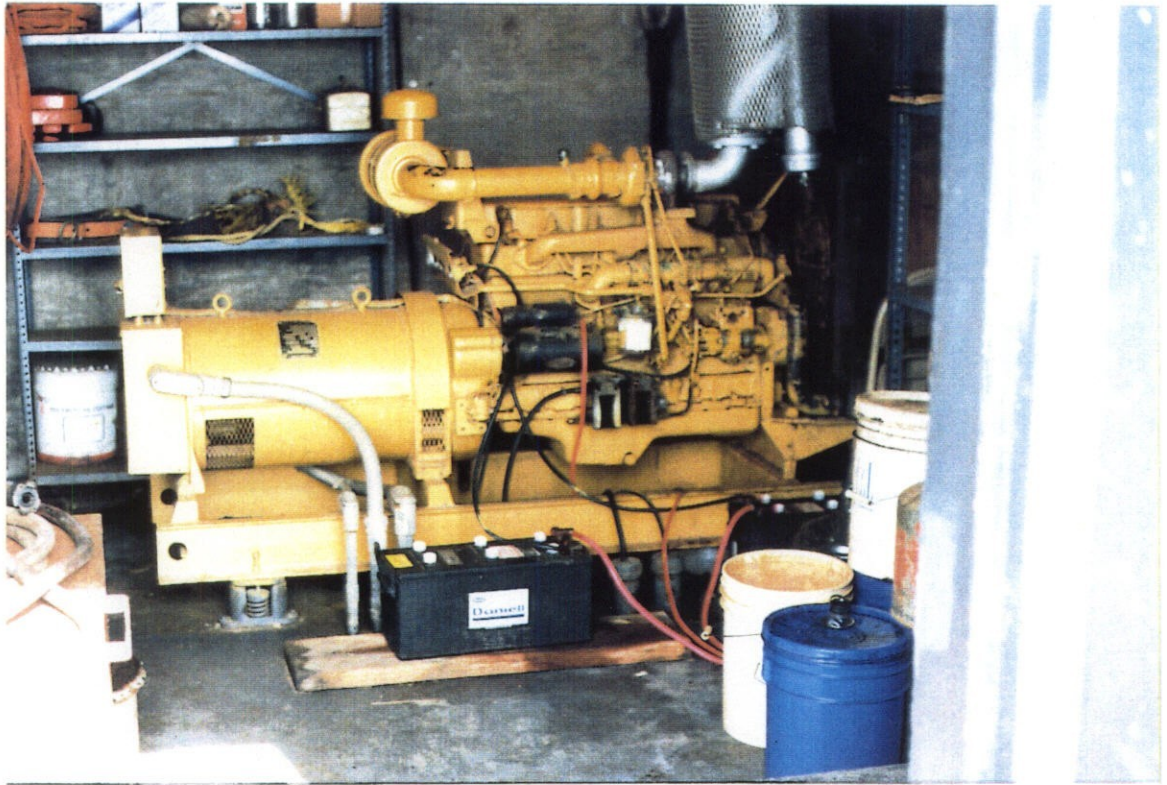
PHOTO NO. 16 - EMERGENCY POWER GENERATOR. NOTE FUEL OR LUBE OIL HAS LEAKED ON THE FLOOR.

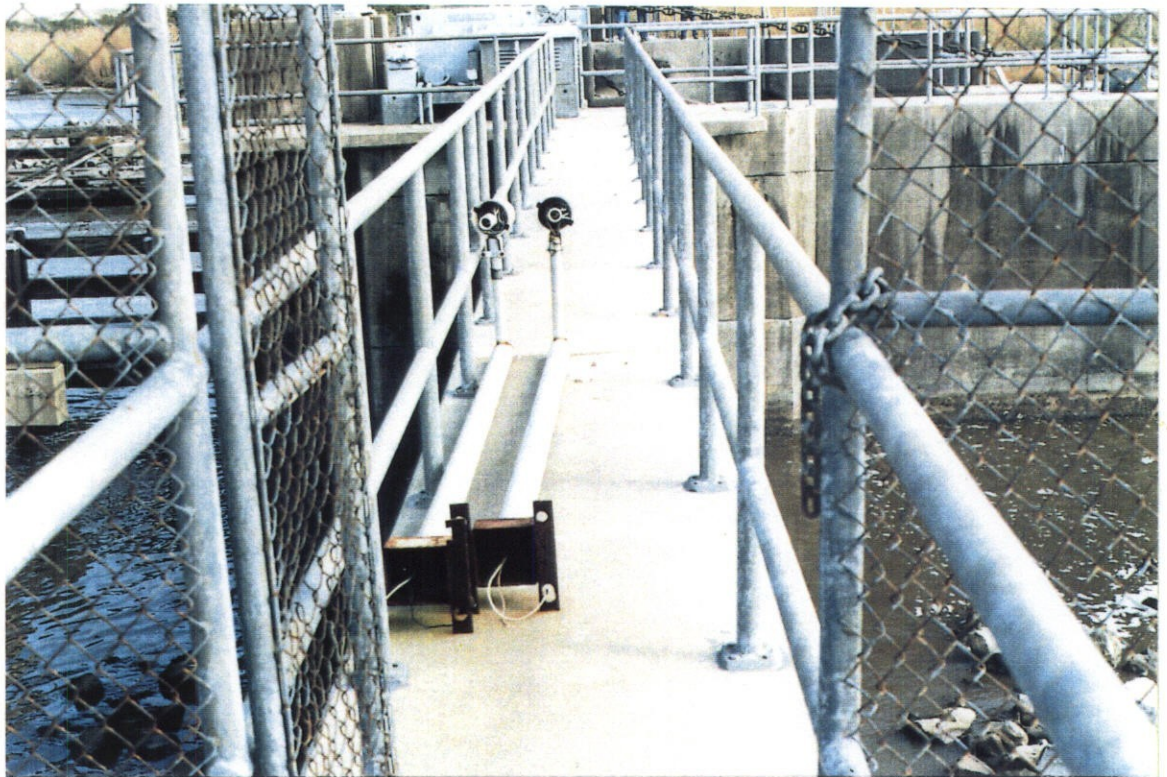
PHOTO NO. 17 - LIGHT POLES REMOVED AND STACKED ON THE ACCESS WALKWAY ON TOP OF THE WEST FLOODWALL.

4. Paragraph 6-02v, page VI-5. This recommendation does not fully address the original observation contained in paragraph 5c of the LMVD Trip Report. If the decision is made to not reinstall the light standards to their original position, and just remove the exposed wires at the original base location as proposed in the referenced paragraph, then it apparently means that the local sponsor intends for the light poles to remain in their "make-shift" location as described in the trip report. This is not acceptable, as the present arrangement is unsightly, as well as unsafe and should be discontinued. Our recommendation is that the light standards be reinstalled as originally designed.

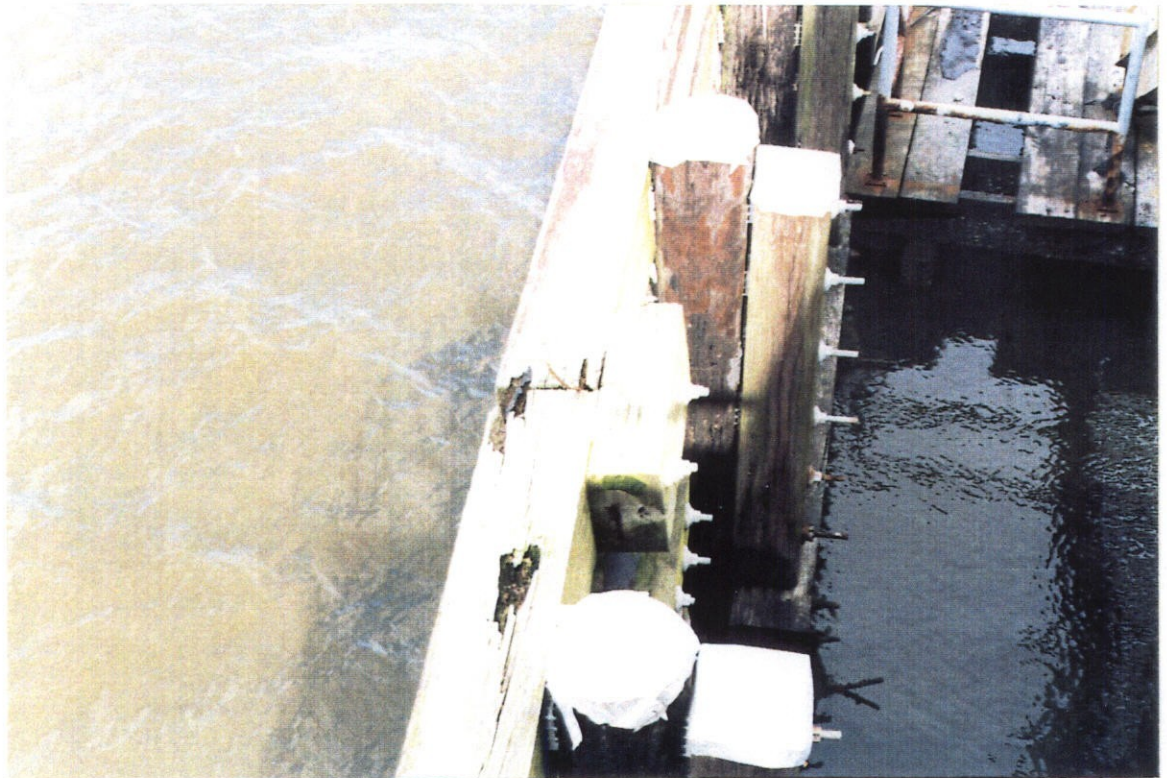
timbers will need replacement in the near future. See Photo No. 21.

PHOTO NO. 21 - NORTHWEST GUIDEWALL. NOTE DETERIORATED TIMBERS.

5. Paragraph 6-02y, page VI-5. When the guide wall timbers are replaced, the spacer timbers on the needle girder storage rack should also be replaced. This was not addressed in Section VI.

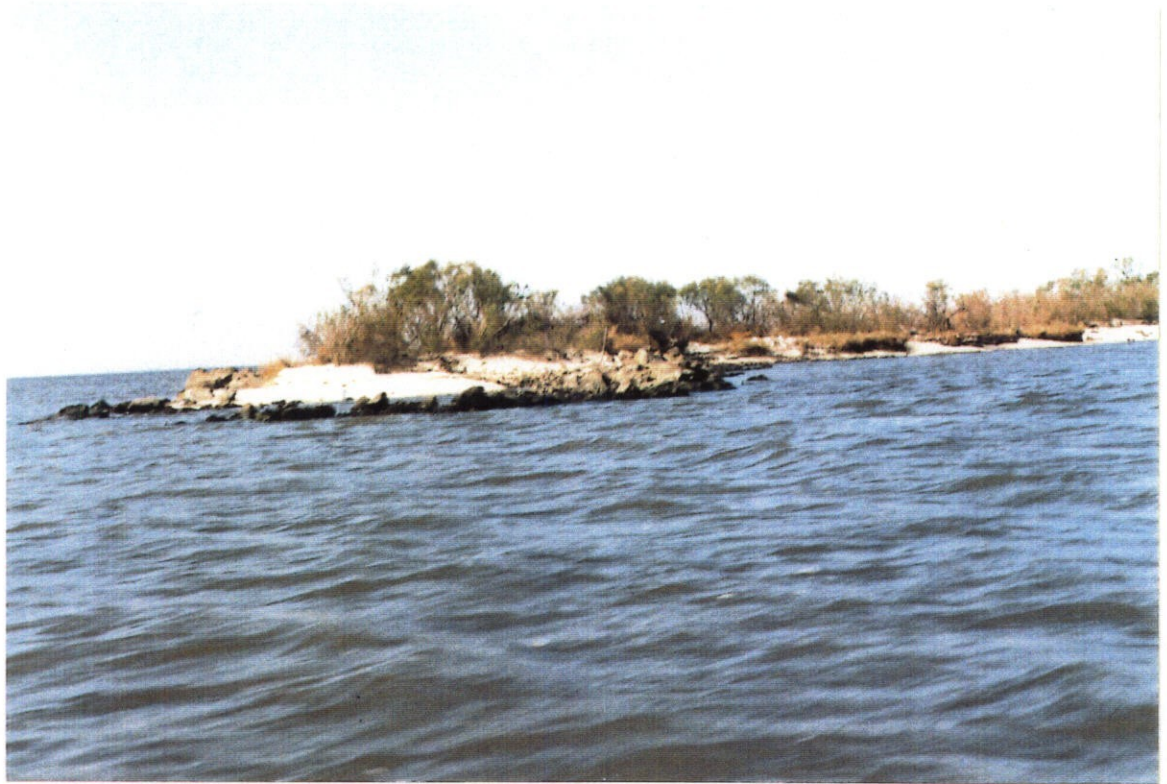
PHOTO NO. 22 - STONE BREAKWATER AT THE SOUTHWEST END OF THE CHANNEL. NOTE LOSS OF STONE FROM THE END OF THE BREAKWATER.

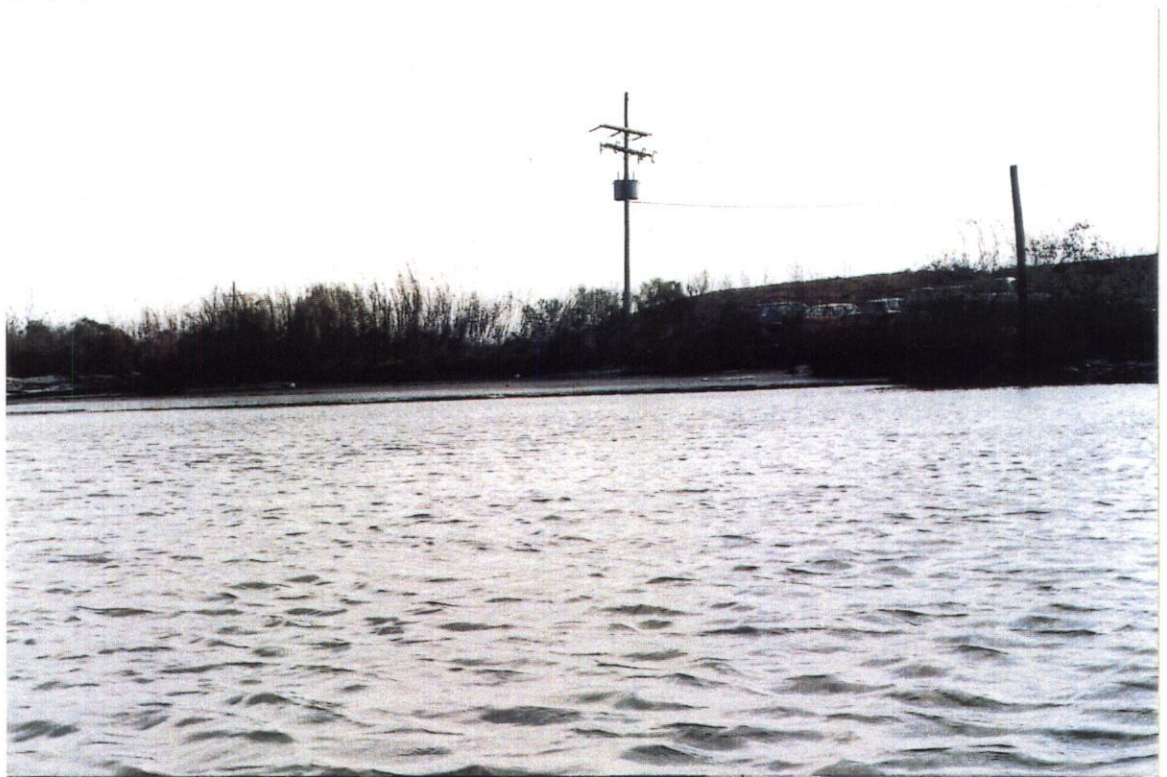
PHOTO NO. 23 - RECEEDING EAST SIDE BANK CAUSED BY EROSION.

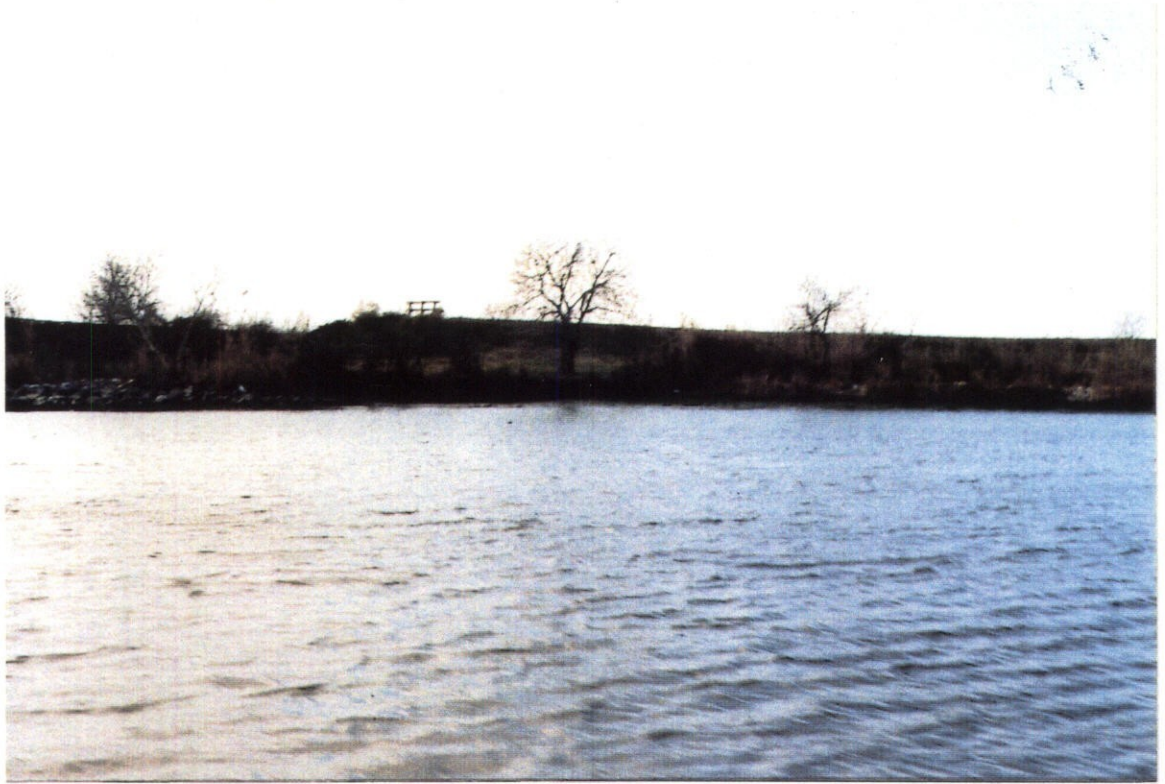
PHOTO NO. 24 - RECEEDING WEST SIDE CHANNEL BANK CAUSED BY EROSION.

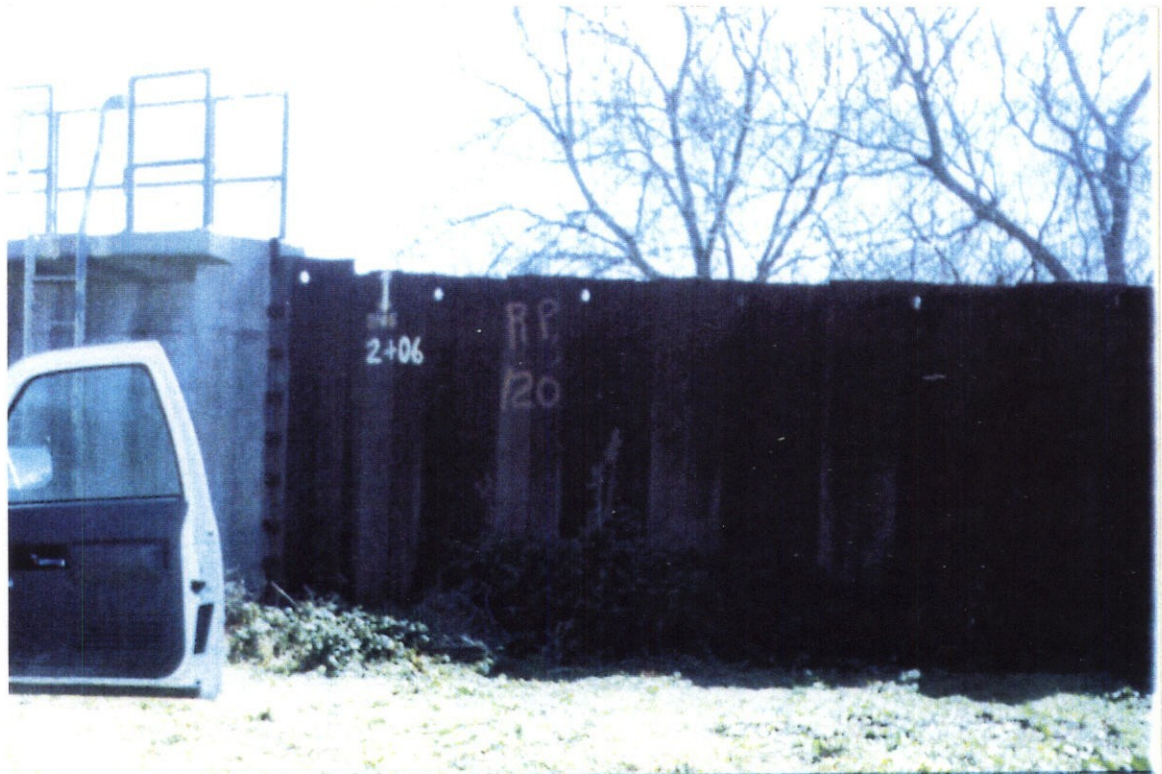
raised in 1992, is now slightly above design grade, while the east end of the west floodwall is 1.7 feet below design grade and the west end is 3.4 feet below design grade. See Photo Nos. 25 and 26. Since settlement of the sheetpile floodwalls is essentially complete, the west sheetpile floodwall should be restored to design grade.

PHOTO NO. 25 - EAST END OF WEST SHEET PILE FLOODWALL. NOTE SETTLEMENT.

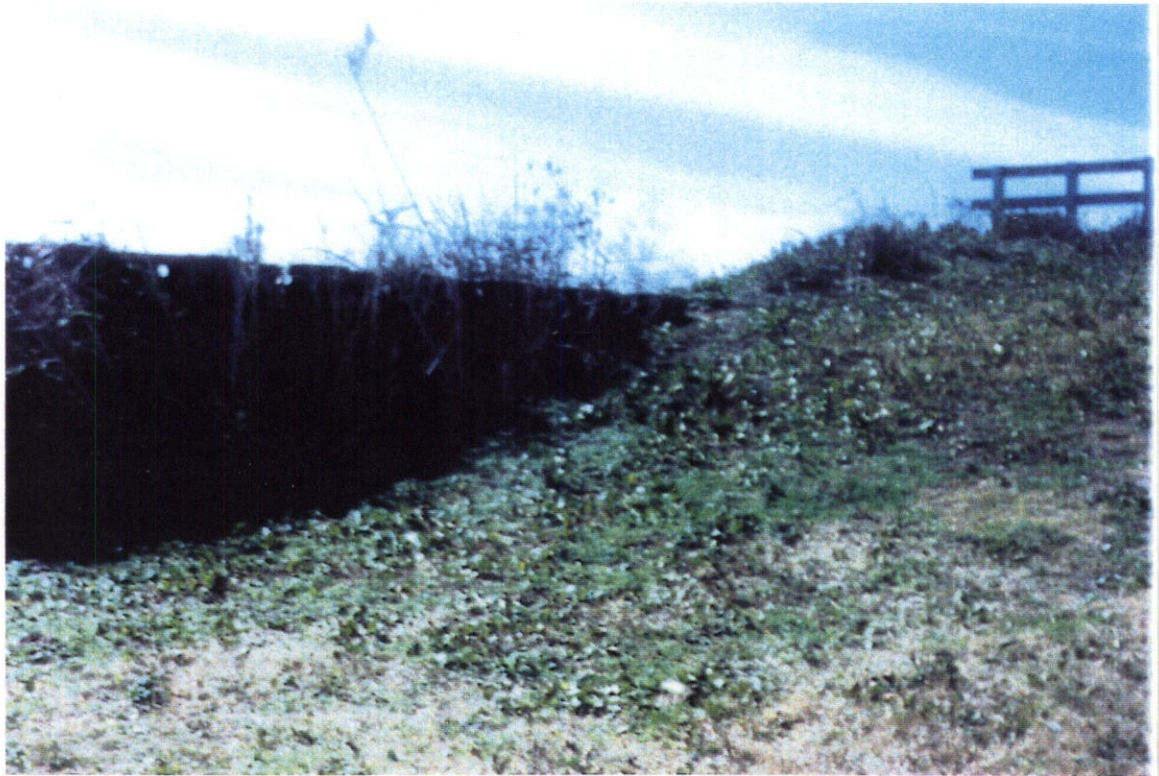
PHOTO NO. 26 - WEST END OF WEST SHEET PILE FLOODWALL.
NOTE SETTLEMENT.

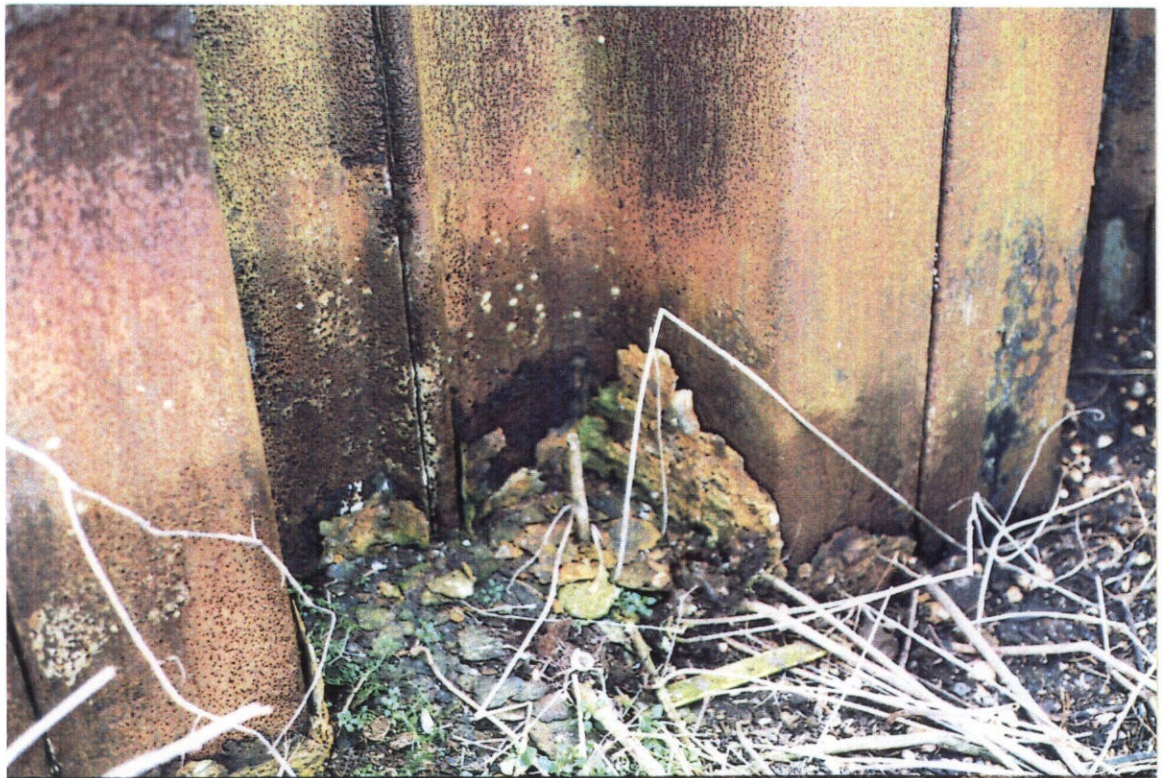
(2) The coal tar epoxy protective coating originally applied to the areas of sheet piling near the ground line has completely deteriorated. See Photo No. 27. It is recommended that the sheet piles be cleaned and painted with coal tar epoxy from slightly below ground line up to the tops.

PHOTO NO. 27 - VIEW OF SHEET PILE FLOODWALL SHOWING
COMPLETELY DETERIORATED COAL TAR EPOXY.

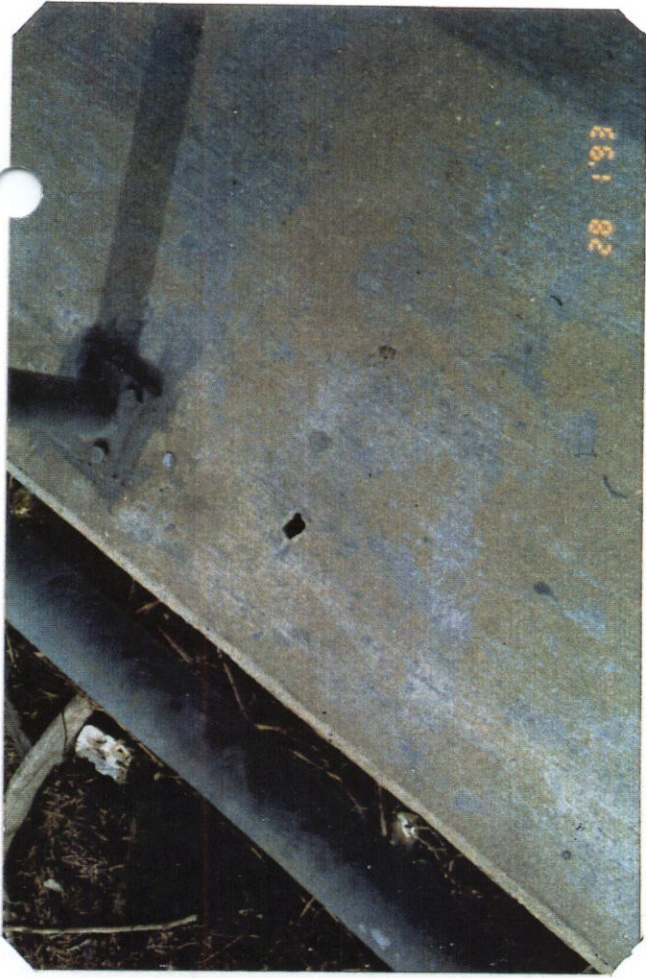
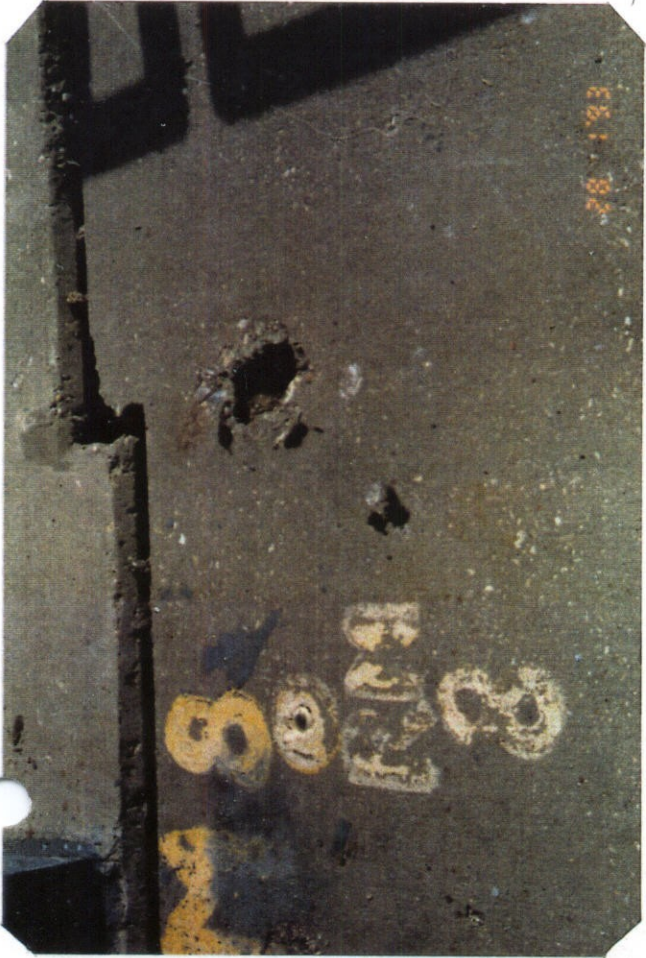
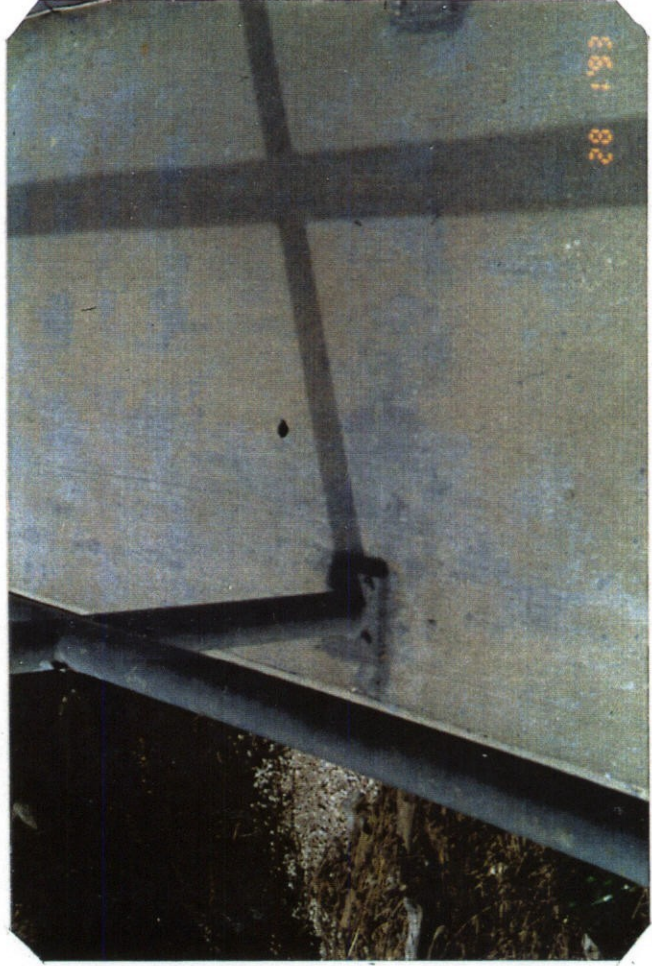
Photo #1 Concrete popout on concrete walkway and Gatebay.
