HURRICANE PROTECTION

EMPIRE FLOODGATE

PERIODIC INSPECTION REPORT NO. 8

17 JANUARY 1996

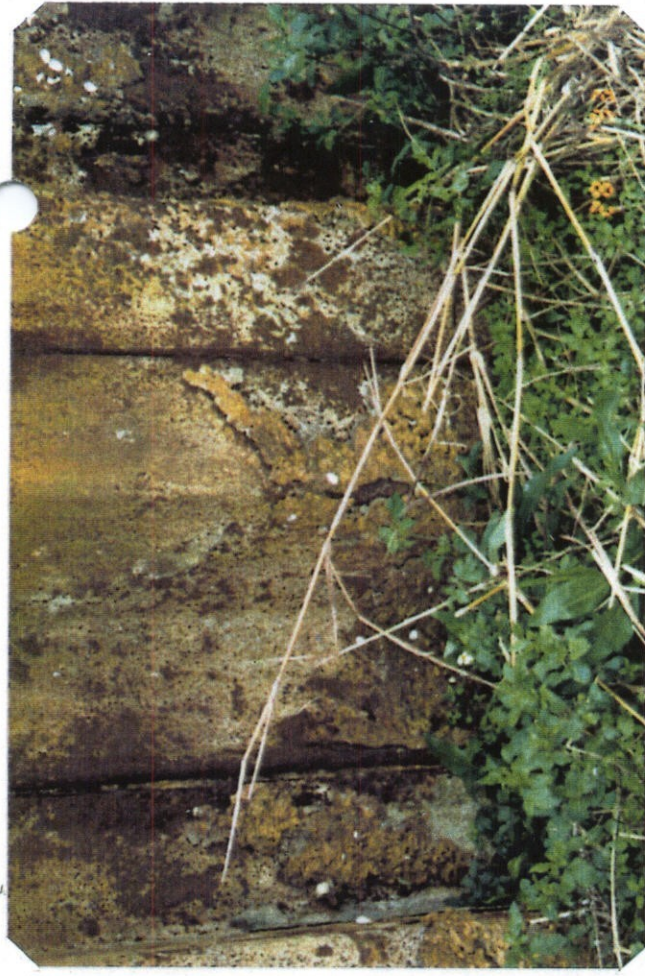
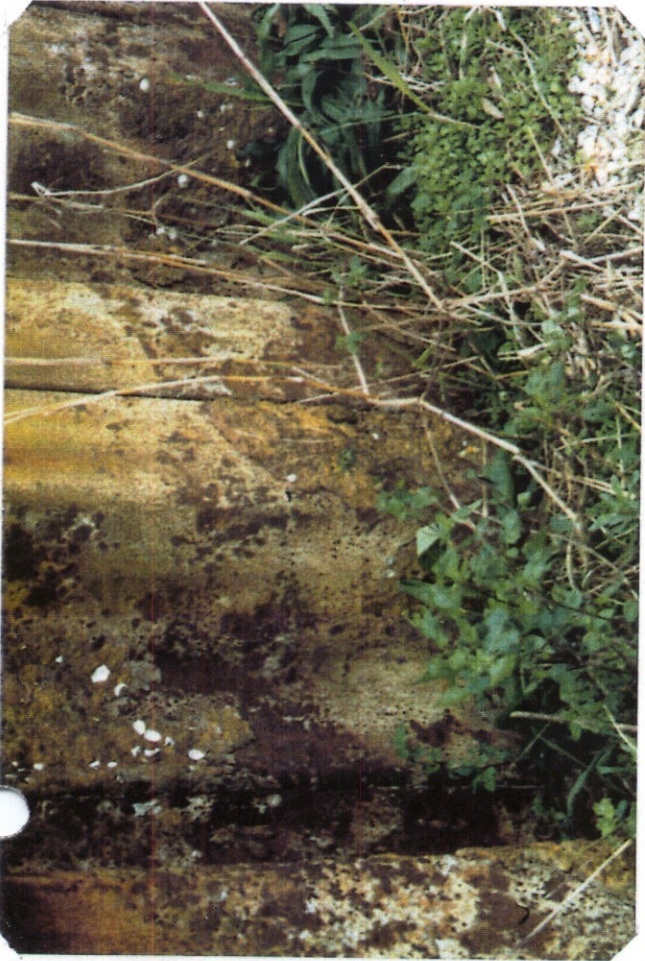
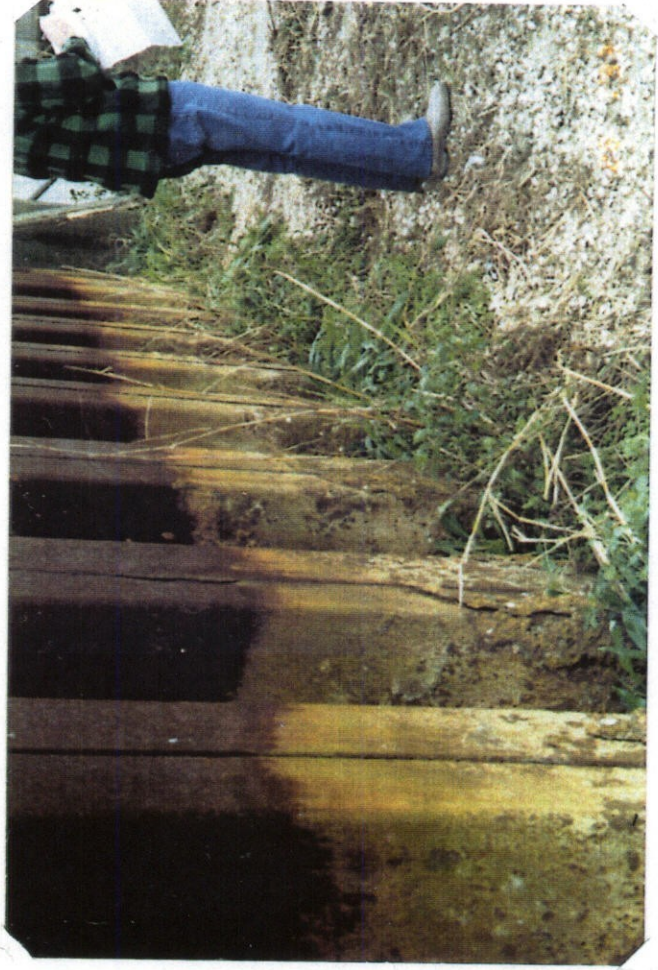
Photo #2 Protecting coating corroded and crumbled.

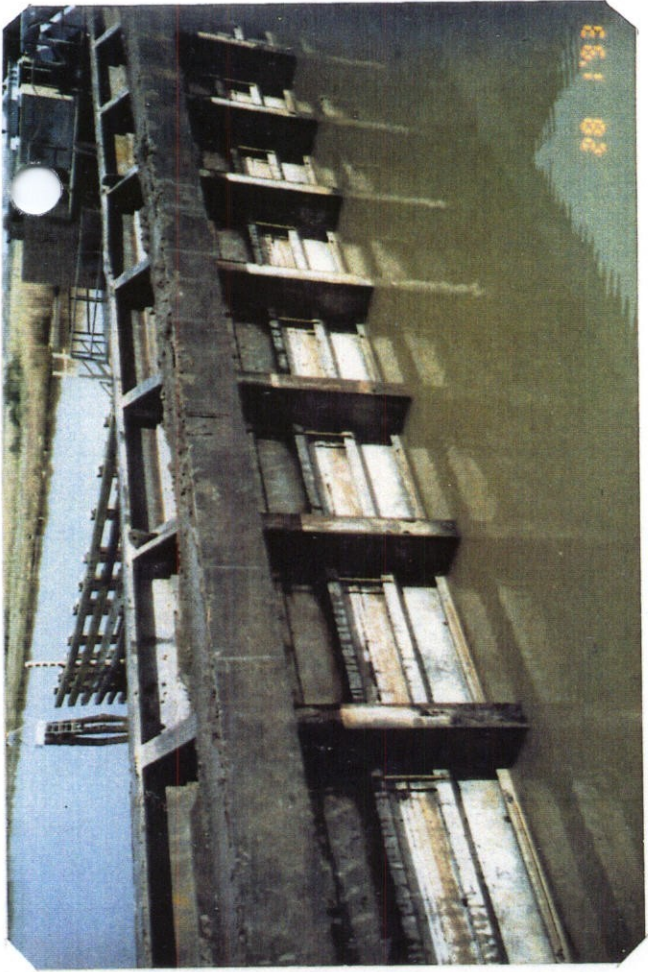
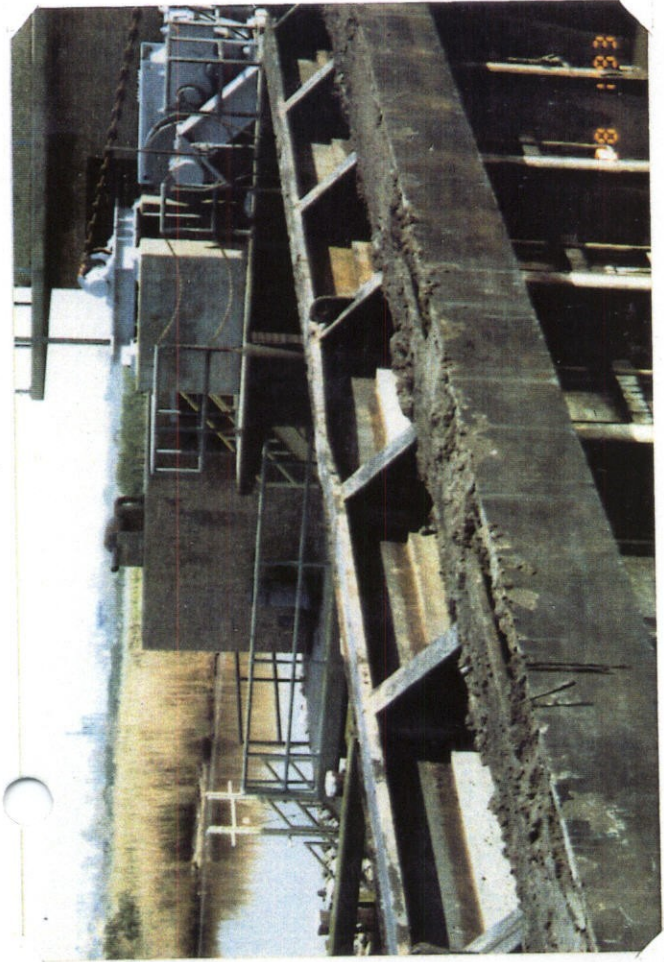
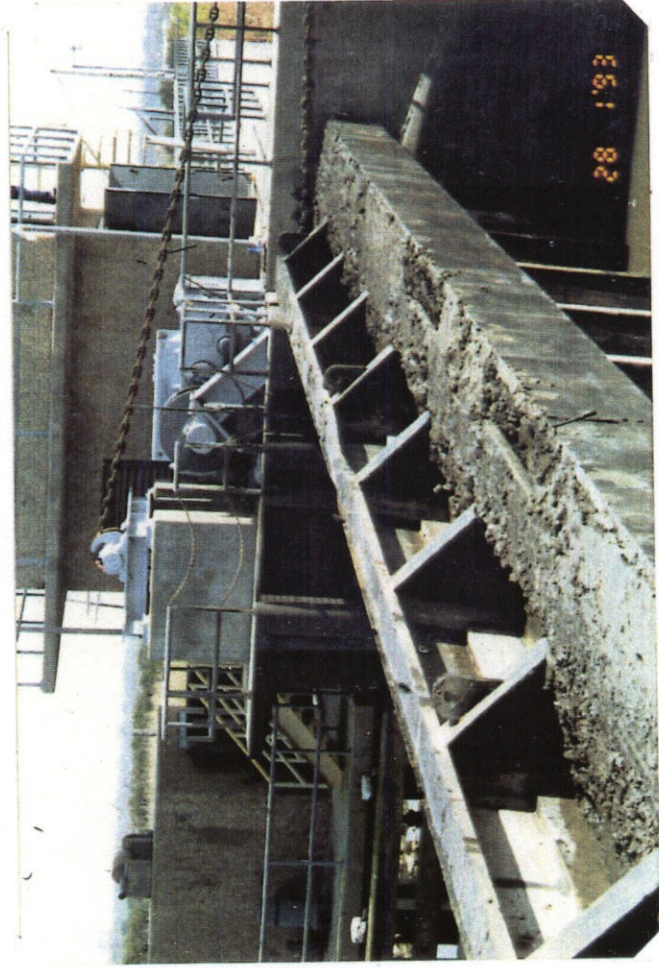
Photo #3 Top of channel beam flange was buckled by vessel.

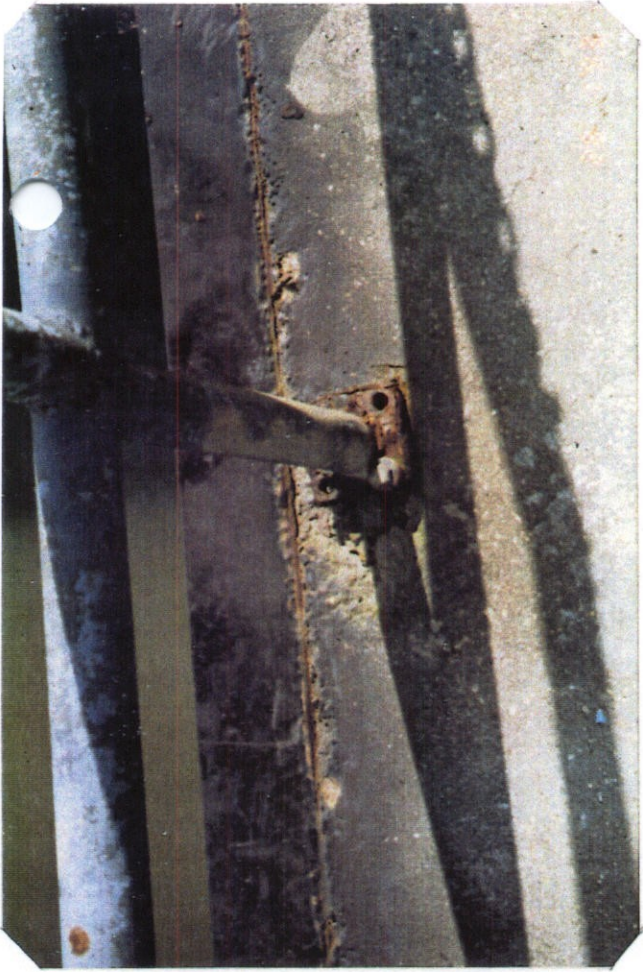
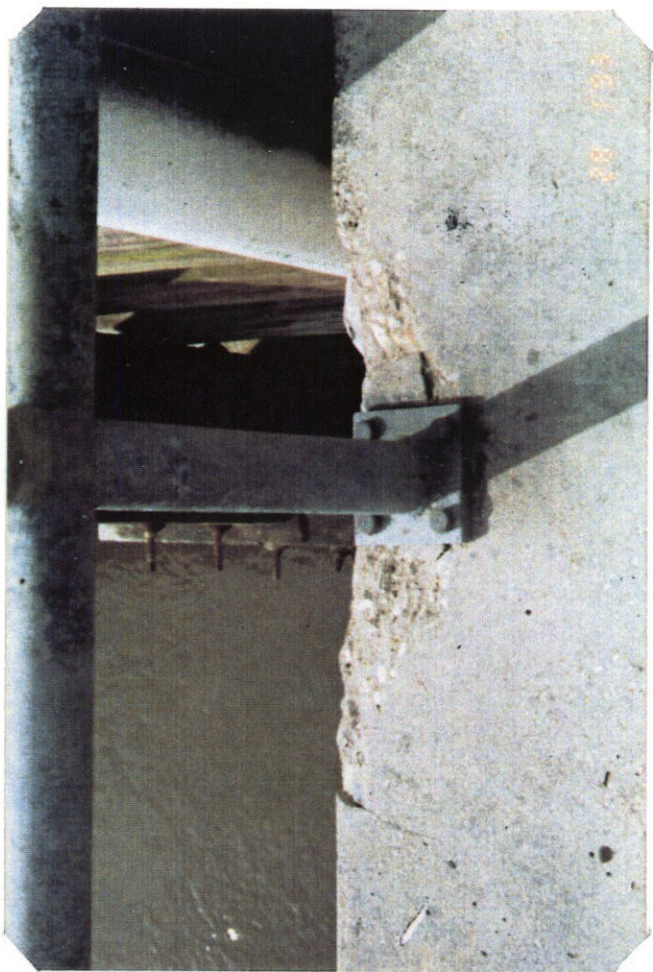
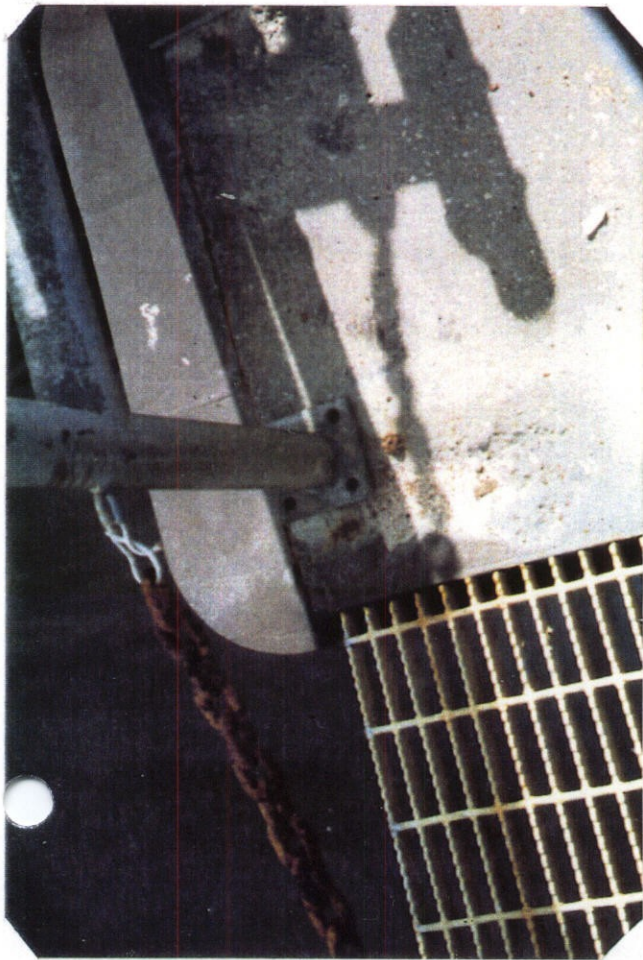
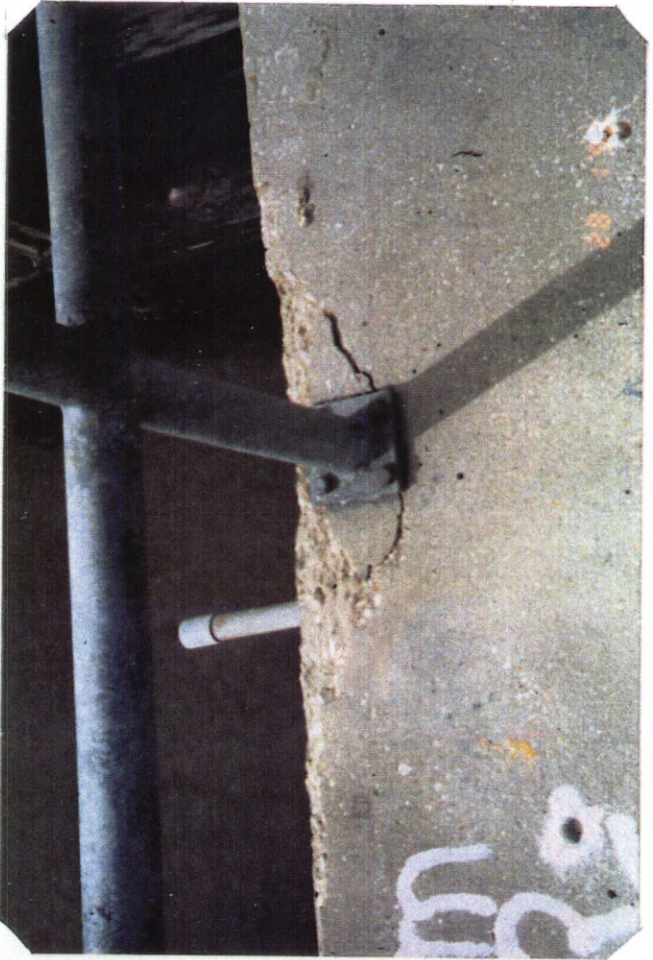
Photo #4 Missing anchor bolts and concrete spalled around bases of handrails.

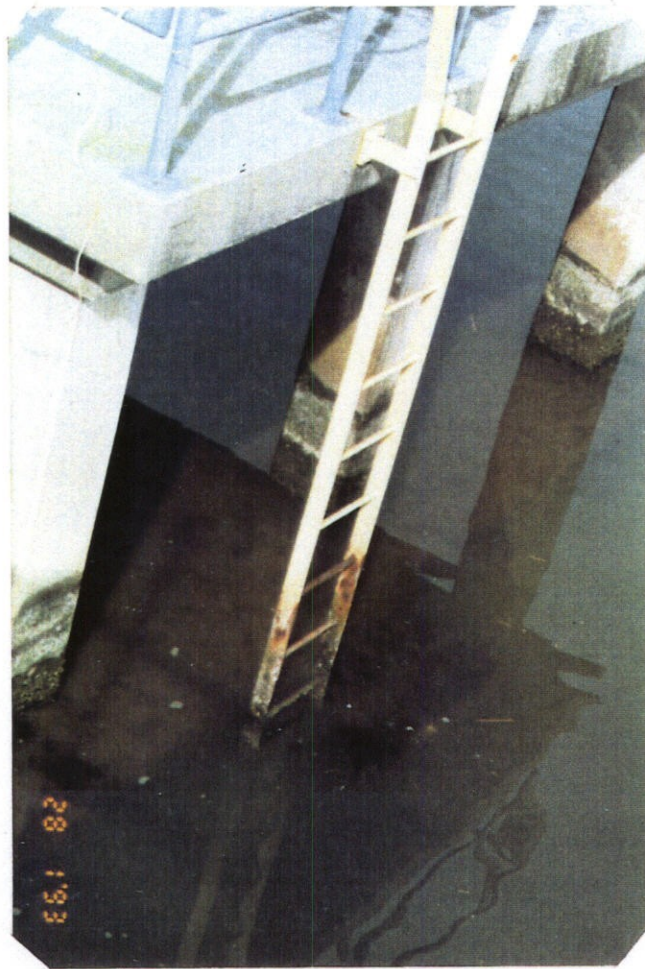
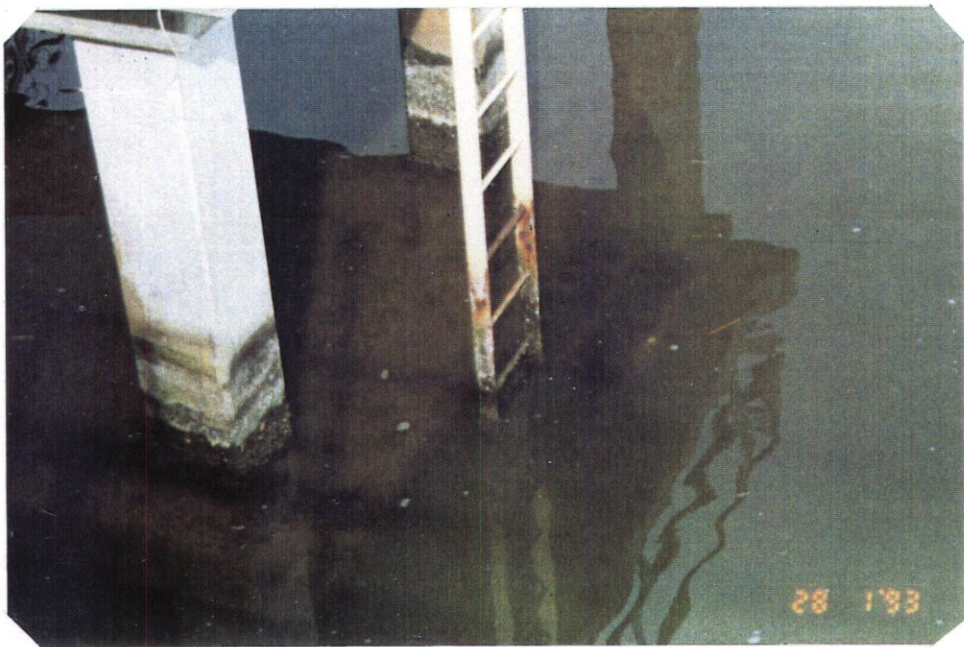
Photo #5 Strings and rungs of stair were rusted.

c. Repair of the access ladder on the pump platform is not addressed in Section VI. The ladder should be repaired as recommended in the LMVD Trip Report.
