12.0 Figures and Photographs

M/V Kuroshima Incident

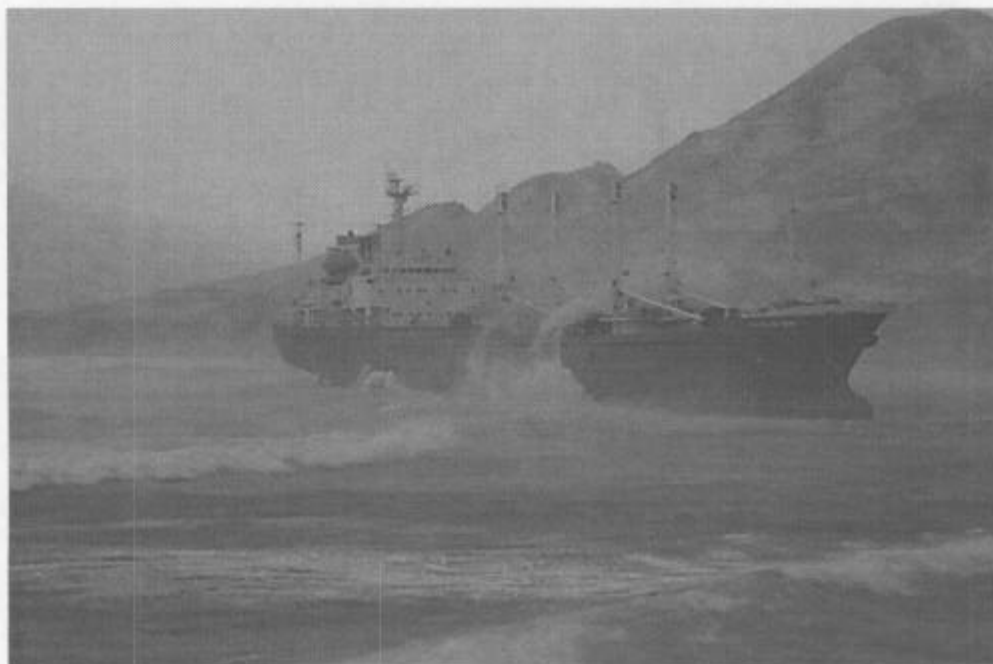
Figure 2: *M/V Kuroshima* aground at Summer Bay Beach, November 1997

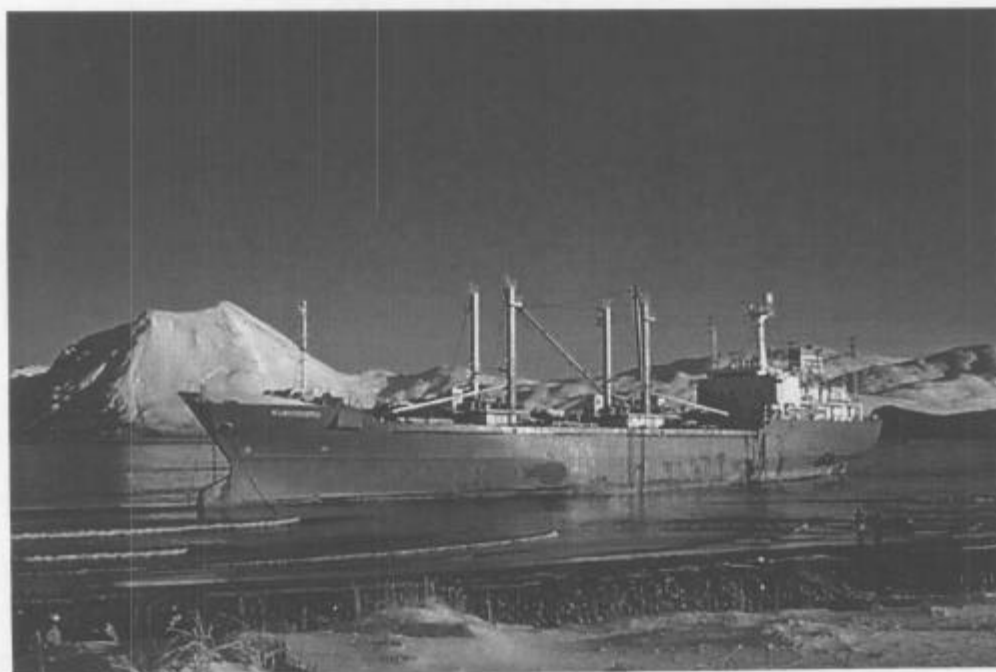
Figure 3: *M/V Kuroshima* hard aground at Summer Bay Beach, December 1997

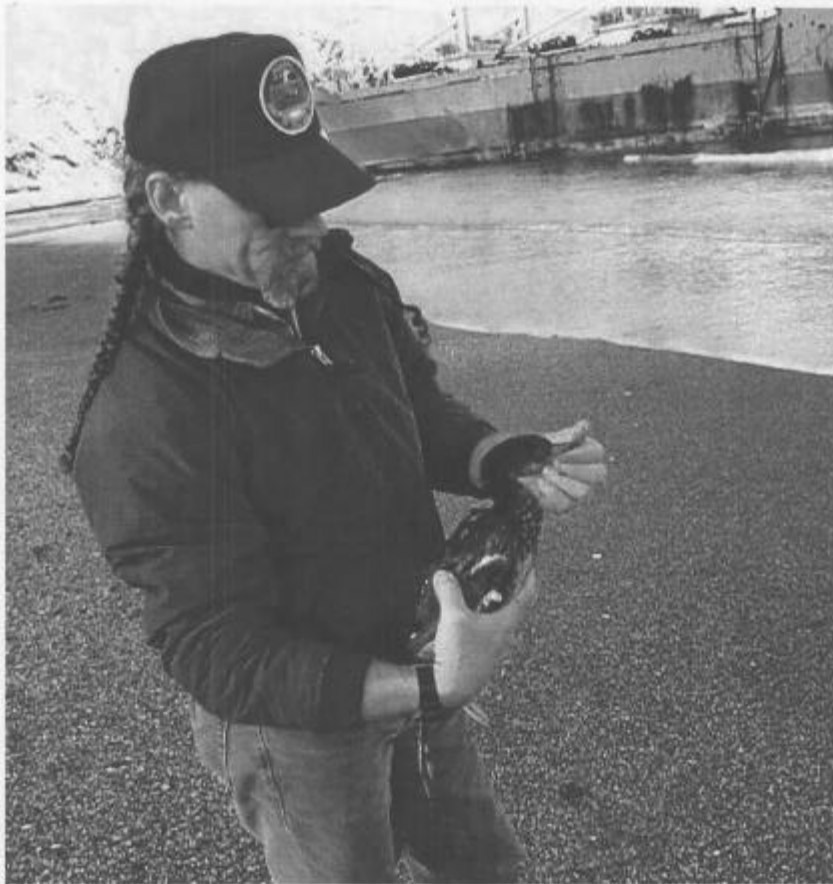
Figure 5: Oiled Bird at Summer Bay Beach

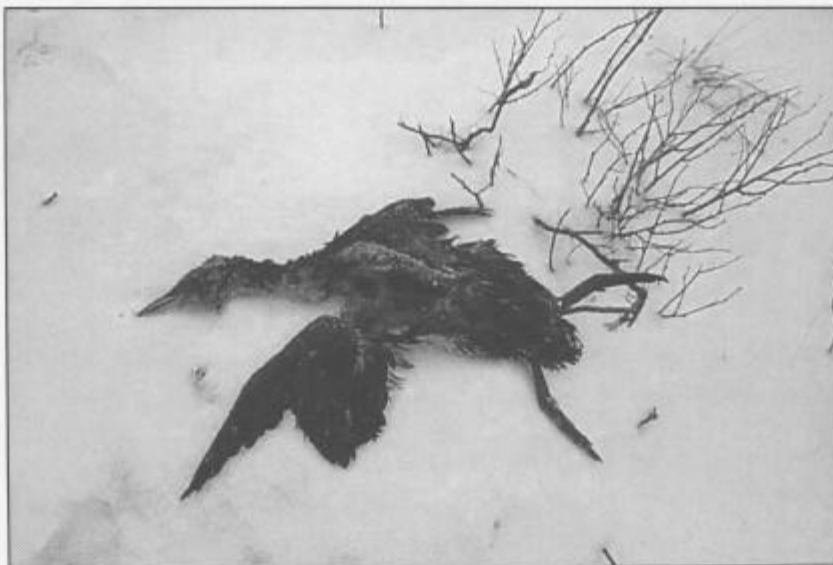
Figure 6: Scavenged Bird Carcass

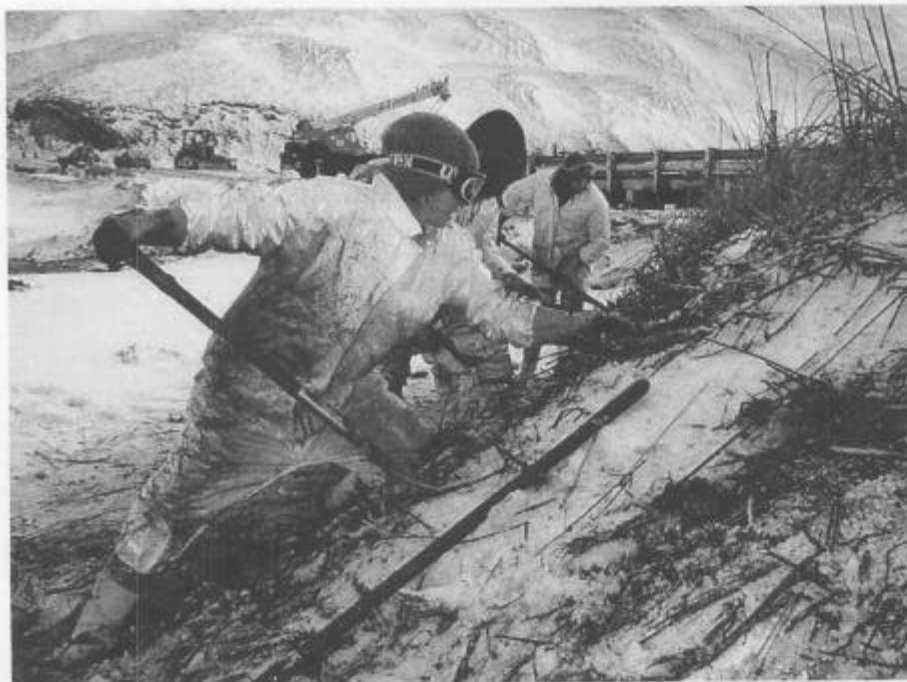
Figure 7: Cleanup of Oiled Vegetation.

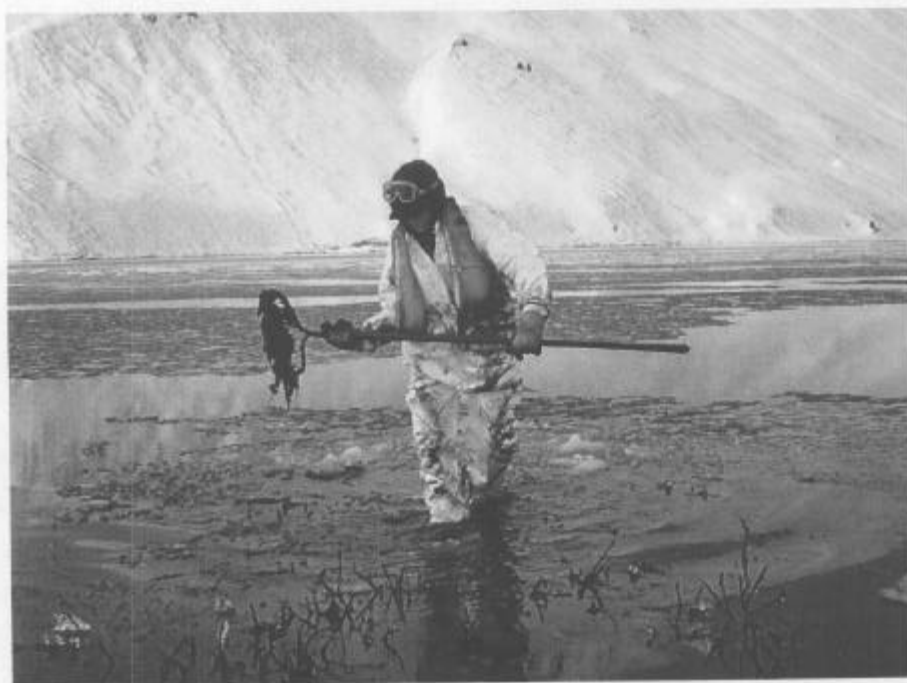
Figure 10: Shoreline Cleanup Along Summer Bay Lake: December 1997

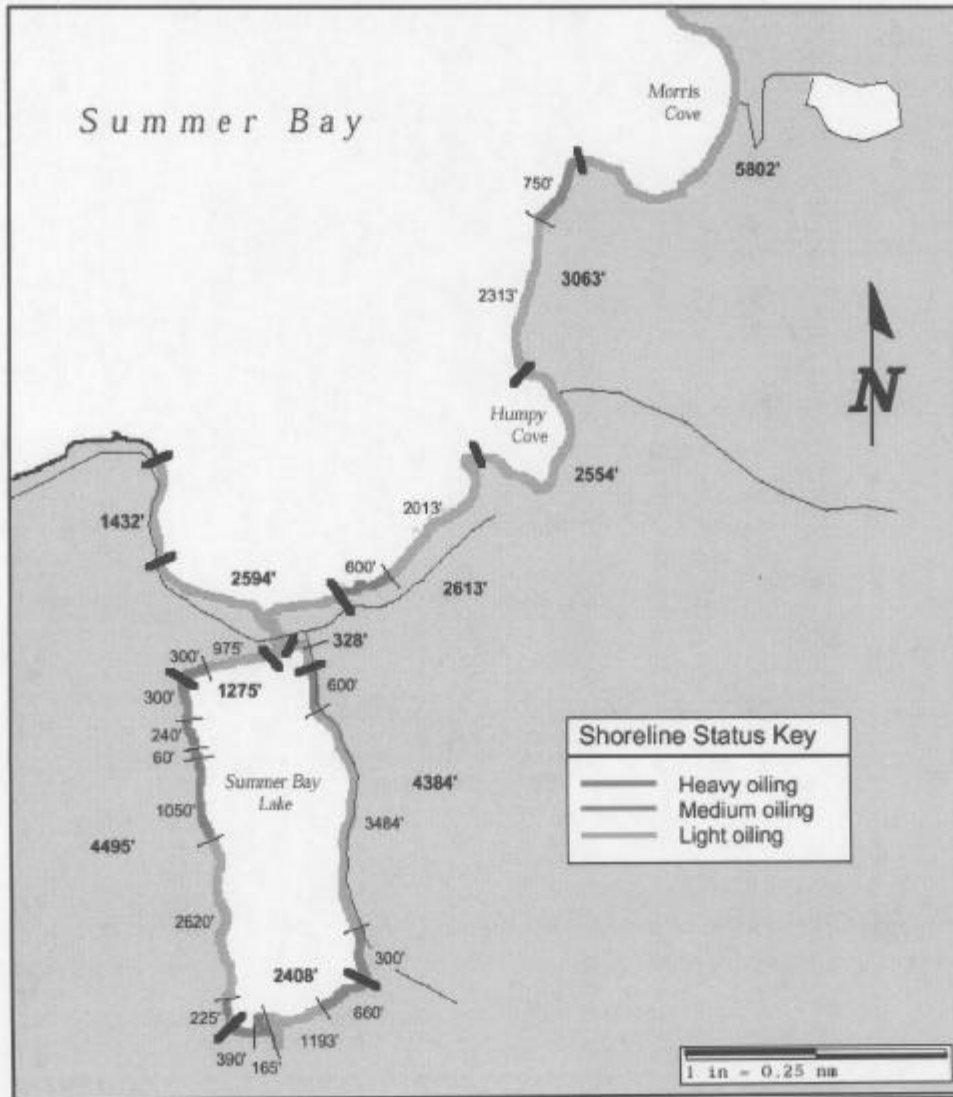
Figure 11: Map of Shoreline Oiling: April 30, 1998

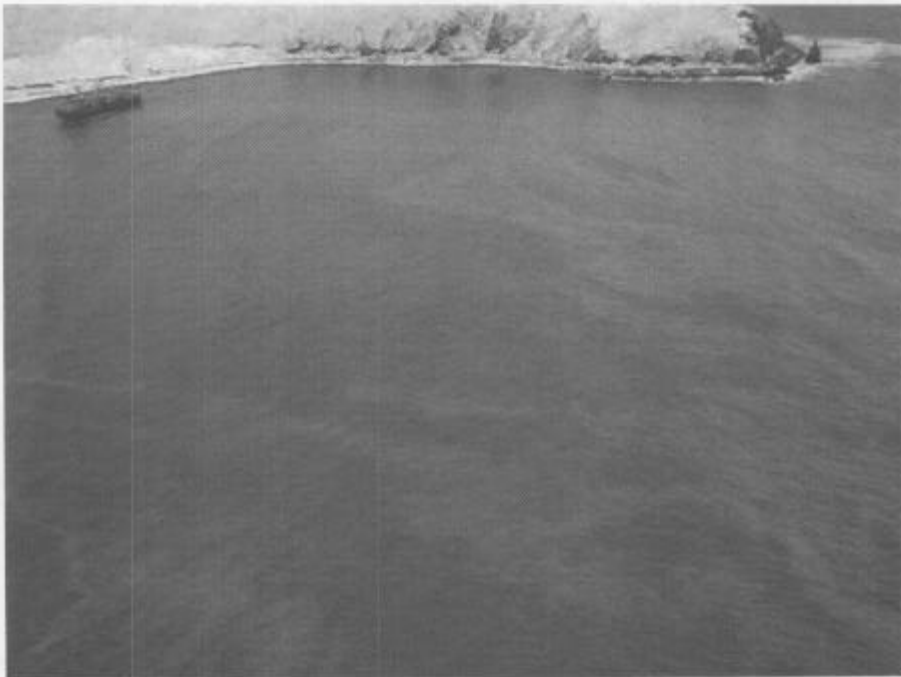
Figure 17: Oil Sheens in Summer Bay, December 1997

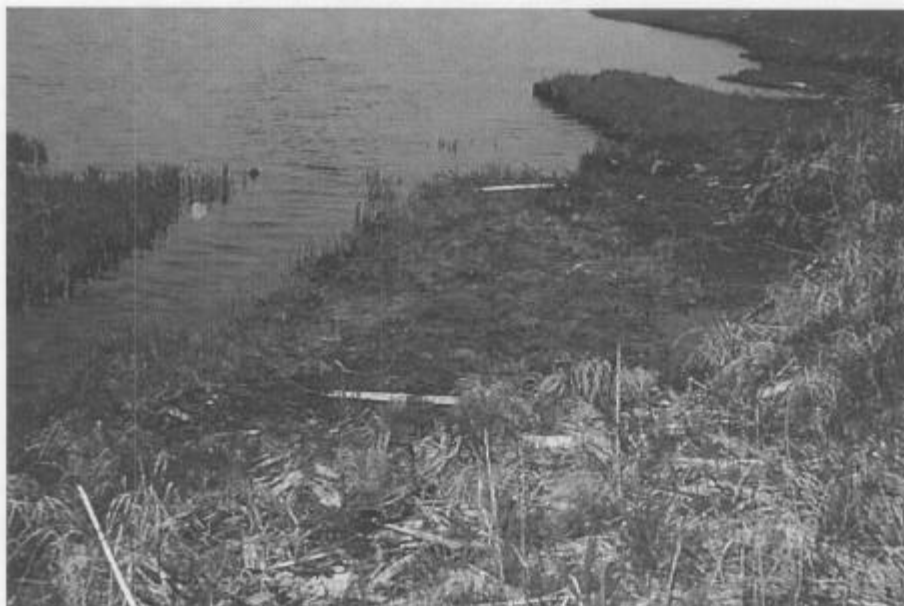
Figure 19: Trampled Vegetation along Summer Bay Lake: June 1999.

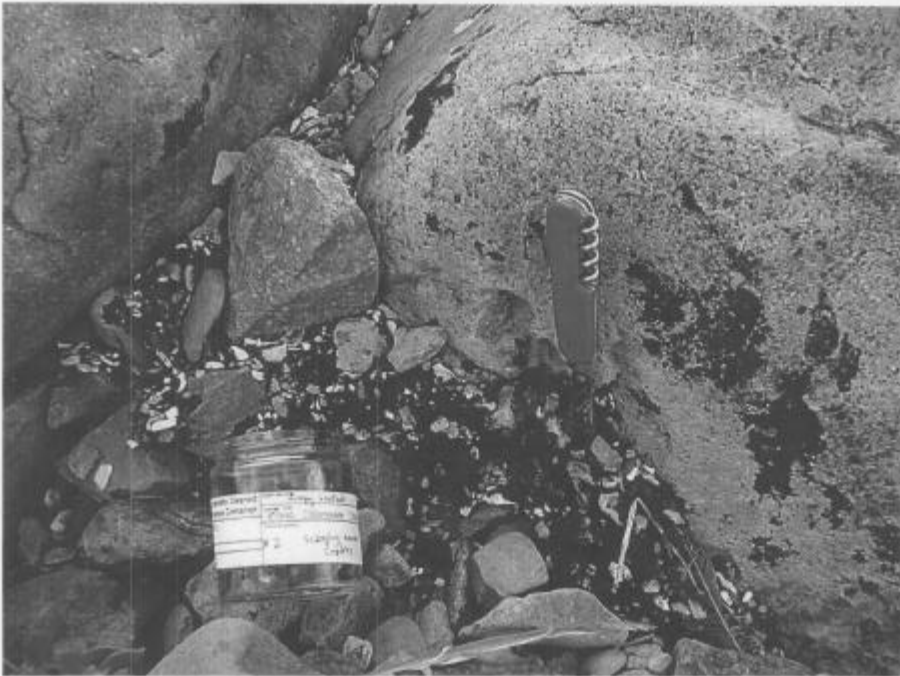
Figure 25: Stranded Oil among Cobble at Humpy Cove: September 2000

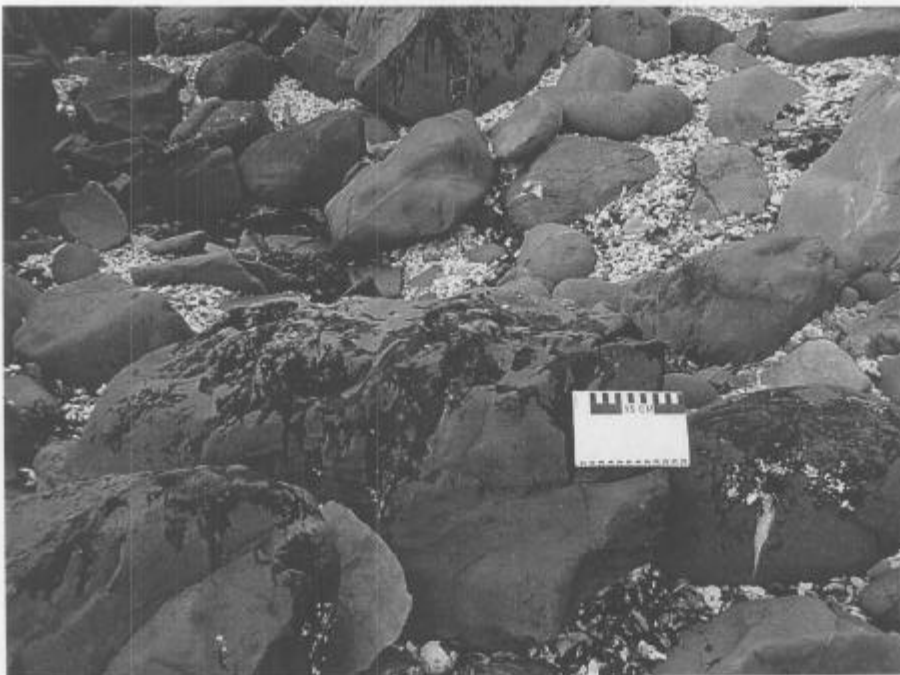
Figure 26: Oil Stains at Humpy Cove: September 2000

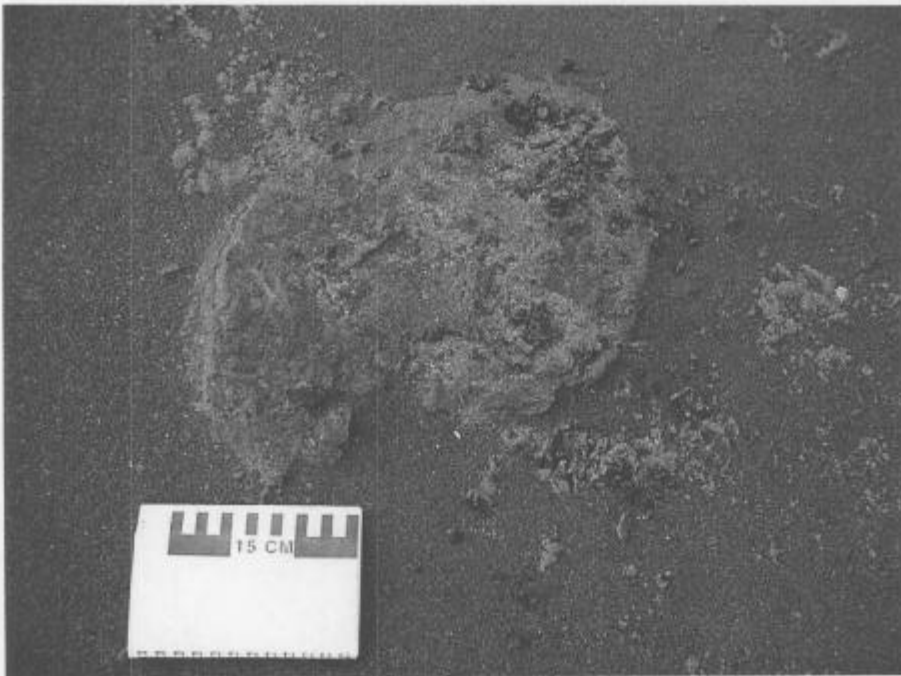
Figure 29: Large Tarmat along North Shore of Summer Bay Lake: September 2000

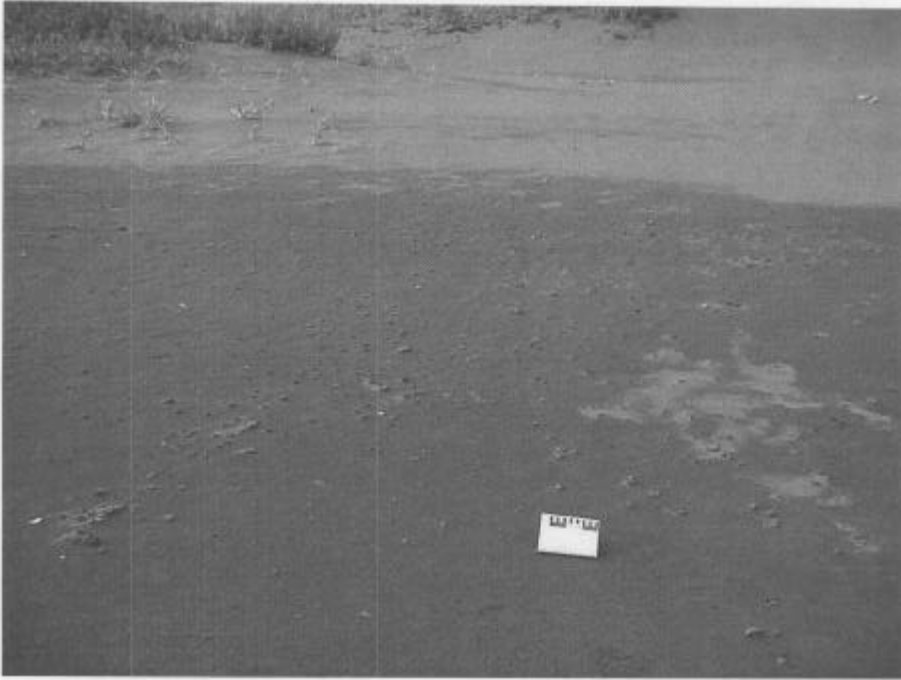
Figure 30: Eroding Tarballs at North End of Summer Bay Lake: September 2000

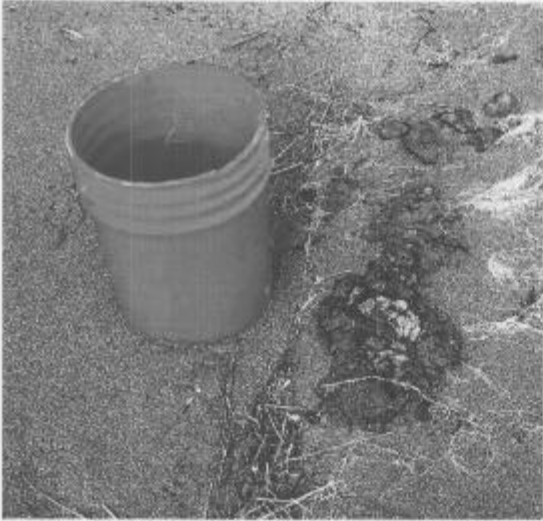
Figure 32: Summer Bay Lake Oiling, May 2001

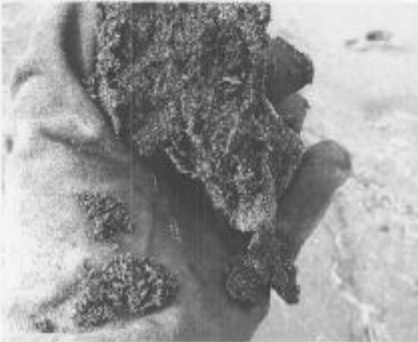
Figure 33: Close-up of oily sand, Summer Bay Lake, May 2001
