Information Bulletin

Inadequate Planning Causes Power Outage

October 1, 2007

2007-RL-HNF-0038

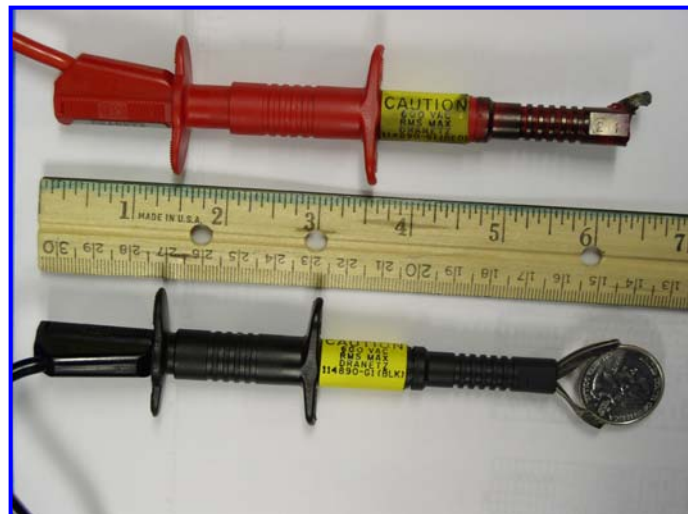
transformer, a short occurred between the secondary and primary lugs causing half of the metal teeth of one probe to vaporize, and trip the circuit breaker on the primary side of the transformer. The open breaker caused a conditioned power loss to twelve laboratory rooms.

When the equipment probes (used for the measurements) were connected to the lugs the probe ends are not shielded/insulated to mitigate shorting events. Insulated probes were not used because the attached probes came with the meter and had been successfully used on the first two transformers. Insulated probes that would have worked existed in the shop.

- Re-evaluate the hazards associated with any work activity. The hazard analysis needs to consider that the final barrier on the work activity is an individual, who due to PPE, physical configuration of the equipment, and tools being used, could make an error at a critical step (as demonstrated by this event)
- Do not perform energized work unless shutting down the system would create more hazards than not shutting down the system unless there is no feasible way to shut the system down and perform the work - i.e., UPS batteries, etc.
- Develop a 'contingency' plan that identifies the appropriate actions for loss of power, controlled shutdown, and restart of identified laboratory analytical instruments that are deemed critical equipment
- Use the appropriate tool for the level of hazard (i.e., insulated leads) to mitigate the hazards
