ELISHA JONES HOUSE AND SHED

HISTORIC STRUCTURE REPORT

**Minute Man National Historical Park
Concord, Massachusetts**

2007

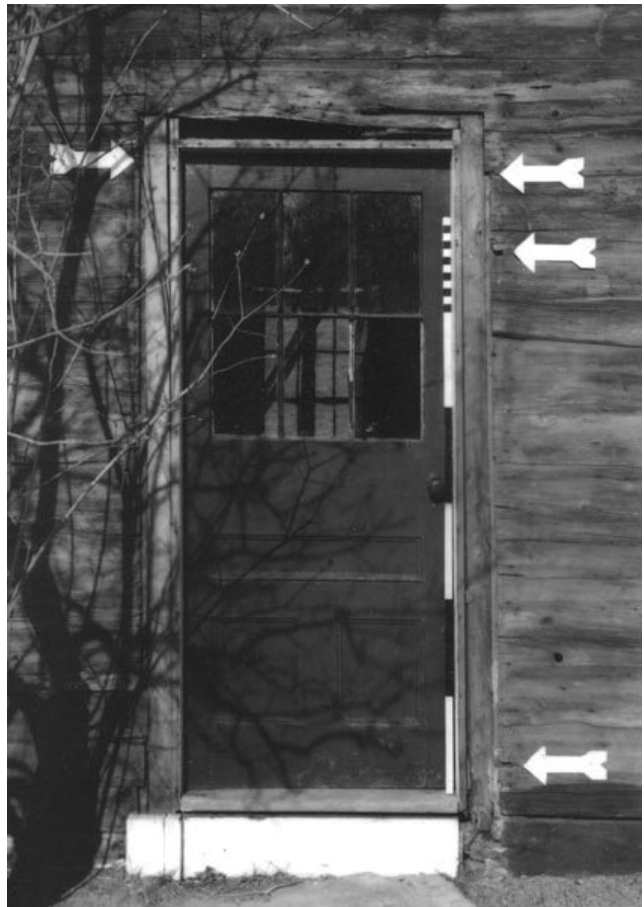
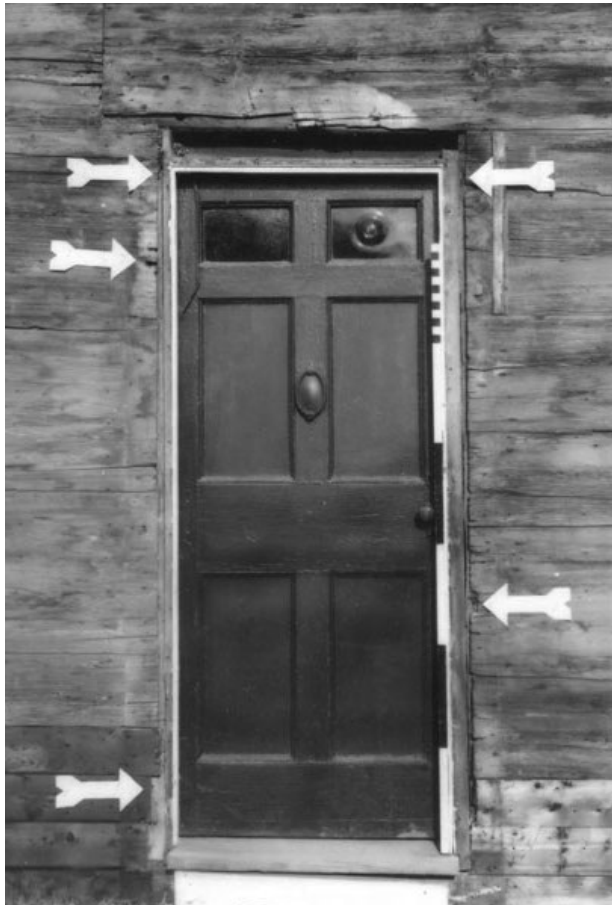
Figure 16. Elisha Jones Shed: Doorway D107, with arrows indicating evidence of original doorway. Upper arrows indicate height of original doorway, and lower arrows on right side indicate holes for original hinge pintles.

Figure 17. Elisha Jones Shed: Doorway D108, with arrows indicating evidence of original doorway. Upper arrows indicate height of original doorway; lower arrows on left side indicate holes for original hinge pintles; and lower arrow on right indicates location of early latch.

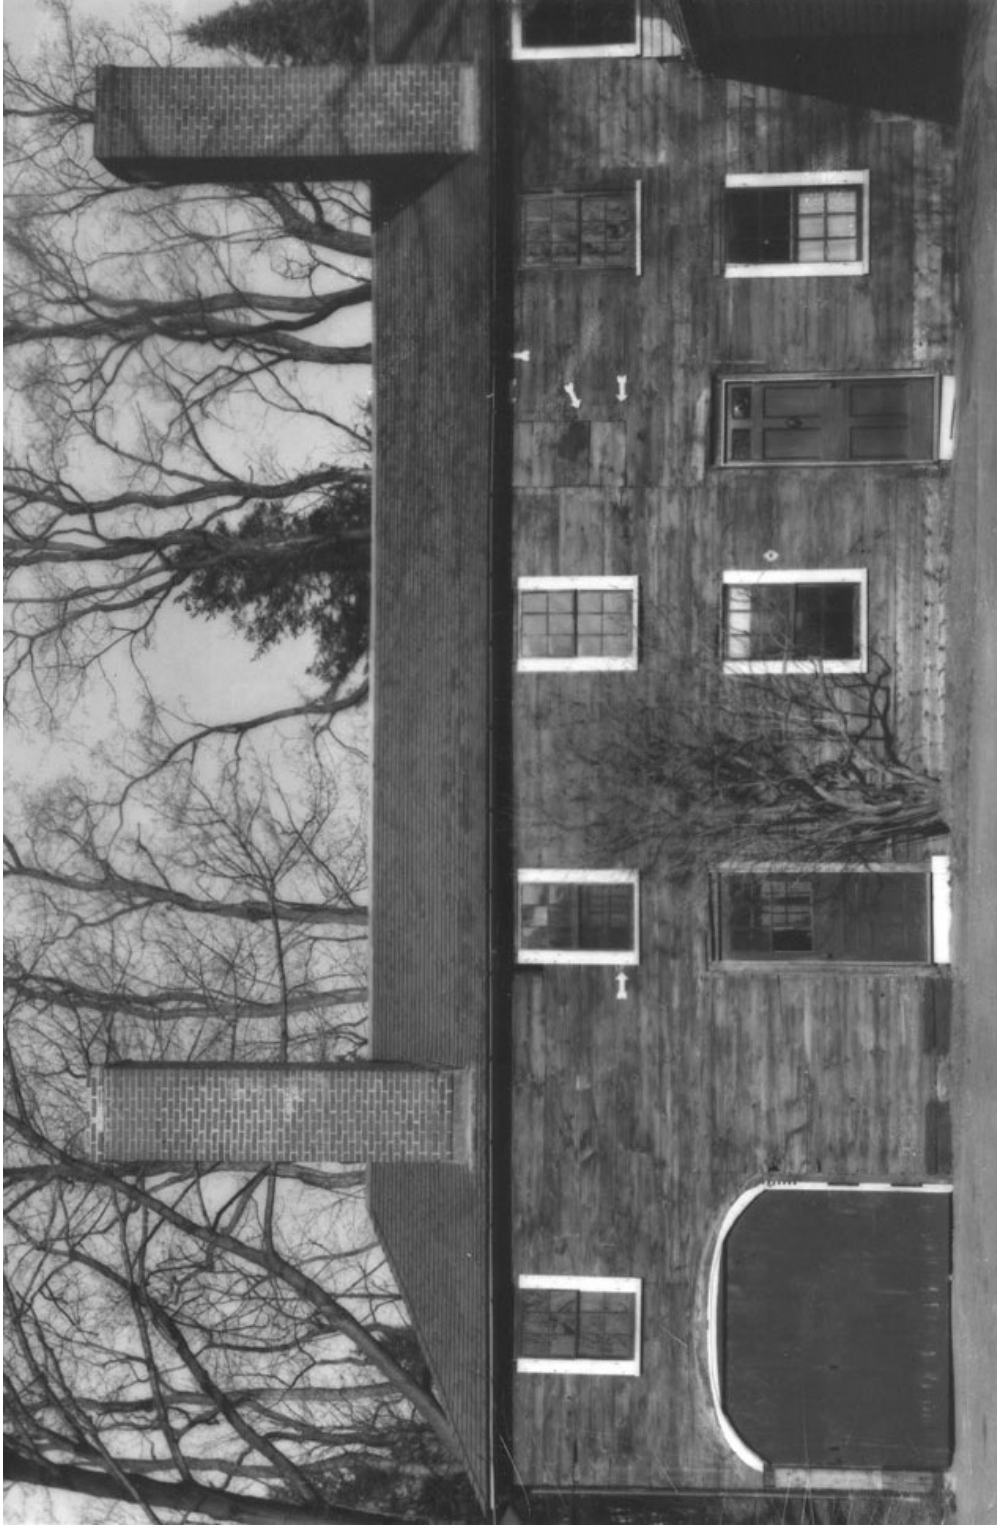
Figure 18. Elisha Jones Shed: West elevation, with arrows indicating evidence of original window openings. The left window (W224) was reused by John Keyes, and the right one was boarded over in 1865.

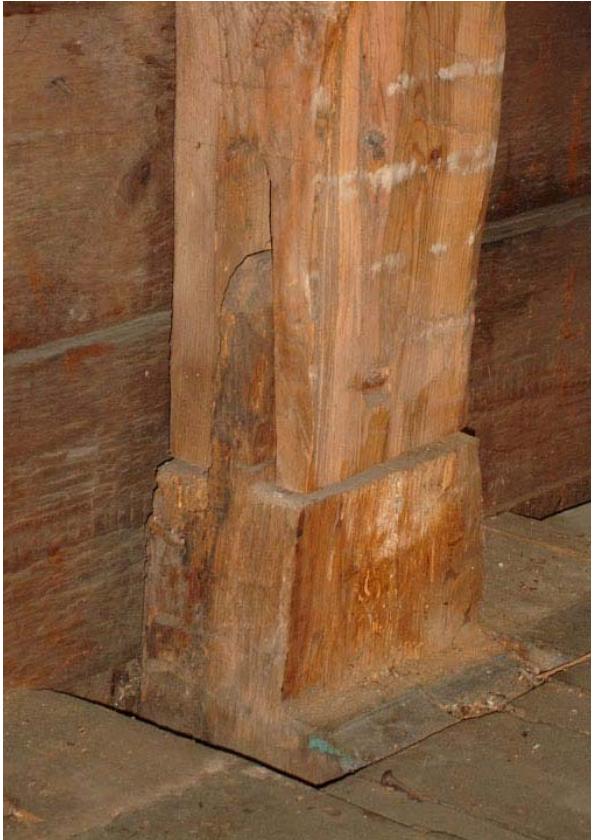
Figure 23. Elisha Jones Shed:
Spliced timber on east elevation
of second story (2006).

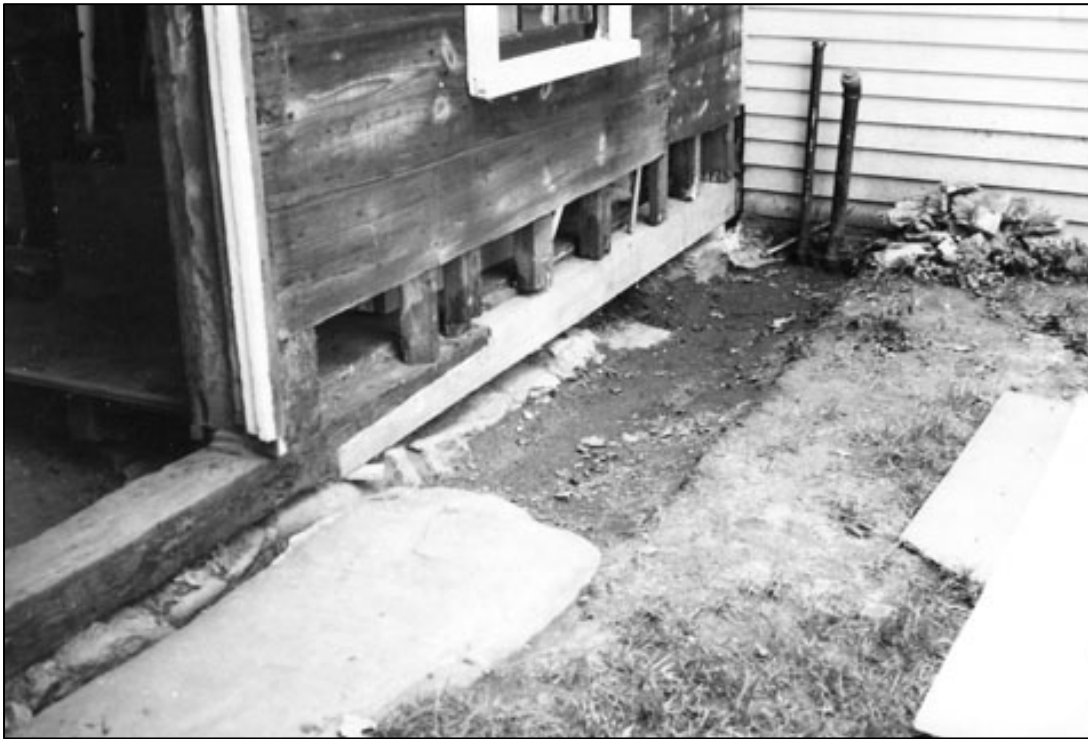
Figure 34. Elisha Jones Shed: West- wall sill repairs at south end of building, with a section of original sill (at left side of photograph) intact, 1974.

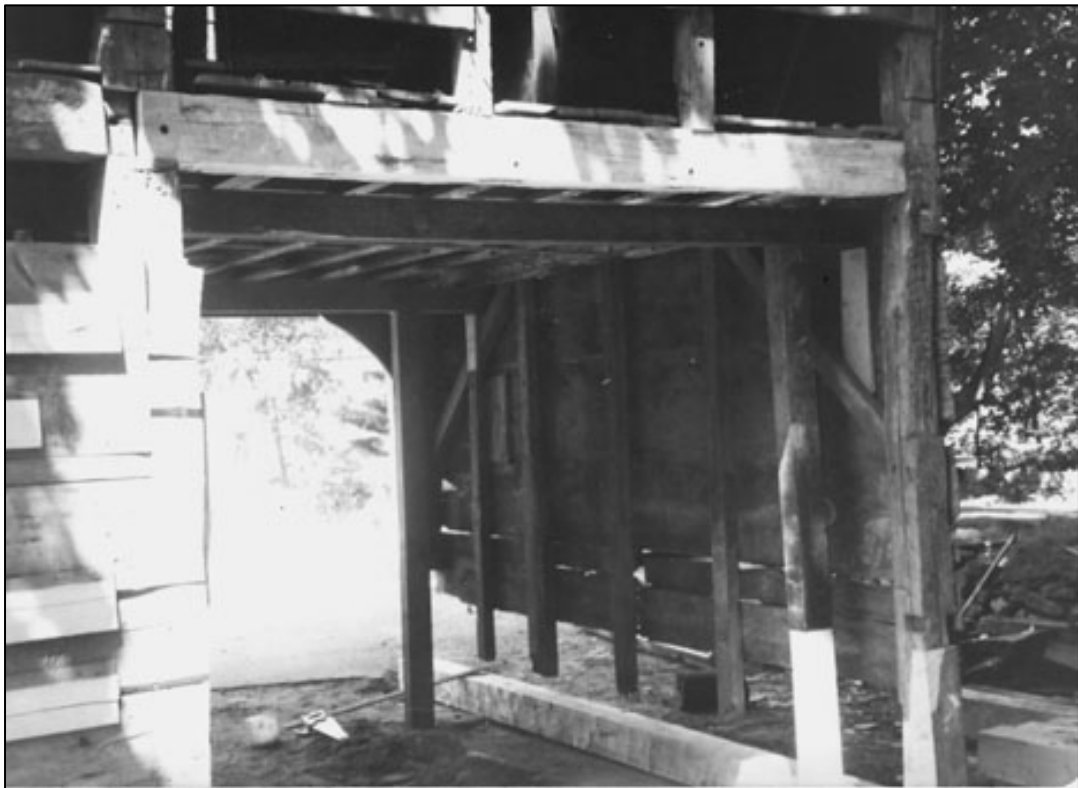
Figure 35. Elisha Jones Shed: East and north wall repairs, including replacement of east- wall girt and north- wall sill, and splicing of posts and studs, 1974.

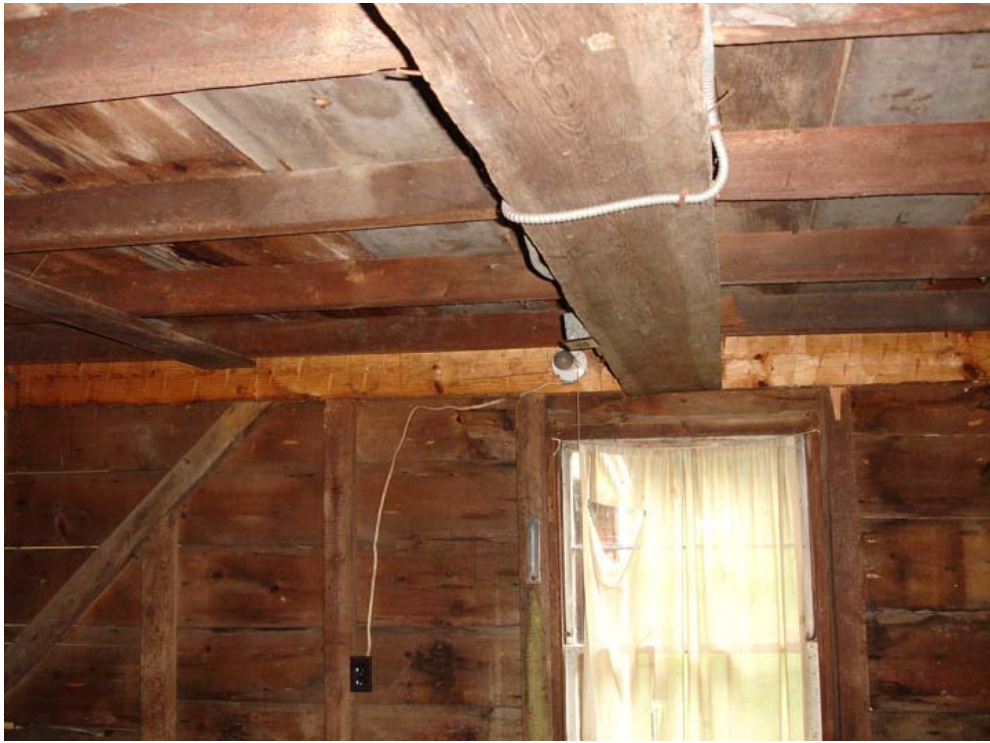
Figure 62. Elisha Jones Shed: Shed Room 104, east wall, exposed framing including summer beam, 1974 replacement girt, studding, and bracing (2006).

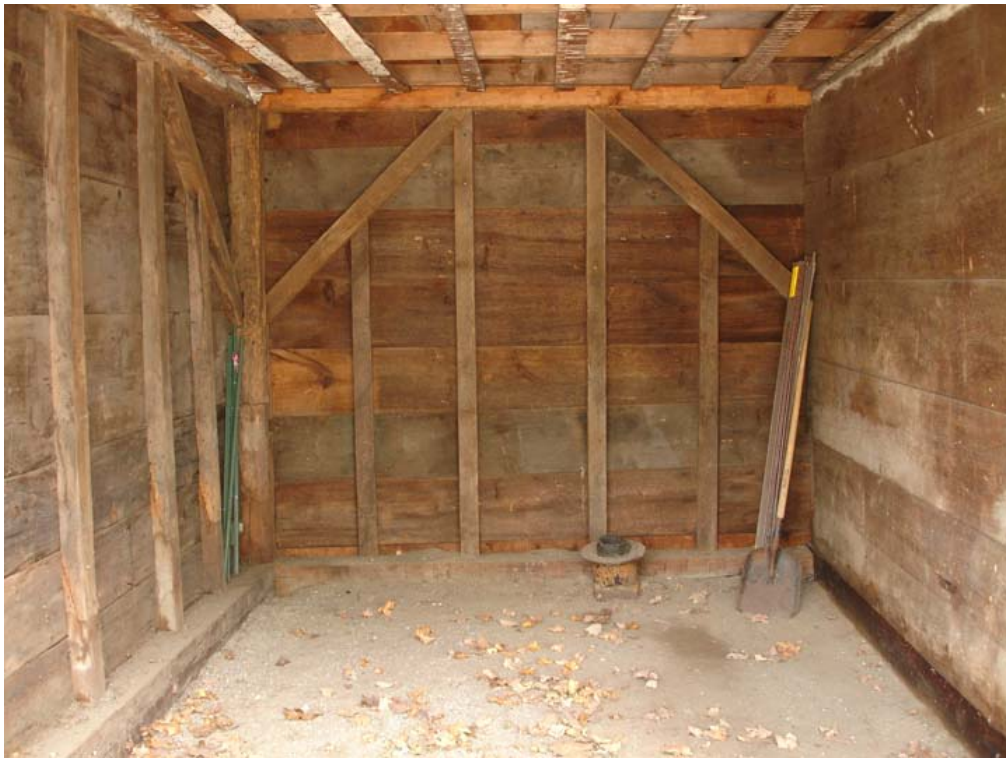
Figure 63. Elisha Jones Shed: Chaise stall, north and east walls, exposed framing including 1974 replacement sill and east girt, spliced studding and corner post, and bracing (2006).
