UNITED STATES
NUCLEAR REGULATORY COMMISSION

SUBJECT: NRC SPECIAL INSPECTION REPORT - INDIAN POINT UNIT 2
STEAM GENERATOR TUBE FAILURE - REPORT NO. 05000247/2000-010

IR 05000247-00-010, March 7 thru July 20, 2000; Consolidated Edison of New York, Inc.; Indian Point Unit 2; Special Team; steam generator tube failure, visual, eddy current inspection, technique qualification, corrective actions.

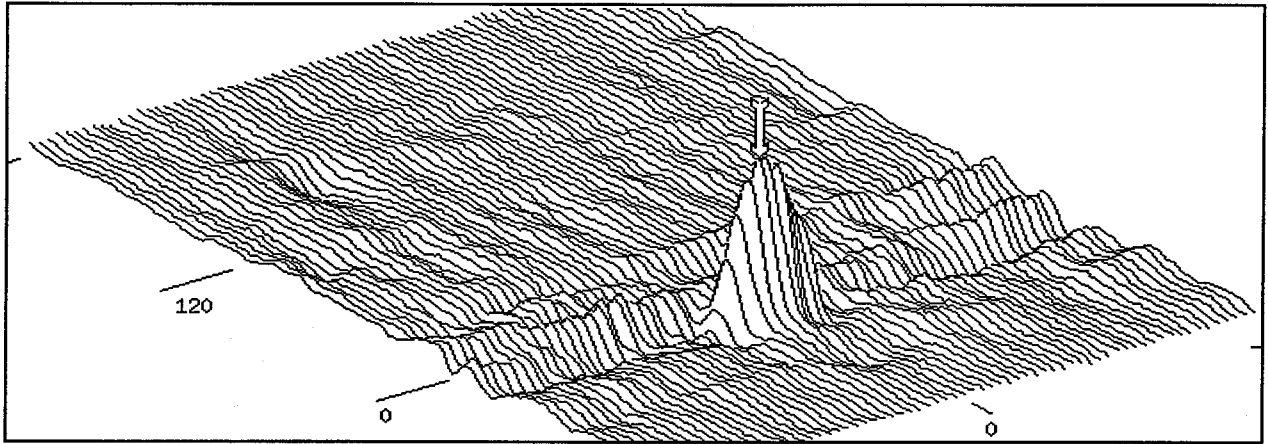
REFERENCED FIGURE 5 - Eddy Current Inspection - Tube R2C67 in SG24

The c-scan plot of the 1997 data from R2C67 is shown in Figure 5. The crack sits beside a noise ridge, in a valley, and is in an easily detectable portion of the tube. The large amplitude of the voltage signal, in relation to the standard calibration notch, would indicate that this is a "mature" crack. No year 2000 data is available since the tube was plugged in 1997.

Figure 5 - Crack in tube 2-67 of steam generator 24, found in 1997.

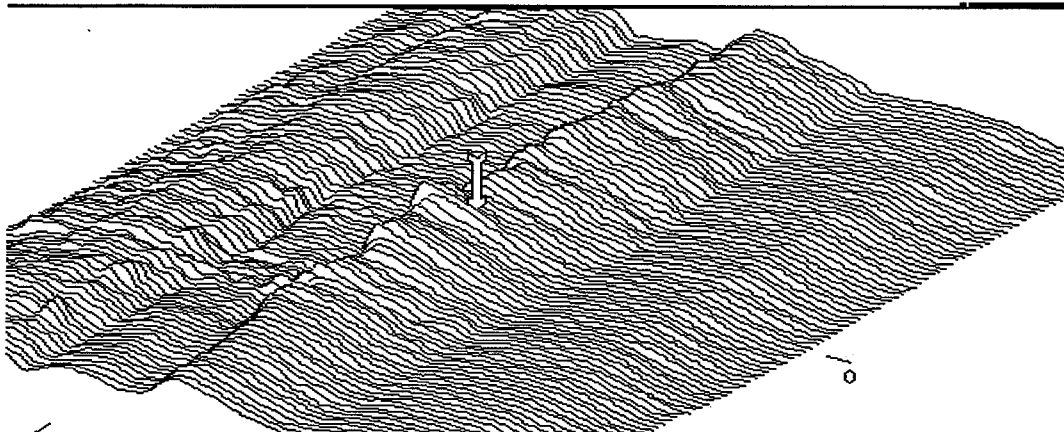
Figure 6 R2C5C-scan with 1997 phase setting.

1. R2C5 in SG 24 - Figure 6 is a c-scan plot of the vertical component of the ECT voltage signal. The defect signal, indicated by the arrow, sits on a noise ridge that runs the length of the tube. This noise ridge is about 1-volt in amplitude. This ridge makes both the detection and sizing of this defect difficult, because of the very low signal-to-noise ratio. Figures 7 and 8 are the lissajous plots for the flaw area and the noise ridge, respectively. No year 2000 data is available since the tube failed.

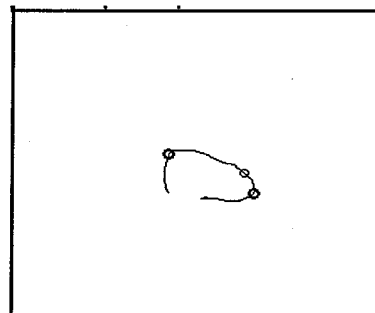
Figure 8 Noise signal that runs the length of the U-bend.

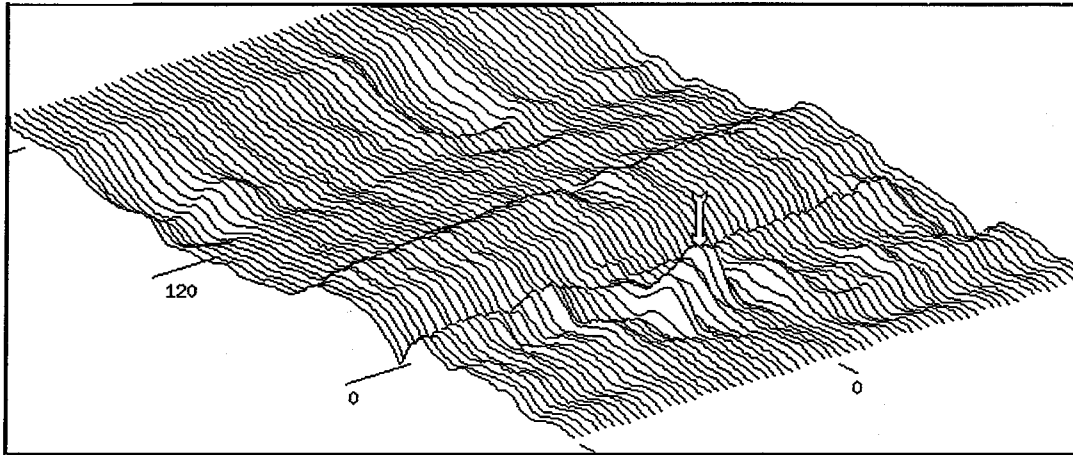
Figure 9 - 1997 mid-range scan

2. R2C69 in SG 24 - Figure 9 shows the c-scan plot for the 1997 data. There is considerable noise present. For comparison, the c-scan plot for the 2000 data is included as Figure 10. The noise features between the 1997 and 2000 data are similar enough to verify that this is the same defect at the same location. The defect voltage is only about 1 volt, and there is a considerable amount of noise on the tube relative to the defect signal, i.e., low signal-to-noise ratio.

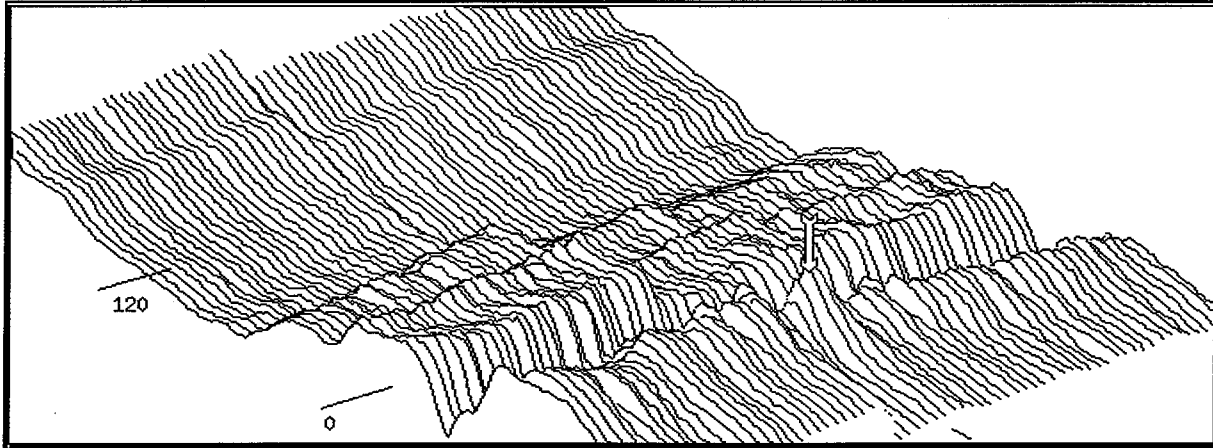
Figure 11 - 1997 scan

3. R2C72 in SG 24 - Figure 11 shows the c-scan plot of the 1997 data. There is considerable noise present. The crack is sitting in a ridge of noise and barely extends above the ridge. For comparison, the c-scan plot for the 2000 data is included as Figure 12. The crack barely extends above a 1-volt amplitude for a short length and exhibits a low signal-to-noise ratio.
4. R2C87 in SG 21 - this tube was identified as having several cracks. Figure 13 shows the c-scan plot of the 1997 data. The most prominent crack is sitting in a relatively clean area of the tube. For comparison, the c-scan plot for the 2000 data is included as Figure 14.
