**Loss of Pitch Control on Takeoff
Emery Worldwide Airlines, Flight 17
McDonnell Douglas DC-8-71F, N8079U
Rancho Cordova, California
February 16, 2000**

Aircraft Accident Report
NTSB/AAR-03/02

The National Transportation Safety Board determined that the probable cause of the accident was a loss of pitch control resulting from the disconnection of the right elevator control tab. The disconnection was caused by the failure to properly secure and inspect the attachment bolt.

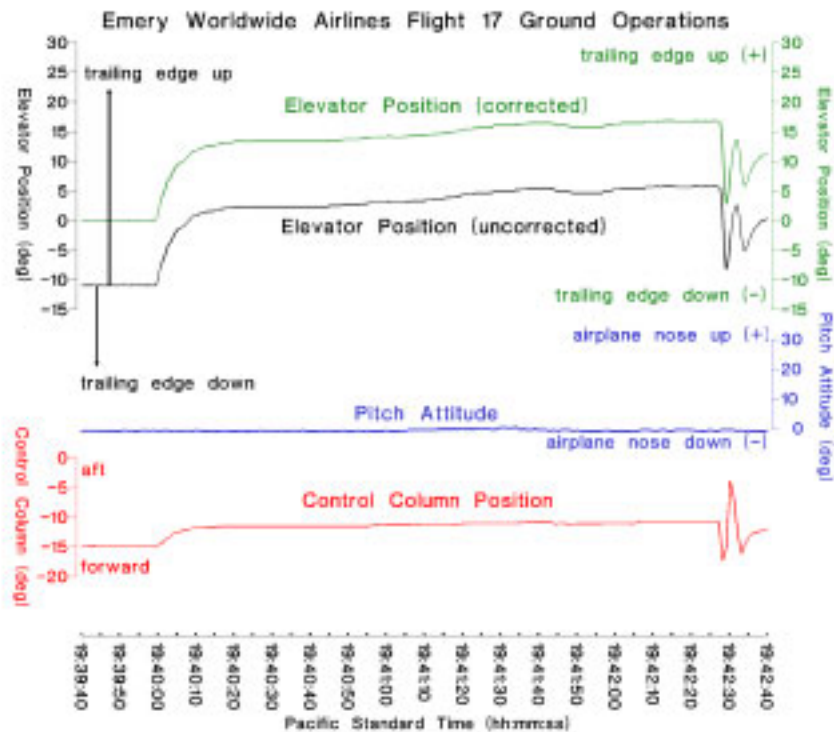
Figure 6. Elevator, pitch, and control column plots recorded by the accident airplane's FDR during ground operations before the accident flight. The first 20 seconds of data were recorded while the gust lock was engaged.

Figure 6 shows the elevator, pitch, and control column plots recorded by the accident airplane's FDR during ground operations before the accident flight. On this plot, the uncorrected data on the far left side of the plot shows an 11° TED elevator deflection when the gust lock was engaged (and the elevator was in its neutral, or 0°, position).

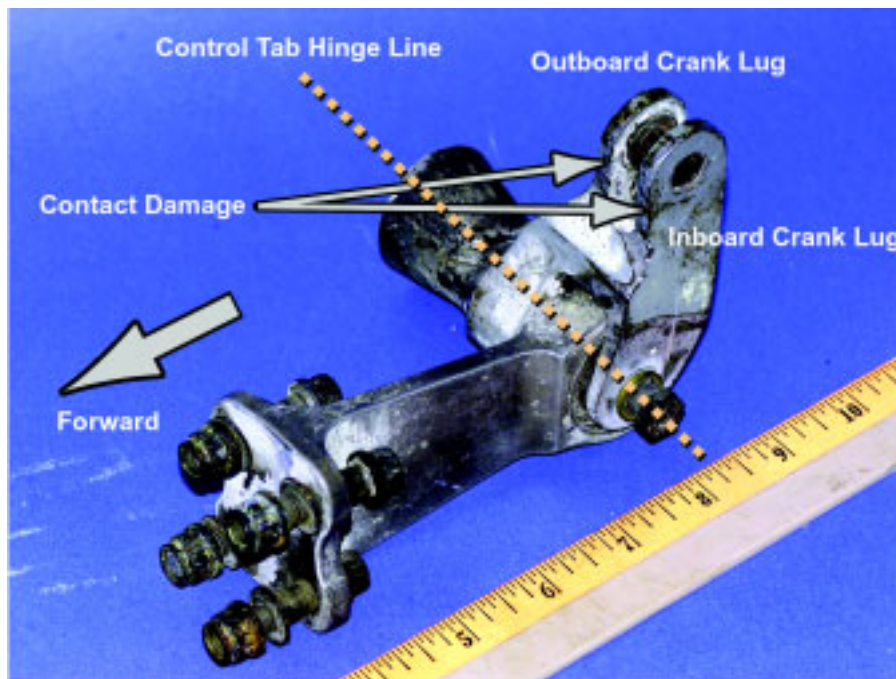
Figure 9. A photograph of the accident airplane's right elevator control tab crank fitting. Note damage on forward face of control tab crank fitting lugs.

(See figure 2, in section 1.6.2, for a diagram of the elevator control tab installation.) The right control tab pushrod was recovered separately, with its aft rod end (which would normally have been bolted to the tab crank fitting) intact. Examination of the forward edges of the elevator control tab crank fitting lugs revealed evidence of repeated contact damage (including gouge marks and indentations). (Figure 9 is a photograph of damage to this area.) The internal surfaces of the pushrod aft rod end bearing and the bushings in the crank fitting lugs showed no visible signs of damage or deformation. The bolt and associated hardware that normally secures the right elevator control tab pushrod to the tab crank fitting⁶¹ was missing and not recovered.

Although the inboard portions of the left elevator, control tab, crank fitting, and attachment hardware were not recovered and were presumed consumed by postcrash fire, the left elevator control tab pushrod was recovered. Unlike the right control tab pushrod, the left control tab pushrod's aft rod end (normally attached to the tab crank fitting) was fractured and about 75 percent of it and its associated bearing were missing. The forward end of this pushrod was fractured at its rod end attachment holes, and the pushrod had about an approximately 90° bend at its midpoint. No fire damage was observed on the left control tab pushrod assembly.

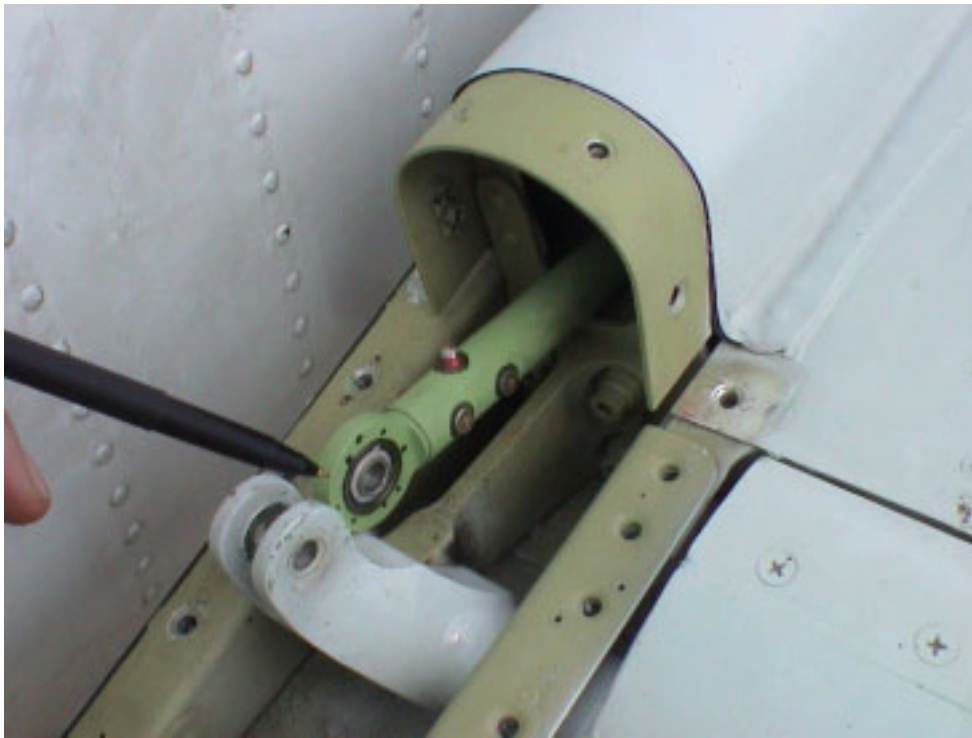
Figure 10. Photograph of the test airplane's right elevator control tab pushrod contacting the crank fitting.

When the aft end of the test airplane's pushrod cleared the crank fitting, it shifted slightly inboard so that it was aligned with the inboard leg of the forward face of the crank fitting. When the test airplane's control tab was manually raised TEU (simulating the effects of aerodynamic forces that would be experienced during the takeoff roll), the crank fitting contacted the aft rod end, obstructing any attempt to further deflect the elevator control tab in the TEU direction. Figure 10 shows the test airplane's pushrod in this position.

When the test airplane's elevator surfaces were manually moved to their TEU limit (about 27° TEU) in this condition, the control columns moved aft from 15.0° forward of vertical (the position in which they were held by the centering device) to about 8.8° forward of vertical, and both elevator geared tabs moved to 27.5° TED. The left elevator control tab deflected fully to about 8.5° TEU; however, the right elevator control tab could not be moved further in the TEU direction than 15.9° TED because of interference with the disconnected pushrod.

The test airplane's elevator surfaces were then moved manually to various TEU deflections (simulating the range of elevator travel that occurred during the accident flight), and measurements were taken to document the right and left elevator control tab deflections and control column positions at those elevator deflections. Based on the Safety Board's test and measurements, an average mismatch of 25° was noted between the left and right elevator control tabs (or about 8 inches of vertical separation if measured at the trailing edge), with TEU movement of the right elevator control tab restricted by contact between the pushrod and the crank fitting. This mismatch between the left and right elevator control tab positions existed regardless of elevator or control column position.

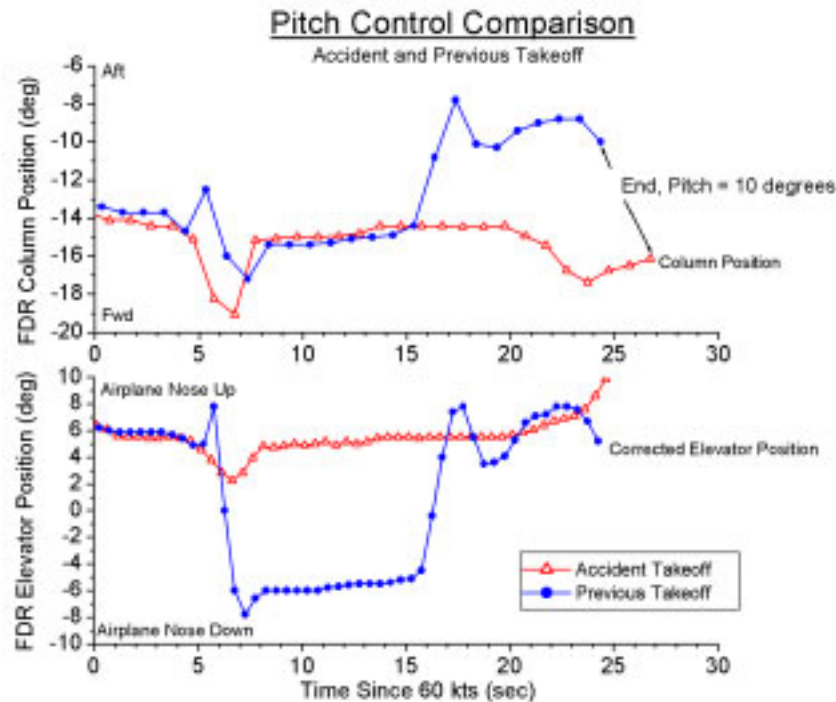
Figure 13. Plots of the control column and corrected elevator position recorded by the accident FDR during the accident takeoff roll and the previous takeoff roll (from RNO).

The study also showed that the stabilizer moved in an ANU direction at the same time that the pilot pushed the control column forward to resume the descent after a brief period of level flight at 10,000 feet. The direction of this stabilizer movement was opposite that which would be expected when the pilot provided a forward control column input. The study showed that the slight ANU stabilizer shift balanced the effect of the change in the relationship between the recorded elevator and control column movements and that the elevator remained responsive to pilot input. Figure 13 shows plots of the control column and elevator for the accident takeoff roll and the previous takeoff roll (from RNO).
