Runway Overrun and Collision
Southwest Airlines Flight 1248
Boeing 737-7H4, N471WN
Chicago Midway International Airport
Chicago, Illinois
December 8, 2005

NTSB/AAR-07/06

Aircraft Accident Report

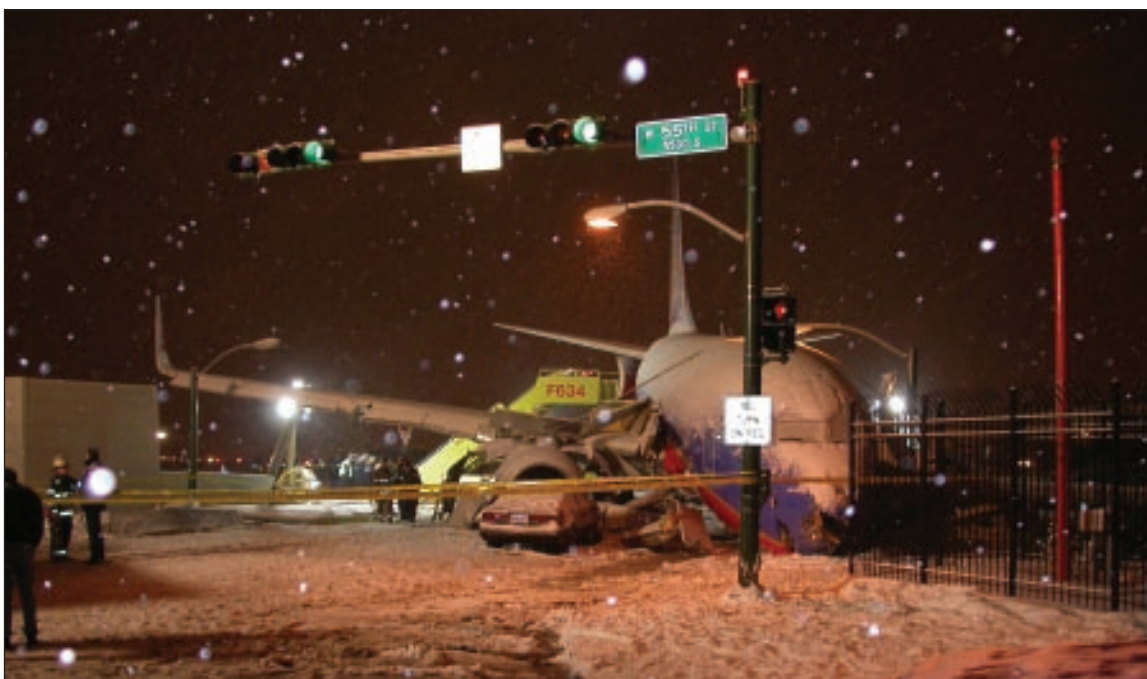
Figure 1. Photograph of the accident airplane in the roadway intersection. (Looking southeast, towards the departure end of runway 31C.)

The airplane rolled through an airport blast fence, an ILS array, a frangible airport perimeter fence, and onto a roadway, where it struck an automobile and a fire hydrant. Damage to the wing leading edges and engine nacelles of the airplane aligned with vertical posts from the airport perimeter fence; there was no damage observed in the airplane cockpit or cabin.

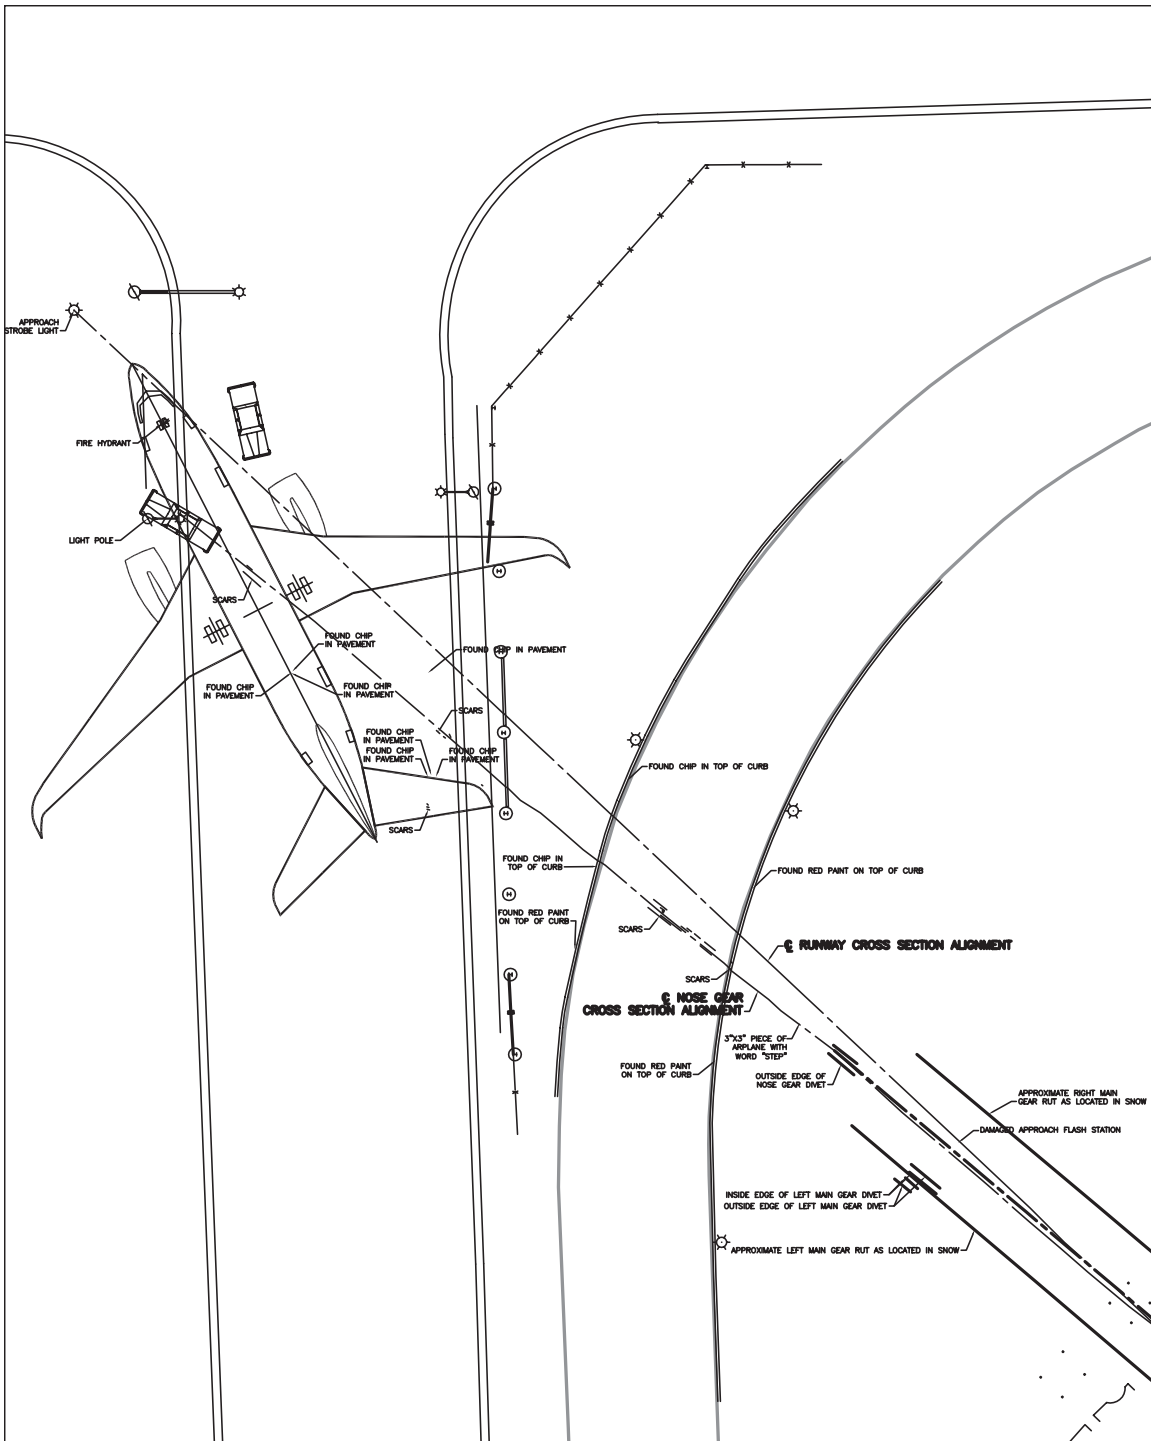
Figure 2. Diagram showing the accident airplane where it came to rest (on a heading of 340°) in the intersection off the end of runway 31C.

The airplane came to rest on a magnetic heading of about 340° at the south side of an intersection located on the northwest corner of MDW. The airplane was resting on the engines, both main landing gear, and the nose of the fuselage, with the nose landing gear collapsed and folded aft. The damage to the airplane was largely limited to the forward lower fuselage, engine cowlings and components, forward portions of the wings, and other wing components,²⁸ with limited damage farther aft. The rear part of an automobile was found damaged beneath the forward portion of the airplane's left fuselage. Postaccident interviews and physical evidence indicate that the automobile was northbound on the roadway and was struck from behind by the airplane.

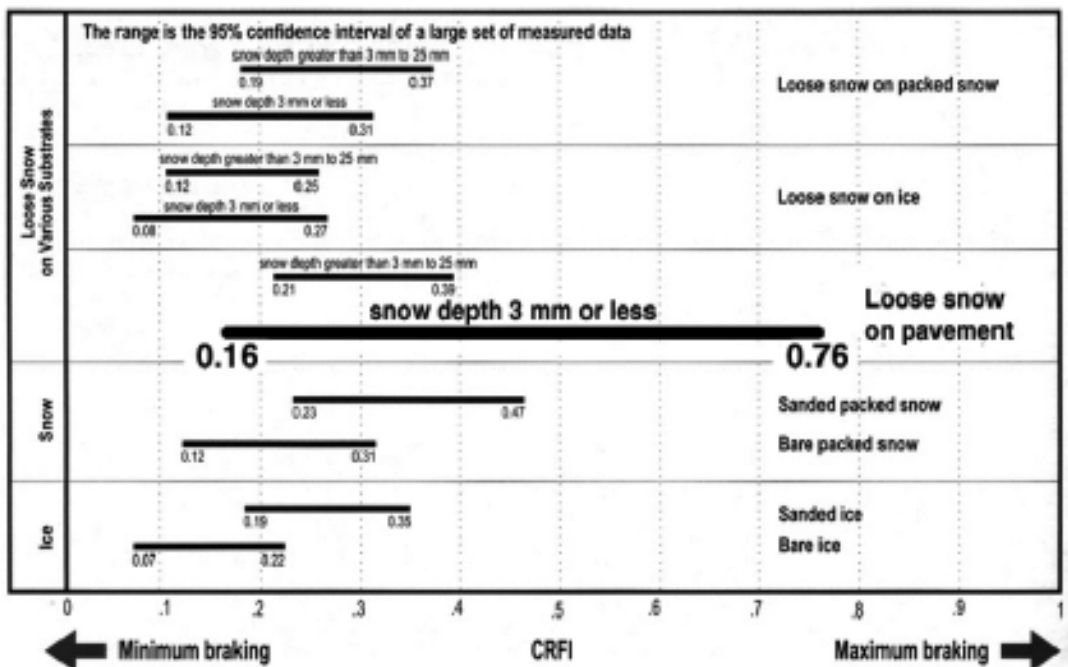
Figure 7. CRFI values for various runway surface conditions. Note that the CRFI values for loose snow 3 mm deep or less on pavement ranged from 0.16 to 0.76 (see the bold horizontal line).
