Analysis of Rail Car Components Exposed to a Tunnel Fire Environment

Center for Nuclear Waste Regulatory Analyses

**U.S. Nuclear Regulatory Commission
Office of Nuclear Material Safety and Safeguards
Washington, DC 20555-0001**

Manuscript Completed: November 2002
Date Published: March 2003

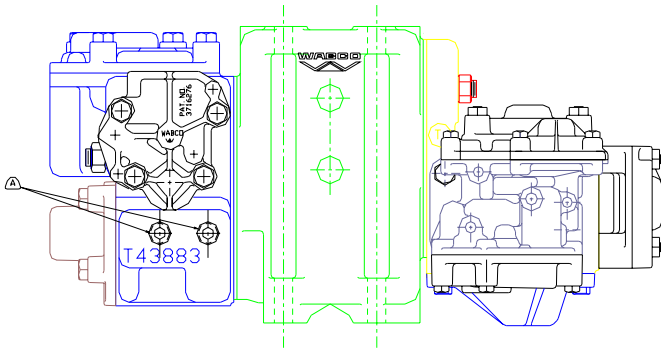
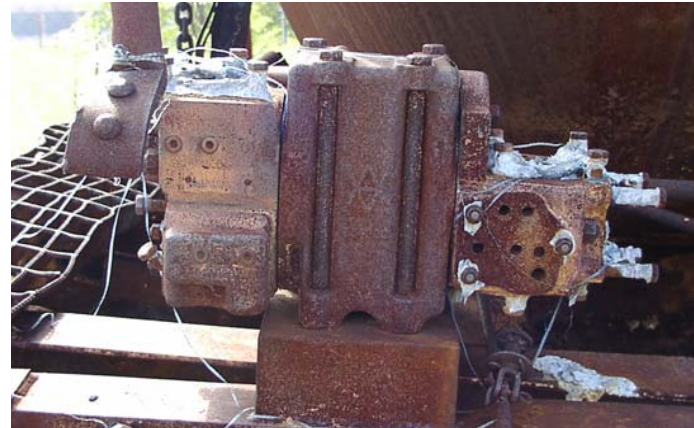
Remainder of ABDX-L Air Brake Valve from Car 52—This air brake valve exhibited evidence of prolonged fire exposure. The valve includes several die-cast aluminum covers, which had completely melted as a result of the fire. The valve was found approximately 10 m [33 ft] uphill from the spill site, and approximately 1 m [3.3 ft] from the tunnel floor. A similar valve assembly was found at the midpoint of Car 51, approximately 20 m [66 ft] uphill from the fire source. Although the exact model type was not determined, the valve cover was clearly from the same family of products and was assumed to be composed of the same aluminum alloy. A third air brake valve was found approximately 30 m [100 ft] from the spill site, and analyzed.

Figure 3-1. The ABDX-L Control Valve (Clockwise from Top: Valve Body Schematic, Photograph of Damaged Valve on Car 52, Corresponding Outline of the Valve Body)

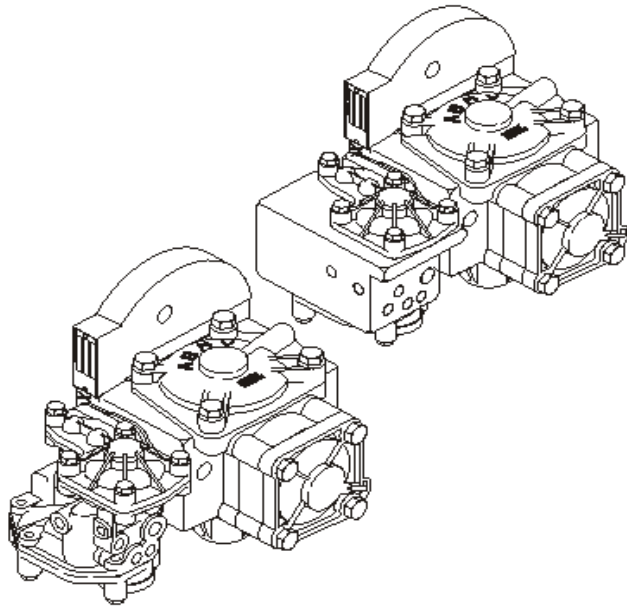
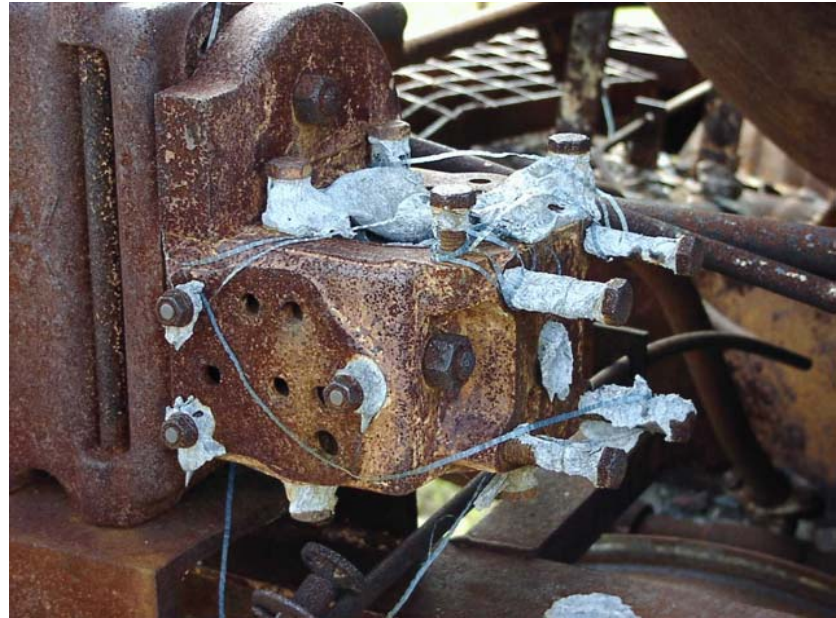
The primary area of interest in the analysis was the aluminum alloy cover over the release valve in the service portion of the valve assembly shown in Figure 3-2. The location of the cover is marked by the four bolts remaining on one side of the valve and the associated aluminum residue.

Figure 3-2. ABDX-L Service Portion Outline and Photograph

Complete Melting—The aluminum section reached its liquidus temperature. This is a good assumption considering the condition of the covers in Figure 3-2.

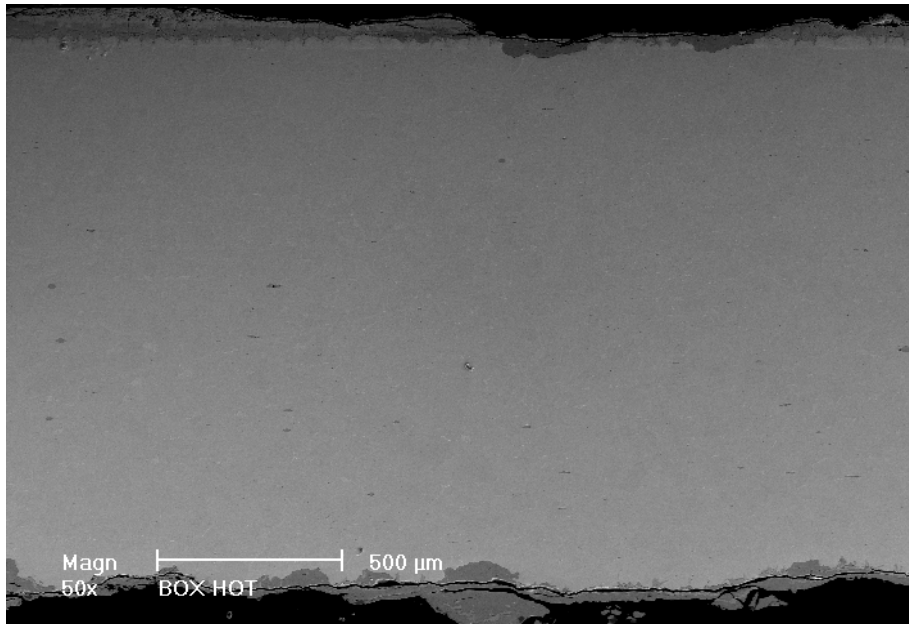
Figure 4-8. Cross Section of Car 50 Roof Approximately 3 cm [1.2 in] from the Edge Directly Exposed to the Fire. Thickness of the Metal Was Approximately 1,464 μm [0.057 in].

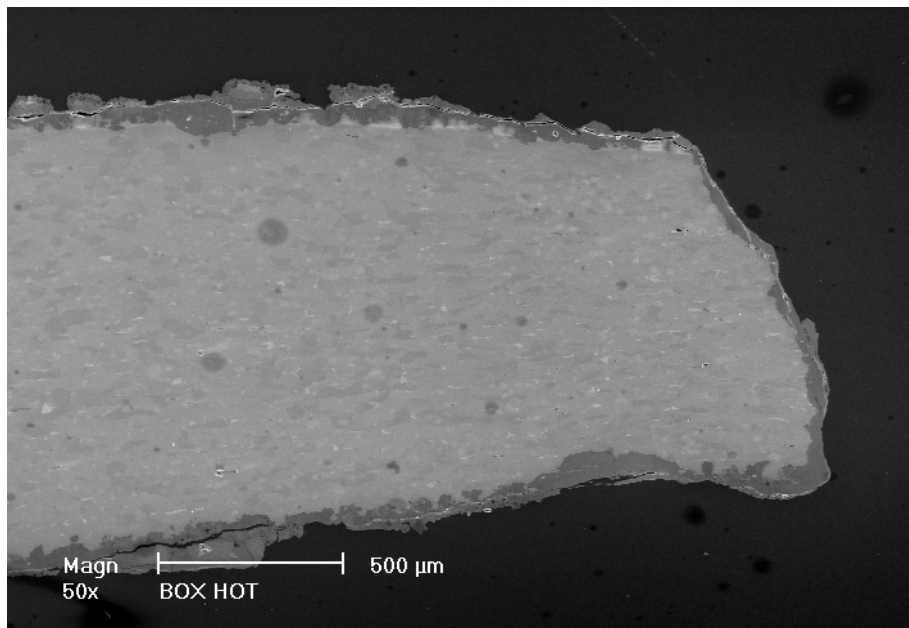
Figure 4-9. Cross Section of Car 50 Roof at Edge Directly Exposed to the Fire. Thickness of the Metal Ranged from 829 to 930 μm [0.033 to 0.037 in].

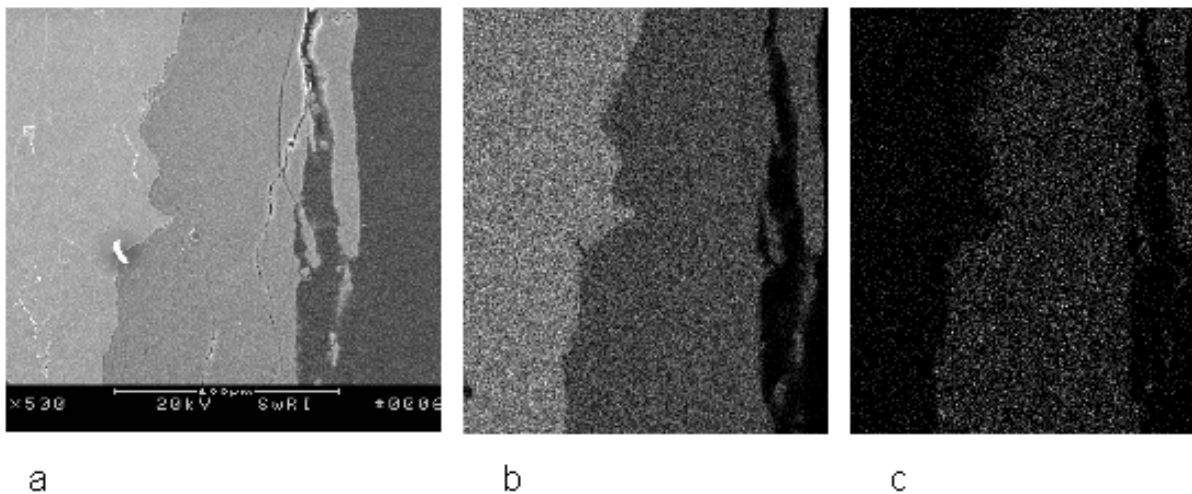
Figure 4-10(a) shows a closeup of the metal oxide scale of the Car 50 roof section near the edge exposed to the fire. Cracks and spalling of the oxide are apparent from the cross section. Figure 4-10(b) shows the scanning electron microscope-energy dispersive spectrometer element map for iron, and Figure 4-10(c) shows the element map for oxygen which confirms the scale is an iron oxide. Based on the analyses of the cross-sectioned specimen, the oxide scale on the roof section exposed to the fire ranged from 50 to 81 μm [0.0019 to 0.0032 in] in thickness. According to the calculations shown in Figure 4-3 scales of this thickness can be produced at temperatures below 700 °C [1,292 °F] for a period of 4 hours. However, the oxide scale shown in Figure 4-10(a) has clear signs of spalling which may have reduced the scale thickness that remained attached to the damaged roof section.

Figure 4-10. (a) Secondary Electron Image from Car 50 Roof at Edge Directly Exposed to the Fire, (b) Iron Image Map, and (c) Oxygen Image Map

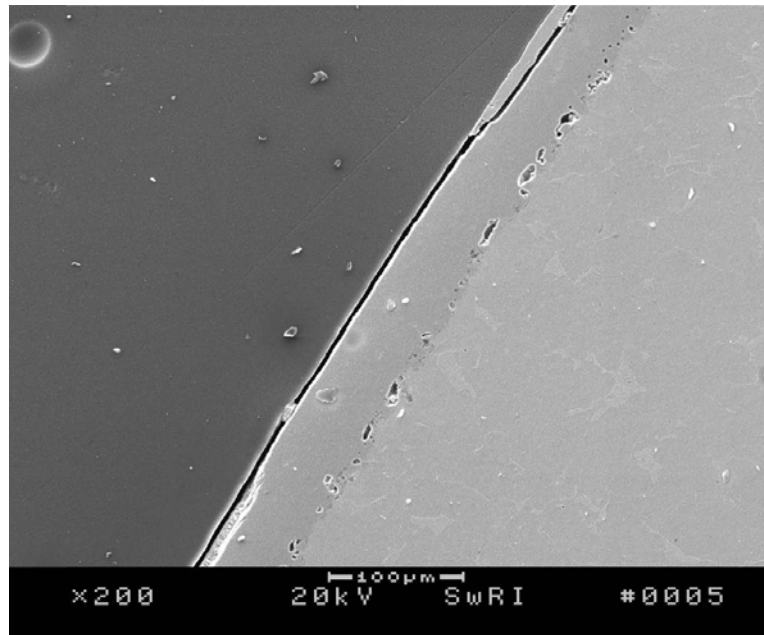
The cross section of the air brake bolt is shown in Figure 4-11. The oxide scale on the bolt shank was determined to be 53 μm [0.0021 in]. Little spalling or cracking of the oxide layer was observed, suggesting the temperature was less than that achieved by the roof panel of Car 50. Based on the predicted metal oxide thickness shown in Figure 4-3, a 53- μm [0.0021-in] oxide scale could be expected in 4 hours at 627 °C [1,160 °F]. At higher temperatures, spalling of the oxide would be expected.

Figure 4-11. Scanning Electron Microscope Secondary Electron Image of Car 52 Air Brake Valve Bolt Showing Metal and Oxide Layer

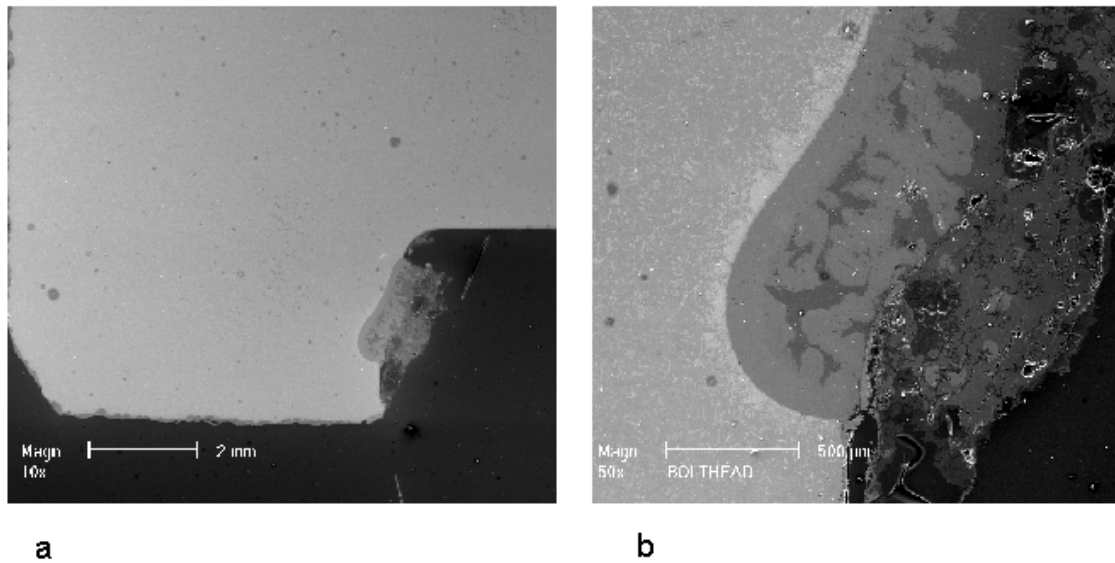
Figure 4-12(a) shows a cross section of one of the air brake assembly bolts. During the analysis of the specimen, several regions were found where an aluminum–iron phase had formed. A higher magnification of such a region is shown in Figure 4-12(b). Using an energy dispersive spectrometer, the composition of the bolt was determined to be 98.4 atomic percent iron with no measurable concentration of aluminum. In the mixed aluminum–iron region, the composition was found to be 66 atomic percent aluminum, 4 atomic percent silicon, and 30 atomic percent iron. The liquidus temperature for a 66 atomic percent aluminum and 34 atomic percent iron binary is 1,180 °C [2,156 °F] and the solidus temperature is 1,165 °C [2,129 °F] (ASM International, 1992). The aluminum–iron binary phase diagram does not contain low melting point eutectic compositions. The addition of 4 atomic percent silicon is not expected to significantly alter the solidus or liquidus temperatures based on examination of the iron–silicon and aluminum–silicon binary systems.

Figure 4-12. (a) Scanning Electron Microscope Secondary Electron Image of Car 52 Air Brake Valve Bolt Head Showing Iron and Aluminum and (b) Closeup of Iron with Aluminum

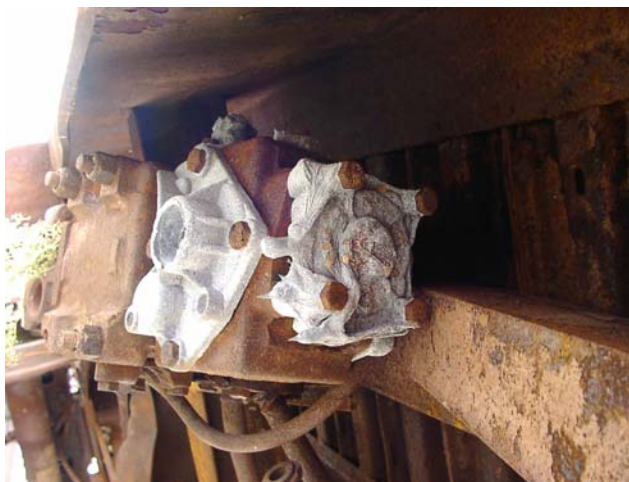
A second aluminum witness was found approximately 20 m [66 ft] uphill of the fire source. This piece is shown in Figure 6-1. It is interesting to note that this piece did not melt completely, which would indicate the very specific conditions required to melt the valve assembly on Car 52 were likely not encountered at approximately 20m [66 ft] away.

Closer analysis of the damage caused to the valve cover found at Car 52, indicates that a separation distance of approximately 20 m [66 ft] was sufficient to limit the exposure conditions in this area, as evidenced by the level of damage to the valve cover. Considering only partial melting in this area, temperatures at the surface of the aluminum were only slightly above 600°C [1,112°F] (enough to initiate melting) but were not maintained for any appreciable duration.

Figure 6-1. Air Brake Valve Found 20+ m [66+ ft] from Fuel Spill Site (Note Only Partial Melting at This Location)
