Research  
Paper  
FPL-RP-566

# Field Performance of Timber Bridges

## 15. Pueblo County, Colorado, Stress-Laminated Deck Bridge

Lola E. Hislop

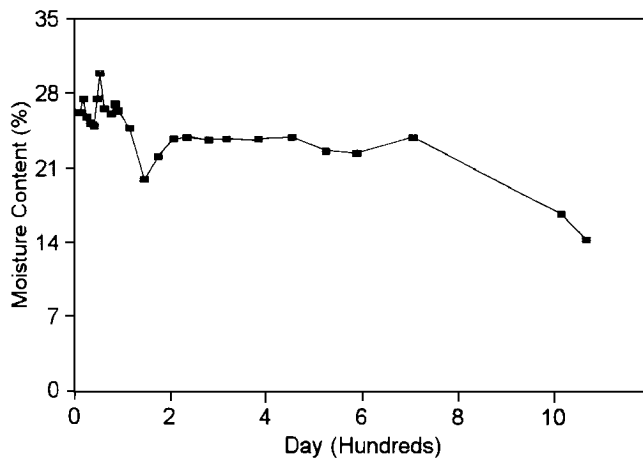
The average moisture content in the deck of the bridge during the monitoring period is shown in Figure 17. The laminations were installed initially at an average moisture content of 28%, near the FSP. After construction, moisture content fluctuated and, in general, slowly decreased to approximately 25% during the first 2 years. Then, the moisture content rapidly decreased to 16% during the next year. Typically, moisture content fluctuates in the outer 25 to 76 mm of the deck with a very slow downward trend.

Based on the arid location, the equilibrium moisture content of the deck is likely to be 13% to 15%. Although the outer 25 to 76 mm are near equilibrium, the interior portion is probably greater. Globally within the deck, the moisture content will continue to slowly decrease. Small fluctuations will likely occur in the outer 25 to 76 mm throughout the life of the structure with climatic changes. This will also occur at the ends of the bridge as a result of the cracks in the asphalt surface at the ends of the span, which allows moisture migration from the topside.

Figure 17—Average moisture content levels in the deck.

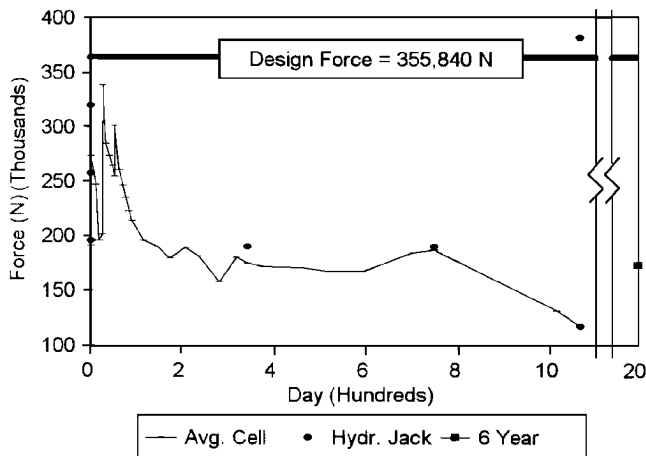
The stressing bar force for the 3-year monitoring is shown in Figure 18. In general, the bar force behaved similar to that of other stress-laminated bridges (Ritter and others 1995). Each restress was to a final level slightly less than the 355.84 kN design force. During the first 4 months after the final bar tensioning, the force rapidly decreased approximately 50% to 177.92 kN, where it remained level for 20 months. During the next year, the force decreased to 117.87 kN.

The main causes of bar force loss were stress relaxation and decreasing moisture content. Stress relaxation is the slow compression of the wood cells. It is more pronounced as moisture content increases above 20%. Because the moisture content remained near the FSP for the first 2 years, stress relaxation effected bar force changes whereas shrinkage caused by loss of moisture had little effect. During the final year, shrinkage had the greater effect with the decrease in moisture content and subsequent dimensional changes in the laminations.

Figure 18—Average bar force obtained from load cells installed on two stressing bars.

- Bar tension force decreased by 67% during the 3-year FPL monitoring. This is attributable primarily to the large decrease in moisture content as well as wood stress relaxation. At the end of the monitoring, the bars were retensioned and during the 3 years since that time, the force has decreased by 50%. This is a slightly less loss compared with the initial 3 years, showing a decrease in the rate of moisture content loss and stress relaxation. Restressing of the bridge should be performed within the next year and will probably not be necessary again for several years.

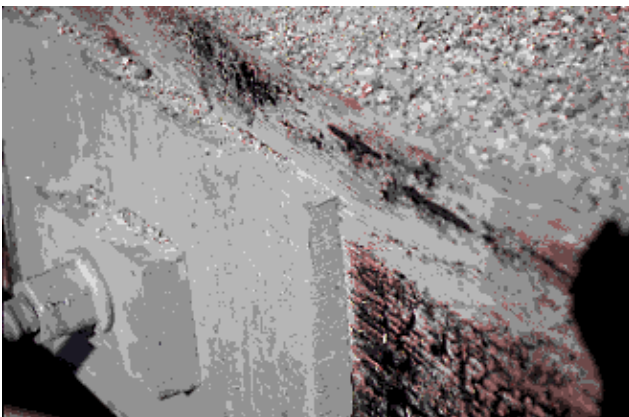
The outside deck laminations are generally in good condition. There has been some (up to 9.5 mm) plate crushing into the outside lamination on the west side (Fig. 28). This is probably due to undersized bearing plates, especially considering the high moisture content of the laminations. Checking was evident on the top surfaces of rail members exposed to wet-dry cycles. Checking was most pronounced in the end grain of the timber rail posts. In addition, the top of the bridge rail showed minor checking, but the depth of the checks did not appear to penetrate the preservative treatment envelope of the member. Inspection showed an excessive amount of preservative leaching on some exposed surfaces.

**Figure 28—Crushing of the bearing plates into the outside lamination, up to 9.5 mm.**

- There is a 12.7-mm sag in the deck as a result of dead load. No camber was built into the deck to offset the effects of dead load.
- The bearing plates have crushed as much as 9.5 mm into the outside laminations. This is probably due to the plates not being adequately sized for the applied force and the reduced strength of the wood as a result of the high moisture content. The crushed areas of the outside laminations are susceptible to deterioration, and preservative should be applied. Wood checking is evident in the exposed end grain of the rail posts and other components. This probably would not have occurred if a bituminous sealer had been applied to the end grain at the time of construction.

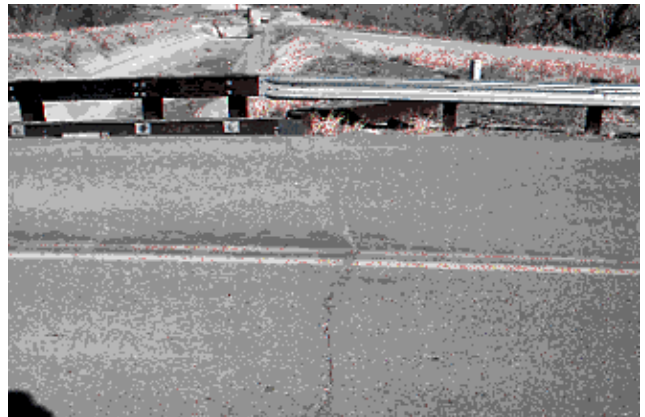
Inspection of the asphalt wearing surface indicated 12.7-mm-wide transverse cracks at the ends of the span (Fig. 29). Otherwise, the wearing surface was in good condition with no other signs of distress, such as cracking, rutting, or shoving.

**Figure 29—Transverse crack (12.7 mm wide) in asphalt at both span ends.**

- The asphalt wearing surface is in good condition except for transverse cracks at the ends of the bridge. These cracks should be filled to prevent moisture migration to the ends of the deck laminations and timber abutments.
