In-Place Detection of Decay in Timber Bridges-An Application of Stress Wave Technology

Roy F. Pellerin and Jeff A. Lavinder (Authors), Washington State University
Robert J. Ross and Robert H. Falk, USDA Forest Products Laboratory
Norbert Volny, Volny Engineering

In: Ritter, M.A.; Duwadi, S.R.; Lee, P.D.H., ed(s). National conference on wood transportation structures; 1996 October 23-25; Madison, WI. Gen. Tech. Rep. FPL- GTR-94. Madison, WI: U.S. Department of Agriculture, Forest Service, Forest Products Laboratory.

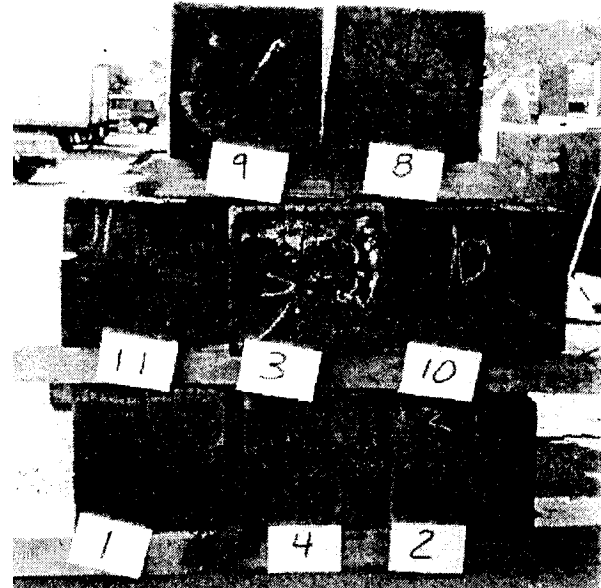
Figure 6—Tops of Columns

Laboratory Evaluation of Bridge 117— The laboratory evaluation at the WMEL began with a visual inspection of all the components. The stringers, decking and caps appeared to be structurally sound. Column inspection revealed excessive decay to most of the bottoms and a few of the tops. Figure 6 shows the tops of the columns and the decay damage; Figure 7 shows the bottoms of the columns.

Reasons for the deterioration of the columns were obvious when the laboratory evaluation was completed. As can be seen in Figures 9 and 11, the penetration of the creosote was poor in the tops of the columns when compared to the penetration in the bottoms (Figures 10 and 12). All of the columns had both ends squared for the compression test. After squaring the ends, it was hypothesized that the columns had been 'cut to fit' when they were being placed. The tops were cut so they would fit the bridge at the time of construction. Additional treatment had been applied to the tops after they were cut, but the penetration was poor. Essentially, this created a treated column with the top being penetrated more easily by moisture. The treated shell helped keep the moisture in, accelerating the decay process. The hypothesis is backed by the fact that all of the bottoms were decayed in the columns (Figure 7) where the moisture was locked in. With the exception of column 5, the tops of the columns showed little visible decay. Both the stress wave evaluation in the field and in the laboratory spotted excessive decay in all of the columns.

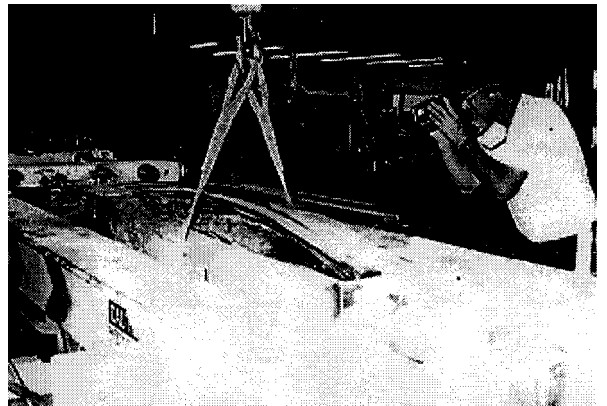
Figure 13—Column #5 at failure in the compression test

The columns were loaded until failure. Column 5 failed abruptly (Figure 13) at an ultimate load of 37.5 kips. The National Design Specifications (NDS 1991) Supplement tabulates compression parallel-to-grain values for Douglas-fir Larch as 700 psi for No. 2 grade in Table 4D. Adjusting for loading rate and changing the tabulated fifth percentile to the median value, the capacity should be 258 kips. The load duration factor can be calculated from Figure 14 (National Design Specifications 1991). The columns' low capacity is a direct result of the extensive decay in the column. Decay had completely deteriorated the interior of the column. Figure 15 shows column 5 after the compression test.

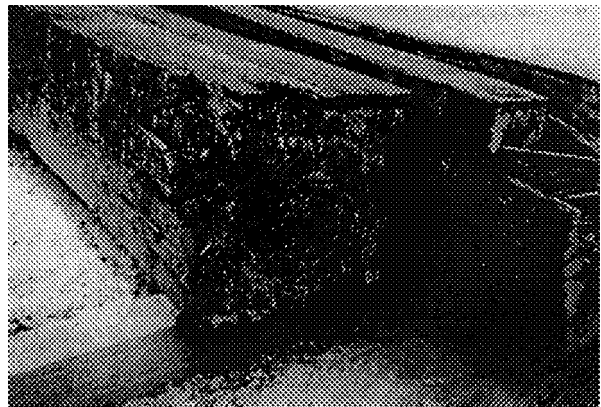
Figure 16—Column #12 after failure

Column 12 was loaded to an ultimate load of 172.0 kips. The column failed by a compression failure where the end was decayed (Figure 16). The visual inspection failed to identify the decayed area. However, the stress wave evaluation of column 12 showed a high stress wave time at the point that it failed in compression. The decay pocket can be seen in Figure 16 on the upper left corner of the picture.
