Incidents Associated with Oil and Gas Operations

Outer Continental Shelf 1995-1996

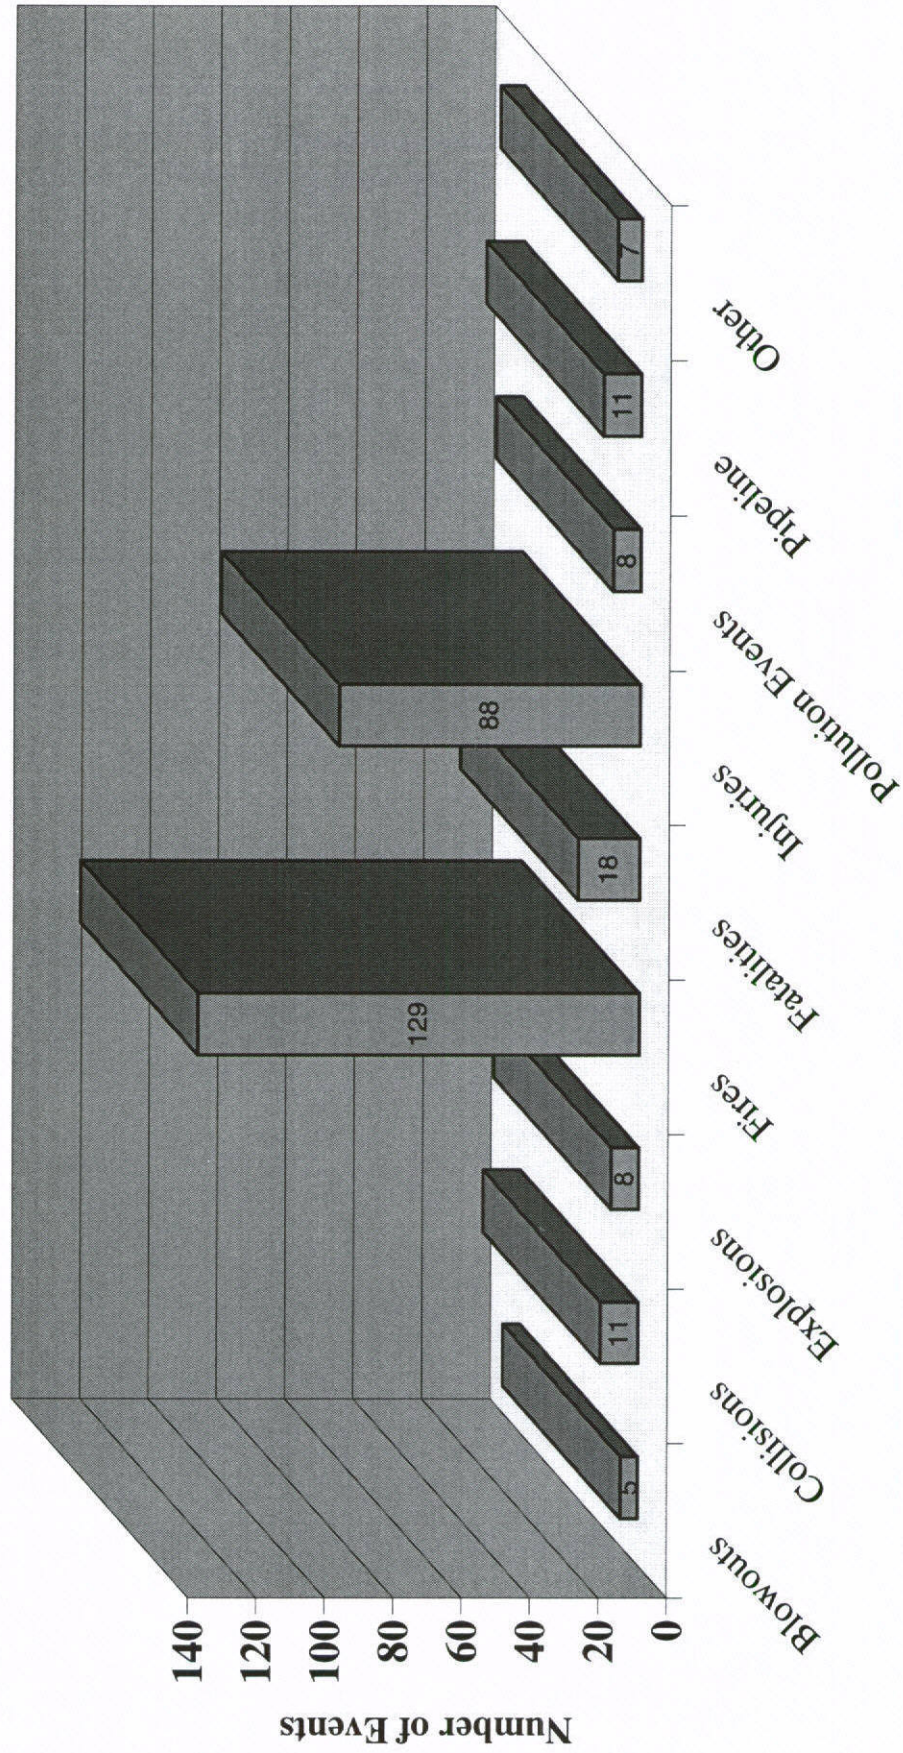
OCS Incidents Reported to MMS 1995-1996

During 1995-1996, 285 incidents occurred on the OCS (see bar chart in the Appendix, p. A-2). Almost half (129) of these incidents were fires. Most of the fires were minor and resulted in little or no damage and no injuries. Almost one-third of the incidents were injuries, with 88 occurring during 1995-1996. The majority of these injuries were minor. Both the number of fires and number of injuries recorded in TIMS doubled from 1995 to 1996. Part of this increase may be a result of changes in GOM record-keeping requirements that became effective August 1996. Blowouts, explosions, fatalities, pipeline incidents, and incidents in the other categories have also shown some increase from 1995-1996. During 1995-1996, there were 5 blowouts, 8 explosions, 18 fatalities, 11 pipeline events, 8 significant pollution events (≥ 50 bbls), and 7 incidents in the "other" category. There were also 11 collisions with OCS facilities during this period.

During 1995-1996, 285 incidents occurred on the OCS (see bar chart in the Appendix, p. A-2). Almost half of these incidents were fires, with 129 occurring during 1995-1996. Most of the fires were minor and resulted in little or no damage and no injuries. Almost one-third of the

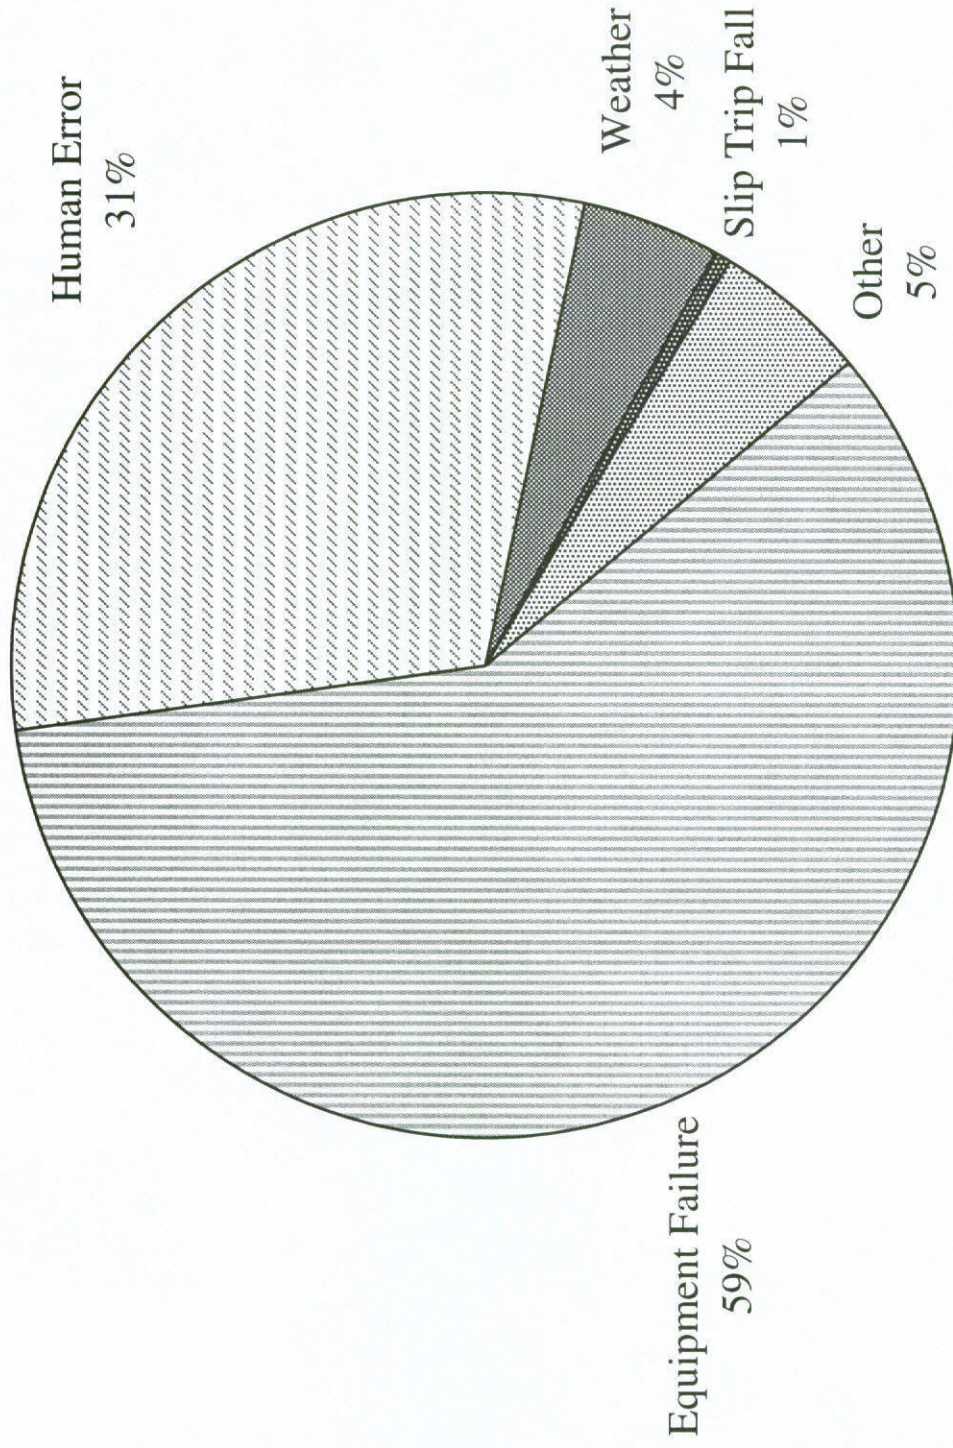
Causes of OCS Fires 1995-1996

Using the cause determinations from the initial incident reports, the primary cause of fires was equipment failure, the second most frequent was human error. For injuries, the primary cause was human error, the second most frequent was slip/trip/fall, and the third most frequent cause was equipment failure. The primary causes of fatalities were human error and slip/trip/fall. Most fatalities occurred during production operations. The second most common operation was drilling, and the third was well completion and welding operations. Blowouts were mainly a result of equipment failure and human error, occurring primarily during drilling operations and secondly in well completion activities. Explosions mainly occurred during production activities and were primarily caused by equipment failure and human error. Collisions with OCS facilities were caused primarily by human error and equipment failure. Pie charts showing the causes of these incident categories can be found in the Appendix of this report.

Using the cause determinations from the initial incident reports, the primary cause of fires was equipment failure, followed by human error. For injuries, the primary cause was human error, followed by slip/trip/fall, and then by equipment failure. The primary causes of fatalities were human error and slip/trip/fall. Most fatalities occurred during production operations, followed by drilling, then well completion and welding operations. Blowouts were mainly a result of equipment failure and human error, occurring primarily during drilling operations followed by well completion activities. Explosions mainly occurred during production activities and were primarily caused by equipment failure and human error. Collisions with OCS facilities were caused primarily by human error and equipment failure. Pie charts showing the causes of these incident categories can be found in the Appendix of this report.

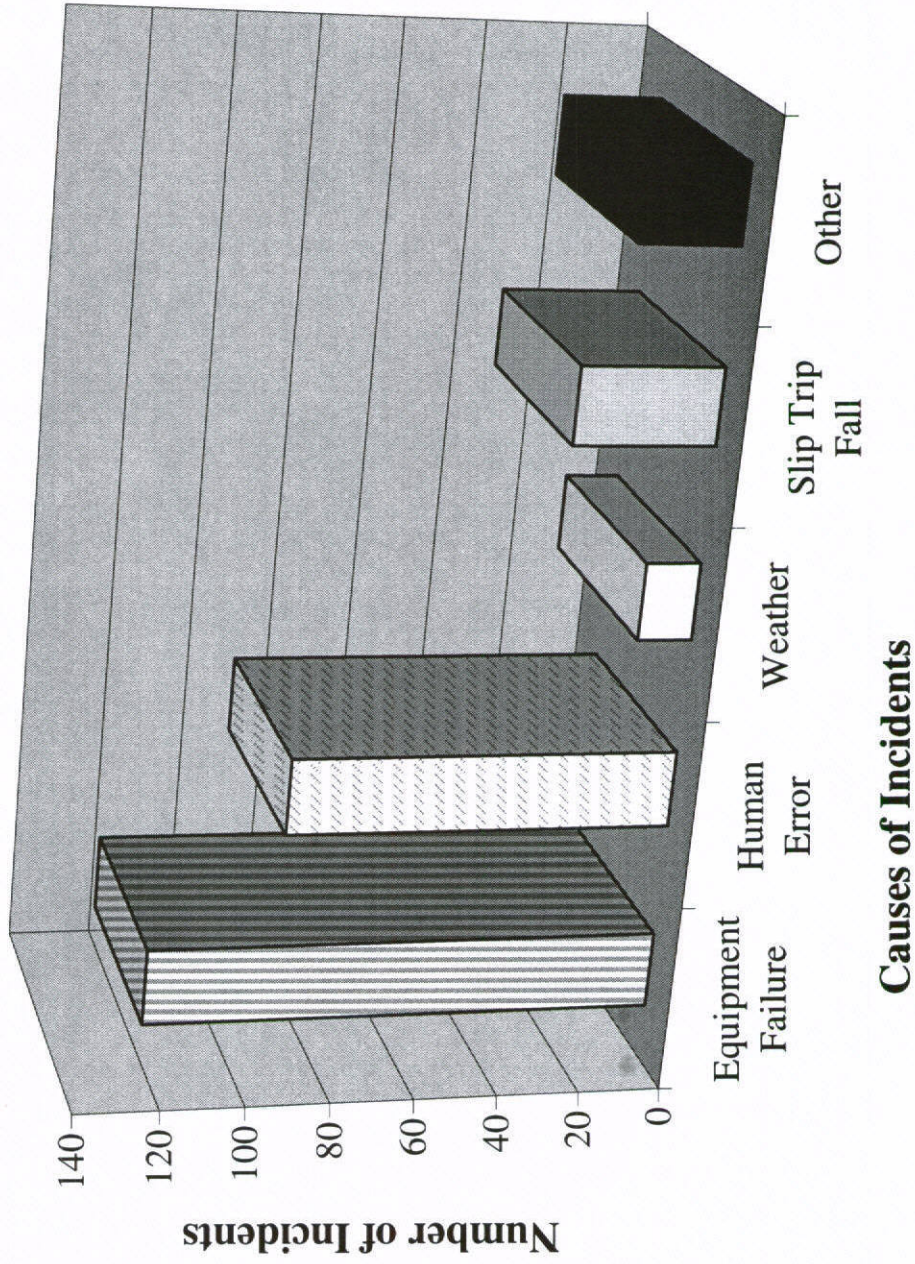
Summary of OCS Incident Causes 1995-1996

Overall, the most frequent cause of incidents in 1995 and 1996 was equipment failure; the second most frequent cause was human error. The majority of these incidents occurred during production operations.

The majority of the 1995-1996 incidents occurred during production operations. Overall, the main cause of all incidents in 1995 and 1996 was equipment failure followed by human error. As shown in the report, there are a large number of events caused by human error. Due to the wide scope of the term, MMS is trying to narrow the definition of this cause.
