**An Assessment of the Impact of Social Trails Use  
on Cultural Resources in Technical Area 70,  
Los Alamos National Laboratory, New Mexico**

**U.S. Department of Energy  
National Nuclear Security Administration  
Los Alamos Site Office**

**Jennifer E. Nisengard and Sherri Sherwood,  
Environmental Protection Division,  
Risk Reduction Office and Ecology and Air Quality Group**

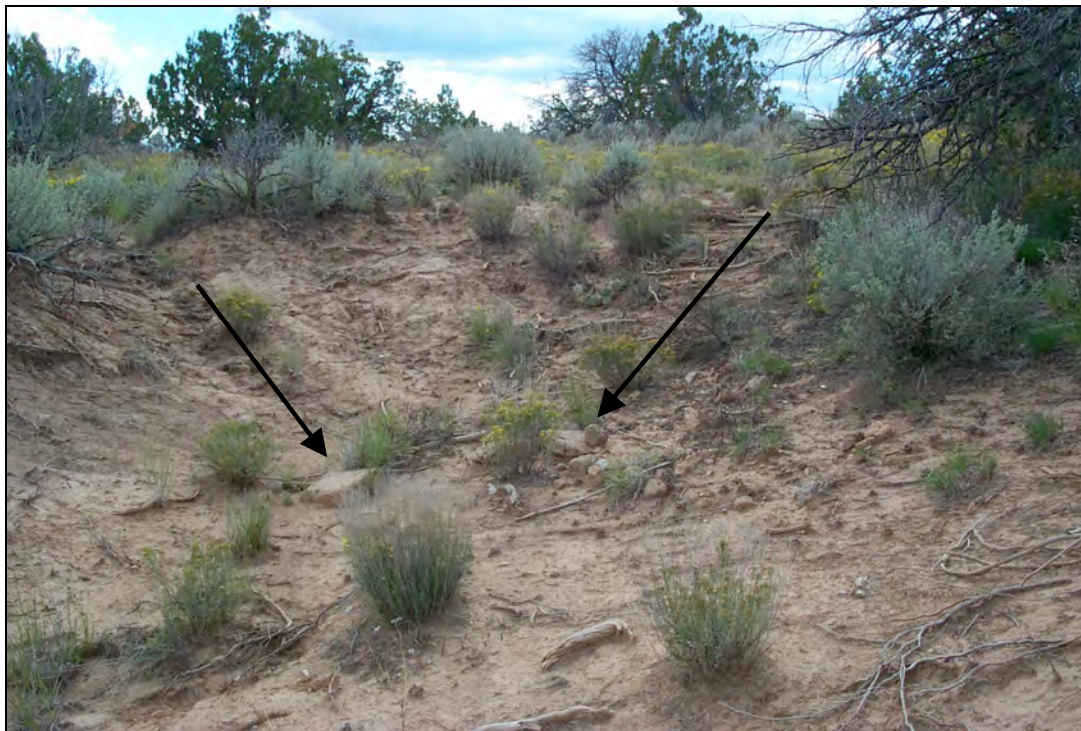
The three primary impacts related to cultural resources in TA-70, caused or exacerbated by recreational trails use, are erosion (Figure 3), looting (Figure 4), and vandalism and/or modern disturbances, some of which are recent and some of which are historic (Figure 5). Natural erosion, primarily from wind and water, accounts for the majority of site and trail impacts. Areas of TA-70 have been impacted by severe erosion, with tree roots visible at many sites along the trail routes; the location of this TA, atop a mesa, accounts for some of the erosion in the area. An additional cause of the severe erosion in the TA is that grazing and wildfire prevention efforts have allowed piñon and juniper to establish in areas that were previously grasslands. These trees are able to out compete the understory for water and nutrients so the grasses die off, leaving the soils unprotected and subject to increased erosion (Sam Loftin, personal communication).

**Figure 3. Severe erosion impacts a Coalition period Ancestral Pueblo site (arrows indicate the shaped tuff blocks used to construct the roomblock).**

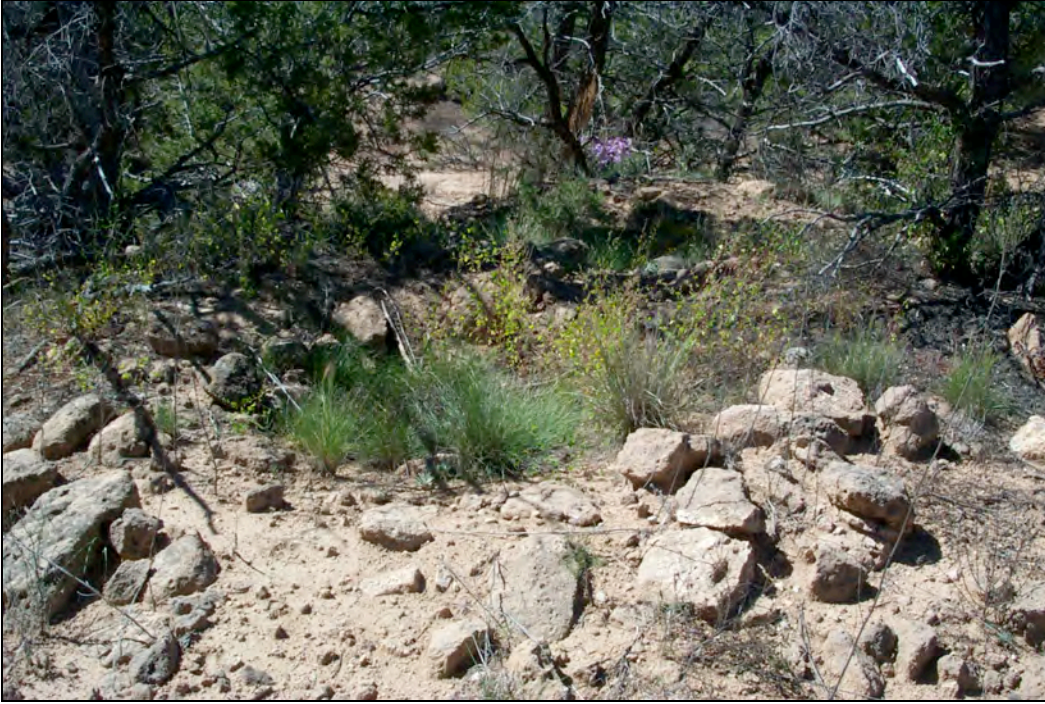
**Figure 4. A depression in the center and piles of the shaped blocks provide evidence for site looting at this Ancestral Pueblo site.**

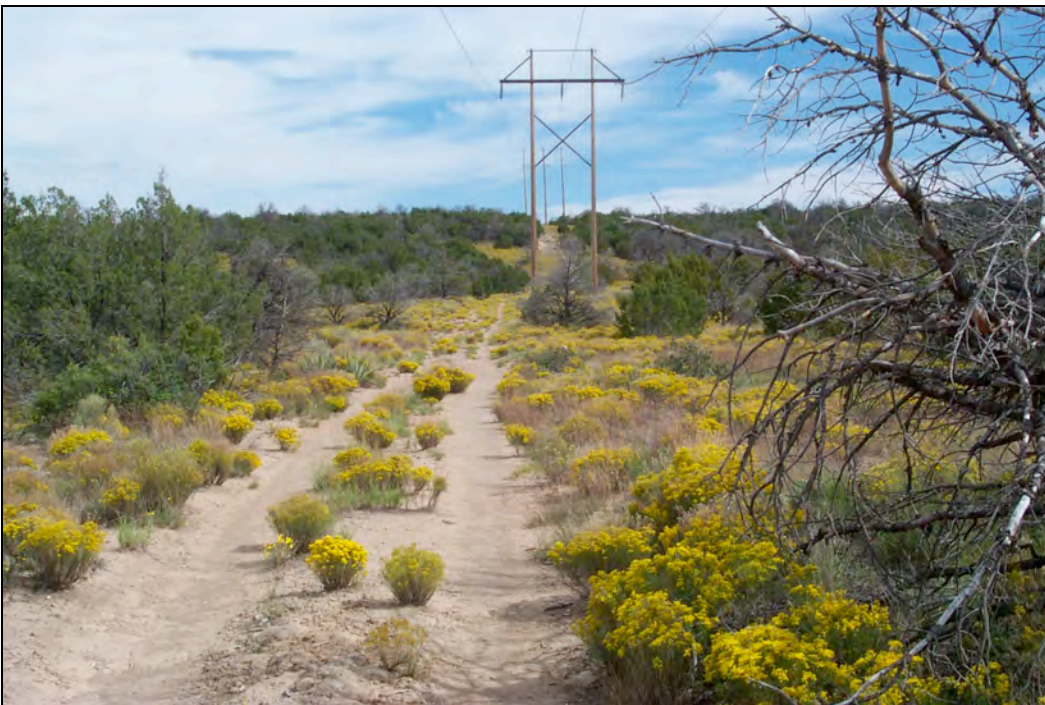
**Figure 5. Erosion occurring along a power line road.**

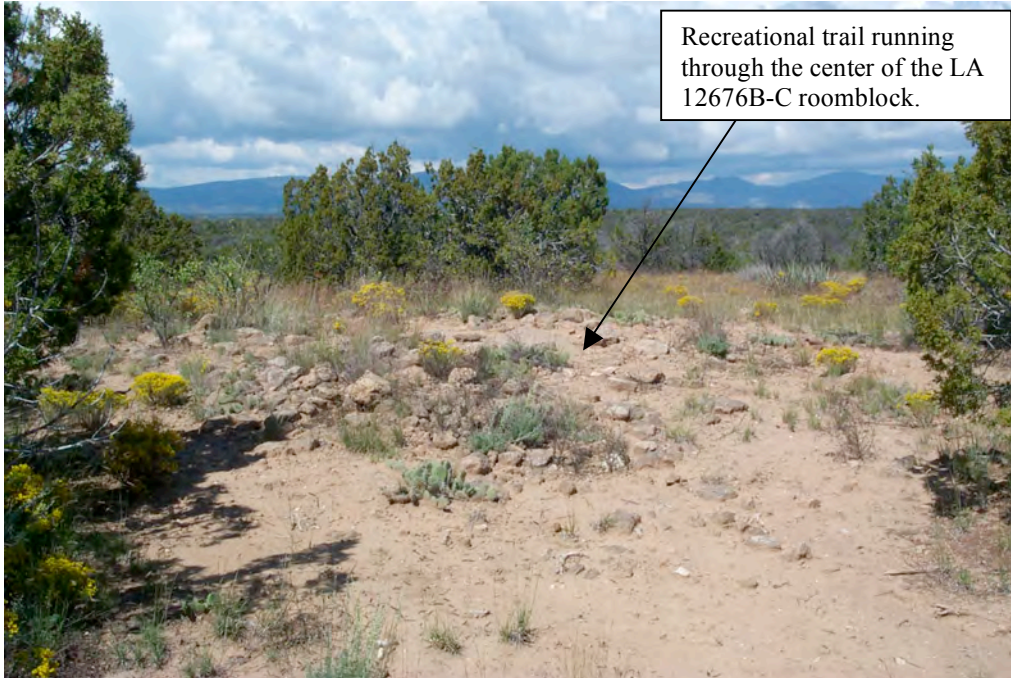
LA 12676B-C is a Coalition period roomblock impacted by erosion and the use of a road and Trail Segment 2B. Erosion at the site is minor when compared with other sites in TA-70. The road and trail have created the primary site impacts. However, many artifacts, including ceramics, chipped stone, and ground stone, were visible in the road bed, so casual collection activities do not appear to be impacting the site's integrity (Figure 6). The two-track road runs through the eastern midden area associated with the site (Figure 7). During the site visit, assessors recommended diverting the road away from the midden to minimize future impacts to the site. Because the area is relatively flat with few trees, the road running through the site should be blocked and could be rerouted with minimal effort.

**Figure 6. LA 12676B-C is a Coalition period pueblo roomblock; Trail Segment 2B runs through the center of the site (see inset).**

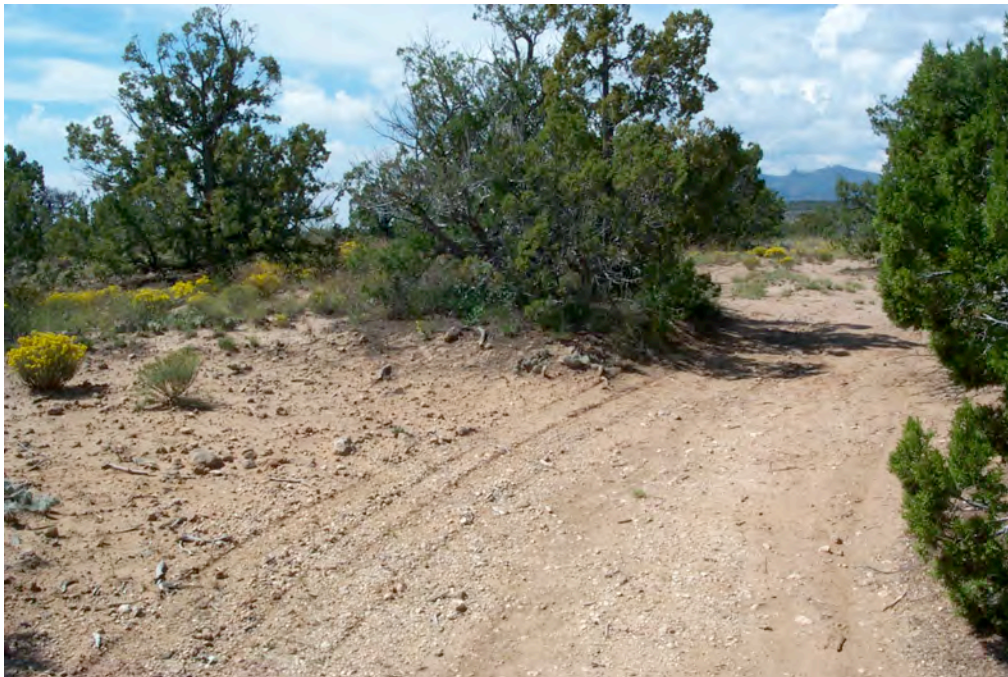
**Figure 7. The eastern midden at LA 12676B-C is bisected by the two-track road.**

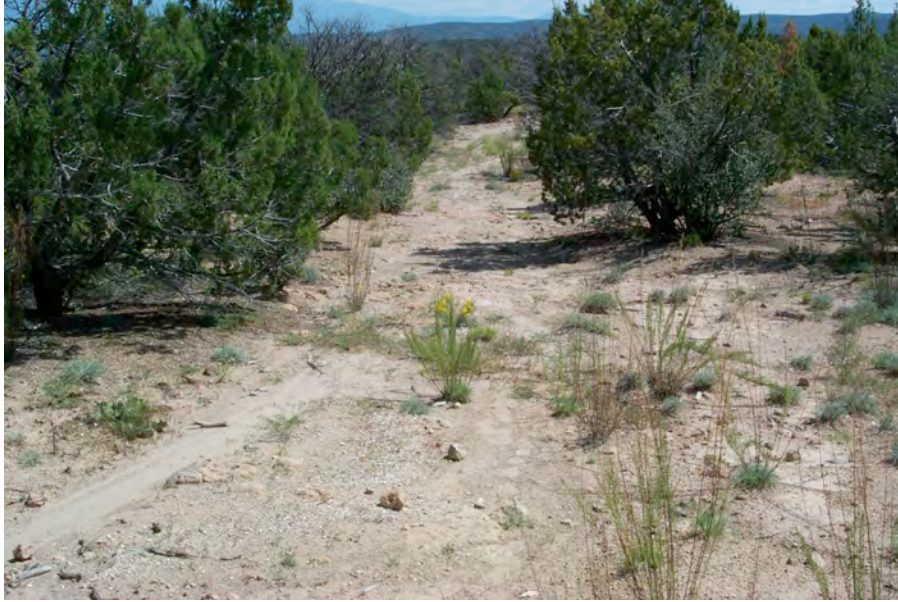
LA 139567 is a Late Archaic lithic scatter bisected by an infrequently used two-track road (Figure 8). The road has formed a channel that runs through the site and there is some modern trash at the site. Assessors recommend closing this portion of the road to prevent future impacts to the site as it does not appear that the road is heavily used.

**Figure 8. LA 139567, two-track road bisects the Late Archaic site.**

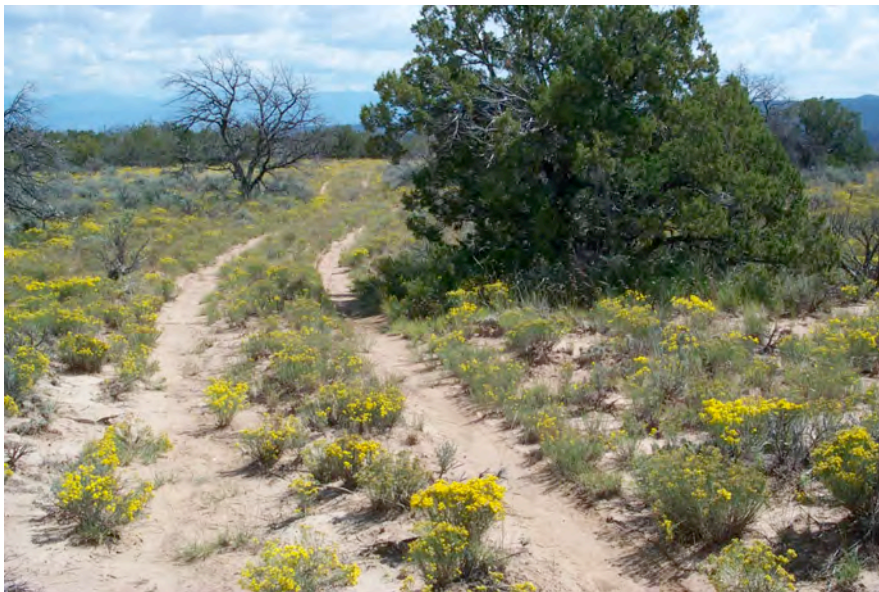
LA 21646 is a lithic and ceramic scatter of undertermined age. A two-track road runs through the site, which is heavily eroded. It appears that vehicles, possibly ATVs, have been driven through the site (Figure 9). There are very few artifacts visible at the site, which may be a result of erosion, collection, or both. Assessors recommend that site protection measures be taken by installing protective fencing, rerouting the road, or posting signs to encourage preservation of the cultural resources characteristic of the area.

**Figure 9. LA 21646, two-track road runs through the artifact scatter.**

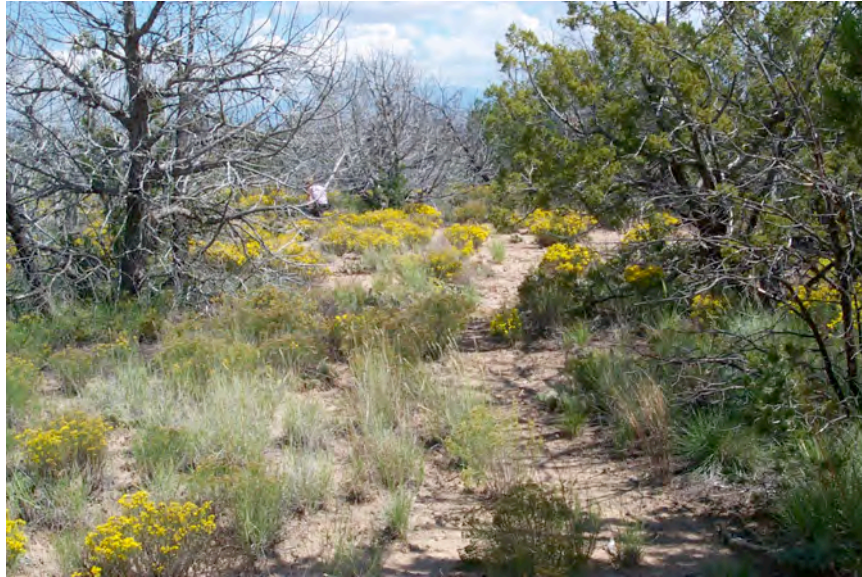
LA 21647 is an Ancestral Pueblo period roomblock impacted by Trail Segment 2B. The trail/road leads up to the site and a trail runs along the southwest side of the site while use of the

**Figure 10. Trail Segment 2B and LA 21647. Trail leads up to site and runs along the southwestern side of the site.**

road is impacting the associated midden (Figure 10). Assessors recommend closing the road before it reaches the site to prevent future impacts to the roomblock and the midden.

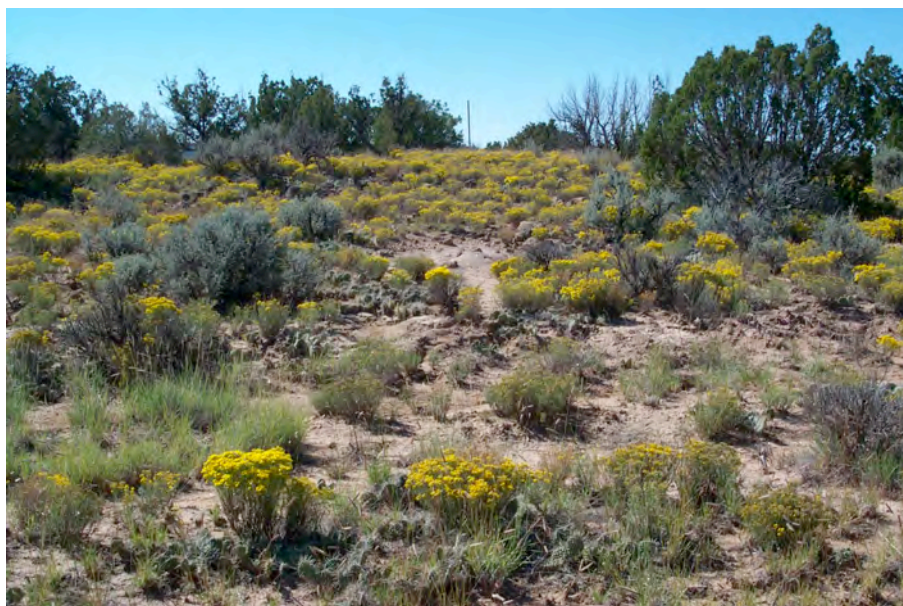
Trail Segment 2C, a two-track road, runs through LA 6786, a Coalition period one- to three-room structure (Figure 11). There are artifacts on the surface of the site, however, not as many as would be expected if the site were less accessible. Some modern trash, including broken glass, was identified at the site. While mild to moderate erosion impacts the site, the structure itself is severely eroded. Erosion controls would benefit the site.

**Figure 11. Trail Segment 2C and LA 6786 trail/road run through the site (road is visible in the bottom of the photograph).**

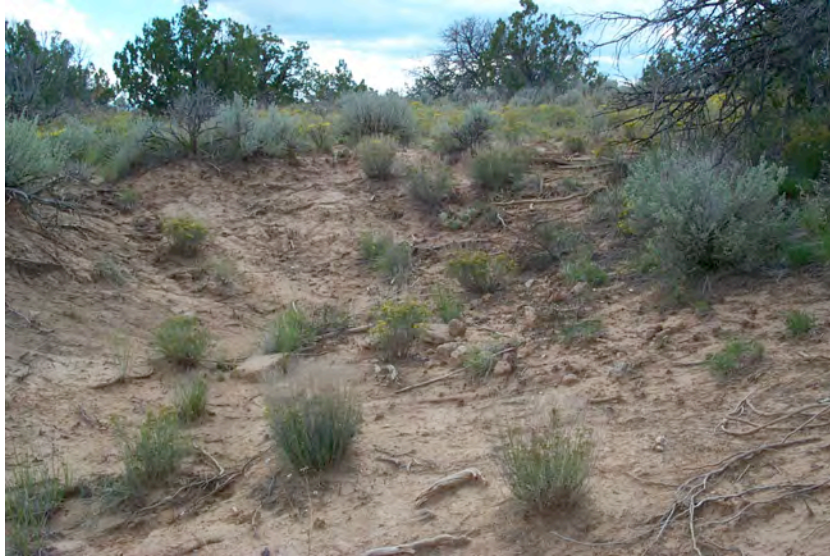
SWEIS 129 is a one- to three-room structure impacted by severe erosion as shown in Figure 12. This site is one of the examples of the extreme erosion that has impacted several sites situated in TA-70, tree roots are exposed and the integrity of the cultural resources in the area has been compromised. While the site is not impacted by the road or Trail Segment 2C, it would benefit from some erosion controls and/or data recovery activities.

**Figure 12. Trail Segment 2C and SWEIS 129, a one- to three-room structure, impacted by severe erosion.**

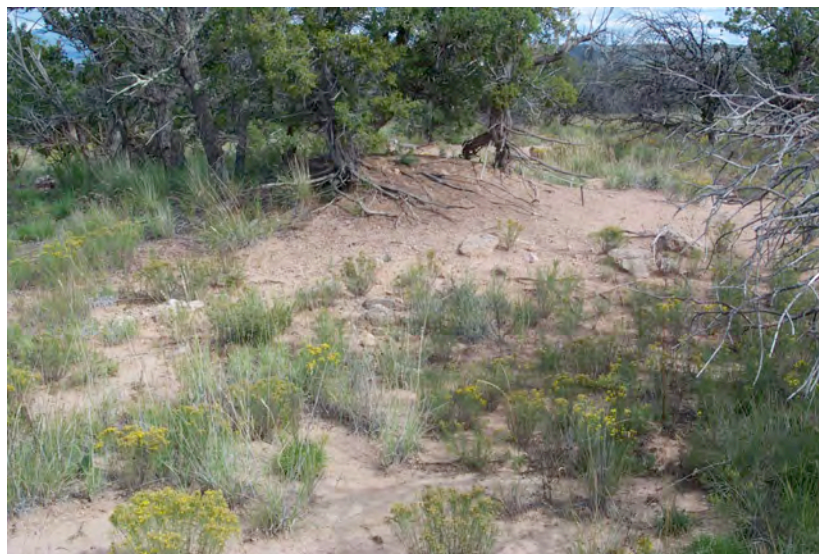
SWEIS 130 is very similar to SWEIS 129, it is a one- to three-room structure situated along Trail Segment 2C that has been, and continues to be, impacted by severe erosion. Erosion controls would likely benefit the site—if any of the trees that have exposed roots fall over they will further damage the site (Figure 13). Assessors also suggest removing the string from the site.

**Figure 13. Trail Segment 2C and SWEIS 130, a one- to three-room room structure, impacted by severe erosion.**

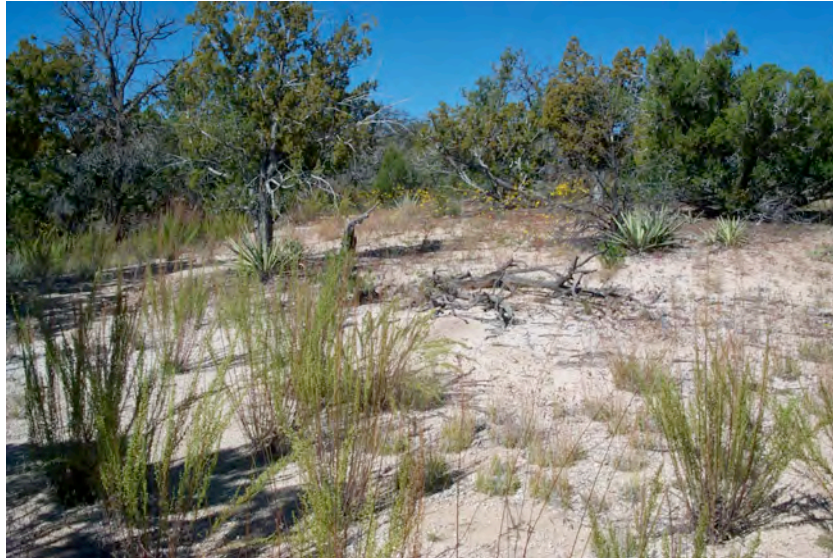
SWEIS 135 is an Archaic lithic scatter that is not impacted by the trail segment or the road, but again has been impacted by severe erosion in the TA-70 area (Figure 14). Assessors note that the erosion identified at this site is not as extreme as at other sites, but will continue to impact site integrity.

**Figure 14. Trail Segment 2C and SWEIS 135, an Archaic lithic scatter, impacted by moderate erosion.**

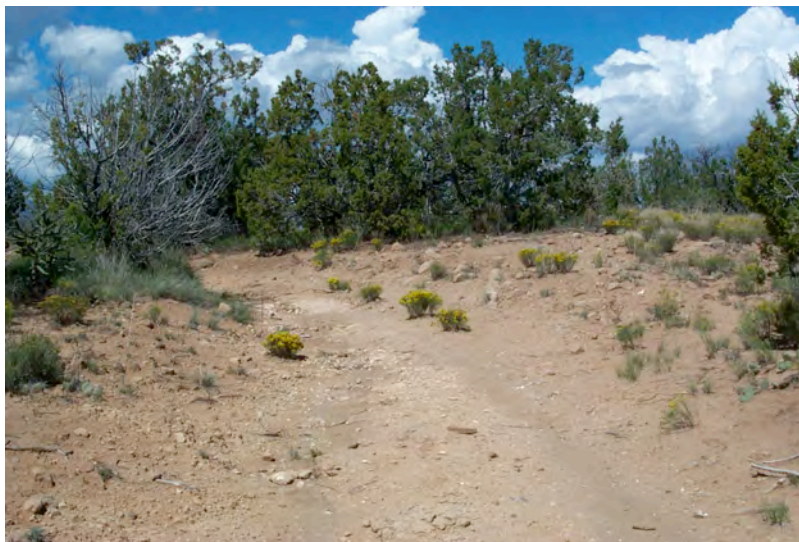
LA 29794 is a Coalition period roomblock situated in an easily accessible area of TA-70 with a trail/two-track road that runs through the site (Figure 15). The site is littered with broken glass and cans and continues to be impacted by the trail/road. Assessors recommend that the trail/road be rerouted with the old road fenced off and some reseeding and other erosion control measures undertaken to protect the site from further damage.

**Figure 15. Trail Segment 3B and LA 29794, a Coalition period roomblock, impacted by recreational trails use and littering.**

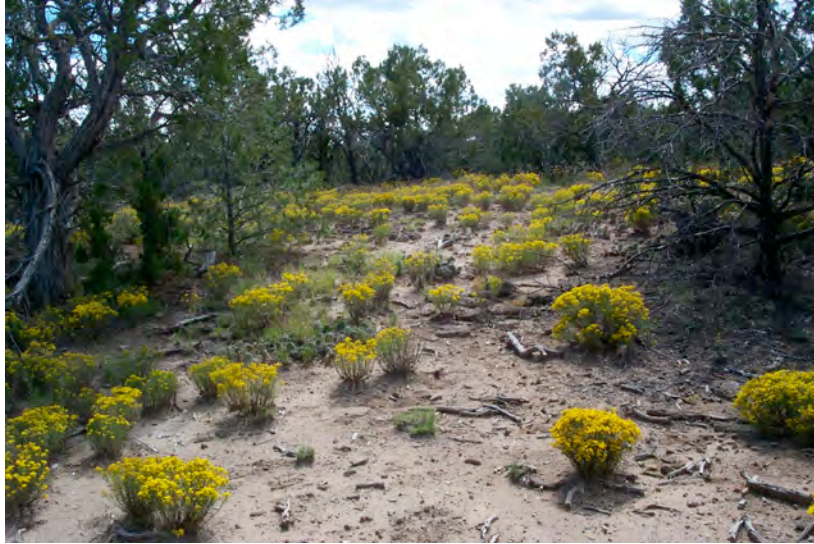
Trail Segment 3B adjacent to LA 29795 is well used, but does not appear to impact the site because it is on bedrock. The site consists of a Coalition period pueblo and an associated midden. However, the proximity of the recreational trail to the site has likely increased casual collection activities, as few artifacts were encountered during the site visit. Erosion is also impacting the site and some erosion controls would benefit this Coalition period pueblo roomblock (Figure 16).

**Figure 16. Trail Segment 3B and LA 29795, a site impacted by erosion and trails use.**

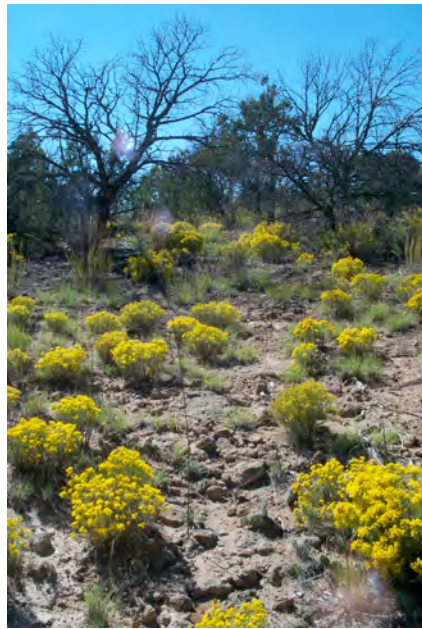
LA 139553 is a Classic period lithic and ceramic scatter that has been subject to severe erosion (Figure 17). Trail Segment 4A does not appear to be impacting the site, but assessors have recommended erosion controls at the site.

**Figure 17. Trail Segment 4A and LA 139553, a Classic period lithic and ceramic scatter, impacted by severe erosion.**

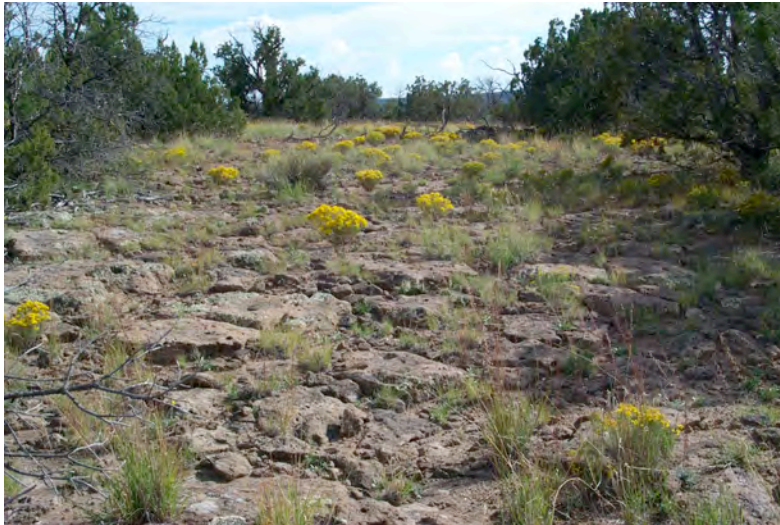
LA 29788 was identified as a Coalition period lithic and ceramic scatter situated on bedrock within the vicinity of Trail Segment 4B (Figure 18). The lack of deposits within the site area caused assessors to question the accuracy of the site characterization. It is possible that all of the artifacts initially associated with the site have been collected; however, assessors recommend an additional site visit to determine whether or not the site is eligible.

**Figure 18. Trail Segment 4B and LA 29788, a Coalition period lithic and ceramic scatter, impacted by erosion and possible collection activities.**

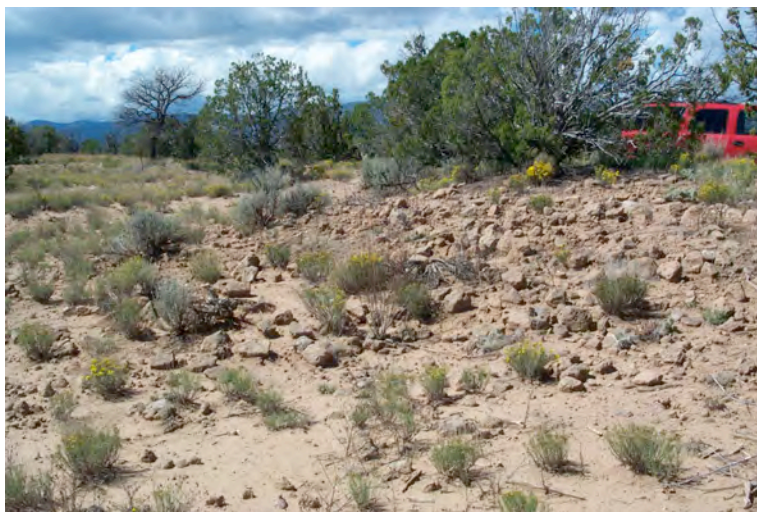
LA 29789 is a Coalition period pueblo roomblock and is impacted by the two-track road/trail that bisects the site (Figure 19). There are artifacts scattered throughout the surface of the site. There is some evidence of looting at the site, although not to the same degree that is evidenced at other sites situated within TA-70. Broken glass was also identified during the site visit. Assessors recommend data collection and rerouting the road/trail away from the site, as it appears to promote erosion, artifact collection, and littering.

**Figure 19. Trail Segment 3 and LA 29789, a Coalition period roomblock, impacted by trails use, a road that runs through the site, possible looting, and littering.**

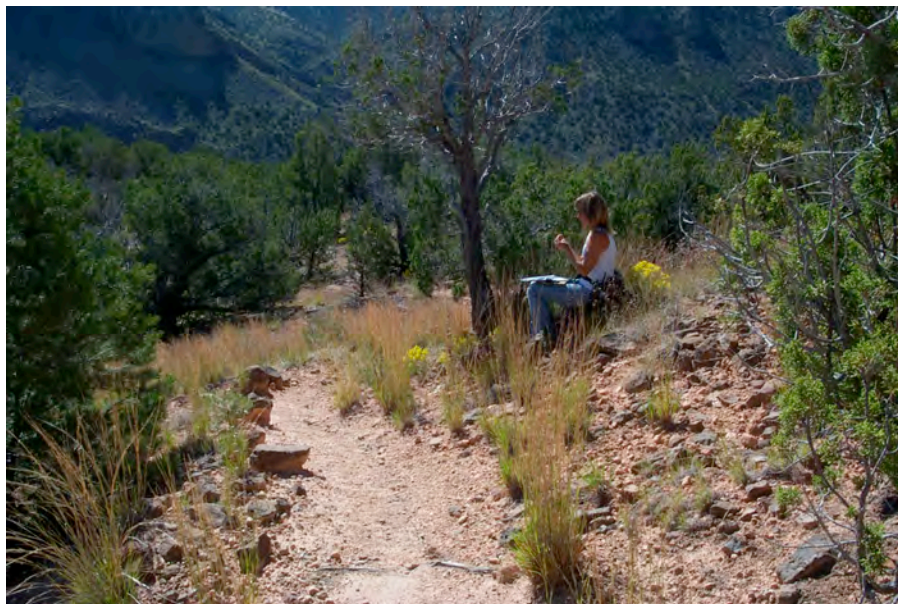
LA 29791 was identified as an undetermined Ancestral Pueblo lithic scatter. Trail Segment 4B runs through the site (Figure 20). No artifacts were encountered during this site visit and assessors recommend that this site be removed from the cultural resources database and/or listed as ineligible.

**Figure 20. Trail Segment 4B and LA 29791, an undetermined lithic scatter.**

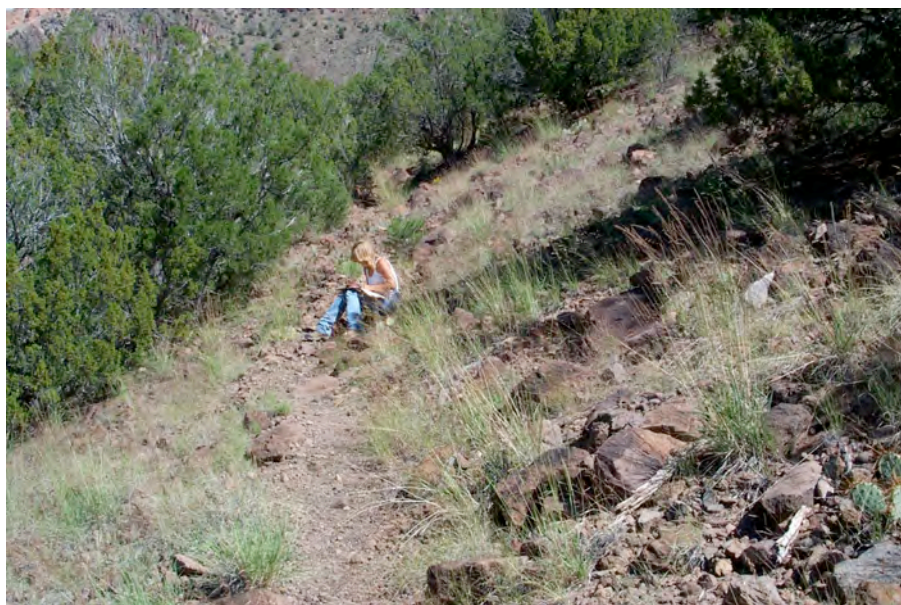
LA 29792 was identified as an undetermined Ancestral Pueblo lithic and ceramic scatter. Trail Segment 4B runs through the center of the site (Figure 21). Assessors found that the sixty percent slope of the location and one hundred percent collection of the site's artifacts by the PARP make the site questionable and suggest removal from the database.

**Figure 21. S. Sherwood sits on Trail Segment 4B in the center of LA 29792.**

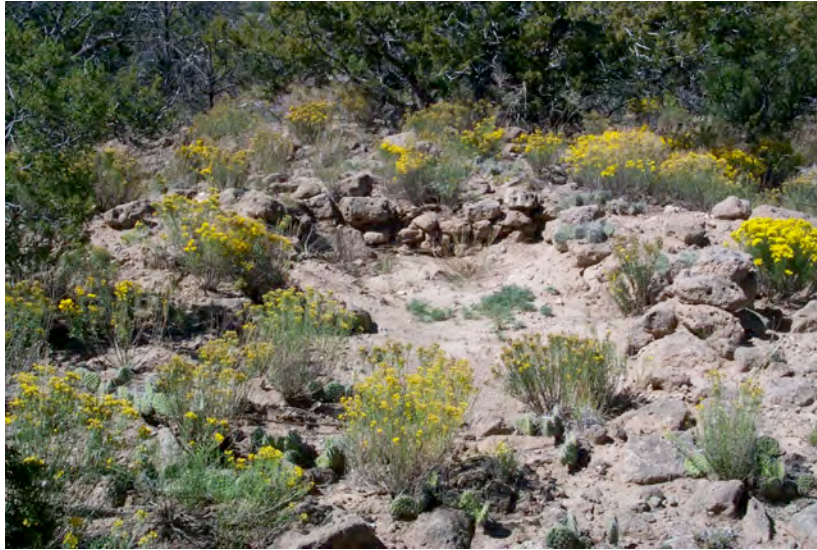
LA 139486 is an Ancestral Pueblo roomblock that has been subject to extensive looting within the last couple of years (Figure 22). A tree has recently fallen into the center of the rubble mound. There are artifacts present on the surface of the site, but recent looter's pits and evidence of other collection activities suggest that the site has been impacted because of its accessibility and characteristics. Assessors recommend string removal and rerouting of the trail away from the site and some revegetation of the area to increase site protection.

**Figure 22. Trail Segment 5C and Ancestral Pueblo roomblock LA 139486. The site has been subject to extensive looting. Recreational trails use has impacted this site.**

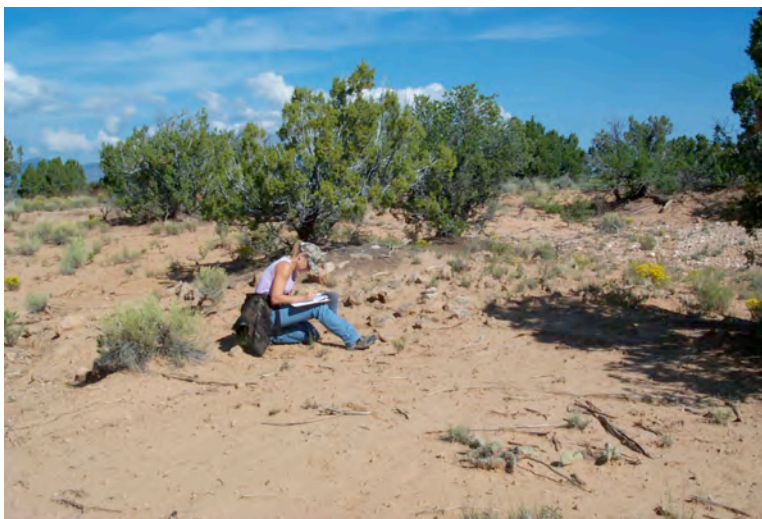
LA 139500 is a one- to three-room structure that has been impacted by severe erosion more than any other activity (Figure 23). The site is adjacent to LA 12677, another one- to three-room structure. The trail leading to the site is not well used and is not visible any longer as a result of the erosion. Assessors recommended removal of the remaining string at the site.

**Figure 23. Power Line Segment 1 SW and a one- to three-room structure (LA 139500) impacted by severe erosion.**
