**Maritime Museum Building**  
**Limited Scope Historic Structure Report**

San Francisco Maritime National Historical Park  
San Francisco, California

National Park Service Contract Number 1443-CX-2000-98-016

Drawing Number 641-41133

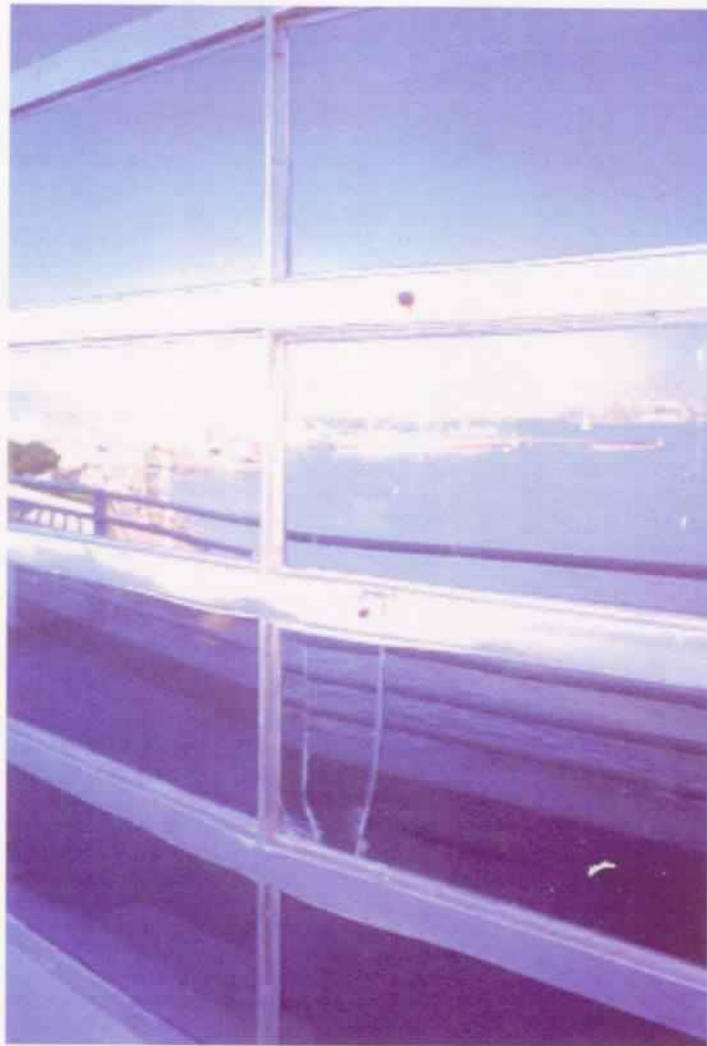
The deterioration of the stainless steel-clad windows is widespread across all facades but is most severe on the north elevation. There are several symptoms of the deterioration. The most obvious exterior condition is warping and displacement of the stainless steel glazing stops. (See **Appendix B, Figure 11**). There are also many panes of broken glass throughout the stainless steel-clad window wall system. The cracking of the window glass and displacement of the stainless steel cladding is caused by the expansion of the underlying steel frames. Deterioration of the steel window frame is indicated by the amount of oxidation stains on nearly all of the horizontal stainless steel cladding members of the building.

The deterioration observed at the window walls systems is due to deterioration and failure of the original glazing detail. When originally glazed, each pane of glass was set in caulk within the glazing pocket. The stainless steel cladding was then installed to cover the exposed steel framing members with the edge of the cladding stopping just short of the glass. The glazing detail was completed by the installation of the stainless steel stops secured to the steel window frame. The stops were also set in caulk. This is a typical glazing detail for the period of the building's construction and it worked well until the original caulk dried out over the years, shrinking and cracking creating voids for the intrusion of moisture. Over time, the intrusion of water has caused widespread deterioration of the underlying steel frames in nearly all of the window wall units. Moisture coming through the openings created by the failed caulk was trapped in the system, especially at the horizontal mullions, causing the steel frame to oxidize and expand, cracking the glass lights, warping the glazing stops, causing rust stains on adjacent materials, and damaging interior finishes. (See **Appendix B, Figure 12**).

*Figure 5. Stainless steel-clad windows on the north elevation of the third floor. Note the displaced condition of the stainless steel and cracked window lights.*

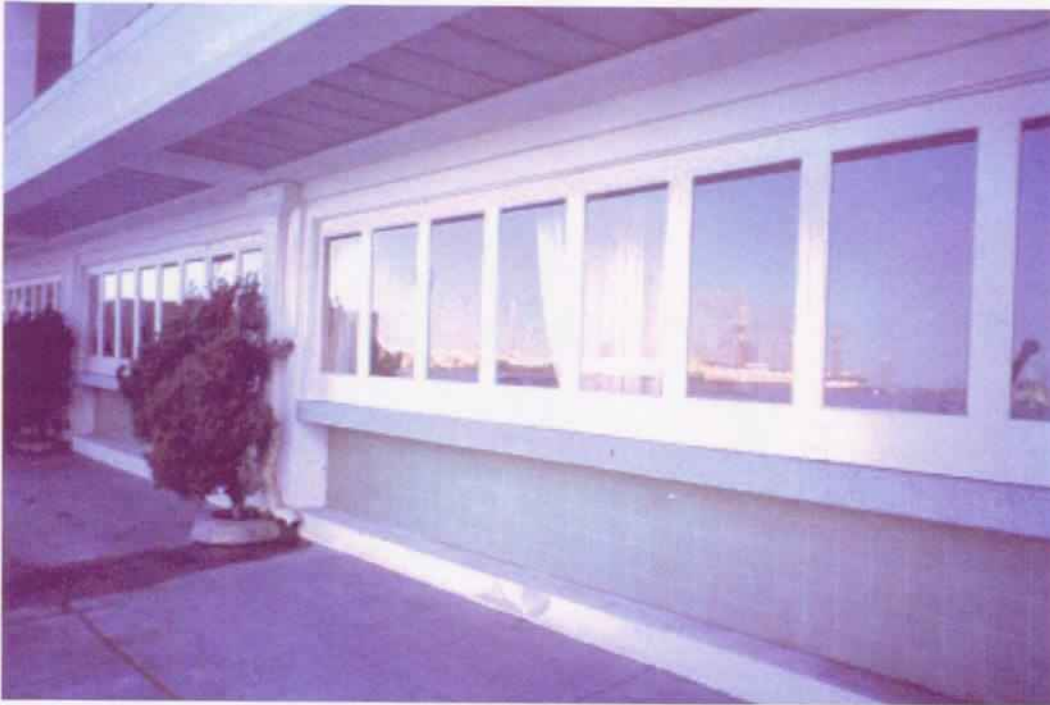
*Figure 10. Series of wood bifold windows on the first floor, north elevation, at the former concession area. These windows are in good condition and require only minor repair.*

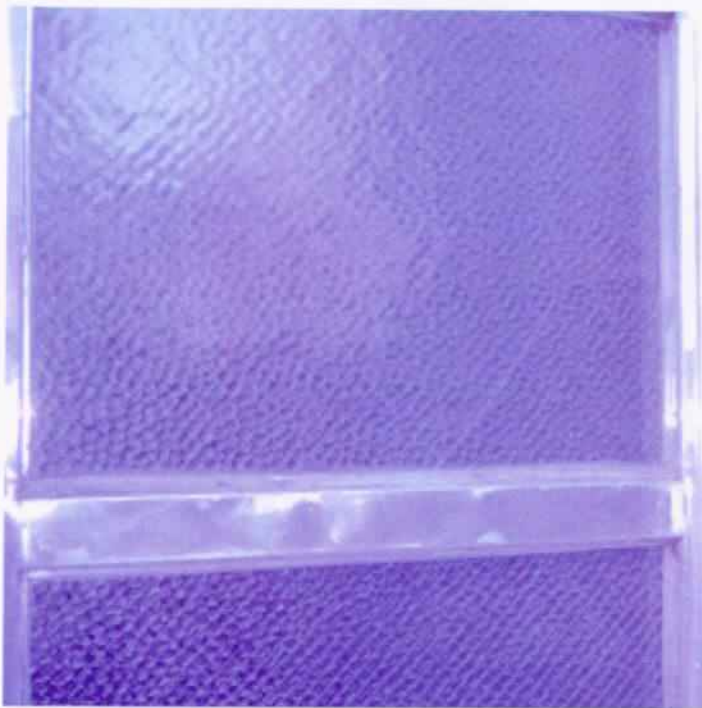
*Figure 11. Horizontal mullion at stainless steel-clad first floor windows. Deterioration of the sealant, visible here at the left side of the mullion, allows water to enter the window system, corroding the steel armature and displacing the cladding.*

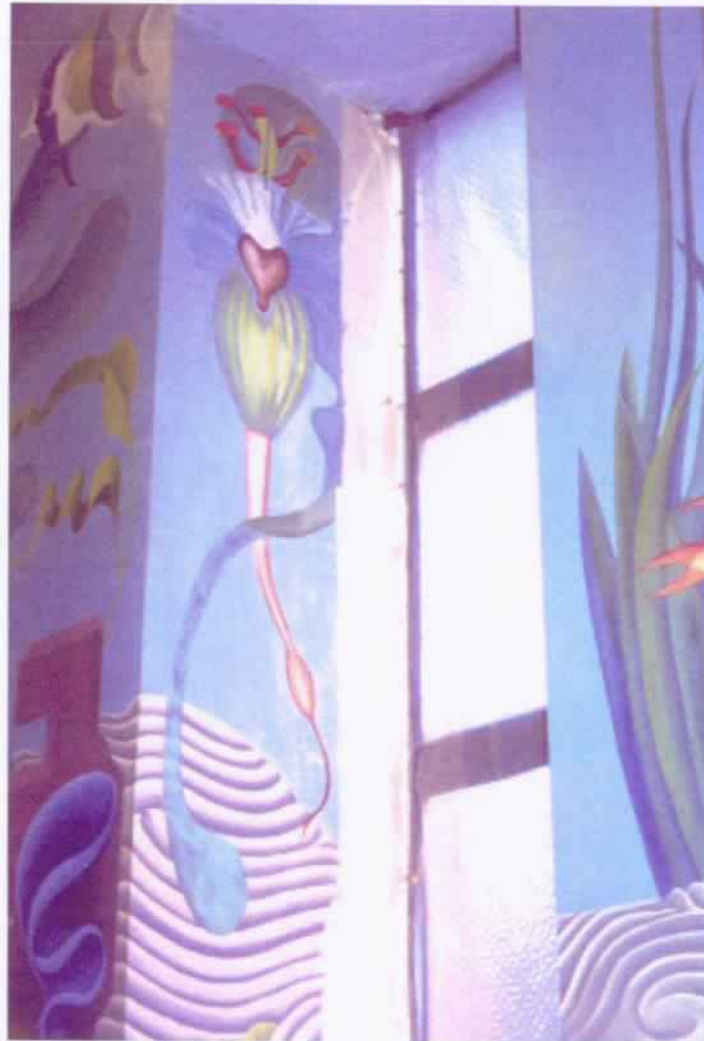
*Figure 12. Second floor mural at the return of a window opening showing damage to the mural due to water intrusion at the window.*

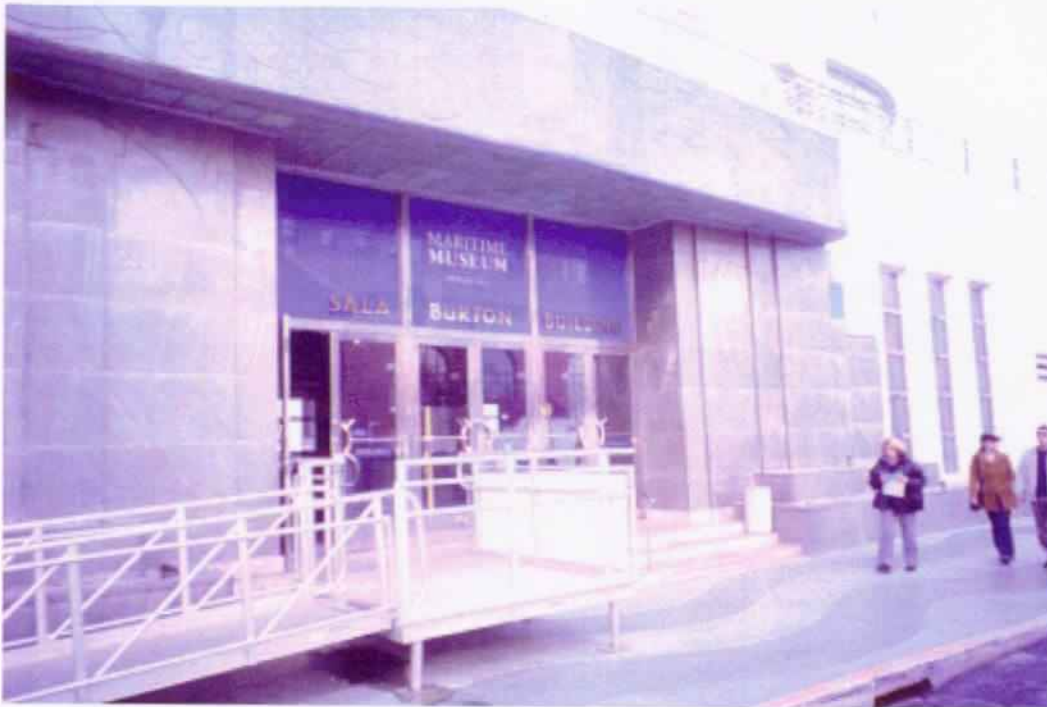
*Figure 13. Stainless steel doors and transom windows at the main entrance to the Maritime Museum. These doors and windows and the original ship wheel hardware are in good condition.*

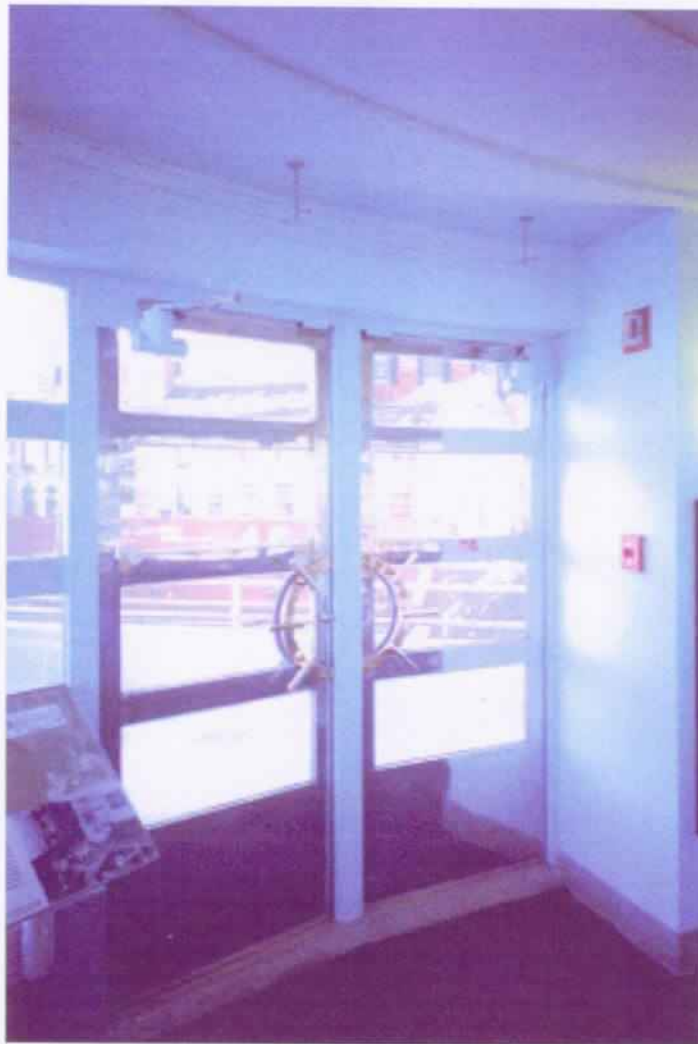
*Figure 14. Stainless steel doors at the fourth floor penthouse from the interior. These doors, exposed to severe weather conditions, are in poor condition.*

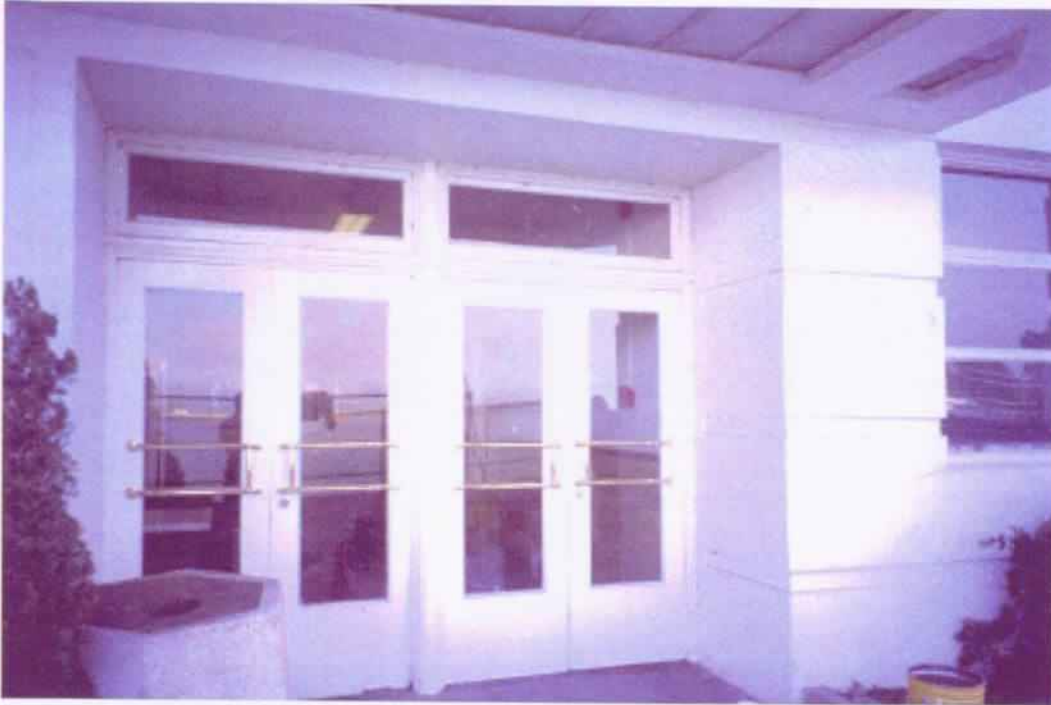
*Figure 16. Set of double wood doors at the first floor, north elevation. These doors are in good condition.*

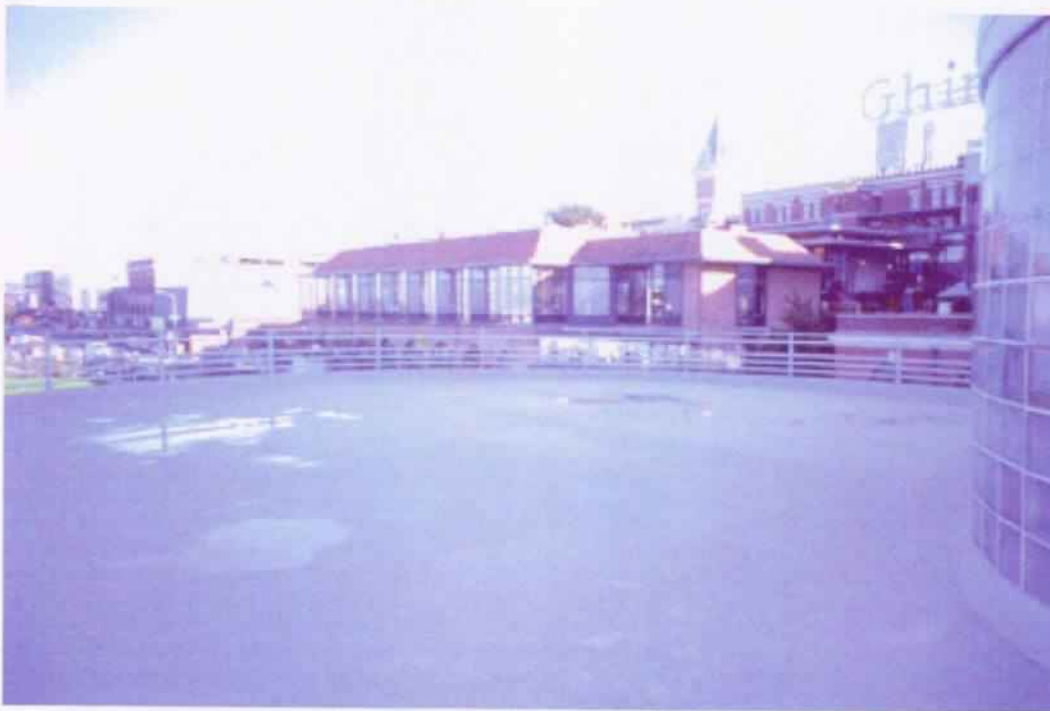
*Figure 17. Third floor observation deck roof. Water tends to pond on the flat roofs after heavy rain.*

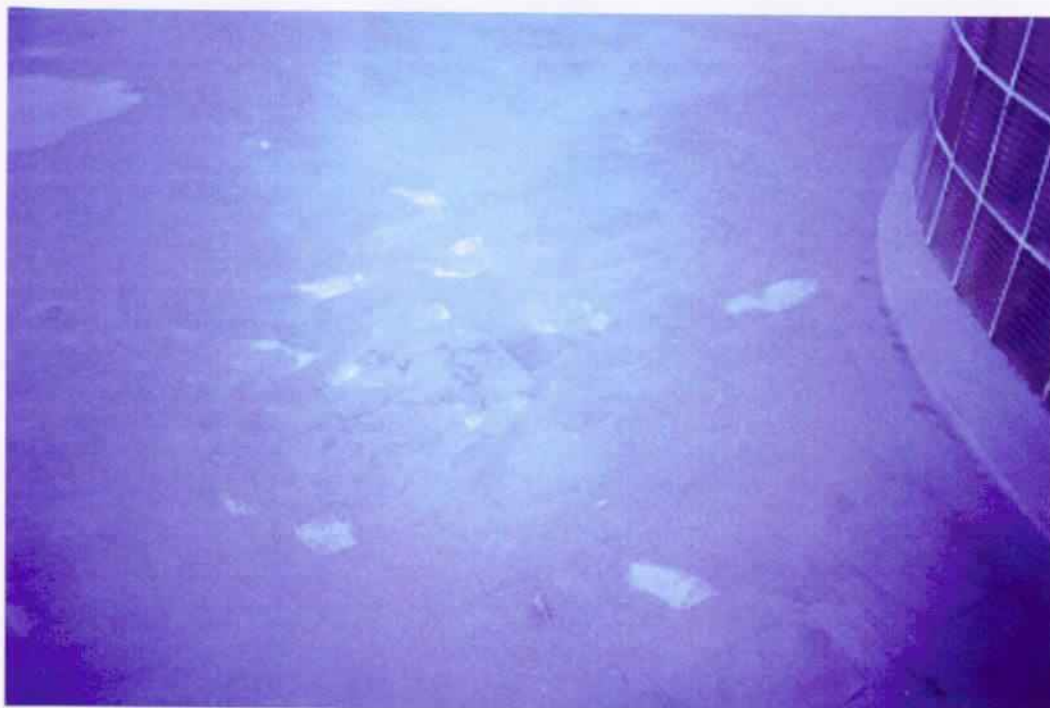
*Figure 18. Waterproofing coatings have been applied over the original roof deck. These coatings are showing signs of deterioration and are continuously repaired. The pattern of the original fired clay tile roof pavers is visible underneath the waterproofing membrane.*

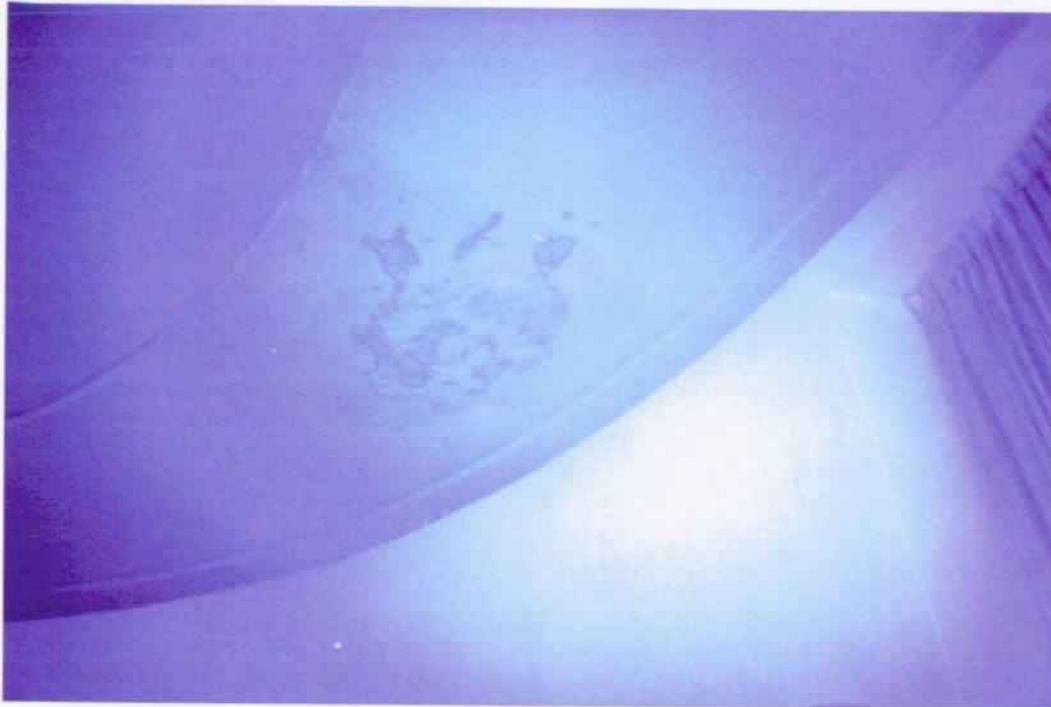
*Figure 19. Water staining on the ceiling of the east recreation room on the second floor. This staining is indicative of water leaks through the building's roof decks.*

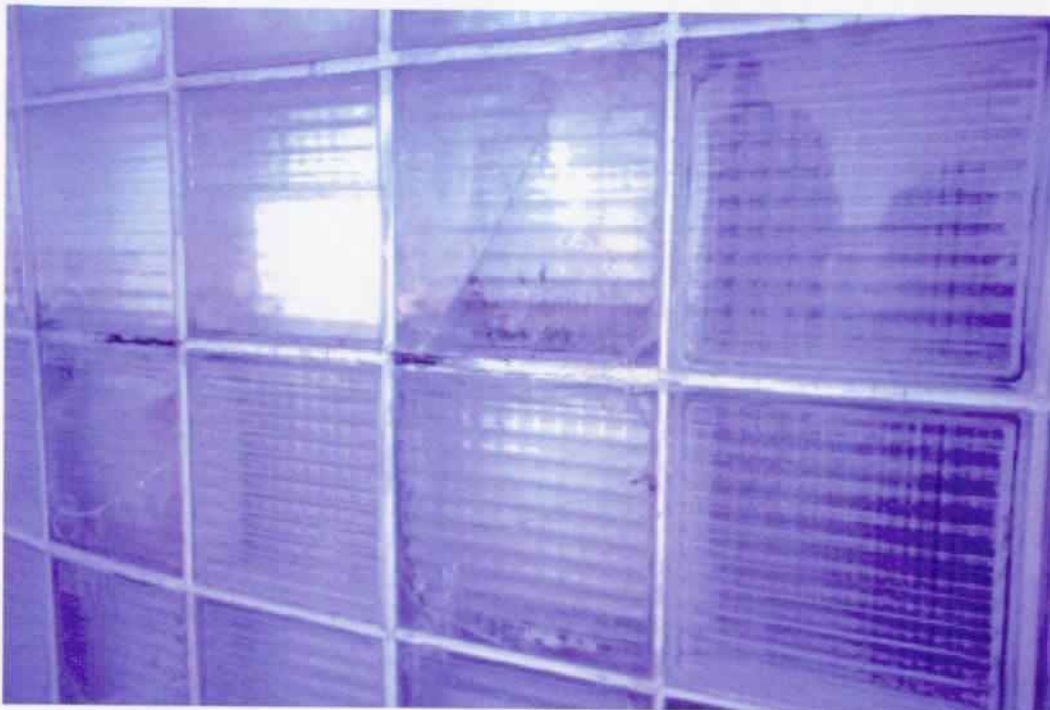
*Figure 21. Glass block units in the third floor pantry. Mortar deterioration, cracking of the units, and collecting of water inside the blocks are common.*

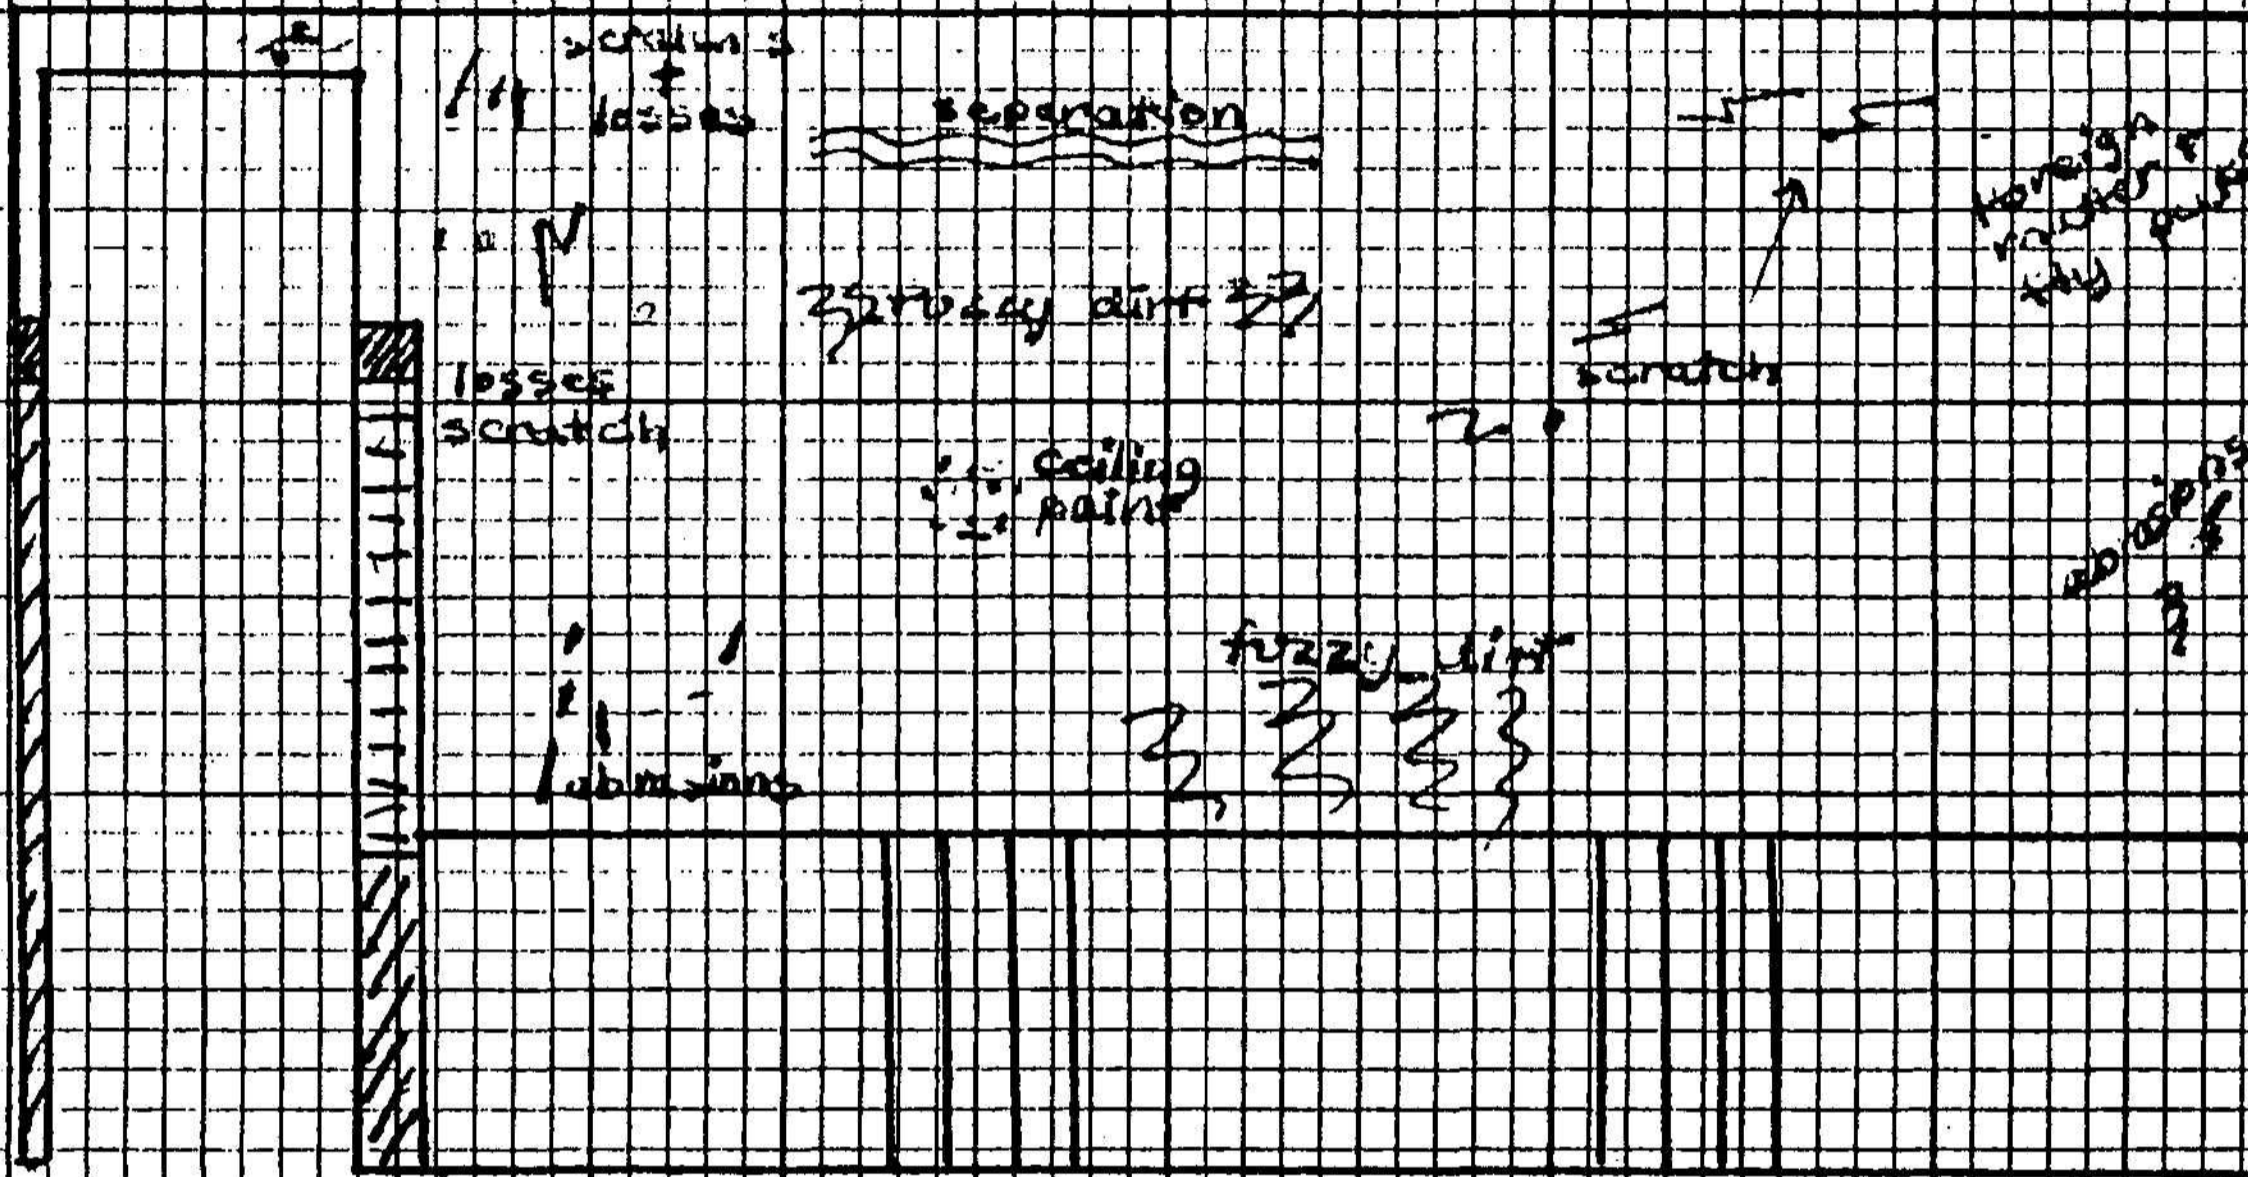
location: Maritime Museum, first floor

abrasion/scratches

scattered losses
