U.S. Department of Labor

06AA23(e)

Evaluation of Possible Lightning Damage to Gas Wells and
Evaluation of Lightning Strike Locations near Wolf Run Coal
Company, Sago Mine, MSHA I. D. No. 46-08791

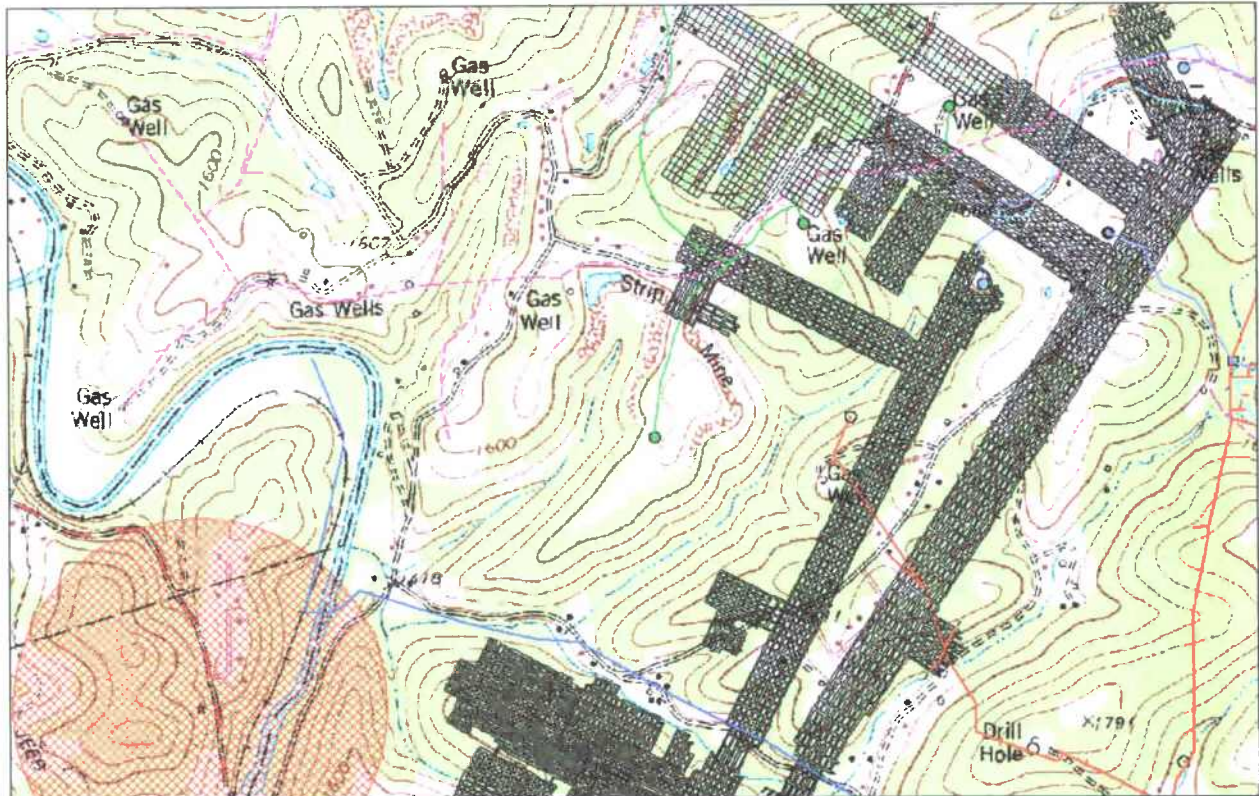
6:26:35 a.m. strike location and passed current along the buried metal gas line, traveling approximately two miles to the cased gas well adjacent to the abandoned 2nd Left section, subsequently igniting methane in the sealed area (Figure 1). The obvious limitation on this evaluation is that over seven months of snow, rain, and vegetation growth could have obscured or obliterated physical evidence of a January lightning strike.

Figure 1. Red star at center of red crosshatch area (highlighting 500-meter 50% confidence interval) indicates position of 101 kA lightning strike reported by Vaisala at 6:26:35 a.m., January 2, 2006. Dashed purple lines represent buried metal gas lines owned by Keyspan. Red, blue, and green lines represent gas lines owned by other companies. Active gas well located on promontory 2,800 feet north-northwest of lightning strike is serviced by purple dashed Keyspan line, which runs approximately two miles east past gas well (light blue dot) that is adjacent to abandoned 2nd Left area.

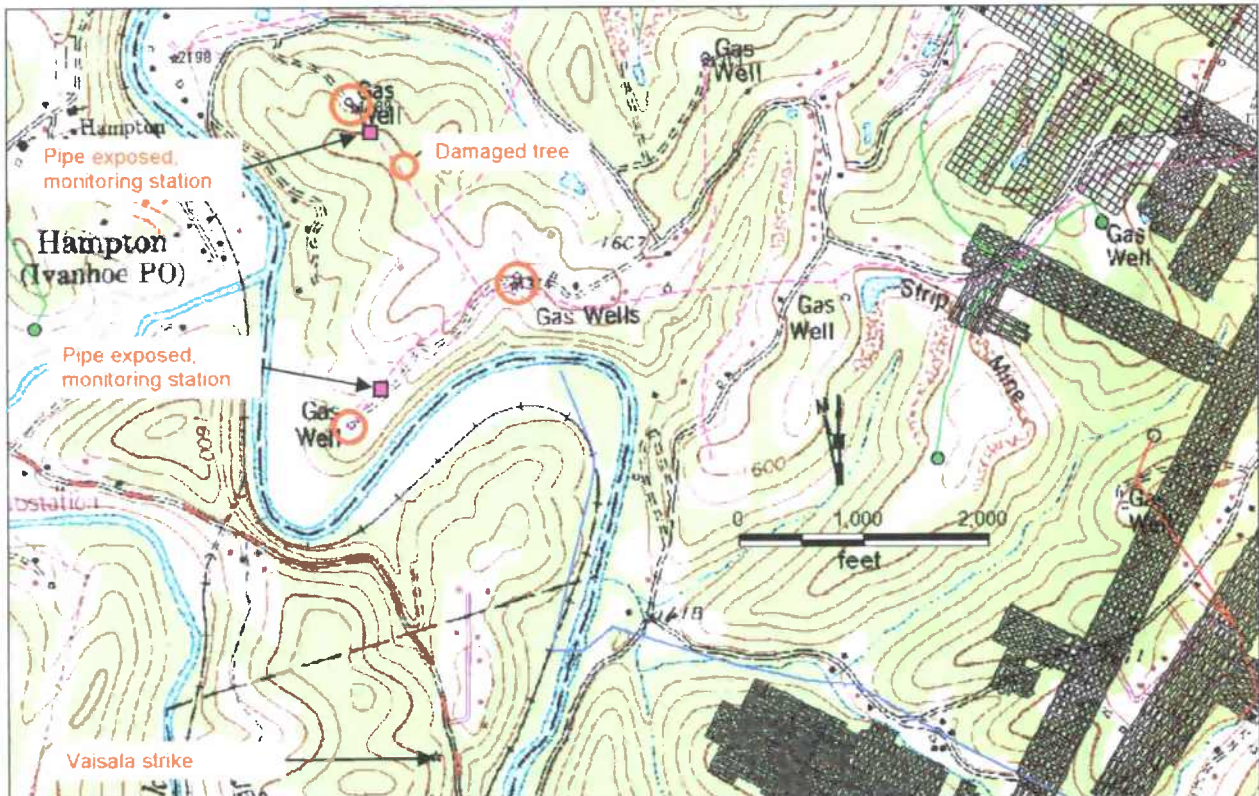
Observations began at the well located 2,800 feet north-northwest of the lightning strike recorded by Vaisala at 6:26:35 a.m. on January 2, 2006 (Figure 2). No visible damage that might be expected of high heat flow such as searing, discolored metal, or molten/beaded metal was apparent at the gas well, exposed piping, or holding tank (Figure 3). The surrounding area in an approximately 200-foot radius was visually inspected for damaged trees or fulgurite formation (glass formed from melted and recrystallized soil or rock as a result of a lightning strike). No obvious lightning damage to trees was apparent, although some small, dead trees were shedding bark. Additionally, a number of trees, identified as sycamore trees by the mine engineer, were shedding thin sheets of bark, although this appeared to be a common occurrence for

this kind of tree because several in different parts of the observed area were in the same condition. No areas of glassy sand or soil, or holes that might indicate the presence of a fulgurite were noted in the surrounding ground. The ground along the trend of the buried metal gas line was scrutinized for similar possible effects of lightning, but no scarred, scorched, or glassy patches of ground were noted along the length of buried pipe until it connected with the exposed monitoring station approximately 300 feet northeast of the well (Figure 2).

Figure 2. Gas wells (circled red) visited for this evaluation. Purple boxes represent monitoring stations for gas wells where metal gas lines are exposed at surface. A damaged tree was observed along the trend of a connecting gas line (purple dashed line), but appeared to be old damage. No lightning strike was reported at this location on January 2, 2006.

Observations continued along a dirt farm road (shown as a double dashed line on the topographic map), which followed the trend of the buried Keyspan gas line, until connecting with another gas well approximately 1,800 feet northeast of the initial Keyspan well (Figure 2). No evidence of lightning damage was observed at this location, either to the metal well, tank, or piping, or to the surrounding trees or ground. Similarly, no obvious damage such as scorched ground, fulgurite formation, or damaged trees was observed along the length of the buried gas line between the two wells.

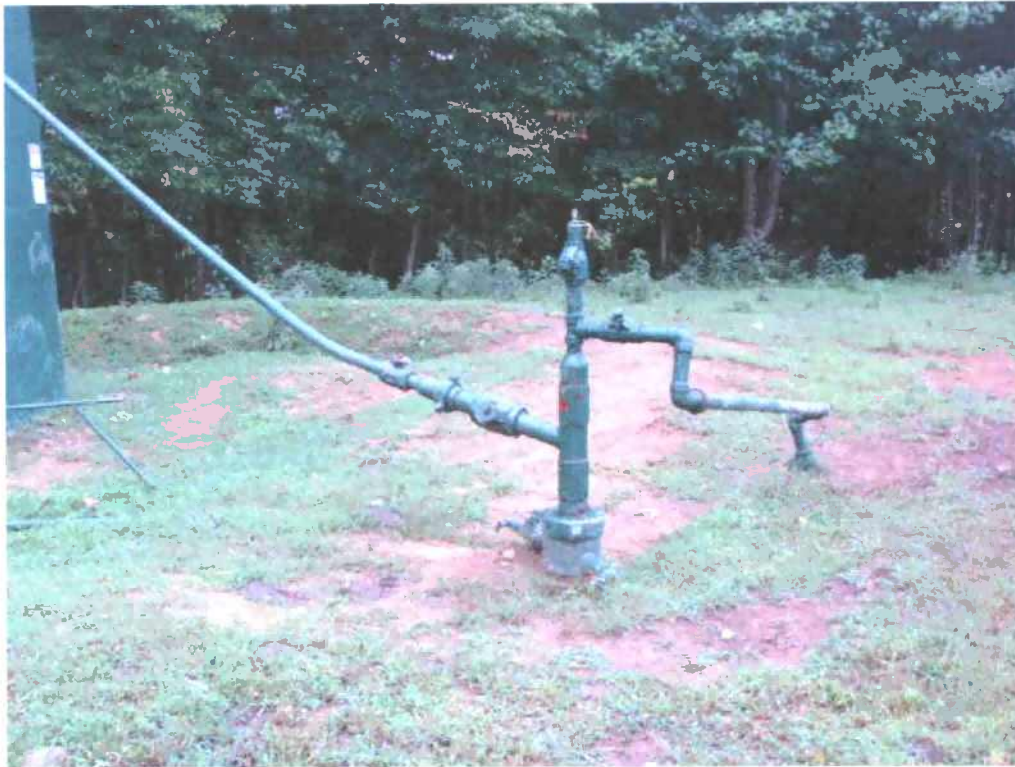
Figure 3. Keyspan well located 2,800 feet north-northwest of 6:26:35 a.m. Vaisala lightning strike location that shattered a large tree. Well is serviced by an approximate 3-inch diameter metal pipe that is buried until exposed at a monitoring station 300 feet to the northeast. No evidence of lightning damage was apparent to the metal, or the surrounding trees and ground.

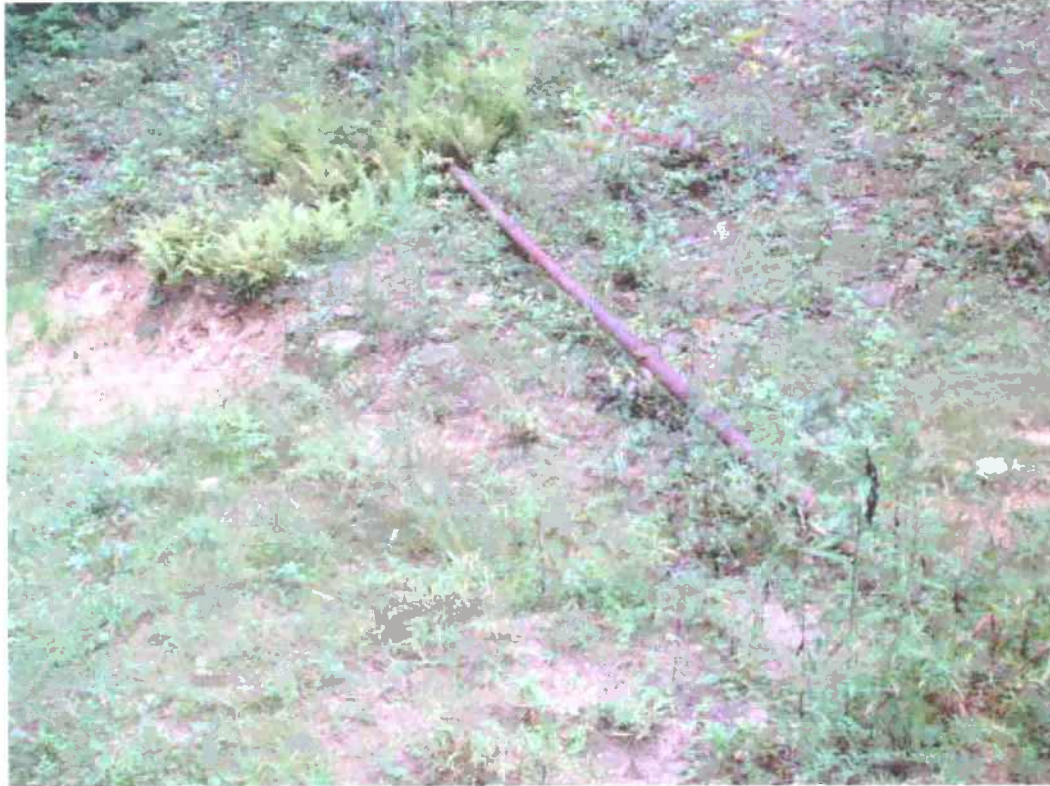
Observations continued on the north side of the hill, where a third Keyspan well was located approximately 2,600 feet Due North of the first well visited, and serviced by a metal pipe from a spur that ties into the line the connects the first two wells (Figure 2). This well did not have an exposed surface tank, although a buried metal pipe trended from the well to a monitoring station approximately 200 feet up the hill slope, where the gas line was exposed. Surface erosion had exposed the rusted metal pipe, which is believed to represent the active gas line (Figure 4). The observation traverse continued up-hill along the trend of the gas line, past the exposed monitoring station, to the top of the hill approximately 600 feet southeast of the well. At the crown of the hilltop, within approximately 50 feet of the buried gas line, a damaged tree was located that appeared to exhibit the effects of a lightning strike (Figures 2 and 5). The damaged tree appeared to represent either an old lightning strike or some other storm damage, although the age of the tree's damage is unknown. The tree was characterized by two forks, one of which was vertical, with a papery, rotten texture pock-marked with insect or bird holes and sloughed-off bark. The other fork was composed of solid but splintered wood, and had fallen to the ground along a cantilever hinge. The wood was weathered brown and appeared to represent an old event, although the age could not be determined.

Figure 4. Rusted metal gas line exposed by erosion in slope adjacent to third Keyspan gas well visited, located approximately 2,600 feet Due North of the first well. Gas line trends from well to monitoring station approximately 200 feet southeast, and then continues underground to tie in with line that connects first two wells visited (compare to Figures 1 and 2).

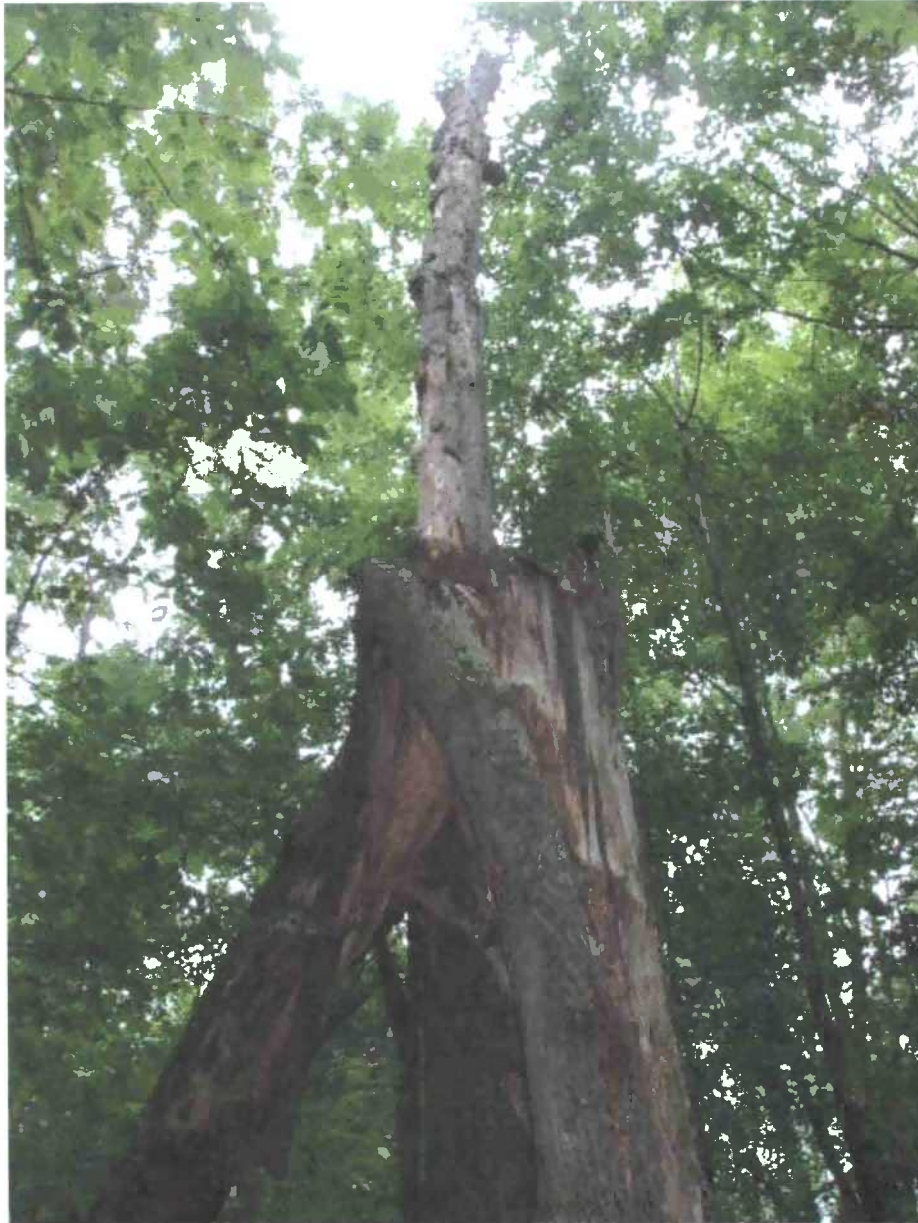
Figure 5. Tree along trend of buried metal gas line on hilltop approximately 4,600 feet Due North of 6:26:35 a.m. Vaisala strike location suggests damage by storm or lightning. Unlike the shattered poplar tree near the 6:26:35 a.m. strike location determined by Vaisala's NLDN, this tree did not exhibit blown-off shards or slivers of wood. The age of the damage is unknown. Compare to Figures 1 and 2 for perspective.

No obvious, physical evidence of damage to the metal well heads or gas lines was observed. Additionally, no obvious damage to the ground was observed in the vicinity of the wells or along the length of buried metal lines. The only tree damage observed was located near a buried metal gas line on a hilltop approximately 4,600 feet north of

the recorded 101 kA 6:26:35 a.m. Vaisala strike (-80.2331° E/38.926° N). The time of this tree damage is unknown, though neither lightning detection network plots a strike at this location. The only other tree damage in the vicinity of the gas wells was represented by sycamore trees shedding bark, and this appears to be a natural occurrence.

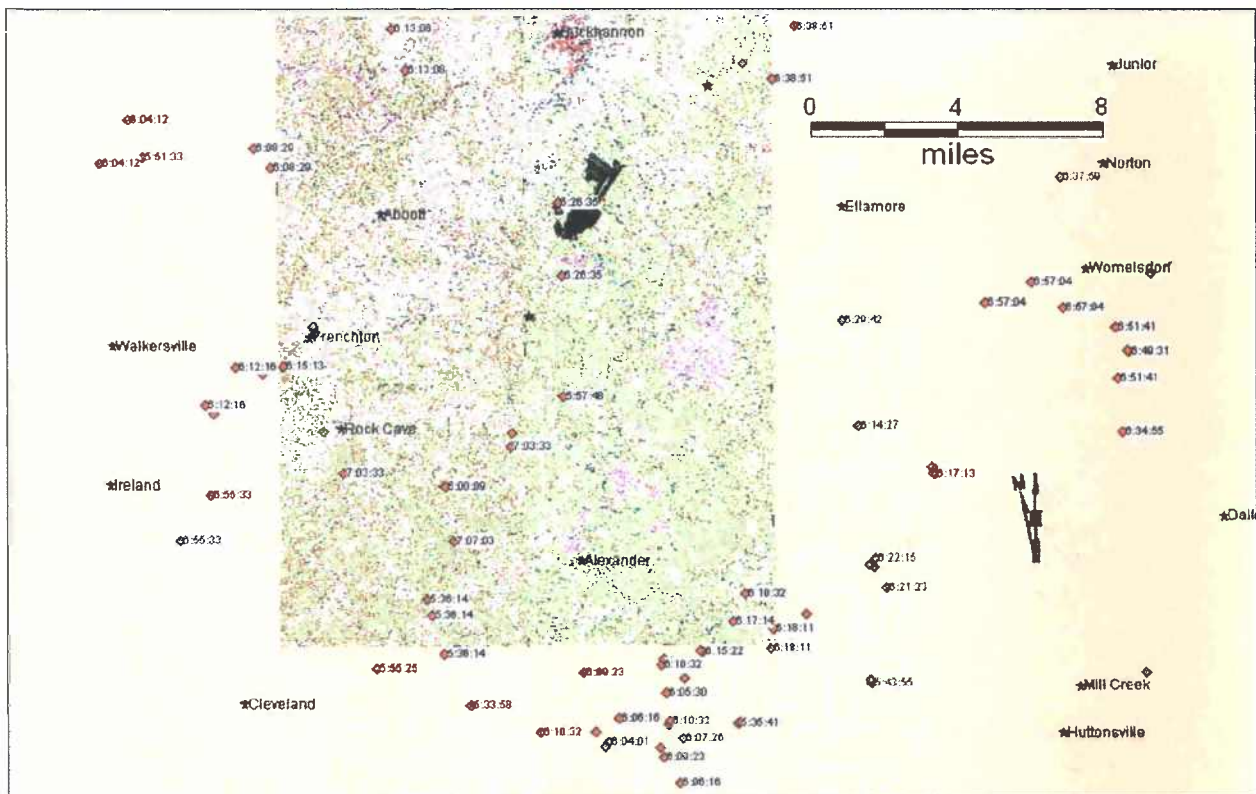
Figure 6 shows the locations of cloud-to-ground strikes recorded by Vaisala within approximately 15 miles of the abandoned 2nd Left explosion area during the time between 4:00 a.m. and 7:15 a.m. on January 2, 2006. The location points are labeled with the time of the strike, as determined by Vaisala. Of all the lightning strikes recorded during this time frame, only two, both at 6:26:35 a.m., occur anywhere near the vicinity (within six miles) of the explosion site in 2nd Left. A cluster of three strikes located between approximately 4.5-6.25 miles northeast of the abandoned 2nd Left area occurred 12 minutes after the inferred time of the explosion, at 6:38:51 a.m. The next nearest lightning strikes are located approximately 6.5 miles to the south and northwest, but from between approximately 15-30 minutes before the explosion. The strike recorded at 5:57:48 a.m. occurred within ½ mile of a power line that connects to the mine, and is located approximately 4.4 miles south of the mine portal. It is interesting to note that there are several examples of clusters of strike locations that occur at the same time, but are separated by distances of between 0.3-2 miles.

Figure 6. Location of Sago Mine on topographic background, with plotted locations of lightning strikes recorded by Vaisala's NLDN system between 4:00 a.m. and 7:15 a.m. on January 2, 2006 within 15 miles of the 2nd Left explosion site.

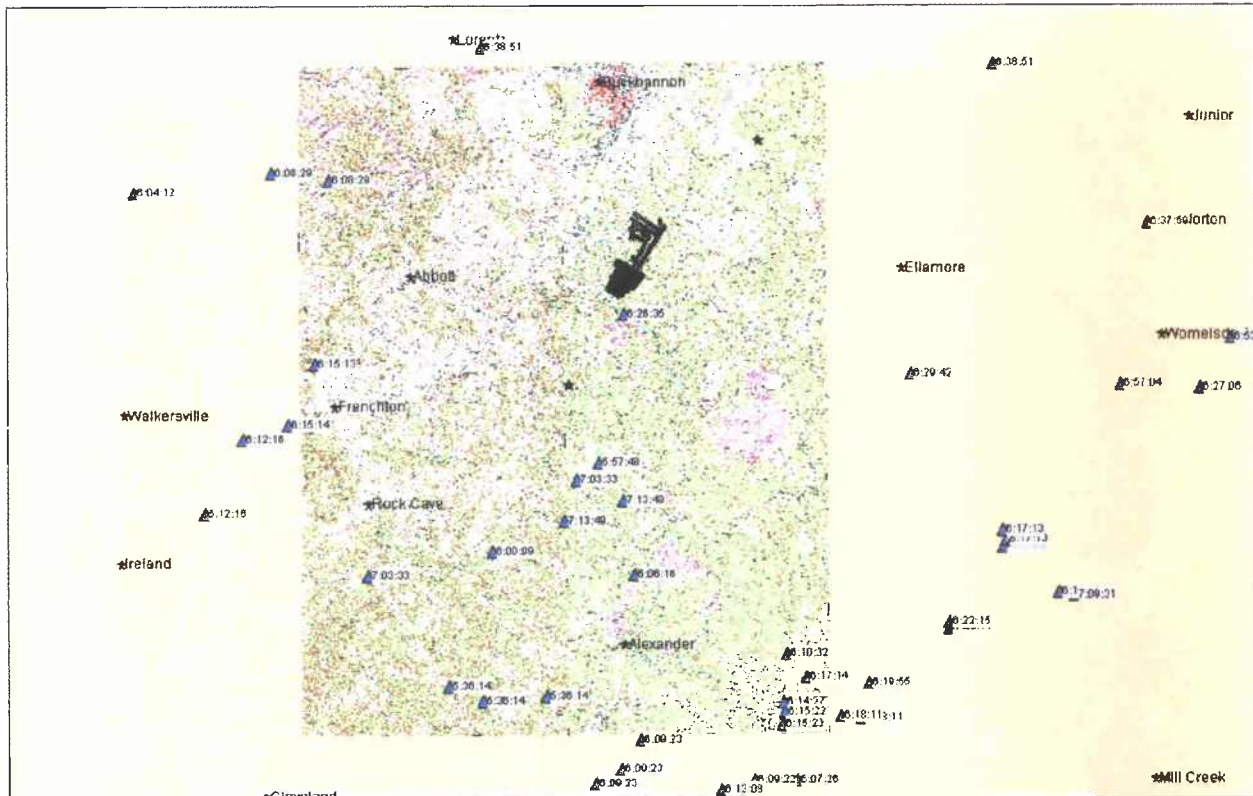
Figure 7 shows the locations of cloud-to-ground lightning strikes determined by Weather Decision Technologies, Inc.'s U. S. Precision Lightning Network (USPLN) within approximately 15 miles of the abandoned 2nd Left area during the time frame between 5:30 a.m. and 7:15 a.m. on January 2, 2006. It appears that, similarly to the data reported by Vaisala, the only lightning strike in the vicinity (within six miles) of the 2nd Left section occurred at 6:26:35 a.m. The next nearest strikes, again similarly to that reported by Vaisala, occurred approximately 6.5 miles south and northwest of the explosion site at 5:57:48 a.m. and 6:38:51 a.m., respectively, approximately half an hour before, and 12 minutes after, the explosion.

Figure 7. Locations of lightning strikes from USPLN between 5:30 a.m. and 7:15 a.m., January 2, 2006, within approximately 15 miles of the 2nd Left explosion area at Sago Mine.

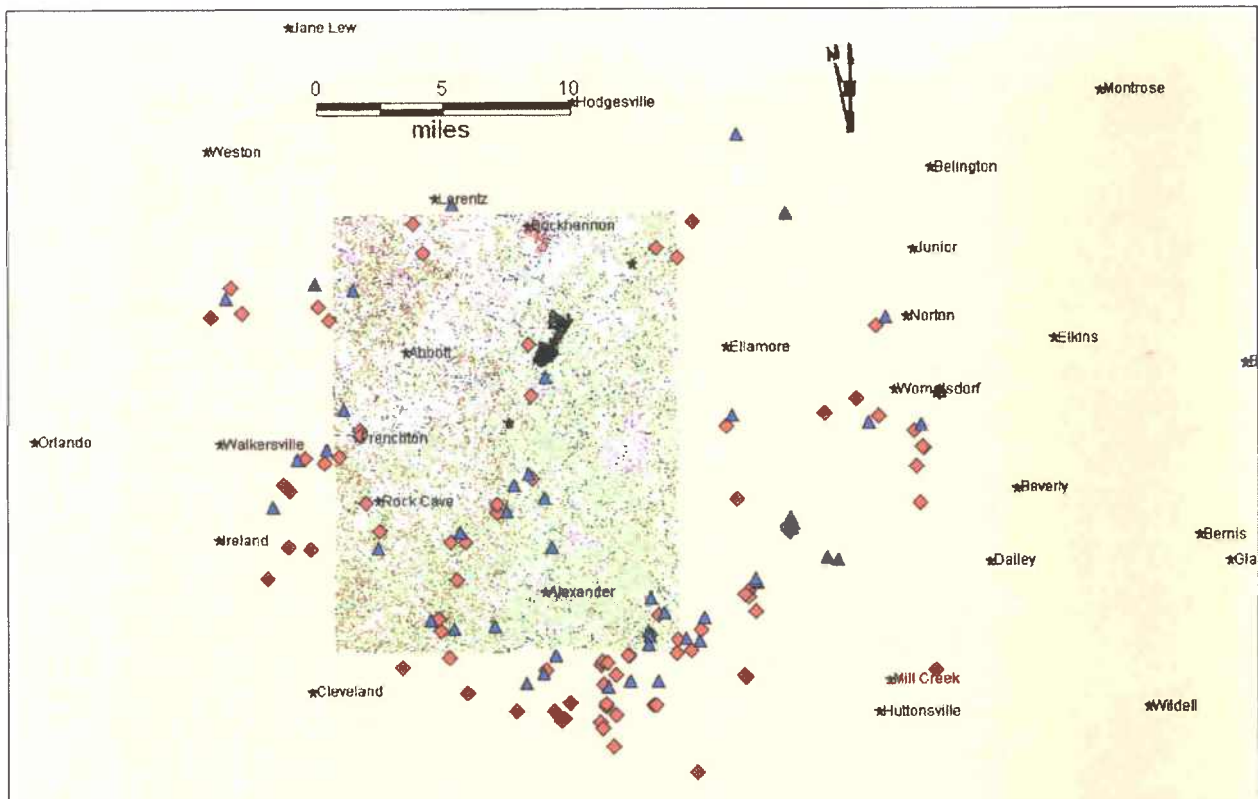
Figure 8 represents a plot of the lightning strike locations reported by Vaisala's NLDN displayed together with those reported by Weather Decision Technologies' USPLN. It appears that not only are there fewer data points represented by the USPLN records compared to the Vaisala records, but that the data points do not generally display an overlap.

Figure 8. Locations of lightning strikes reported by NLDN (red diamonds) and USPLN (blue triangles) in relation to the Sago Mine between 4:00 a.m. and 7:15 a.m. on January 2, 2006.

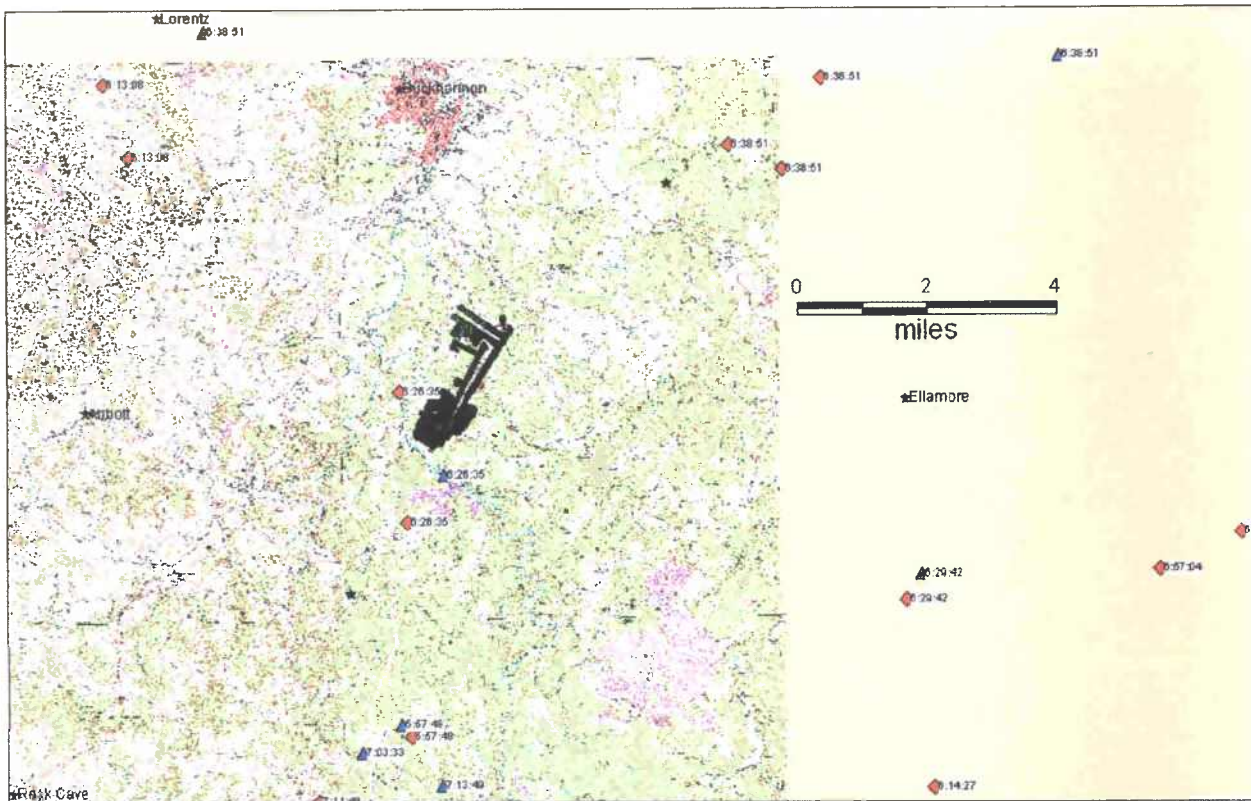
Figure 9 represents a closer view of the Sago Mine with lightning strike locations by NLDN and USPLN displayed with their times of record. It appears that many NLDN strikes have a USPLN “mirror” that occurred at the same time, but are located a variable distance to the northeast. This “mirror” effect may be due to differences in detection methods between the two networks. For instance, NLDN records three strikes at 6:38:51 a.m. located approximately five miles northeast of the abandoned 2nd Left section, while the apparently corresponding USPLN strike is recorded approximately 4½ miles to the east-northeast of the three NLDN locations. The NLDN strike reported approximately 1.5 miles south of the Sago Mine portal, at 6:26:35 a.m. has a USPLN “mirror” located approximately one mile northeast of this location, in the bottom of the Buckhannon River valley. Despite the common association of offset locations at the same time, the USPLN system does not report a “mirror” for Vaisala’s 6:26:35 a.m. strike located at -80.2331° E / 38.926° N, which is believed to have shattered the large poplar tree just west of the mine.

Figure 9. Closer view of the lightning strikes reported by Vaisala's NLDN (red diamonds) and Weather Decision Technologies' USPLN (blue triangles) systems in relation to the Sago Mine, during the time frame between 4:00 a.m. and 7:15 a.m. on January 2, 2006. The USPLN system commonly plots a "mirror" location that is offset by a variable distance from the corresponding NLDN position. However, no USPLN "mirror" is reported for the NLDN strike at -80.2331° E/ 38.926° N, which is located within 200 feet of a shattered poplar tree west of the mine.

It is interesting to note that the USPLN system recorded a "mirror" for the NLDN strike that occurred approximately one mile south of the Sago Mine portal. Vaisala's NLDN system recorded this strike at 6:26:35 a.m., with a peak current of 38.8 kA at -80.2313° E / 38.8968° N. Weather Decision Technologies' USPLN system apparently recorded the same strike at 6:26:35 a.m., but with a slightly different peak current of 35 kA and in a location 4,900 feet to the northeast, at -80.2209°E / 38.9072° N. Similarly, the NLDN system recorded a strike at 5:57:48 a.m. with a peak current of 25.1 kA at -80.231° E / 38.8487° N, located approximately 4.5 miles south of the mine portal. The USPLN system apparently recorded the same strike at 5:57:48 a.m., but with a peak current of 24.6 kA at -80.2336° E / 38.8514° N, which is approximately 1,200 feet northwest of the NLDN location. These recorded positions are within approximately 2,800 feet of a power line that runs north past the Sago Mine. At 6:38:51 a.m., 12 minutes after the
