Appendix JJ - Sago Mine Pump Cable Test

SUBJECT: Sago Mine Pump Cable Test

REPORT NO: L-04022007-1

SUBJECT: Inspection and Testing of Sago Mine Pump Cable

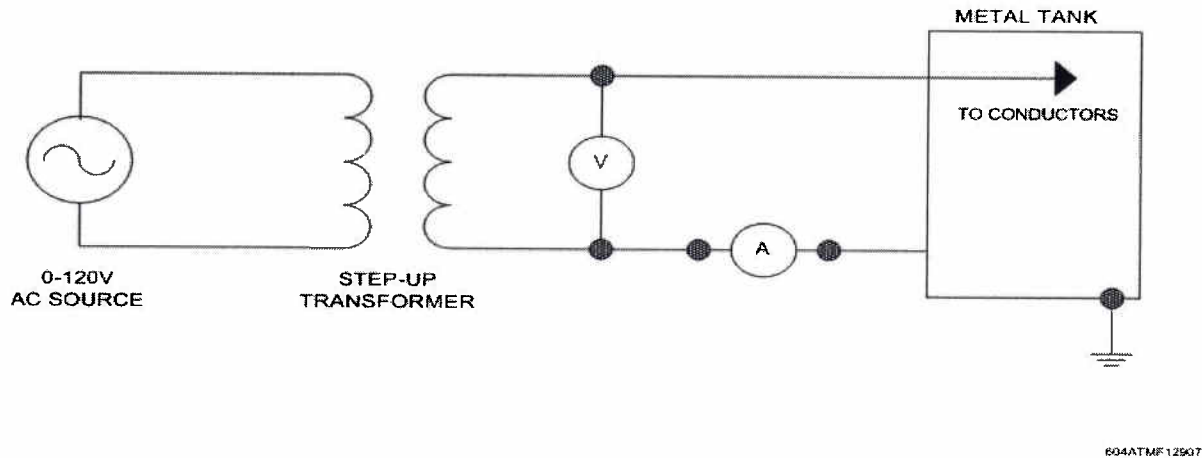
Figure 1. - Test Set-Up

Electrical testing was conducted in a metal tank, with each side and depth of approximately 3 feet. The tank was grounded to the power system ground and filled with tap water. The test cable was immersed in tank water, which was maintained at room temperature for at least 12 hours, and the water level was kept constant.

A 1-foot portion (minimum) of each end of the cable was kept above water as leakage insulation.
