UNITED STATES
DEPARTMENT OF LABOR
MINE SAFETY AND HEALTH ADMINISTRATION
COAL MINE SAFETY AND HEALTH

REPORT OF INVESTIGATION
Fatal Underground Coal Mine Explosion
January 2, 2006
Sago Mine, Wolf Run Mining Company
Tallmansville, Upshur County, West Virginia
ID No. 46-08791
By

Originating Office
Mine Safety and Health Administration
Office of the Administrator
Coal Mine Safety and Health
1100 Wilson Boulevard
Arlington, Virginia, 22209
Kevin G. Stricklin, Acting Administrator
May 9, 2007

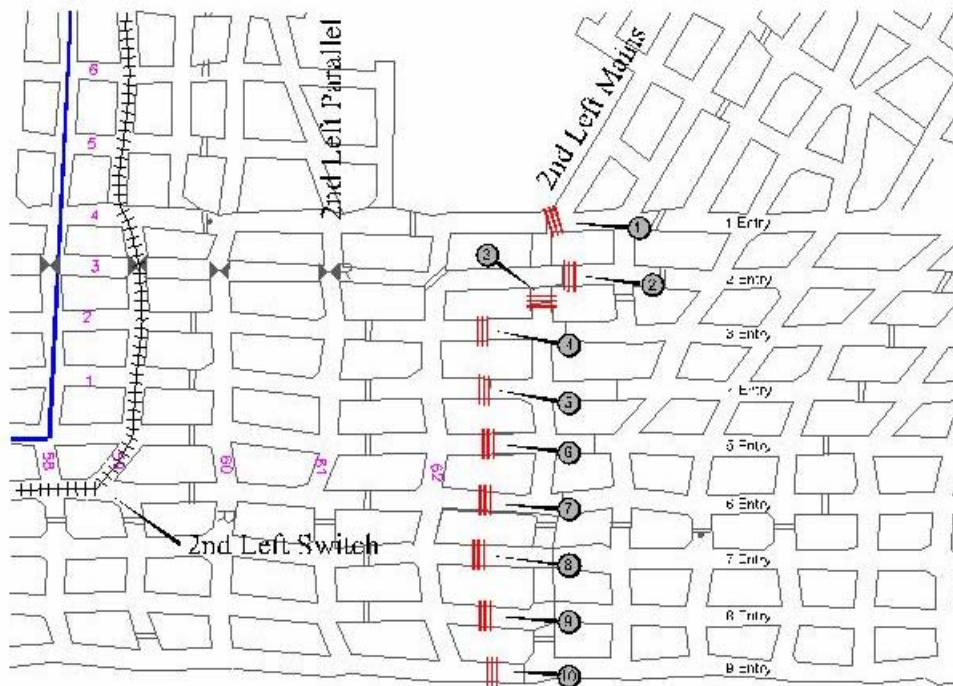
Figure 2 - Location of 2 North Main Seals

On October 12, the mine operator submitted a plan to MSHA to seal the 2 North Mains inby the 2nd Left Parallel. The mine operator also submitted a plan to use Omega Blocks to construct 40 inch thick Omega Block seals. On October 24, the mine operator's requests were approved. Seal construction began on October 24, 2005. By November 9, seven seals had been completed. The operator subsequently completed the next seal in the 63 Crosscut, No. 4 Belt between entry Nos. 2 and 3. The locations of the seals are shown in Figure 2.

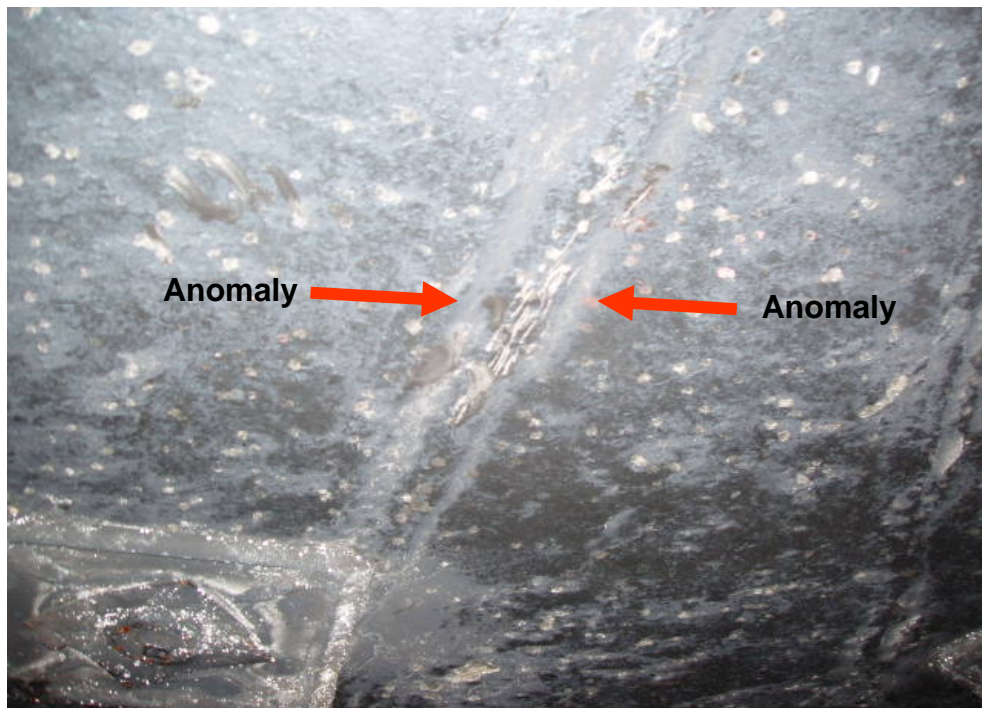
Figure 16 - Anomaly

Two linear geologic features were observed during the investigation. These two prominent features were located in the roof near survey station 4010, within the formerly sealed area of 2nd Left Mains. The features generated interest because they were located in the area where the explosion originated. Because the features seemed uncommon, they were referred to as "anomalies." Due to their location in the area where the explosion originated, some parties speculated that the linear "anomalies" might represent the effects of lightning. A picture of the anomaly is shown in Figure 16.

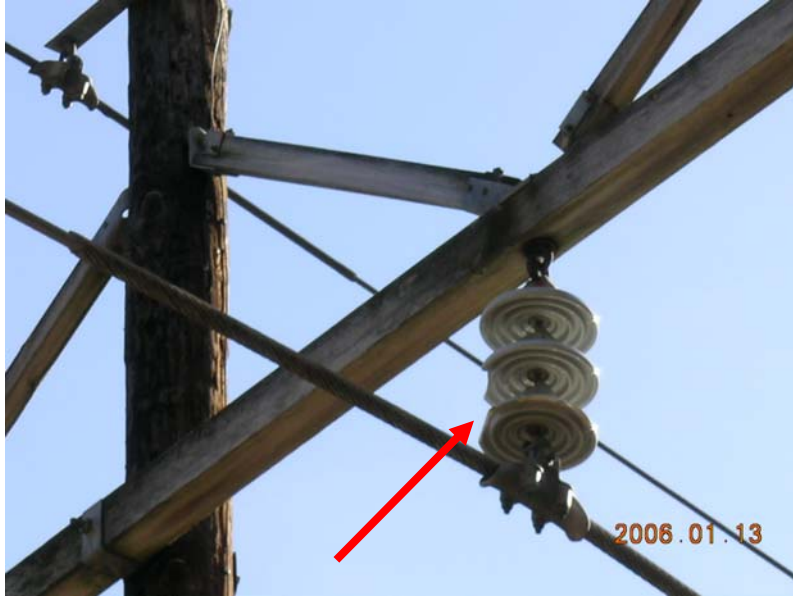
transmission line. The lightning arrester was damaged at the second pole of the branch lines leading to the mine. A map showing the high-voltage transmission and branch lines is shown in Appendix BB. Figures 41 and 42 are photographs of the damaged insulator and lightning arrester below.

Figure 41 - Damaged Insulator

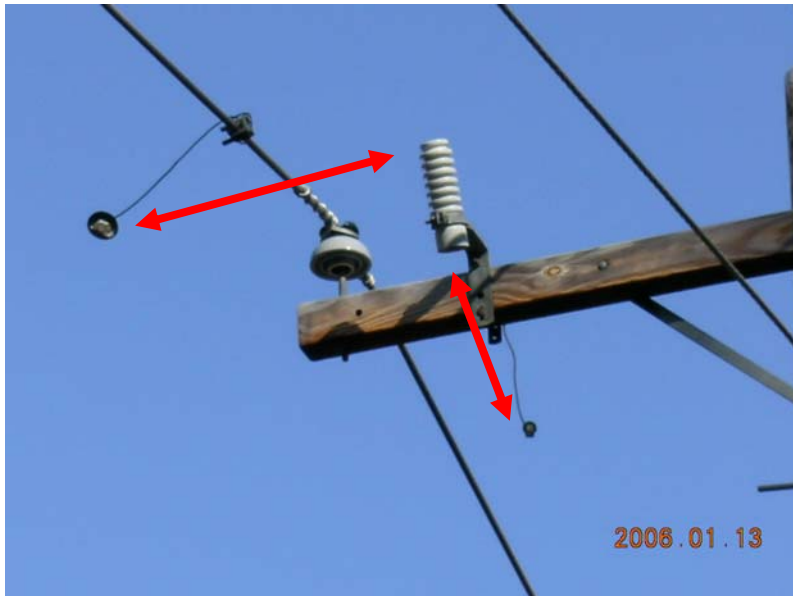
Figure 42 - Damaged Lightning Arrester

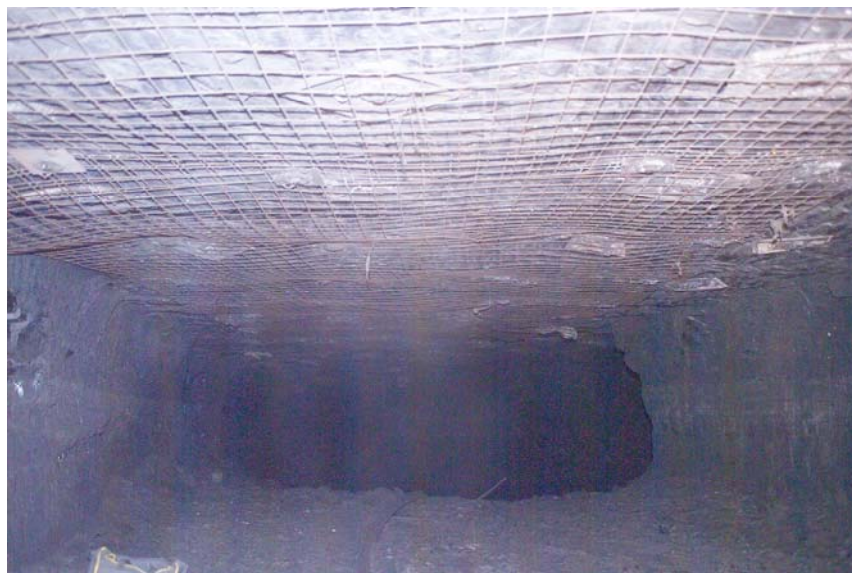
Figure 47 - Picture Taken Near Survey Station 4011

The picture shown in Figure 47 was taken from a location near survey station 4011. There is no damage to roof support members, including wire mesh or roof plates. The origin of this deflagration-type explosion was located within the sealed area near survey stations 4010 and 4011 in the 2nd Left Mains. This particular location did not appear to be exposed to the same magnitude of pressures as the surrounding areas.

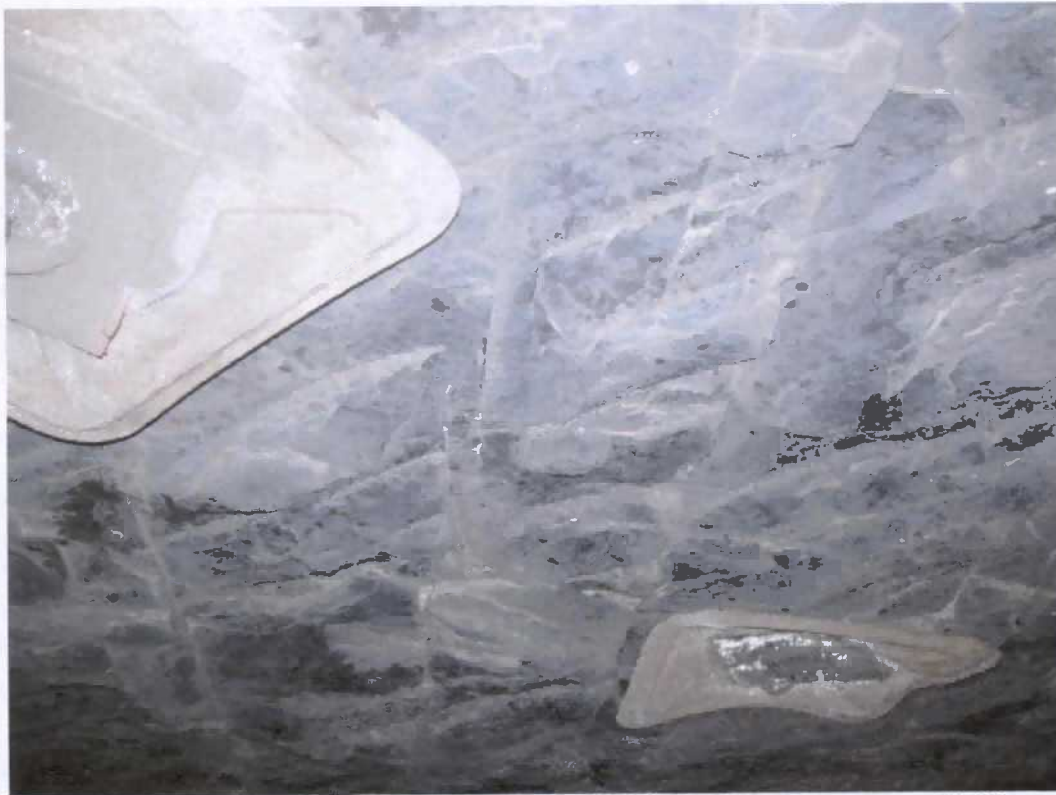
Figure 1. Very well developed joint set, characterized by N 85°E-striking joints spaced 12-20 inches apart. Photo taken in the crosscut between spads 4010 and 4011.

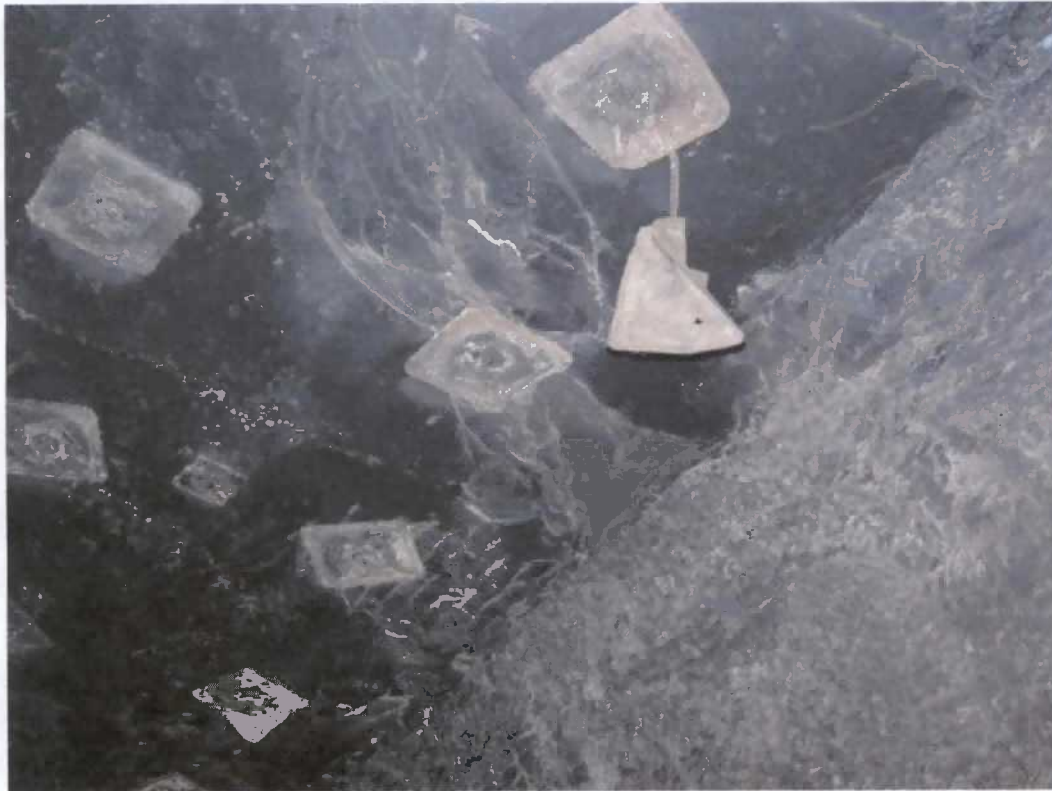
Figure 2. Downward-buckled zone of thinly laminated shale represents a stress pot-out that follows a trend of approximately N 5-7°E. Other linear buckled zones of shale are aligned along the same bearing throughout the observed area.

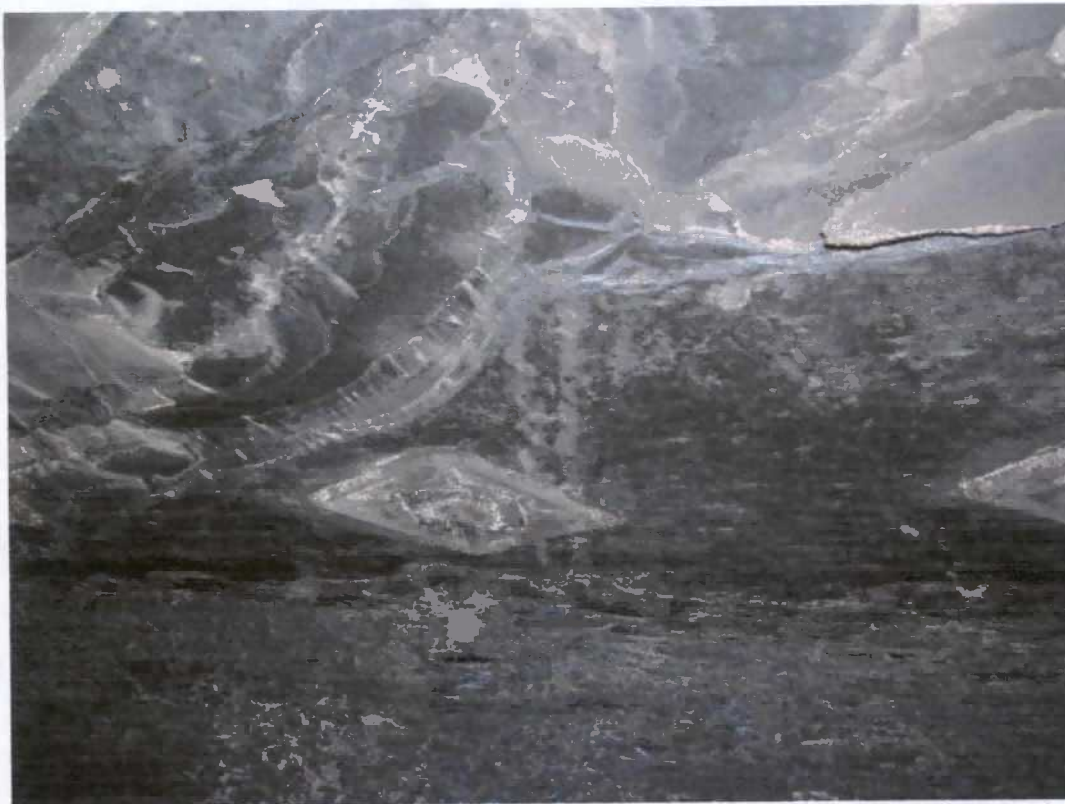
Figure 3. Two pairs of parallel ridges exposed on the underside of the shale roof, and disrupted where a shallow stress pot has broken out of the roof. No evidence of the linear features was found in the thin brow of the stress pot along the trend of the linear feature, indicating that it does not extend upward into the rock.

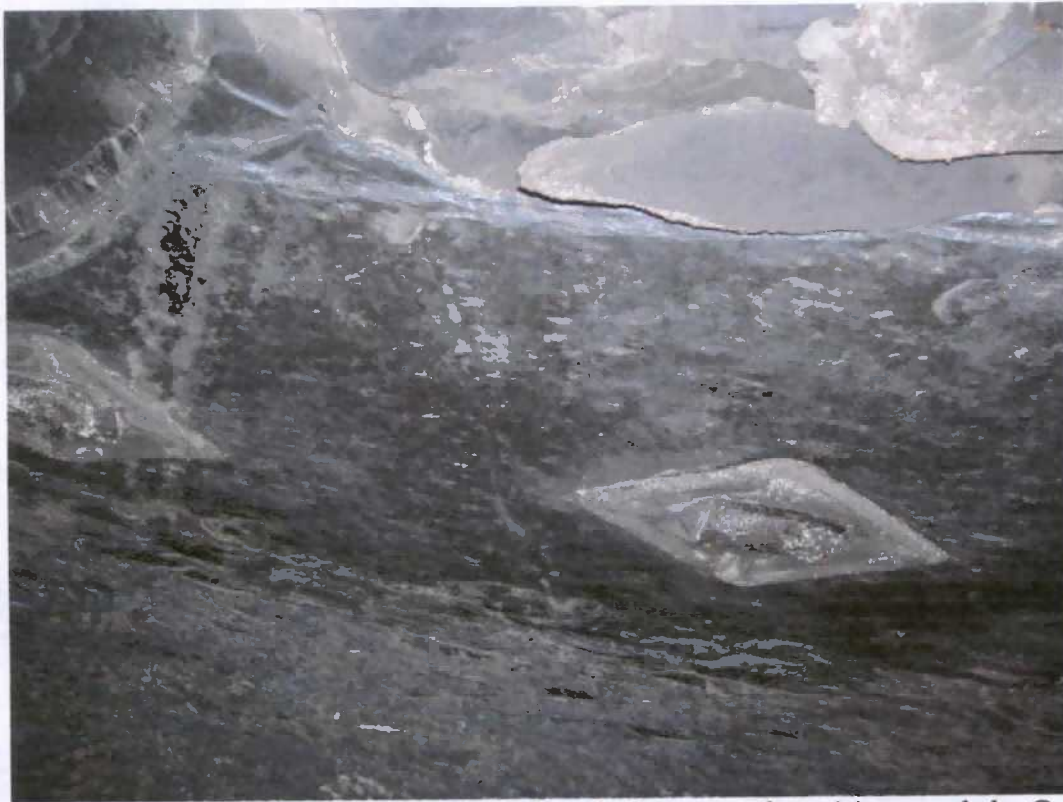
Figure 4. Two pairs of linear, parallel ridges exposed on the bottom surface of the gray shale. Center feature lies along a trend of N 70°E, forming an acute angle with the feature at left, which is oriented along a trend of N 43°E. There is no indication of the linear features extending above the thinly laminated immediate layer of the roof, as exposed in the thin brow formed by the stress pot-out.

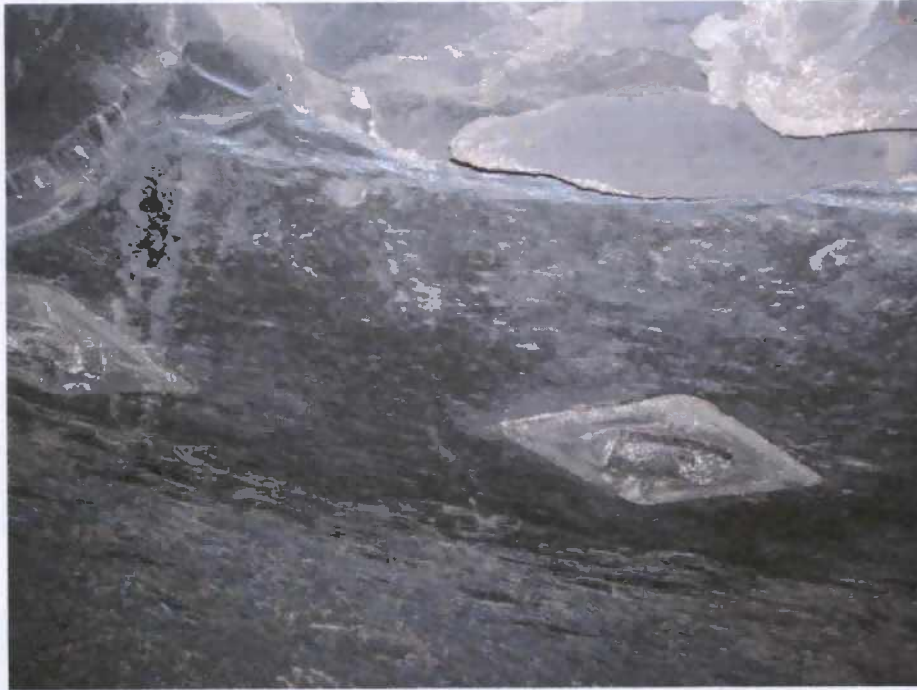
Figure 2. Two sets of paired, linear ridges define an acute angle in the roof horizon just inby spad 4010. R. J. Lee sample collection effort on March 1, 2006 extracted samples of this feature. In this photo, the linear feature is truncated by a shallow stress pot-out.

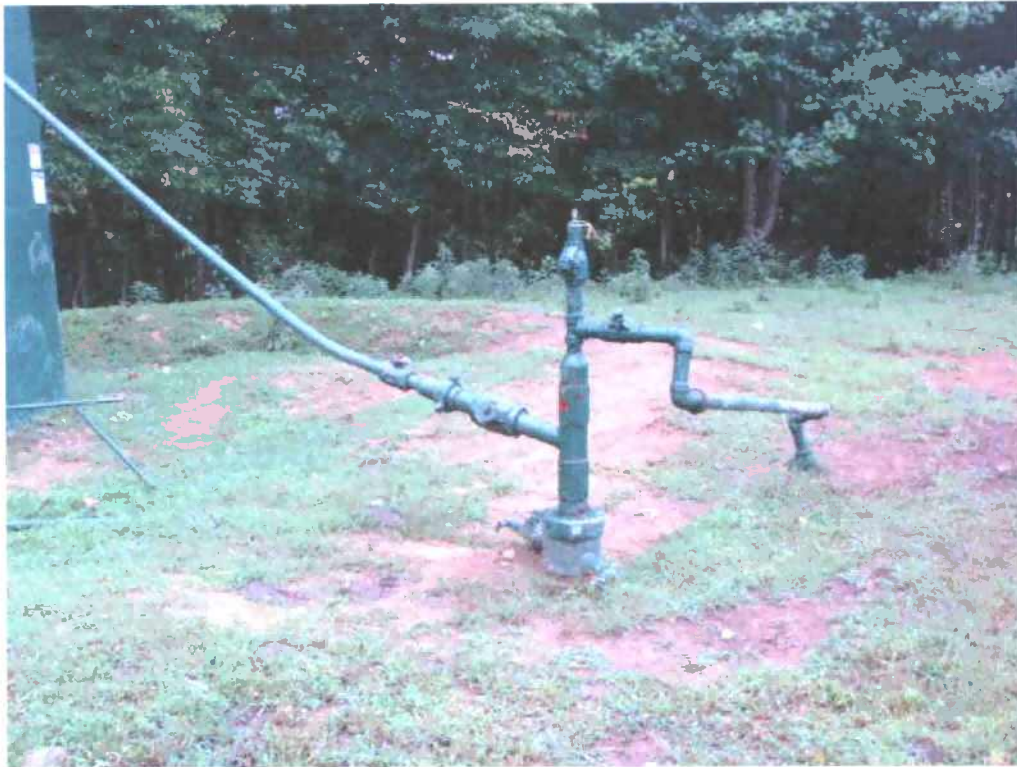
Figure 3. Keyspan well located 2,800 feet north-northwest of 6:26:35 a.m. Vaisala lightning strike location that shattered a large tree. Well is serviced by an approximate 3-inch diameter metal pipe that is buried until exposed at a monitoring station 300 feet to the northeast. No evidence of lightning damage was apparent to the metal, or the surrounding trees and ground.

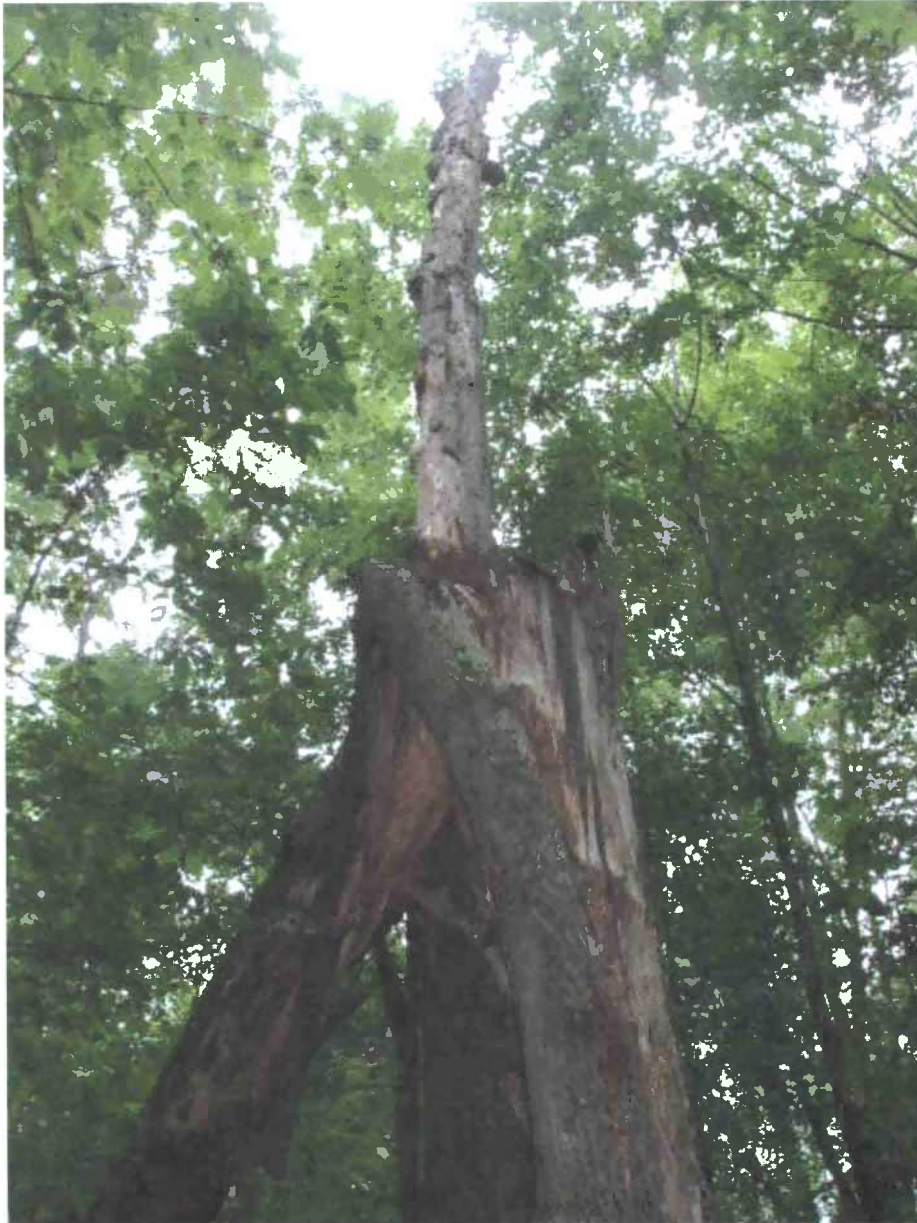
Figure 5. Tree along trend of buried metal gas line on hilltop approximately 4,600 feet Due North of 6:26:35 a.m. Vaisala strike location suggests damage by storm or lightning. Unlike the shattered poplar tree near the 6:26:35 a.m. strike location determined by Vaisala's NLDN, this tree did not exhibit blown-off shards or slivers of wood. The age of the damage is unknown. Compare to Figures 1 and 2 for perspective.

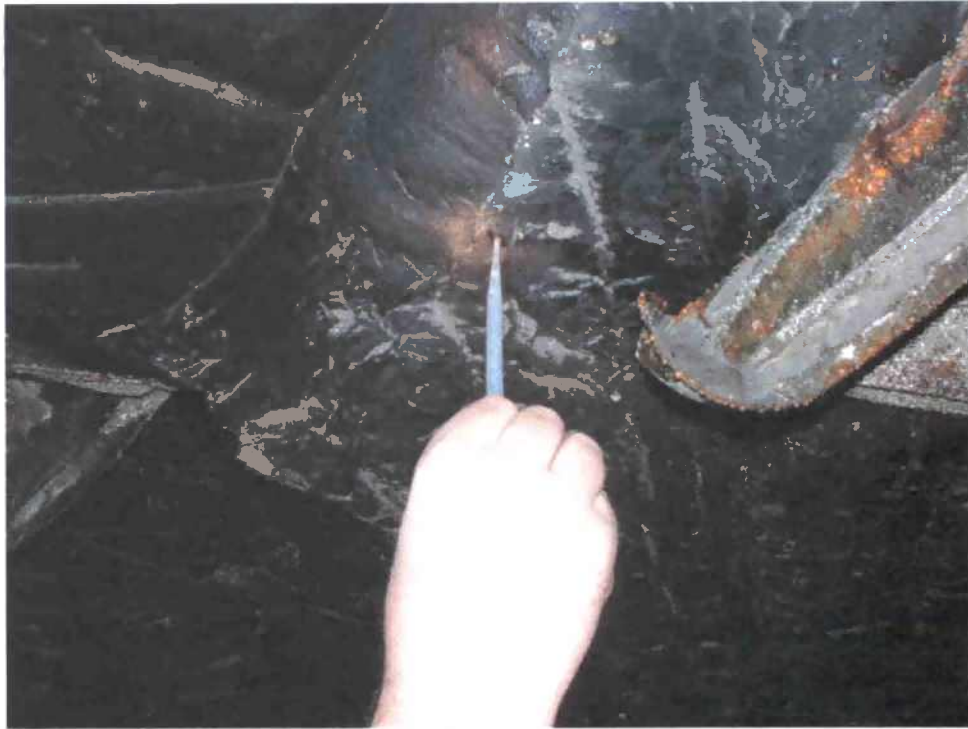
Figure 3. Collection of water droplets on the roof and fracture faces where "blue haze" was observed between spads 3986 and 3981.

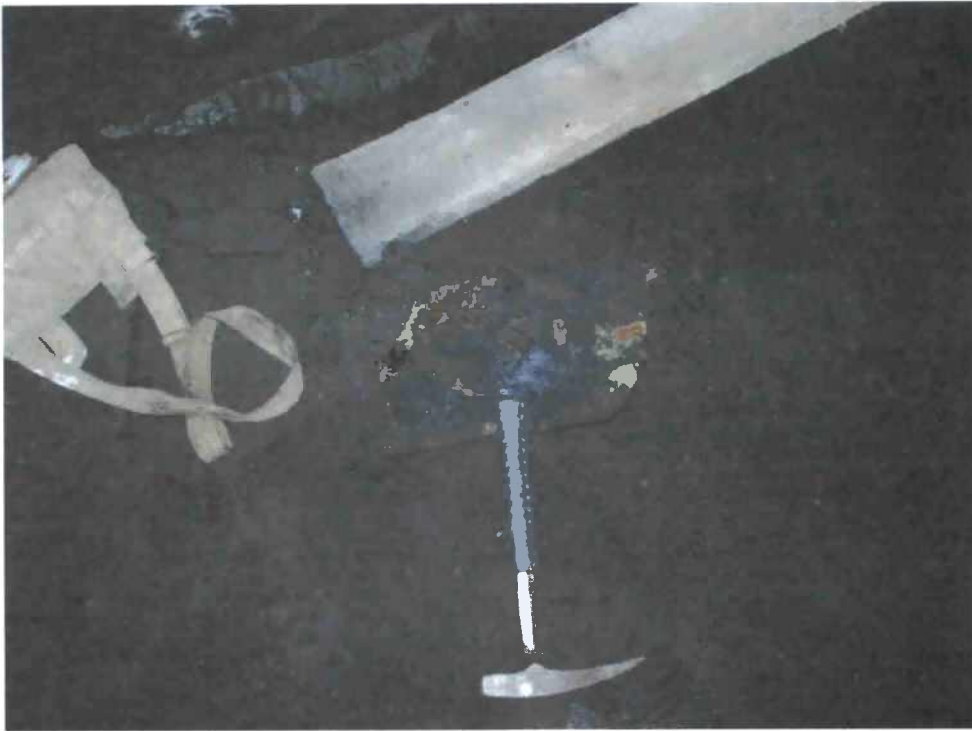
Figure 6. Slab of "blue haze" coated rock retrieved from the right rib approximately 55 feet inby spad 4010. This slab was subsequently split in half, with each half retained by mine and MSHA personnel present.

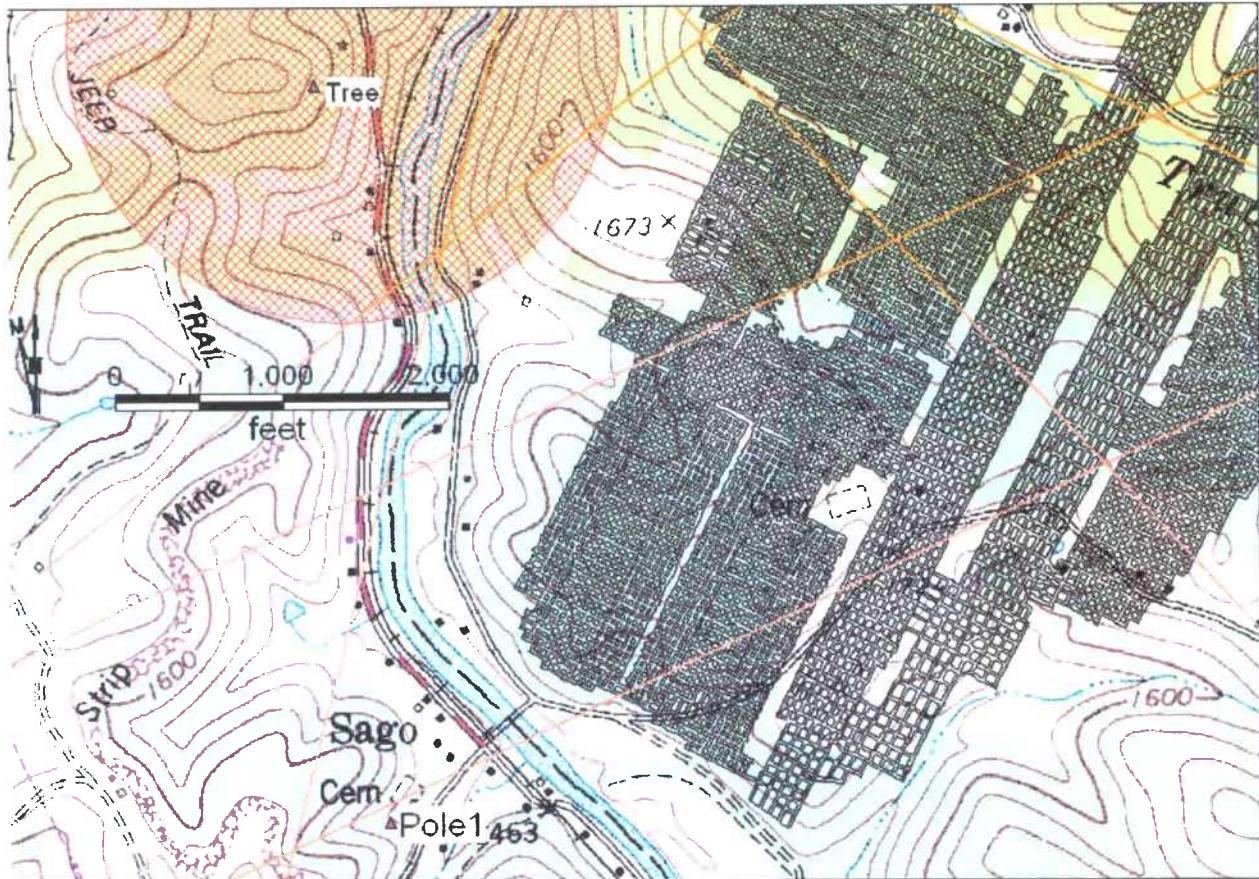
Figure 12. Location of lightning-struck tree, determined by RCD personnel with hand-held GPS unit. Location is 300 feet from plotted location of lightning strike, indicated by small red star in center of cross-hatched area. Locality "Pole 1" represents a twin-pole power line support that reportedly exhibited lightning damage, although the timing of the damage is unknown.
