PA Monitoring Program

Checkdam Photographs from
March 2005 River Trip

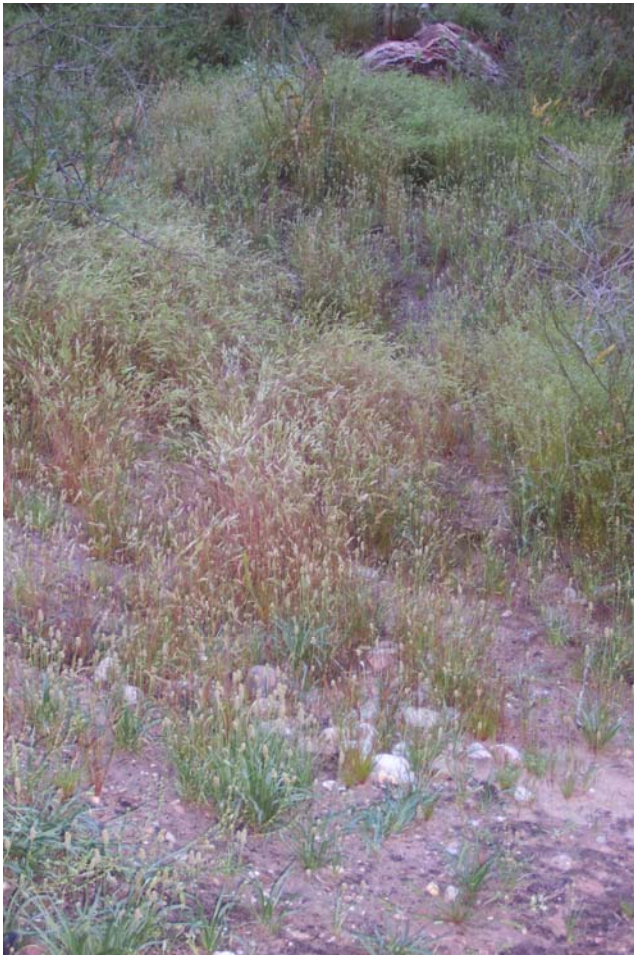
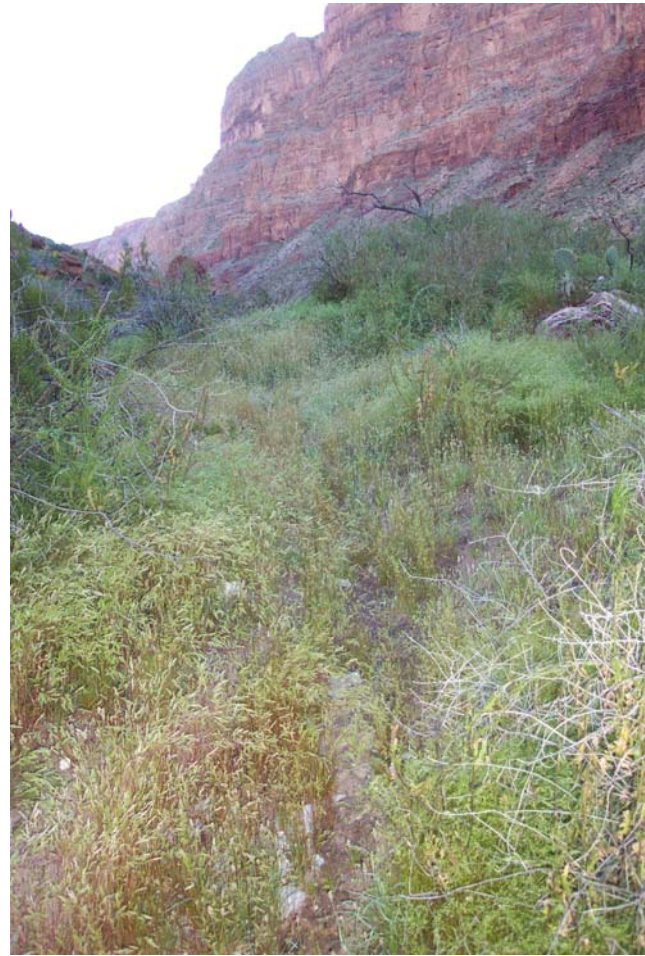
A:15:005

No maintenance completed, checkdams have the aid of additional sediment and grasses to help stabilize the gully.

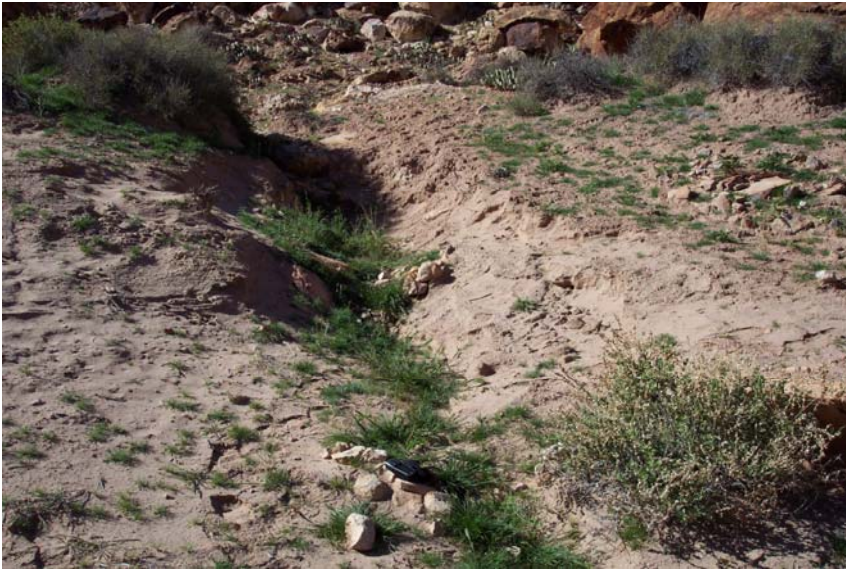
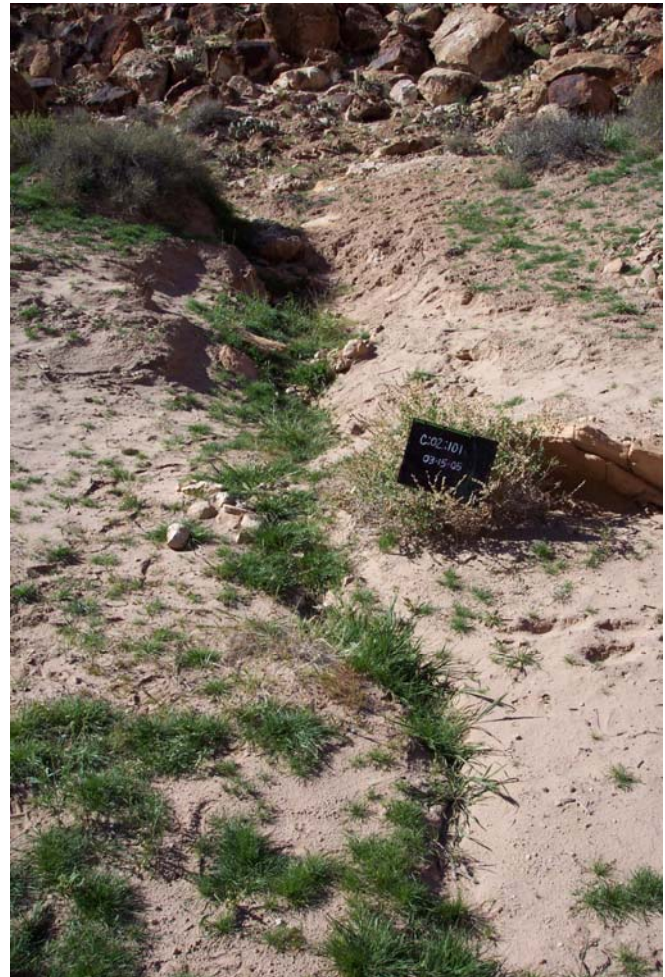
C:02:101

Grasses outline the gully with the checkdams.

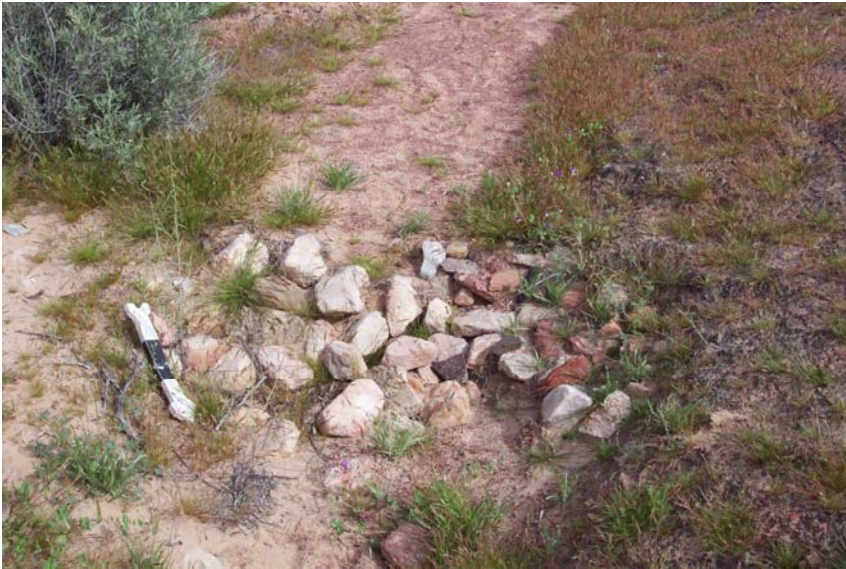
C:13:069

Close up and overview of gully with checkdams.

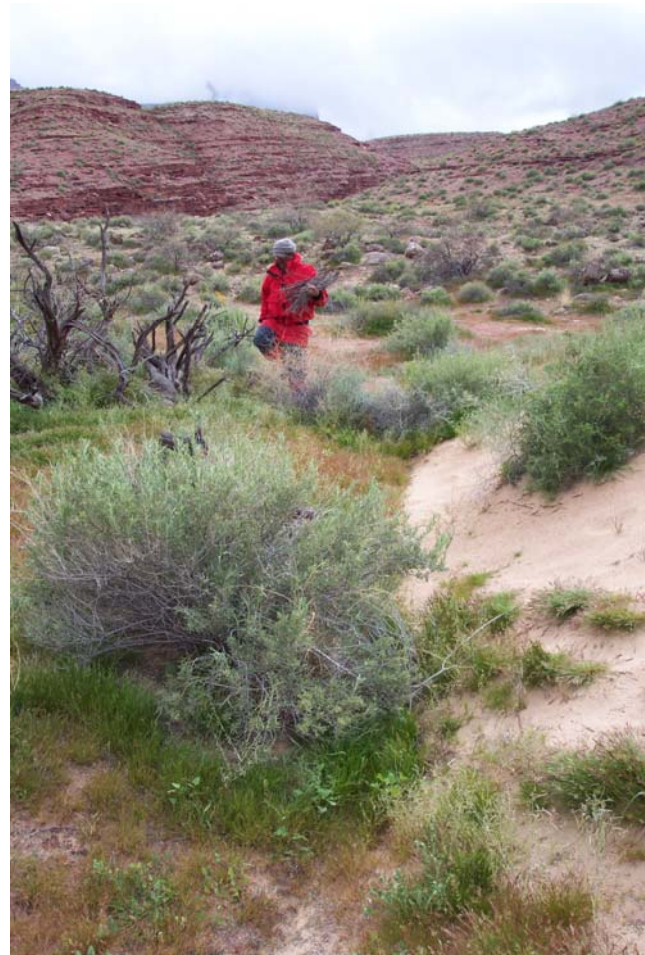
Photo noting approximately 30cm of sediment deposited behind the check.

Grasses fill the gully with the checks.

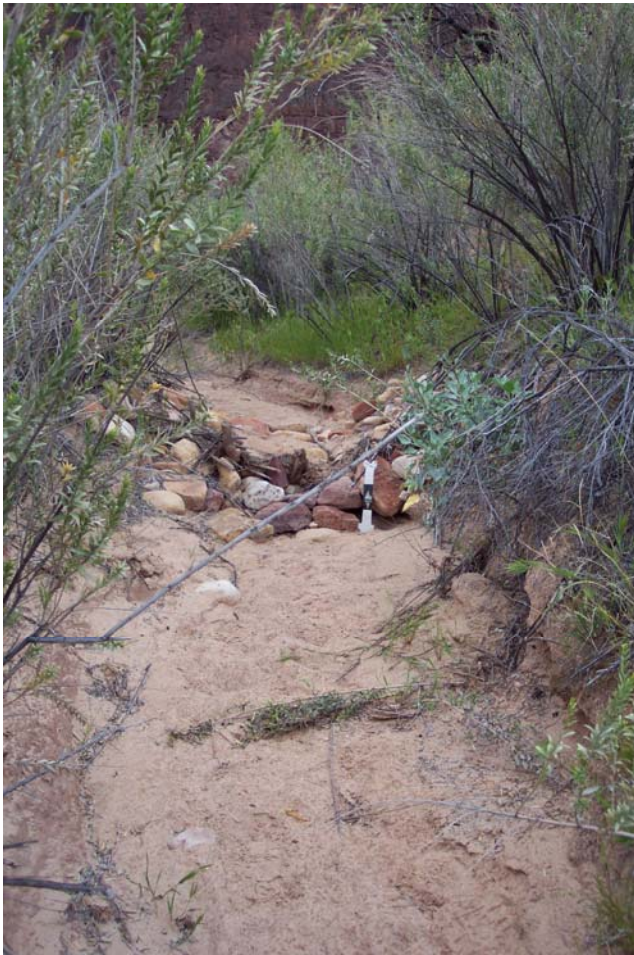
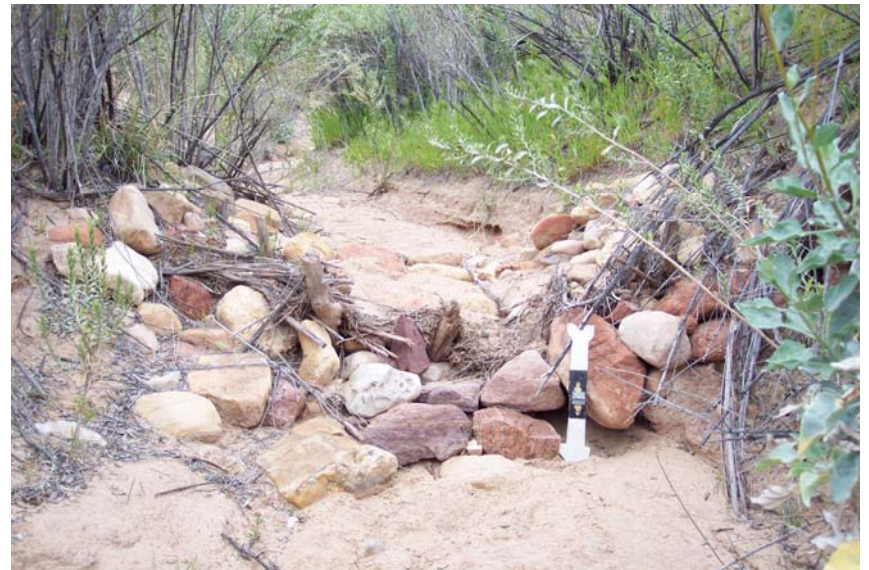
C:13:099

Note approximately 30 cm of deposition behind the checkdam
(checkdams were placed here in FY95)

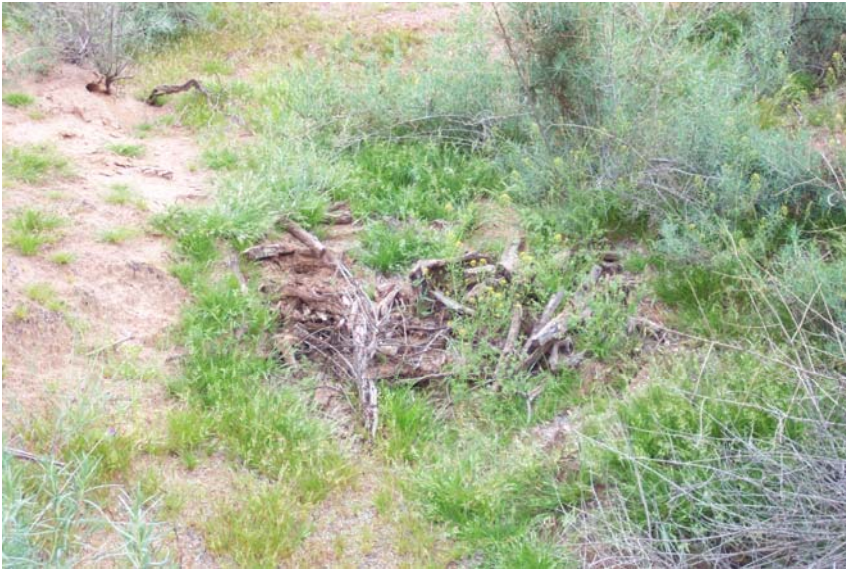
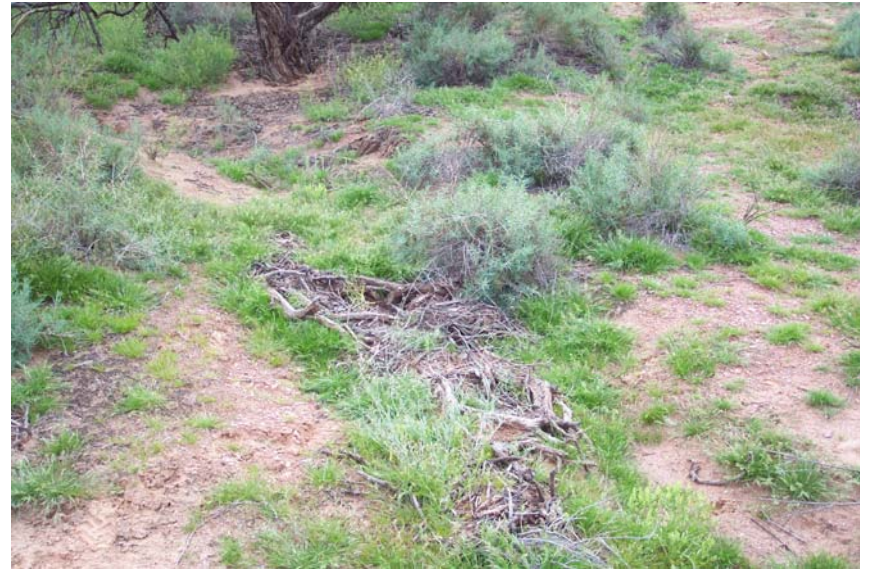
C:13:348

Brush structures with sediment and grasses

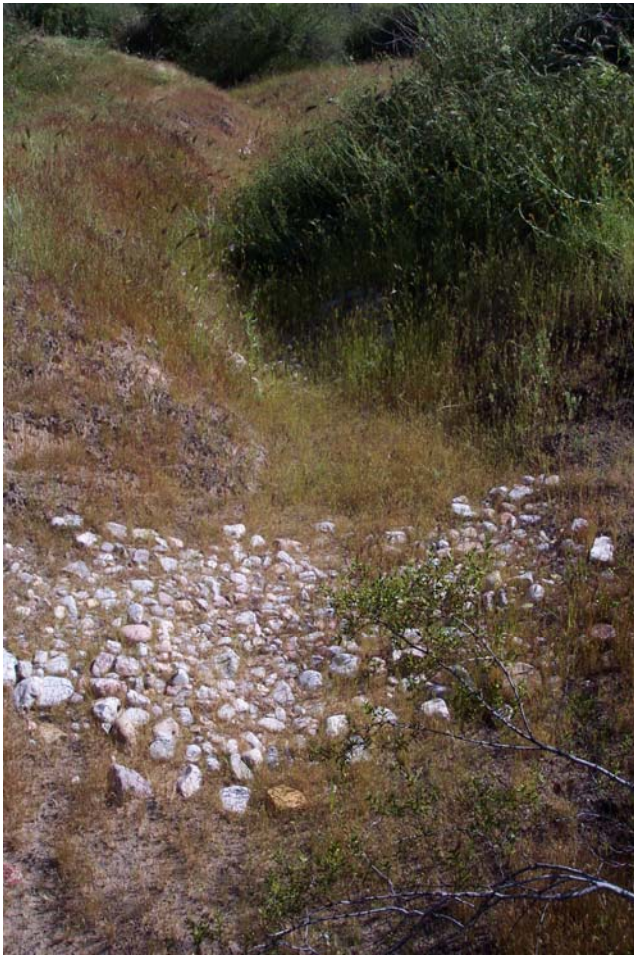
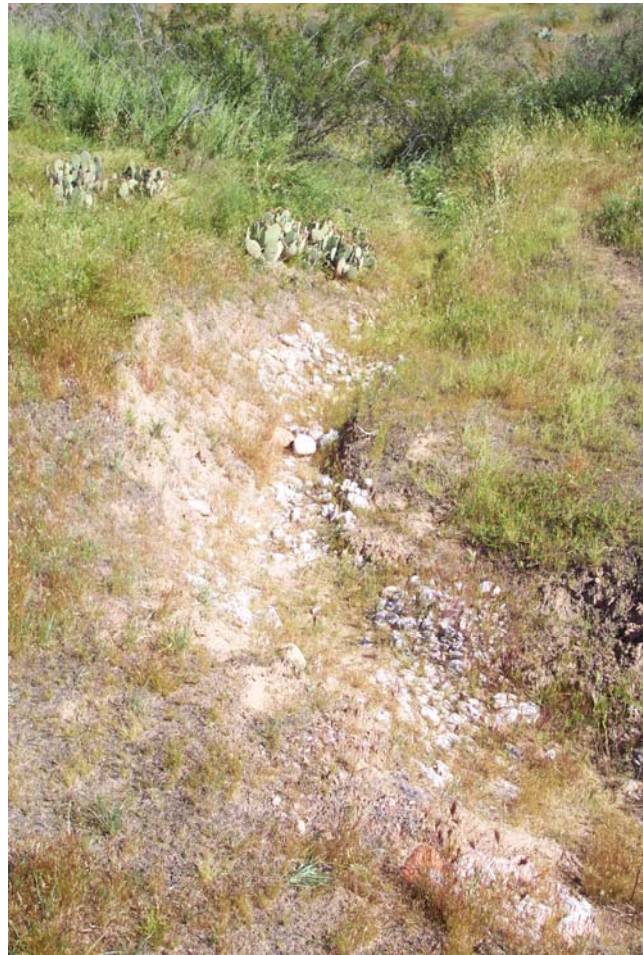
G:03:003

Additional vegetation and sediment in the gully
