EPA/OSHA JOINT CHEMICAL ACCIDENT INVESTIGATION REPORT

Shell Chemical Company Deer Park, Texas

Accident Investigation Report

Shell Chemical Company, Deer Park, TX, June 22, 1997

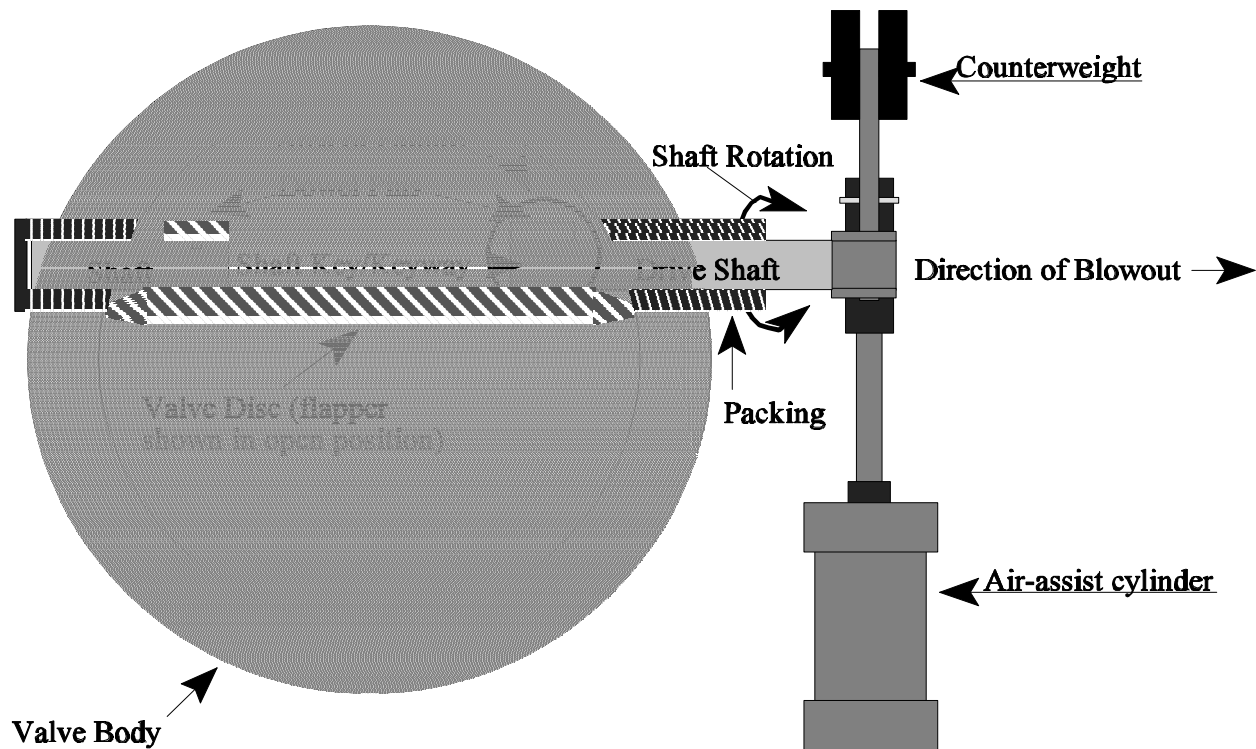
Figure 2: Clow Model GMZ Pneumatically-Assisted Check Valve

The Clow Model GMZ check valve installed as the PGC fifth stage suction check valve had an internal diameter of 36 inches and weighed 3.2 tons. The valve had a design limit pressure of 480 psig, and a design limit temperature of 115 degrees Fahrenheit. The JCAIT found no evidence that these limits were exceeded at any time prior to or during the accident.

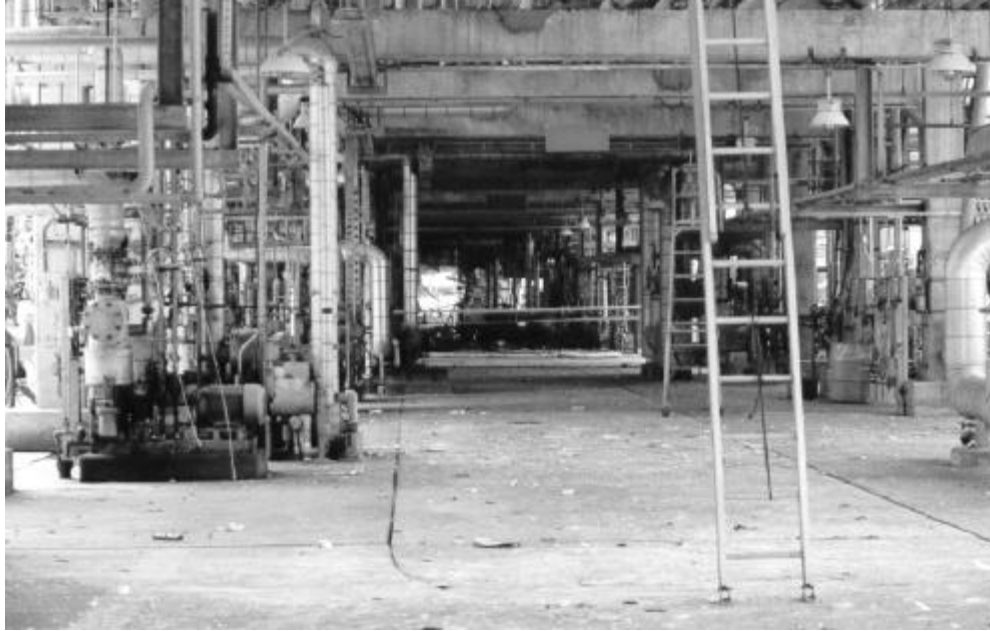
Figure E-5: Photograph looking down pipe alley (passable area underneath pipe rack) where explosion occurred.

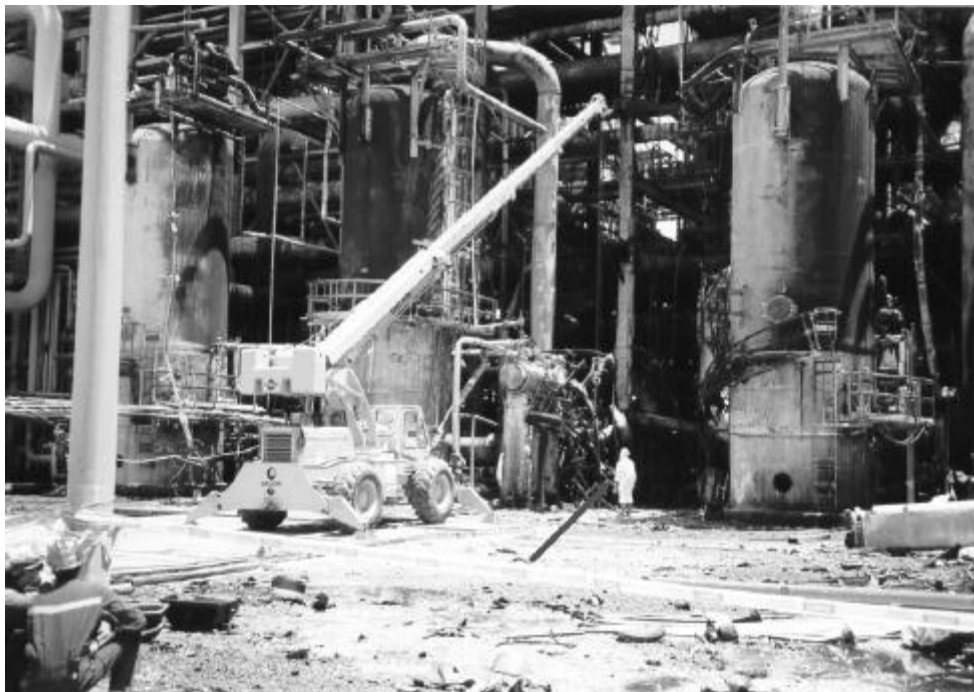
Figure E-6: Photograph of explosion and fire damage in the area of the PGC fifth stage suction and discharge drums (viewed from the north). The man in the lower center provides a reference to the scale of the surrounding structures. The failed check valve was located behind the drum to the man's right.

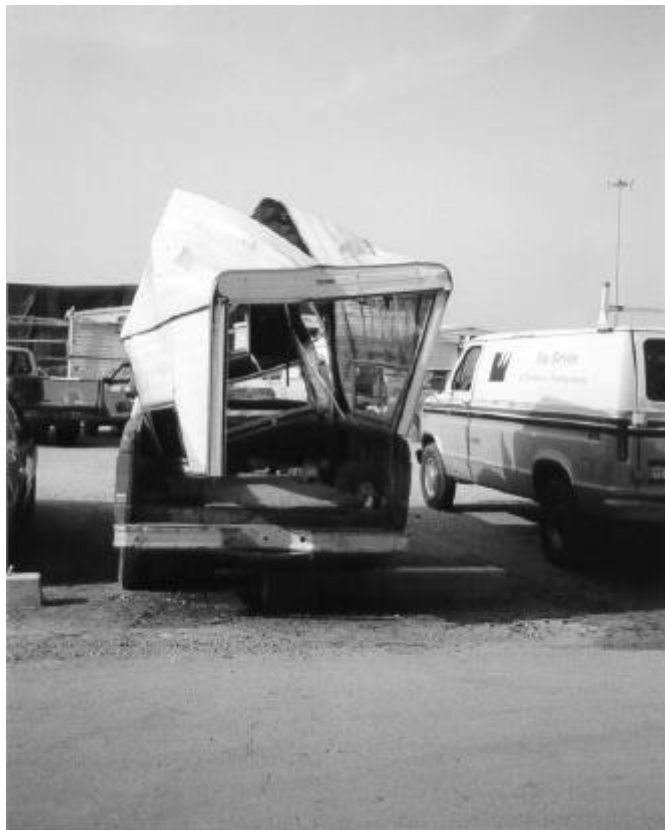
Figure E-8: Photograph of damage to a pickup truck parked near the blast site. Most automobiles parked in this company lot during the accident suffered damage.

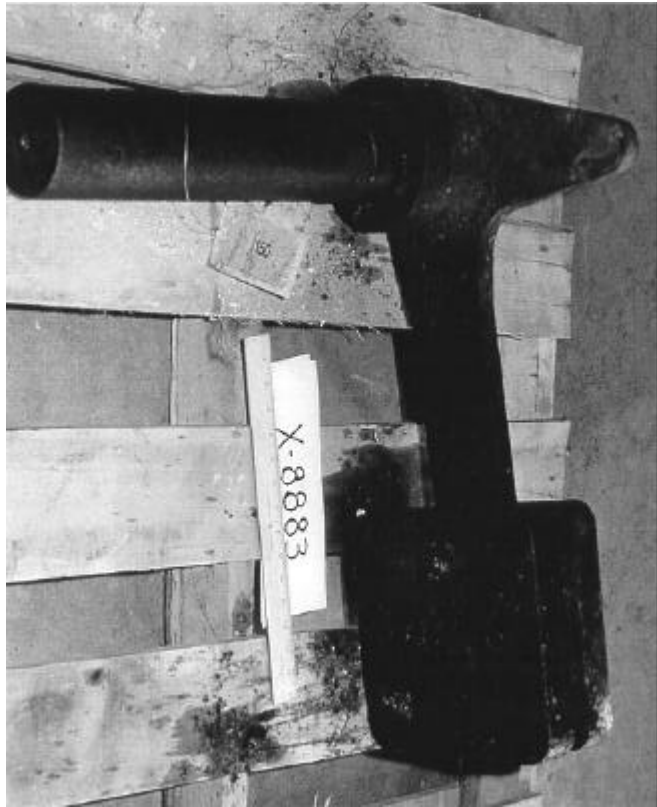
Figure E-11: Photograph shows the drive shaft and counterweight that were ejected from the 36" Clow check valve.

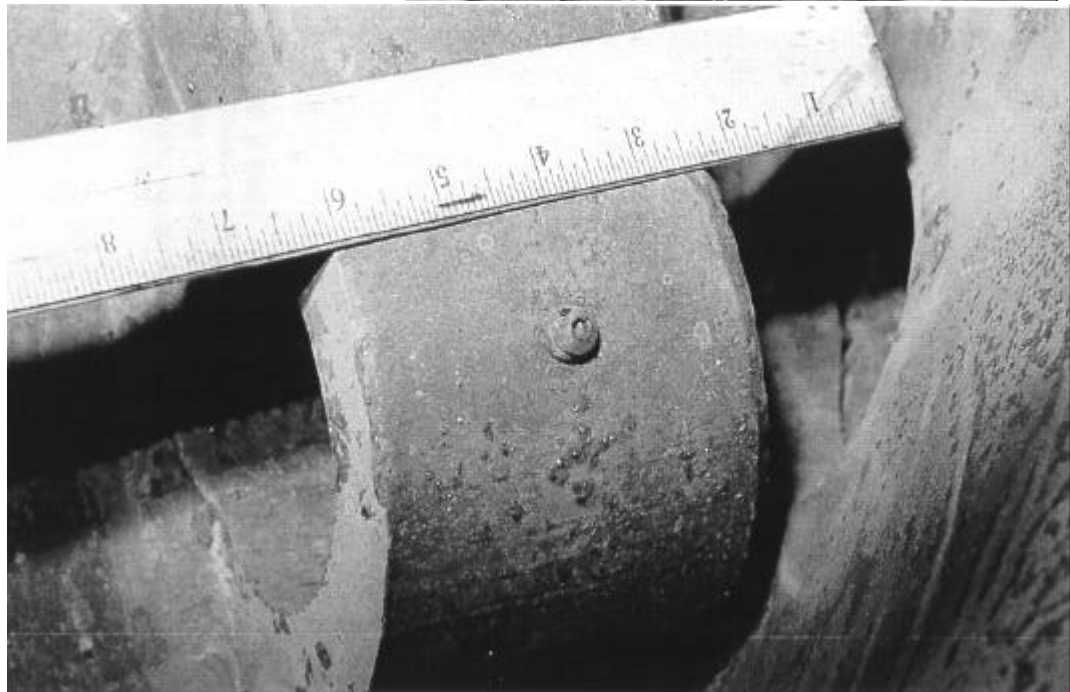
Figure E-12: Photograph shows the head of the machine screw protruding from the portion of the fractured pin. The pin is shown extended slightly out from the surface of the flange, or disk “ear”, from which the valve shaft was ejected.

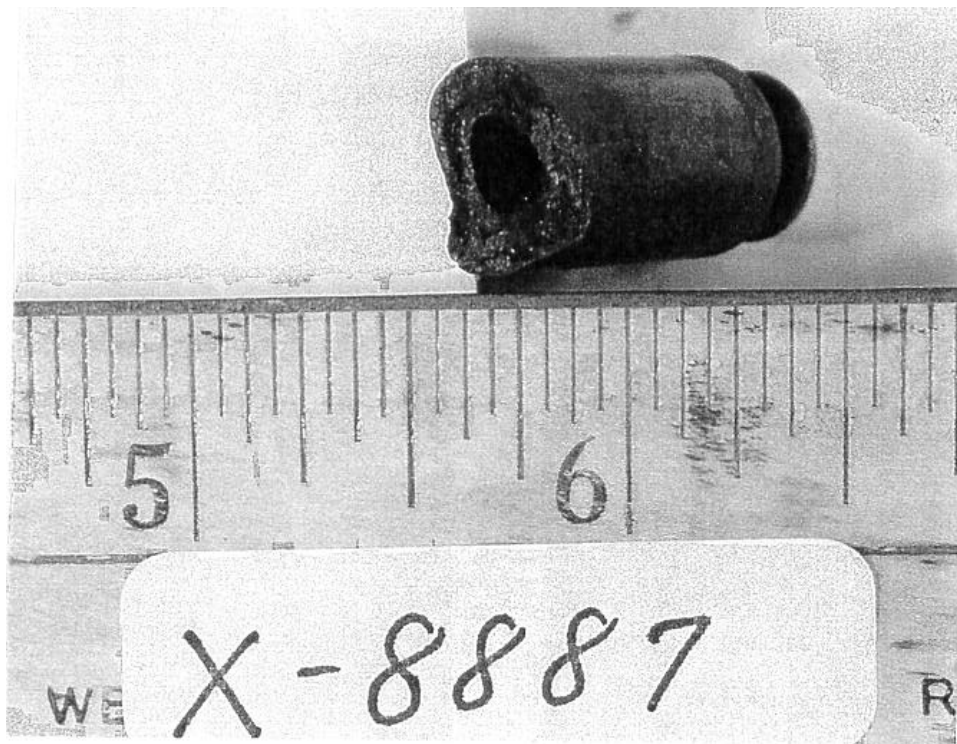
Figure E-17: Views of the longitudinal and transverse cross-sections taken through the intact dowel pin showing the carburized case at both the outside diameter of the pin and within the drilled hole.
