# Rugged Charm

## Ranger Cabin (HS-1) Historic Structure Report

Jewel Cave National Monument  
Custer, South Dakota

November, 1999

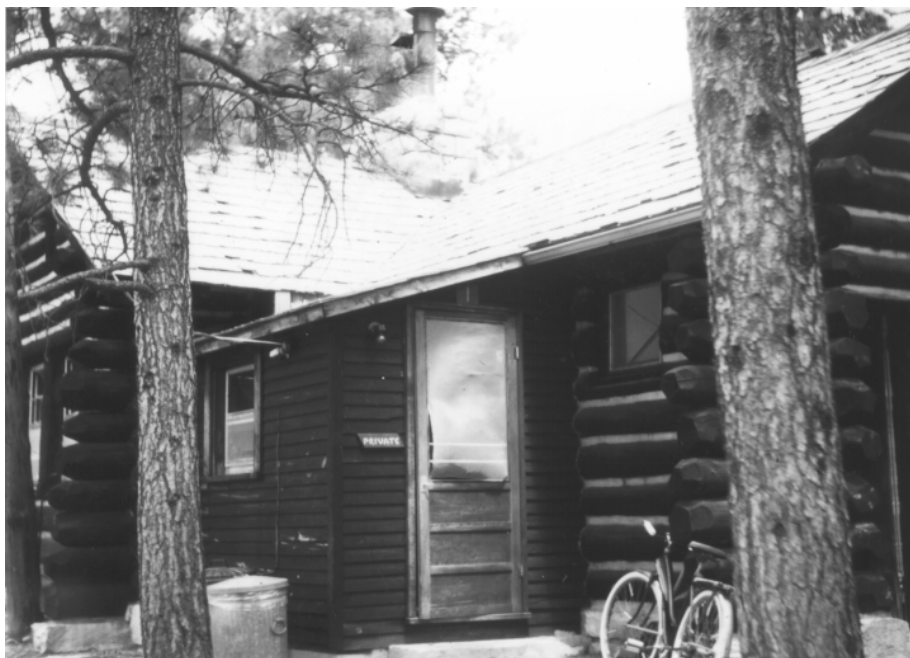
**Figure 20.** Shed addition at rear of the Ranger Cabin, 1972 or 1973. The only known photo of the shed that was constructed around 1946 and demolished in 1982. It may have housed an electrical generator and ice box into the 1950s. From Mary Jo Silbernagle photo collection.

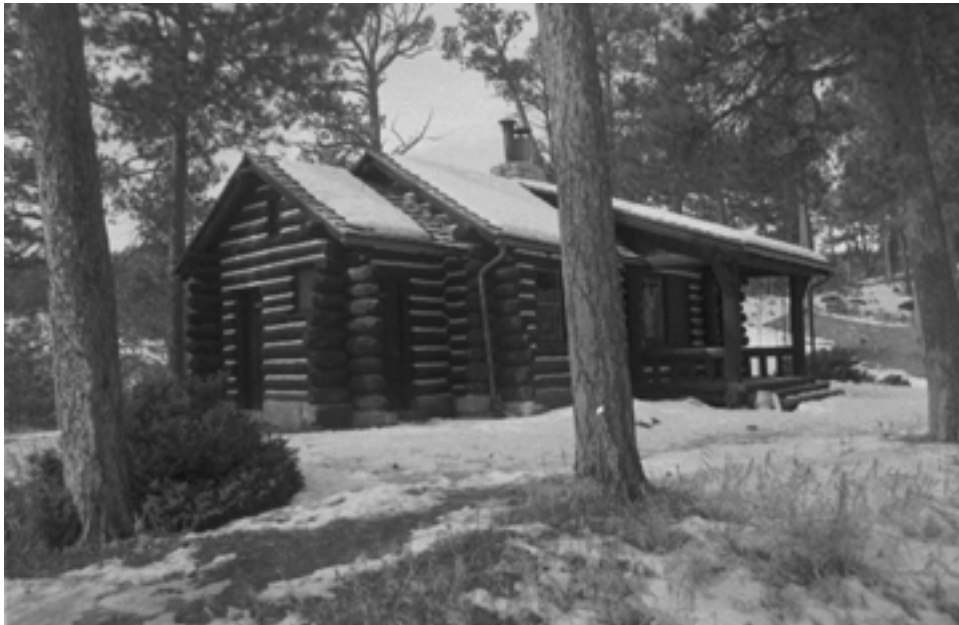
**Figure 21.** Ranger Cabin, view to the northwest, February 1999. Photo by the author.

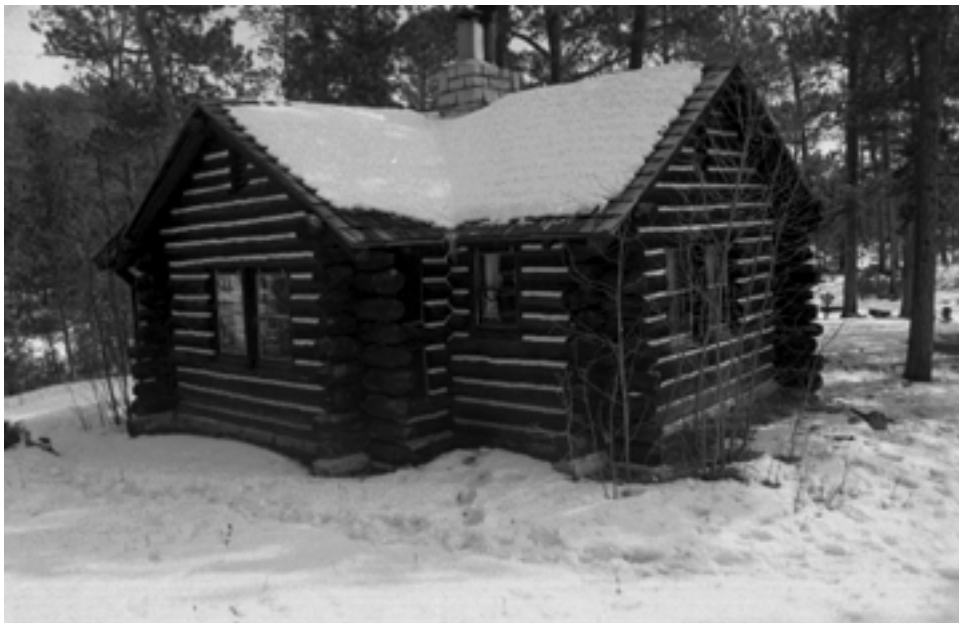
**Figure 22.** Ranger Cabin, view to the southeast, February 1999. Photo by the author.

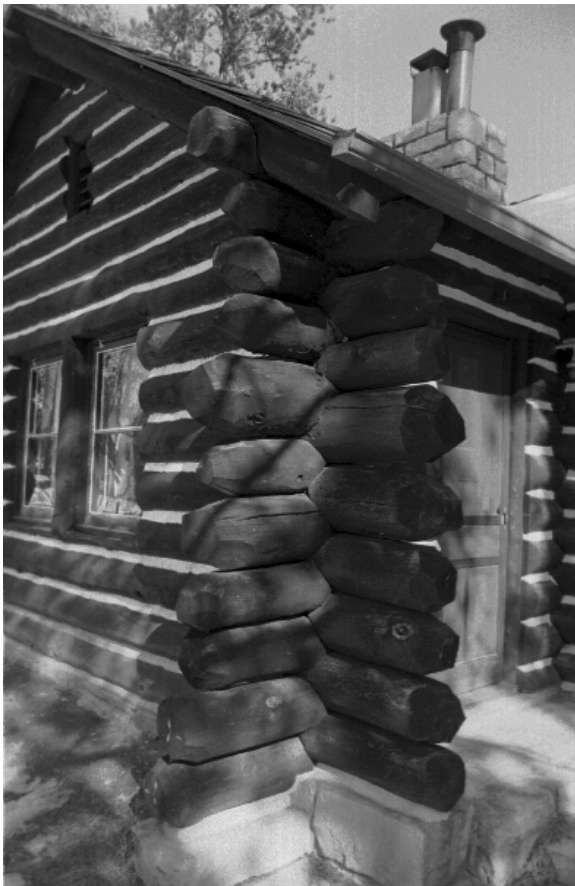
**Figure 23.** Log crowns at southwest corner of kitchen wing. Photo by the author.

Extended log crowns, in concert with long-term, uncontrolled flow of roof drainage over them, combined to degrade the condition of the log crowns. Roof drainage splashing and ponding at the foundation has also contributed to base log problems. A 1980 log condition survey recommended epoxy consolidation of twenty two log crowns and purlins, replacement of seven log crowns, and replacement of two sill logs.<sup>40</sup> By 1982 these recommendations

Recent examination of log crowns revealed that the decay process continues to this day. In fact, many of the 1982 replacement log crowns have themselves decayed due to roof water continuously soaking them. Presently, approximately fifteen log crowns require work from epoxy patching to total replacement.

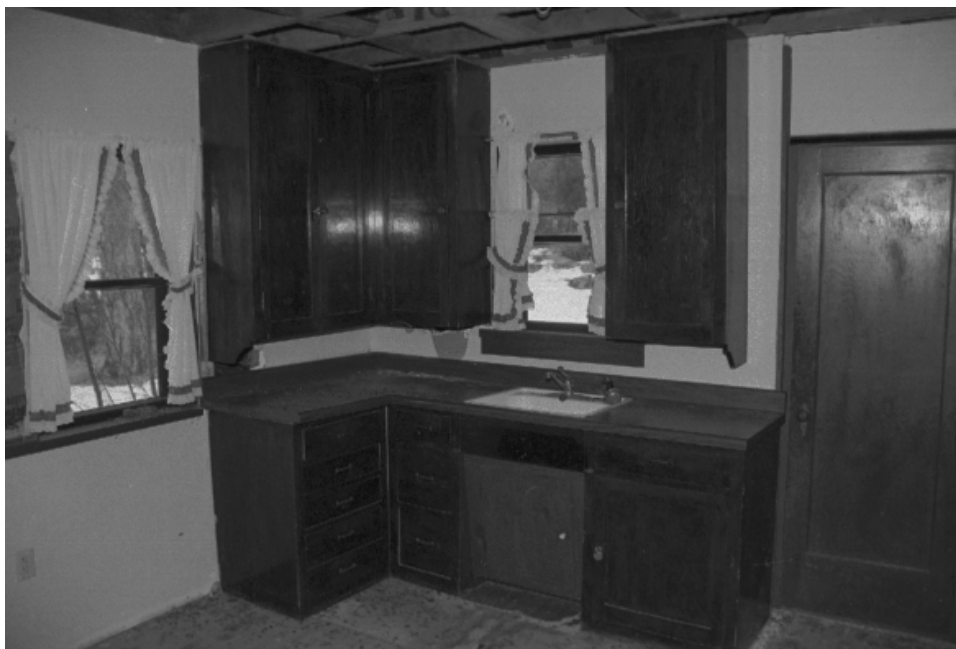
**Figure 24.** Cabinets within the Ranger Cabin kitchen (102). The cabinet door beneath the sink was added in the 1980s, but the single-bowl sink may date to construction of the cabin. Photo by the author.
