Coastal Change During Hurricane Isabel 2003

As part of a program to document and better understand the changes in vulnerability of the Nation's coasts to extreme storms, the U.S. Geological Survey (USGS), in collaboration with the National Aeronautics and Space Administration (NASA), surveyed the impact zone of Hurricane Isabel. Methods included pre- and post-storm photography, videography, and lidar.

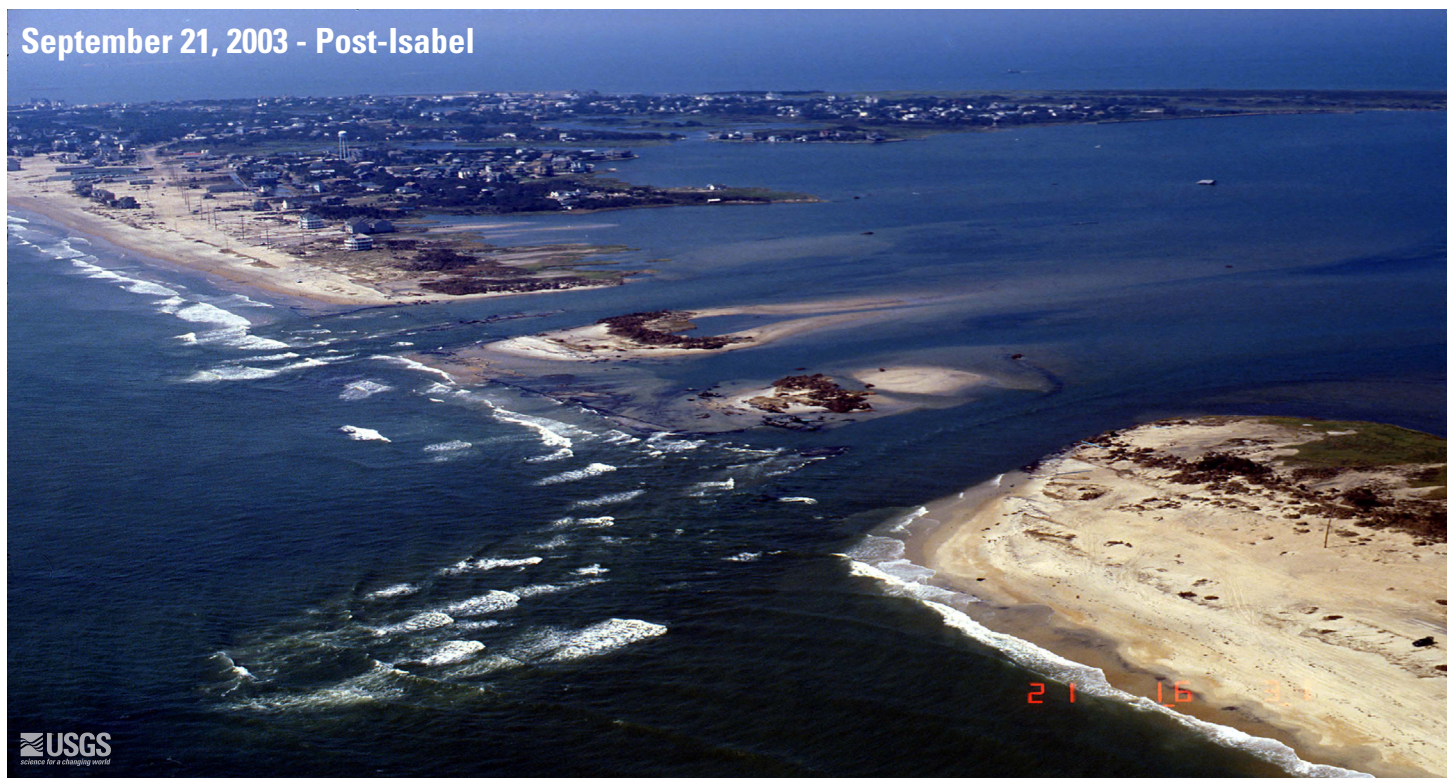
associated with the opening of a new breach about 500 m wide that divided into three separate channels that completely severed the island southwest of Cape Hatteras. The main breach, and a smaller one several kilometers to the south (not shown), occurred at minima in both island elevation and island width.

Figure 2. Hurricane Isabel opened a breach in the island southwest of Cape Hatteras. Combined waves and storm surge attacked the island where the dunes were lowest and the island was narrowest.

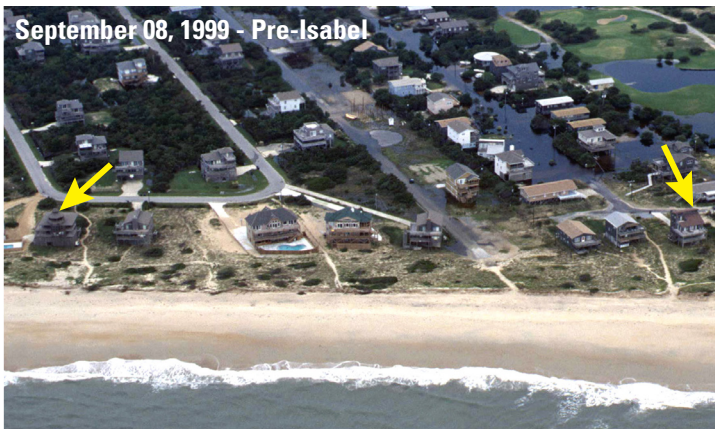
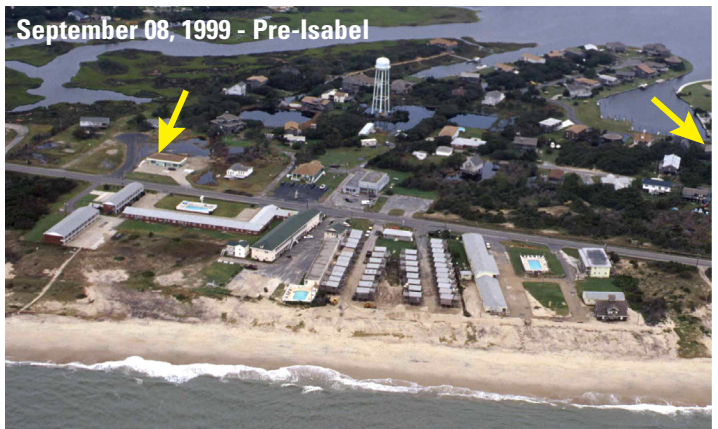
Figure 3. Frisco, North Carolina. USGS aerial photography taken before and after the landfall of Hurricane Isabel. Storm surge and waves overwashed the dunes located seaward of the first row of houses and deposited that sand across the island. (Arrows in all images point to the same features.)

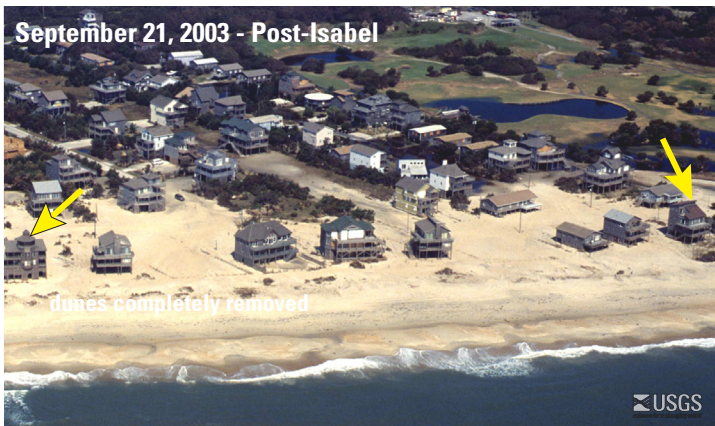
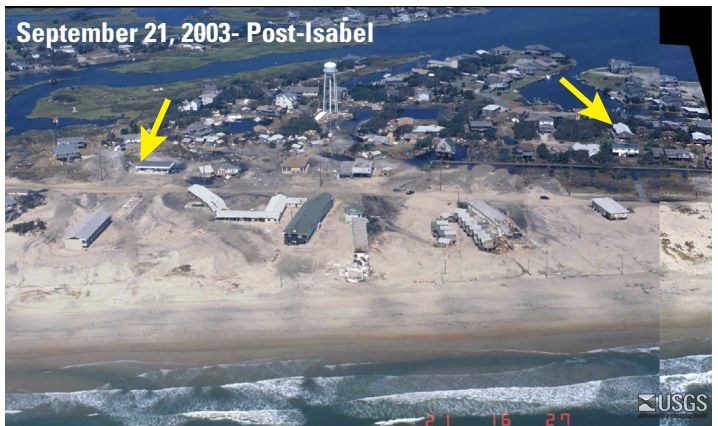
Figure 4. Hatteras Village, North Carolina. USGS aerial photography taken before and after the landfall of Hurricane Isabel. Storm surge and waves destroyed and inundated the dunes protecting the hotels. The water washed the buildings from their foundations and covered roads with sand. (Arrows in all images point to the same features.)

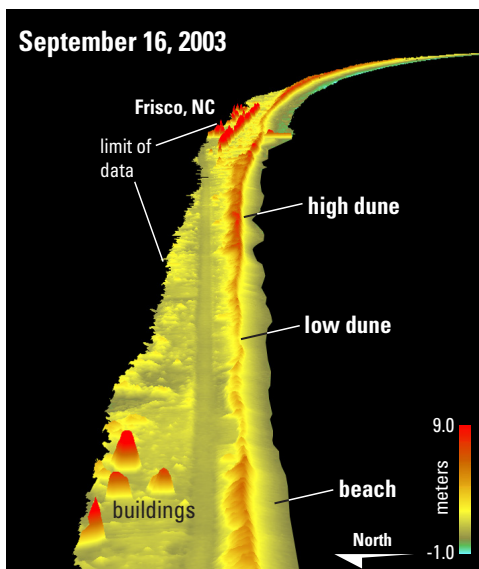
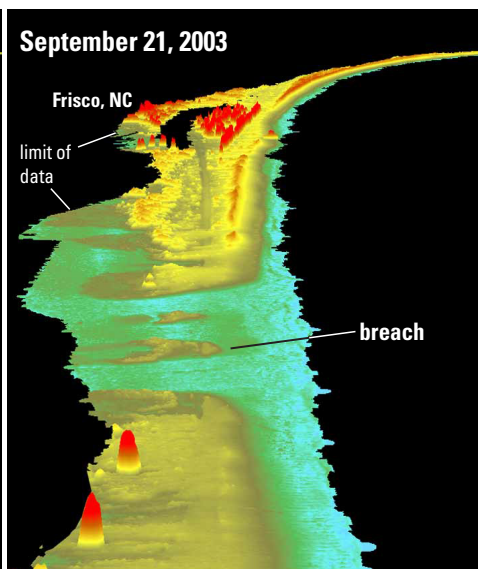
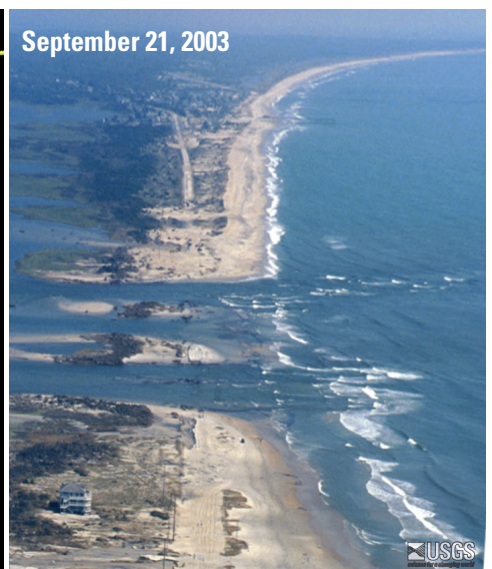
Figure 5. Hatteras Island, North Carolina. Analyses of NASA Experimental Advanced Airborne Research Lidar (EAARL) data from the island show extensive beach changes and dune erosion, as well as the destruction of infrastructure and buildings. Upper right and center: Lidar images show high-resolution topography of a portion of the coast measured with NASA's EAARL before and after Hurricane Isabel. The different colors indicate different elevations, where in the warmer colors represent higher elevations (see scale). Right: An oblique photograph taken by USGS on the same day as the post-storm lidar survey.
