SAFETY & HEALTH HAZARDS ALERT

DOE/EH-0518

Issue No. 2000-01A

UPDATE June 28, 2000 - PRELIMINARY ACCIDENT INVESTIGATION FINDINGS FROM THE PLUTONIUM-238 MULTIPLE INTAKE EVENT AT THE LOS ALAMOS NATIONAL LABORATORY

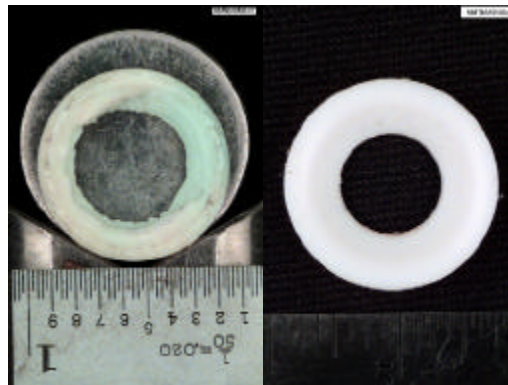
Teflon® is known to experience significant degradation in high radiation environments.¹ The degradation in ball valve seats may manifest itself in shrinkage (as much as 25%) and pitting. Further, Teflon® valve seats in glovebox vacuum lines may experience erosion and, in the case of a Pu-238 glovebox, heat damage from product that has found its way into the vacuum system. Finally, Teflon® tape used to connect threaded connections may also experience degradation.

Figure 2: Teflon® valve seats from failed valve (left) and new valve (right)

Where Teflon[®] valve seats or sealing compounds are used in process piping or associated hardware and the material is subject to high radiation fields, facilities should:

- Implement periodic inspection and replacement program to ensure component replacement prior to failure. In the accident discussed above, the ball valve felt "loose" when operated, due to degraded seats.
- Ensure design criteria carefully evaluate selection of components containing Teflon[®] in radiological services.
- Give consideration to radiation resistant sealing materials or seals composed of metal-to-metal surfaces.
