Joanne D. Lorence  
Program Engineer,  
Facility Representative  
NNSA Los Alamos Site Office

Lessons Learned from  
Type B Accident Investigation  
of the August 5, 2003  
Plutonium-238 Multiple Uptake Event  
at the Plutonium Facility,  
Los Alamos National Laboratory, New Mexico

Douglas M. Minnema, Ph.D., CHP  
Type B Investigation Board Chairperson  
NNSA Service Center

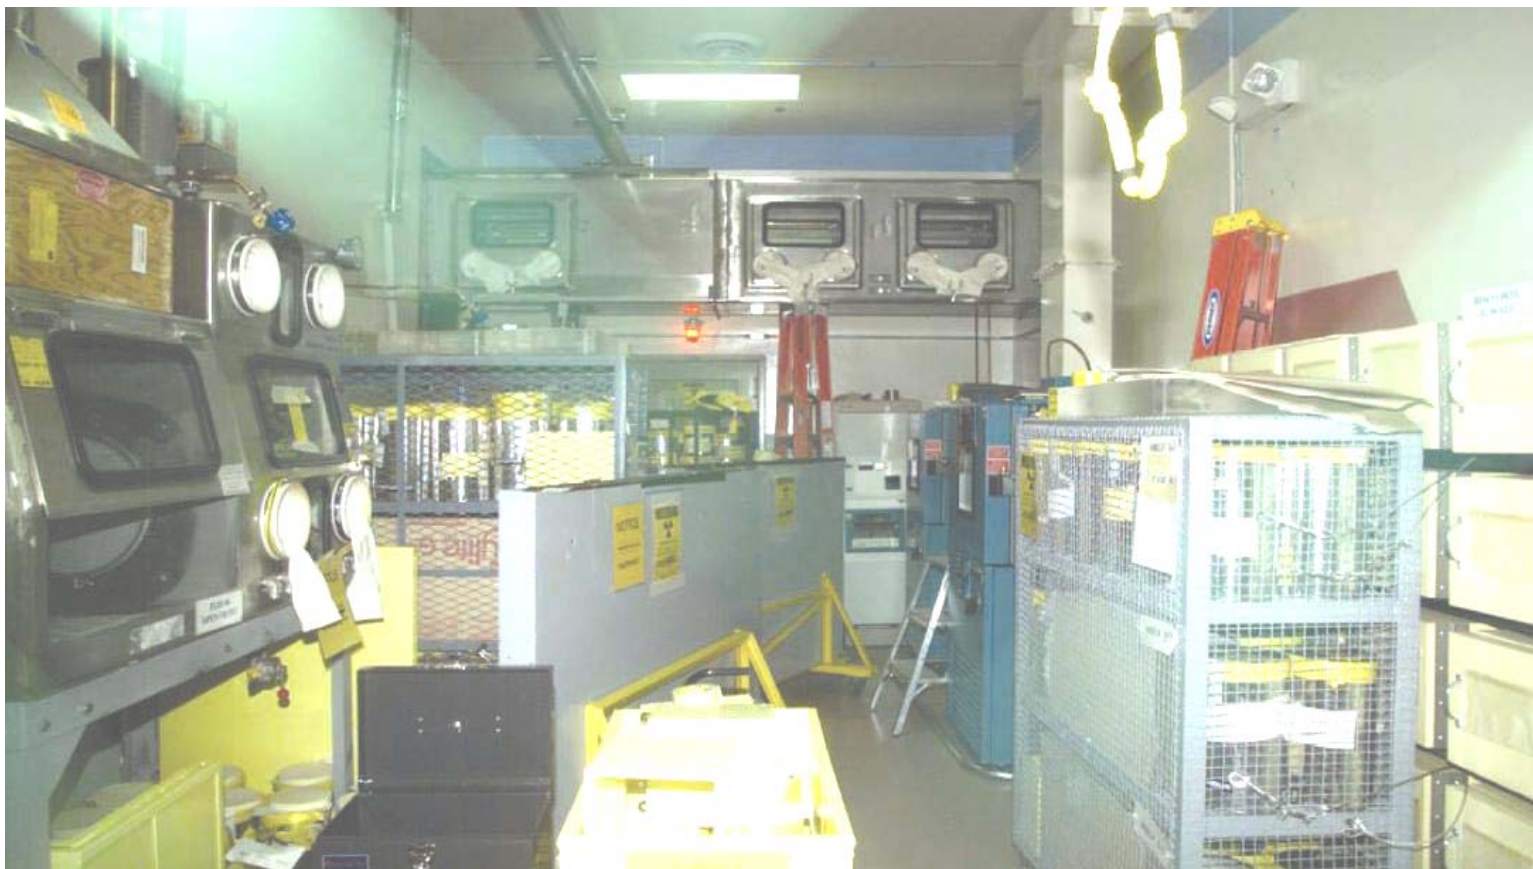
- Room 201B is a 29' by 14' room adjacent to a NMT-9 processing area. The room is used mainly for storing packages containing Pu-238 residues and contaminated materials generated by NMT-9 processing activities.

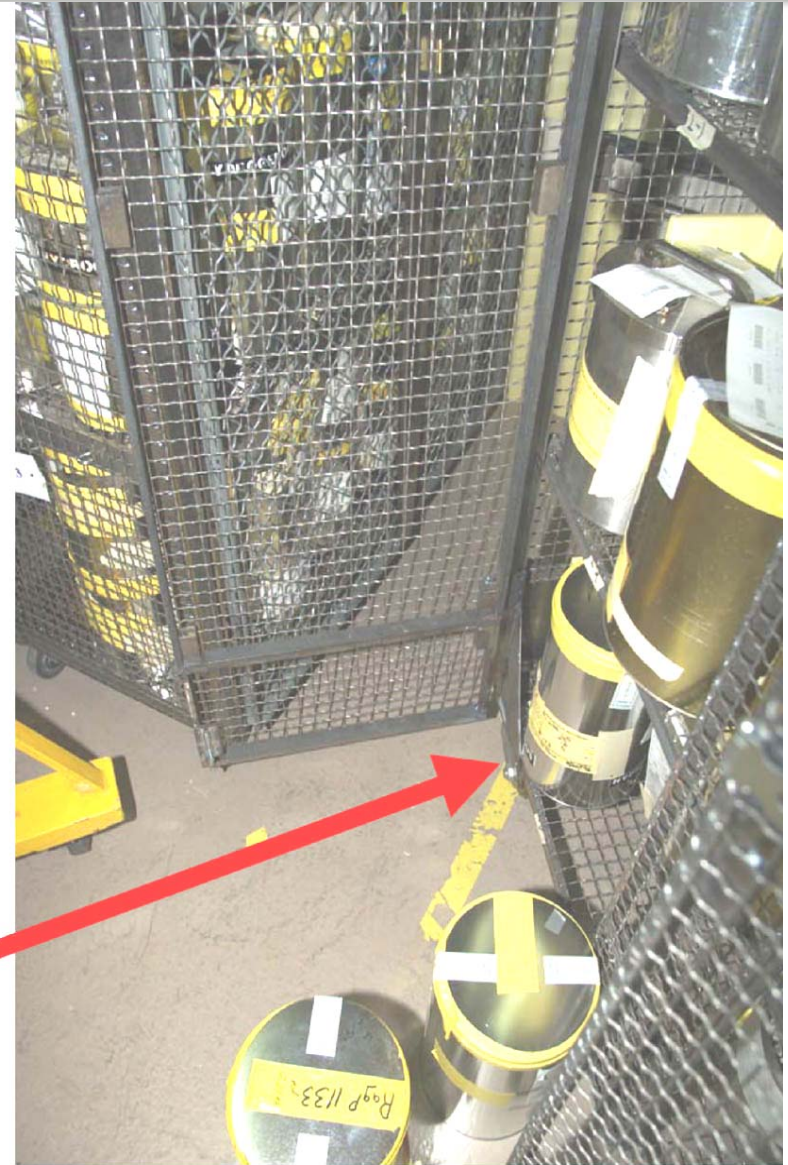
- Release of airborne contamination from a degraded package that contained cellulose material and Pu-238 residues. The failed package had been in storage since 1996.
- Radiolytic, chemical, and thermal decomposition of the contents and the packaging materials caused the failure of two inner boundaries. Corrosion sealed the “breathable” seams of the outer boundary, allowing decomposition gases to build up inside package.
- Simple handling of package dislodged corrosion at seam junction, allowing venting of contaminated gases to room.

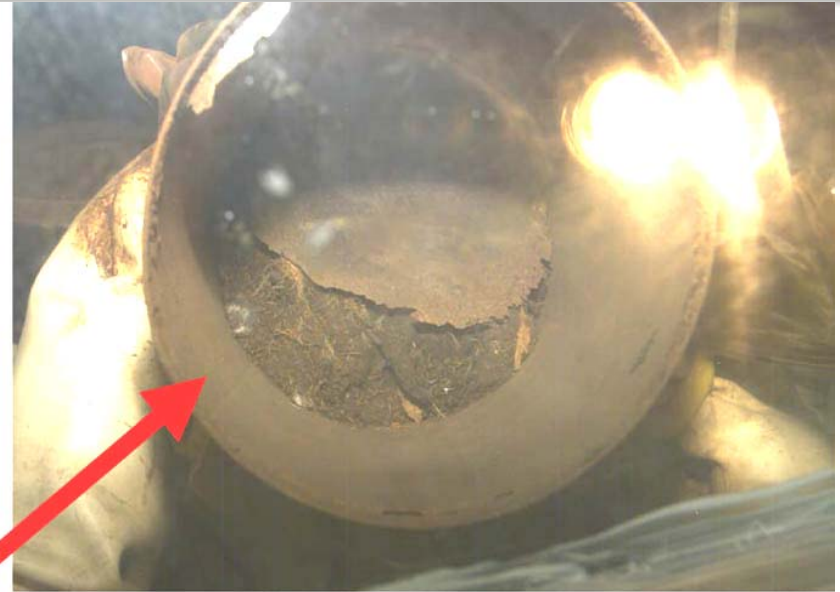
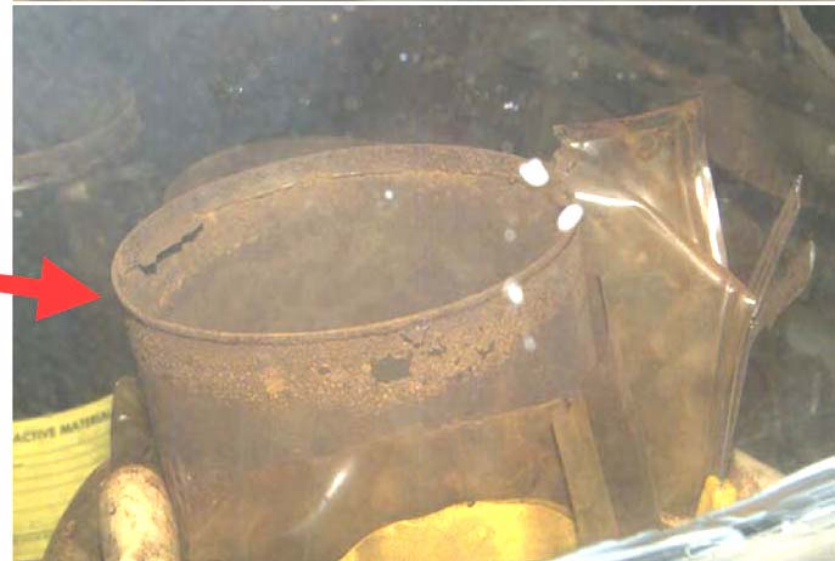
- The inner boundary was a slip-lid can of same design as outer can, but had a particulate filter mounted on the lid. Contents were Pu-238 contaminated cheesecloth. May have had residual nitric acid, cleaning solution, and water.

- Thermal and radiolytic decomposition of cheesecloth creates water and gases.
- Bottom of can corrodes to failure and separation from sidewall.
- Sidewall corrodes to failure near bottom of can.
- (Note: photos are views of the bottom of the can)

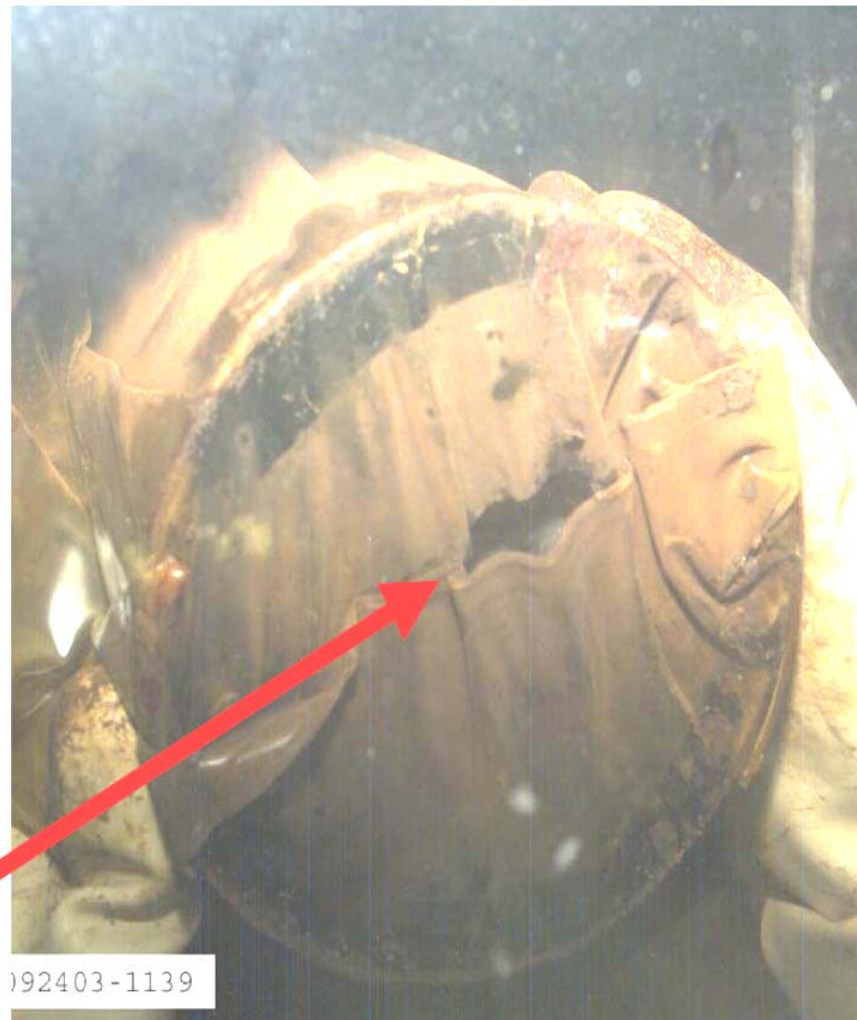
- The second boundary was a heavy gauge PVC bag with a particulate filter. This “bag-out” bag is used to contain the contaminated inner can when it is removed from the glovebox.
- Exposure to alpha radiation caused decomposition of the PVC bag, resulting in generation of hydrogen chloride, which combines with water vapor to create hydrochloric acid. This is indicated by browning of the bag.
- Hydrochloric acid contributed to corrosion of the inner and outer cans.
- Weakened bag fails at stress point along seam on bottom of bag.

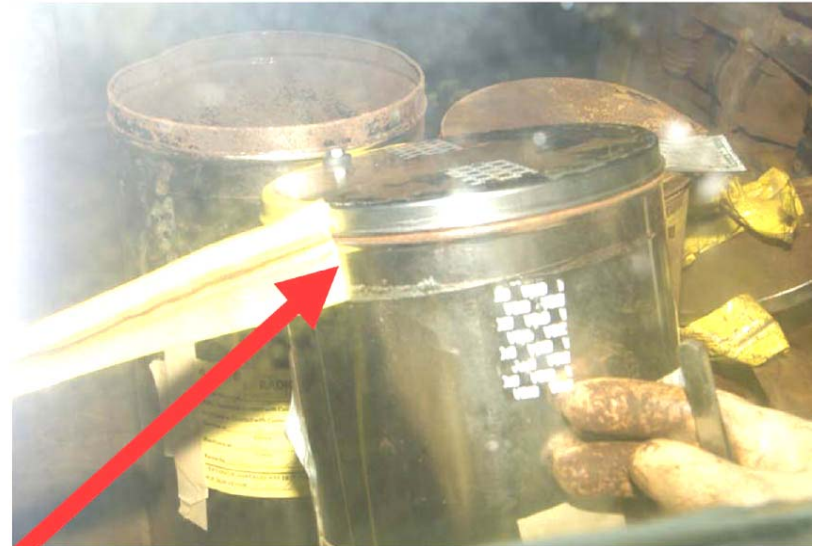
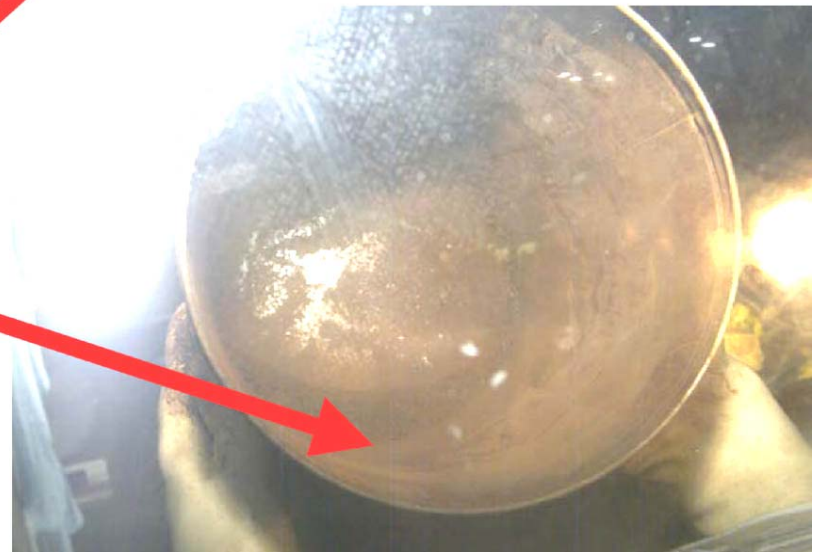
The outer boundary was a slip-lid “foodpack” can with the lid circumferentially taped with vinyl tape. No particulate filter was installed on this boundary, seams and lid were assumed to “breathe” as per manufacturer.

- Acid and water vapor, and decomposition gases passed through filters on inner boundaries and attacked outer can.
- Corrosion products collected under the lid, and held in place by the tape, inhibited breathing around the lid.
- Corrosion products collecting around the bottom edge of the can sealed the seam.

(**Note:** No significant defects are visible on the exterior of the can.)
