LA-13638

A Review of Criticality Accidents

2000 Revision

Issued: May 2000

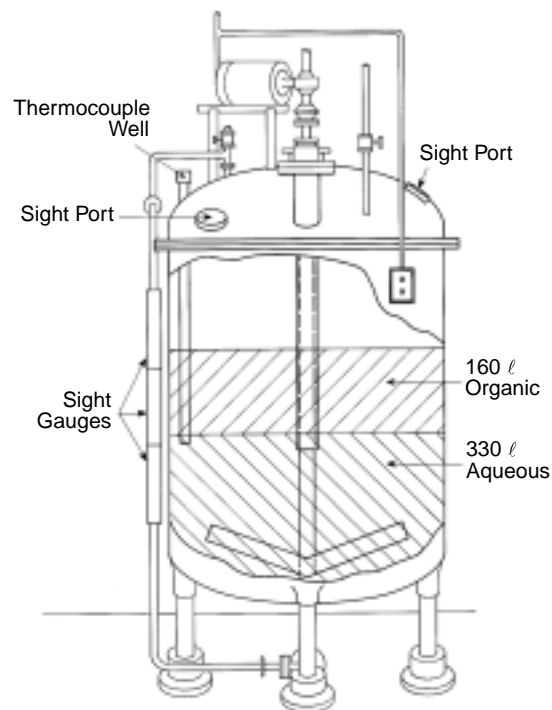
Figure 11. Configuration of solutions (aqueous and organic) in the vessel before the accident.

From these time intervals and the estimate that initially the system was 5 \$ subcritical, the reactivity insertion rate would have been about 5 \$/s. Using coefficients appropriate for the solution, this insertion rate leads to a spike yield of 2.2×10^{17} fissions with the spike completed in 1.65 seconds, that is, 0.45 seconds after prompt criticality was reached. To obtain the observed yield (1.5×10^{17} fissions) in a single spike, the reactivity insertion rate would have to be reduced to about 2 \$/s. Because this is inconsistent with the time involved (about 3 seconds before complete mixing), the only alternative is to assume that the rate was somewhat less than 5 \$/s and that the excursion was terminated in about 3 seconds by the stirring action. One can surmise that the initial action was thickening of the upper layer at the same time reflection was added by the aqueous liquid. This was followed almost immediately by distortion into a less critical, vortex-like shape by the action of the stirring blades and then permanent shutdown due to a uniform concentration of less than 7 g/ℓ.

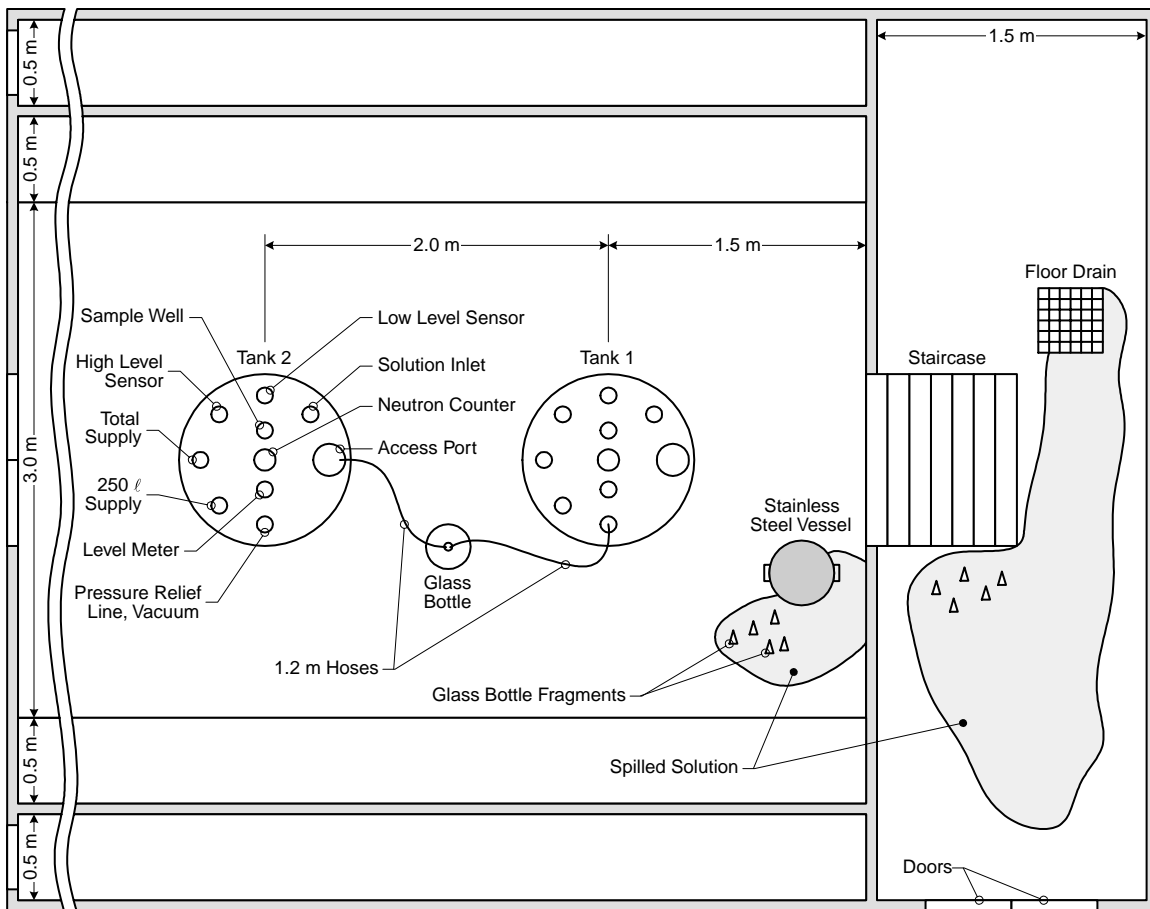
Figure 23. Plan view of the tanks involved in the accident.

Under instructions from the supervisor, the second operator resumed the decanting of the solution from tank 2 to the bottle. By carefully adjusting the depth of immersion of the hose from the access port the

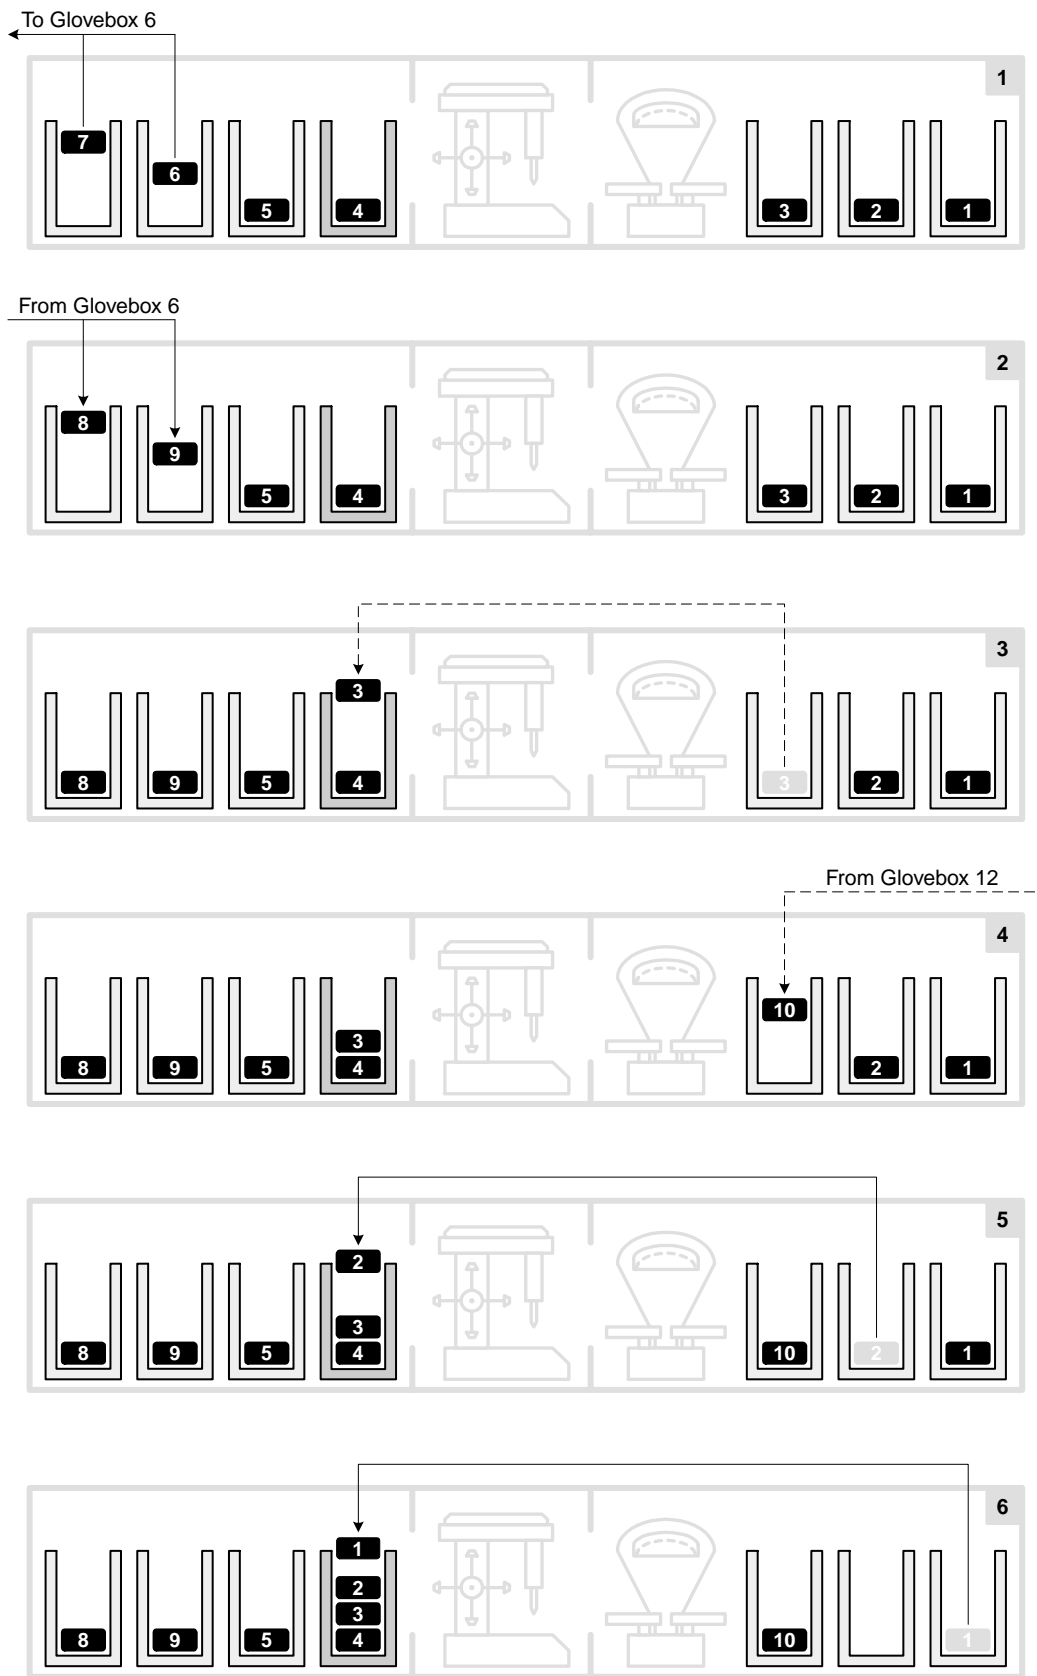
Figure 31. Actual order of ingot transfers from and to Glovebox 13. The solid lines represent the actions of operator A and the dotted lines the actions of operator B.

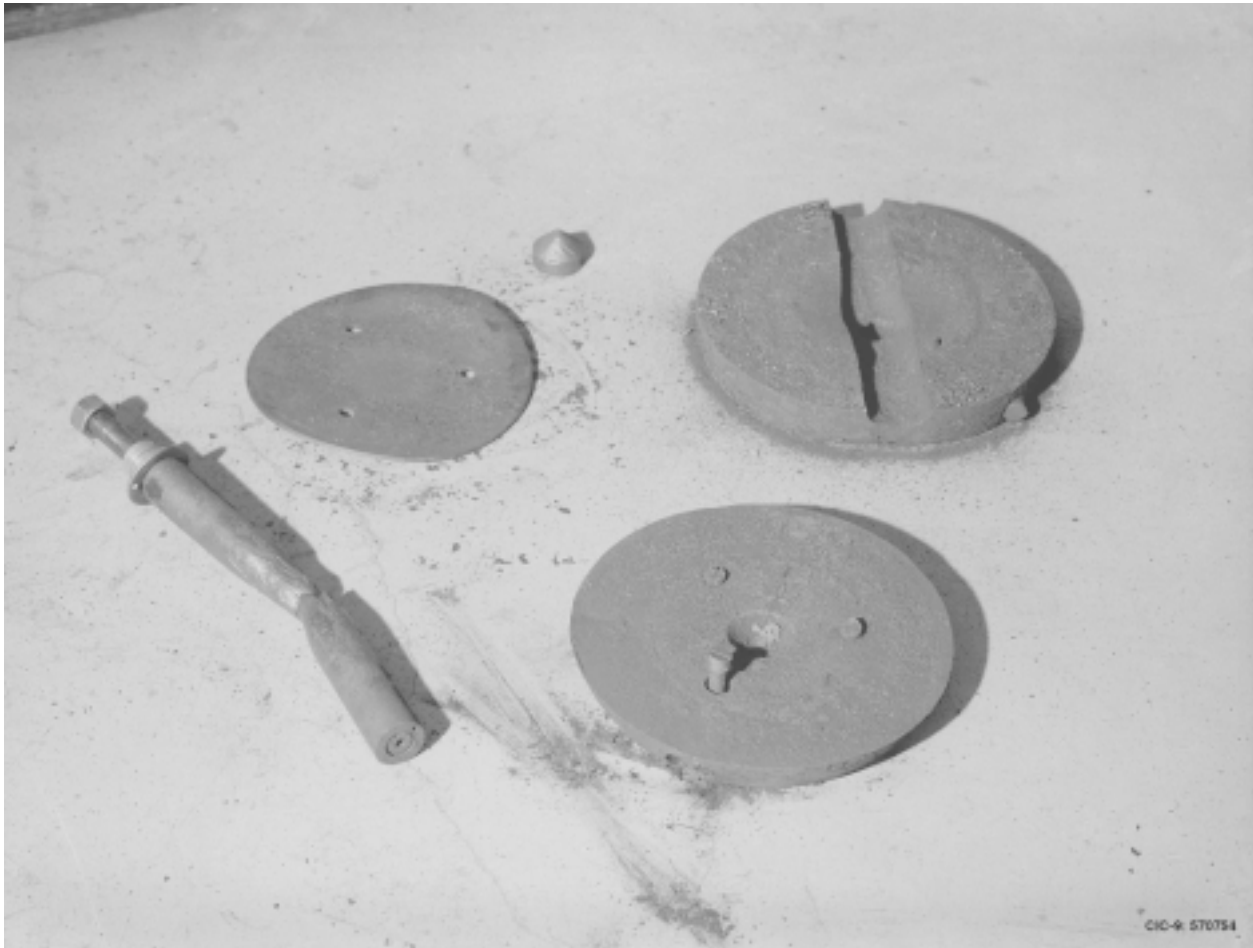
Figure 50. Burst rod and several sections of Lady Godiva showing oxidation and warpage that accompanied the second accident, 12 February 1957.
