Title: CERRO GRANDE FIRE ONE YEAR AFTER:

AN UPDATE ON ER ACTIVITIES TO REDUCE
THE POTENTIAL MOVEMENT OF
CONTAMINATION AT POTENTIAL RELEASE
SITES

Authors: STEVEN J. VEENIS, CPESC

Submitted to: WATER QUALITY & HYDROLOGY GROUP (ESH-18)
ENVIRONMENTAL RESTORATION PROJECT

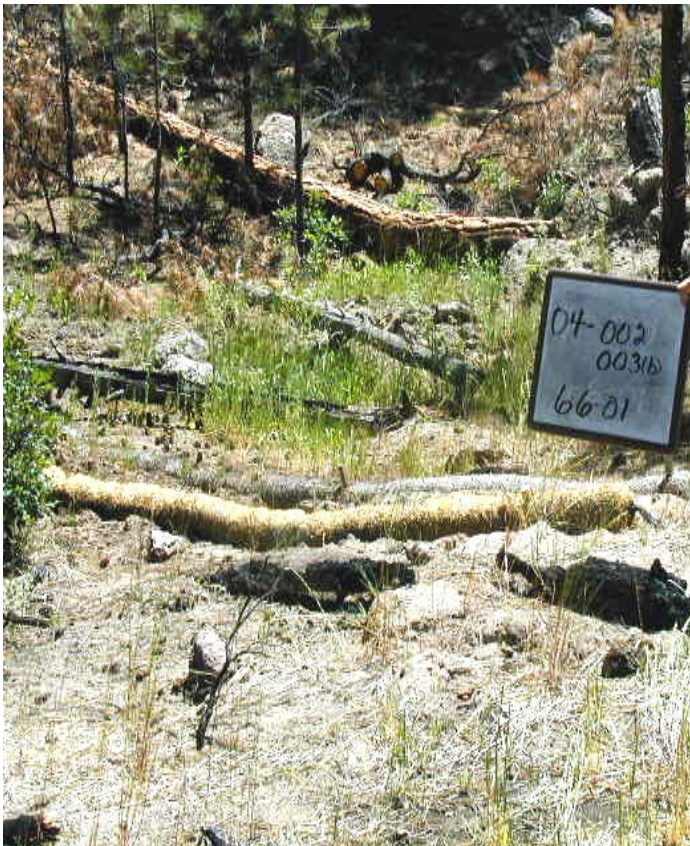
Site is in good condition, with vegetative cover of greater than 50%. The area appears stable with evidence of sediment migration being minimal.

Maintenance consisted of installation of an additional 15 wattles throughout the site. Several trees were trimmed and used as sediment retention in adjacent drainage swales.

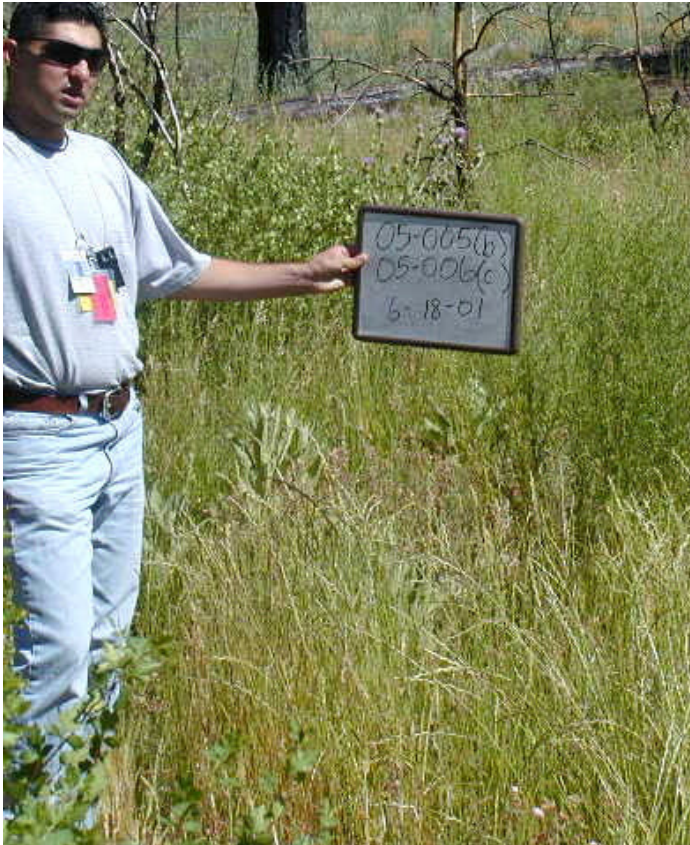
Site is in good condition, with vegetative cover of greater than 70%. Sediment migration is occurring in the steepest part of several drainage channels, but the straw wattles on the flatter bench appear to be keeping sediment from entering into Canada del Buey.

Maintenance consisted of installation of an additional 28 wattles throughout the site. A few more trees were felled within drainages and spot reseeding and mulch were applied.

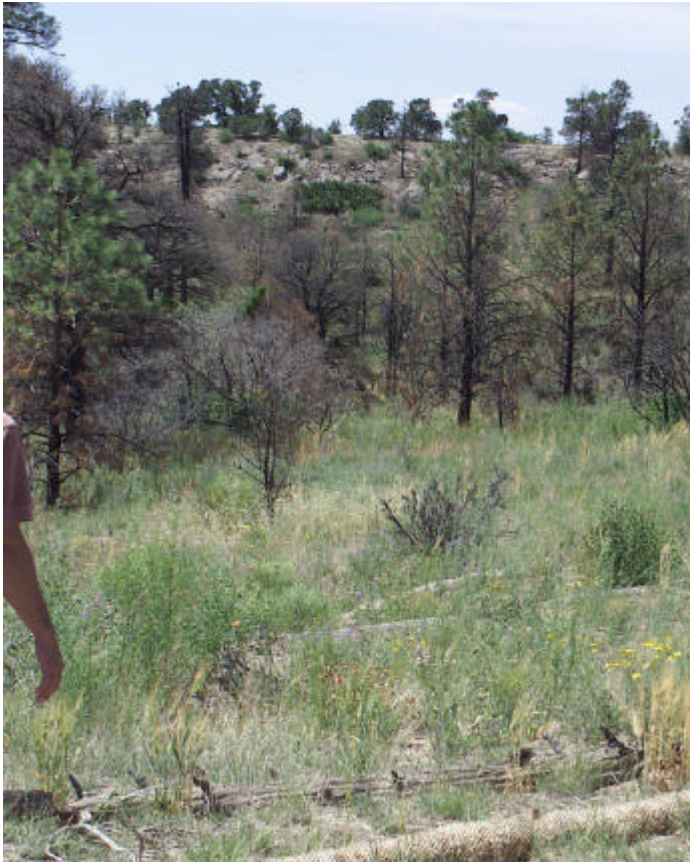
Site is in good condition, with vegetative cover of greater than 50%. Sediment migration is occurring in the steepest part of several drainage channels, but the straw wattles on the flatter bench appear to be keeping sediment from entering into tributary drainage.

Maintenance consisted of installation of an additional 22 wattles directly down gradient of existing wattles. Spot reseeding and mulch were applied where needed.

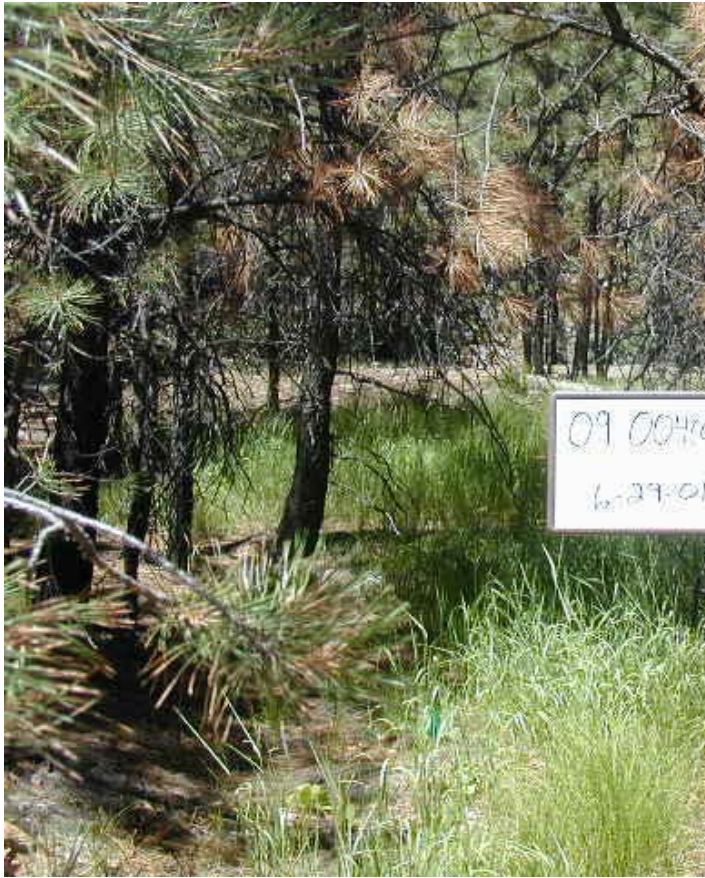
9-004(o) - Erosion Matrix Score 43.8. Inactive NPDES outfall associated with a sump and settling tank within building TA-9-48. The reinforced concrete settling tank within building TA-9-48 (PRS 9-004(n)) is subsurface and was not impacted by the fire as originally suspected.

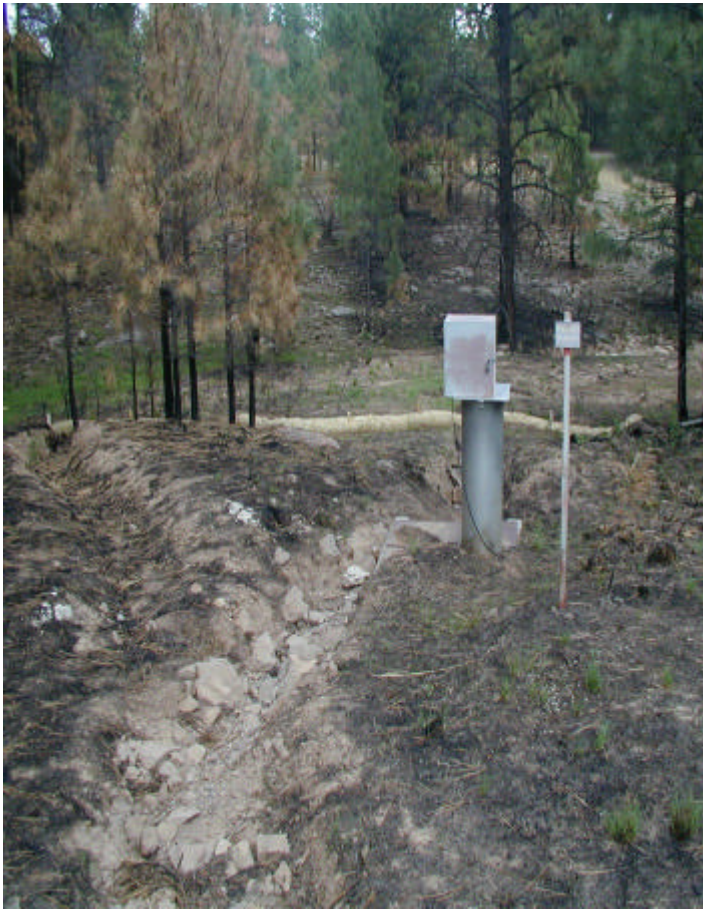
9-009 - Erosion Matrix Score 58.8. A lagoon and sand filters used to treat sanitary waste. After flowing through the sand filters, effluent discharged to a currently inactive NPDES outfall (555 02S).

This site is located south of Pajarito Canyon within the Starmer/Upper Pajarito Watershed Aggregate. The PRS is the former Sanitary Wastewater Treatment Facility north of TA-9. Site has moderate fire damage with ground and canopy cover being impacted.

Straw wattles were installed in the drainage swales and rock check dams were placed in the channels to dissipate flow (using existing materials found on-site). Wattles were also provided upslope for run-on diversion.

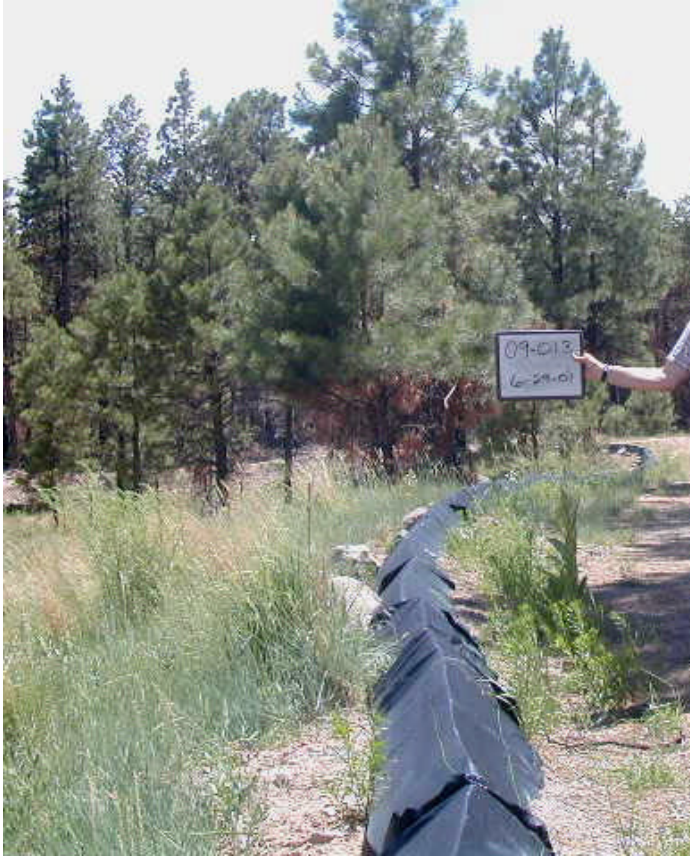
This site is located south of Pajarito Canyon within the Starmer/Upper Pajarito Watershed Aggregate. The area surrounding MDA M was moderately to severely burned as was a majority of the upper Pajarito Watershed. All of the existing erosion controls at the site were destroyed.

Run-on controls were replaced as shown below. The entire site was hand raked, reseeded and mulched. A retention basin was installed at the bottom of the slope to create a “zero discharge” area.

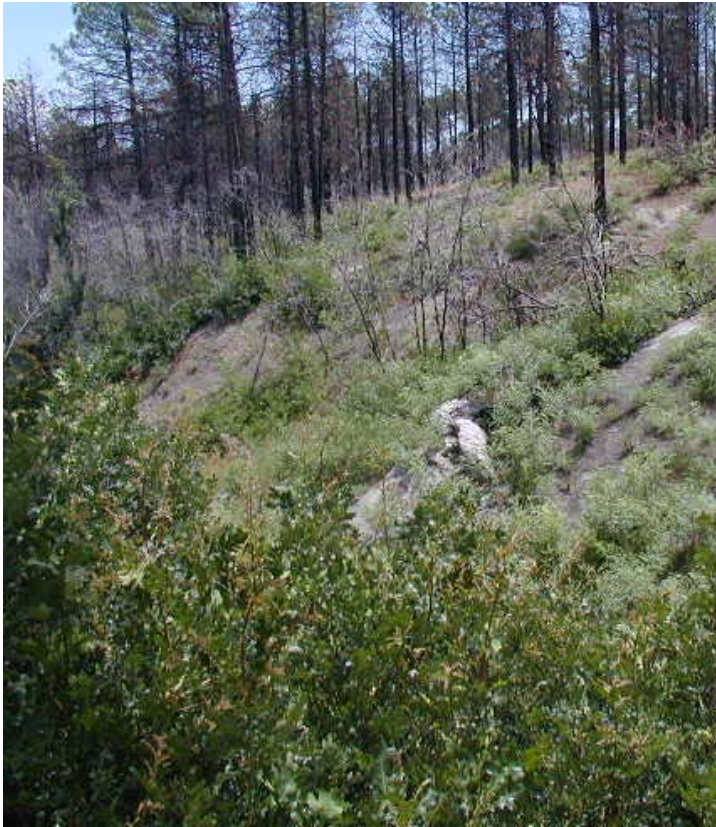
This site is located north of Water Canyon within the S-Site Watershed Aggregate. The site has moderate to severe fire damage in the area surrounding the TA-11 Drop Tower. Log check dams within the major drainages received partial damage. All straw barriers installed around site were destroyed.

The log check dams (on-site materials used) were replaced within the adjacent drainages. Straw wattles were placed on the slopes and geotextile was installed in the areas with the most erosion potential. The area surrounding the Drop Tower was hydromulched to enhance the revegetation process.

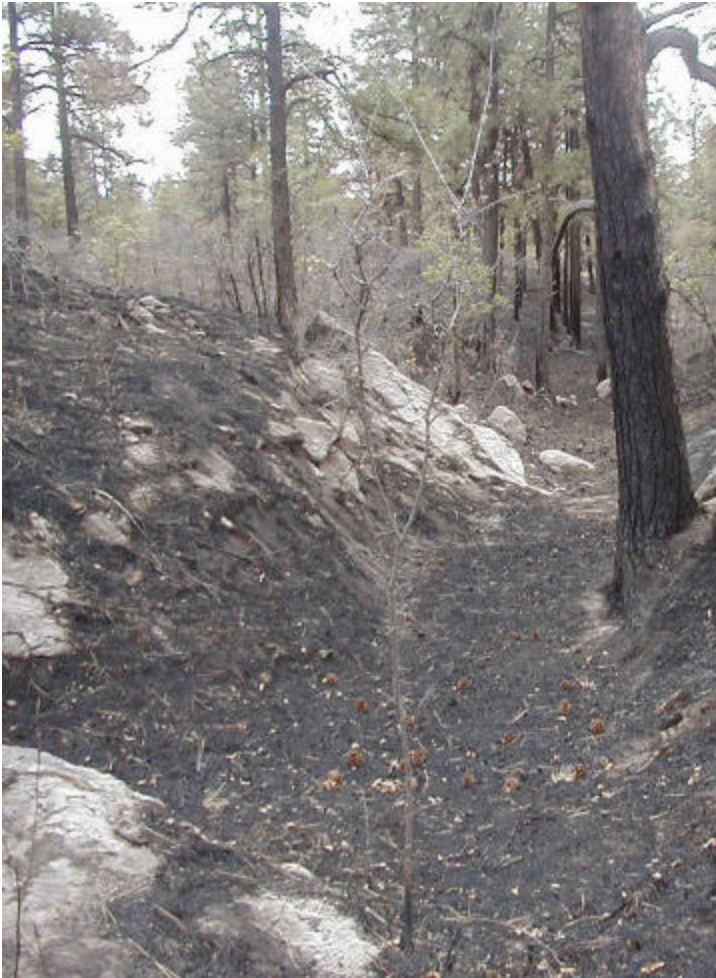
14-009 - *Erosion Matrix Score 53.7*. Surface disposal area consisting of ruptured sand bags which were used for containment during explosives testing activity. Sand could be contaminated with lead, uranium, HE and beryllium.

14-010 - *Erosion Matrix Score 51.5*. High explosive waste sump adjacent to TA-14-2. The site may have contained HE and other chemicals. The sump and drain-line were removed.

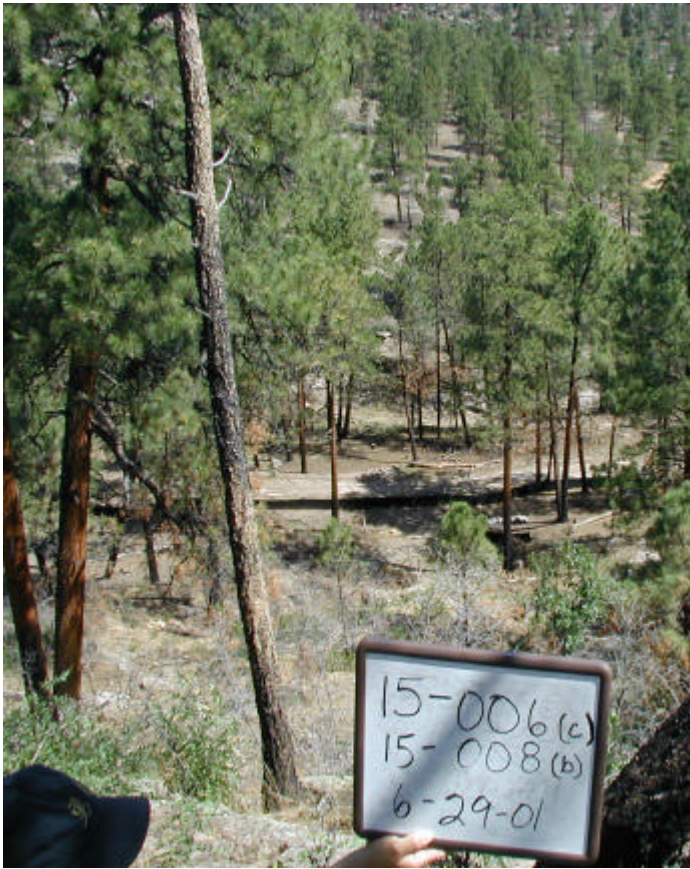
This site is located on the south rim of Three Mile Canyon within the Three Mile Watershed Aggregate. 15-006(c) has moderate to severe burn damage with most of the damage adjacent to the former R-44 Firing Pad. A large amount of firing site related debris has been exposed throughout the site (especially towards the east).

Straw wattles, rock check dams and silt fencing were installed throughout the burned areas. The area was then hydromulched to enhance the revegetation process.

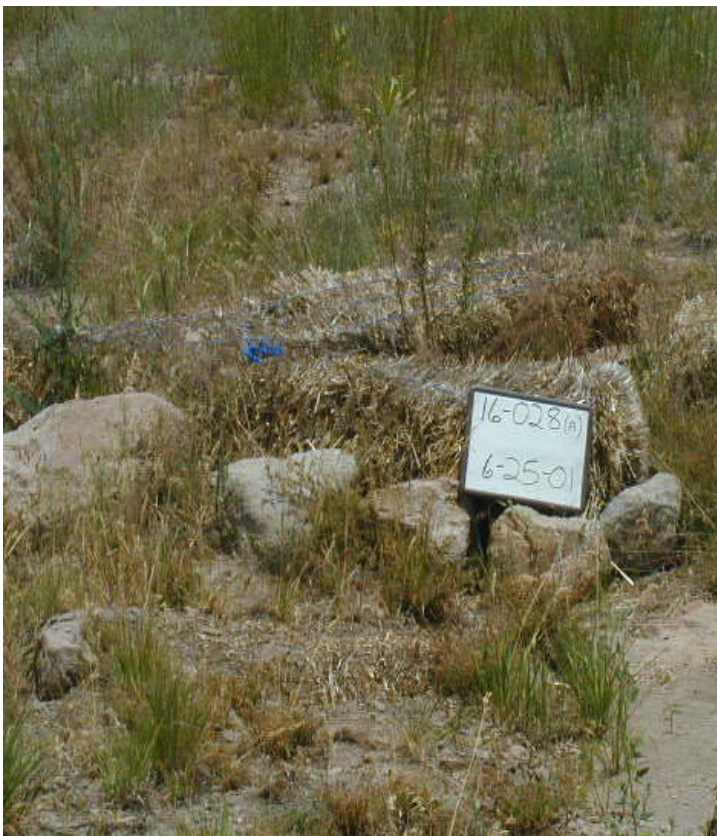
This site is located near a tributary of Water Canyon within the Canon de Valle Watershed Aggregate. The site has minimal fire damage to the west and south. Some minor burning occurred within the SWMU boundary, but consisted mostly of destroyed grasses. The HEWTF remains operational.

Straw barriers and rock check dams (existing materials found on site) were placed within the drainage swale to reduce sediment transport potential.

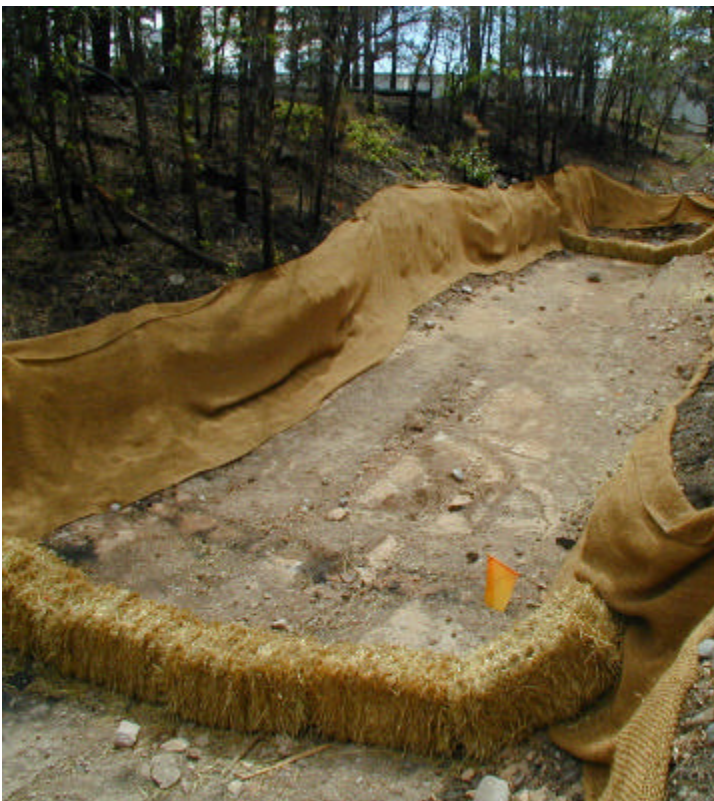
This site is located in a tributary drainage of Canon de Valle within the Canon de Valle Watershed Aggregate. Burn damage is minor to moderate within the SWMU boundary. Heavy equipment on-site was not affected by the fire, although some hoses, drums and misc. equipment were damaged. The upper drainage pond was not burned. The lower drainage received minimal damage from the fire.

Straw barriers were replaced within the drainage channel and jute matting was installed to protect the exposed slopes. All excavated material remains covered with HDPE liners and is surrounded by an earthen berm. The storm water retention pond was unharmed and remains effective as a retention area.

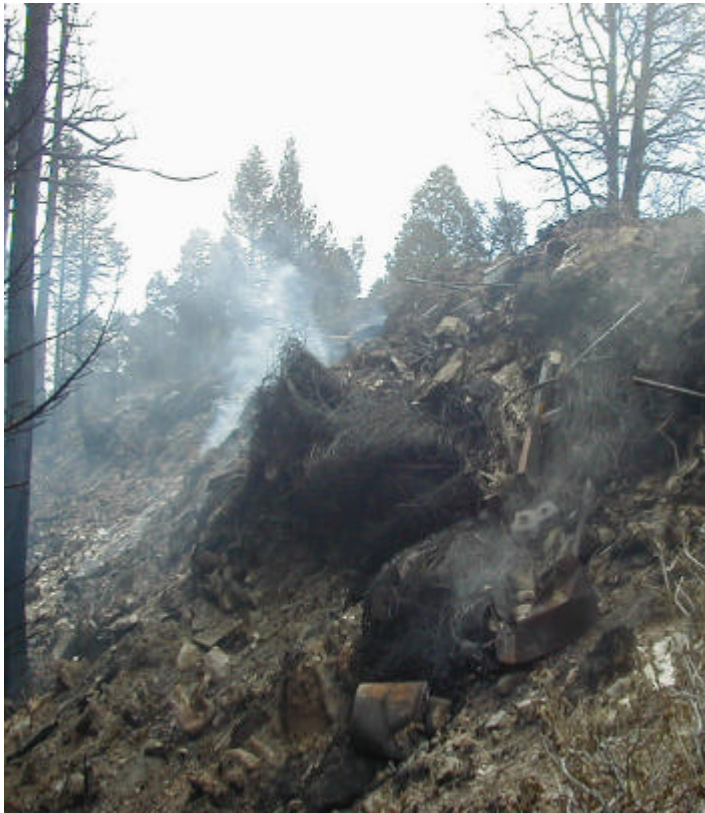
16-019 – Erosion Matrix Score 83.0. A material disposal area (MDA R) that consists of the WW II S-Site burning ground and its waste disposal site. This site was found smoldering on May 18th, 2000.

This site is located near building TA-16-260 above Canon de Valle within the Canon de Valle Watershed Aggregate. The site has moderate to severe fire damage over a majority of the area. Miscellaneous debris was exposed on the mesa and slope above canyon channel. The dissipation controls installed within the eastern drainage were destroyed. The ground and canopy cover was completely destroyed. Ash is up to 12” deep in some areas at the toe of slope. Burning occurred in the Canon de Valle leaving severe erosion potential behind.
