LA-UR-98-4170  
April 1999

# Best Management Practices Report for Installation of Stabilization Measures at Potential Release Sites 49-001(b, c, d, and g)

Environmental Restoration Project  
A Department of Energy Environmental Cleanup Program

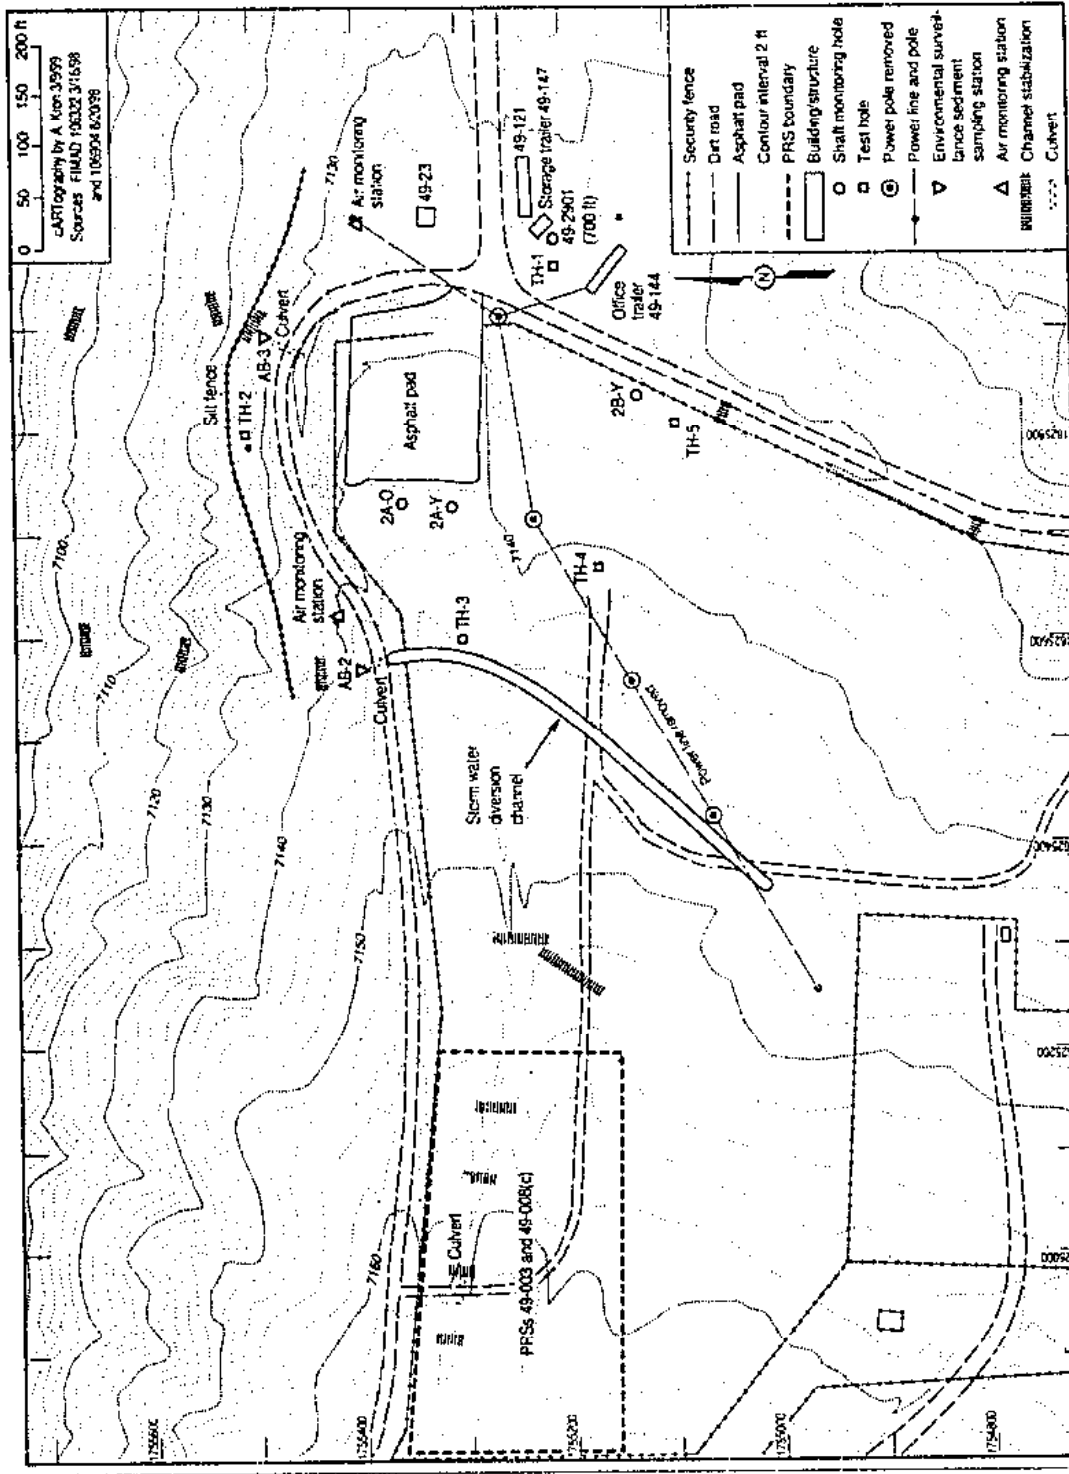
Figure 2-1 Locations of site run-on and runoff controls.

The two principal downgradient channels draining the site were each stabilized in several places with straw bales and by check dams constructed of tree trunks, branches, brush, and rocks. These materials provide energy dissipaters to slow storm water flow and retard sediment migration. The approximate locations of these runoff controls are shown in Figure 2-1. A photograph of a portion of one of the stabilized channels is shown in Figure 2-3.

The principal upgradient channel draining onto the site passes through Potential Release Sites 49-003 and 49-008(c). This channel was stabilized in four places (Figure 2-1) to control potential erosion and transport of sediment into Area 2. In addition, a smaller tributary channel was also stabilized (Figure 2-1), and potential erosion of an adjacent rutted road was controlled by diverting flow from the ruts into the main channel. Straw bales, which act as energy dissipaters to slow storm water flow and retard sediment migration, were used to stabilize the channels.

the subsequent asphalt removal and site regrading phases. Four power poles on the site were decommissioned and cut about 4 feet above the ground when the line was removed. The pole stubs were pulled from the ground during diversion channel construction in June 1998. The original locations of these power poles are shown in Figure 2-1.

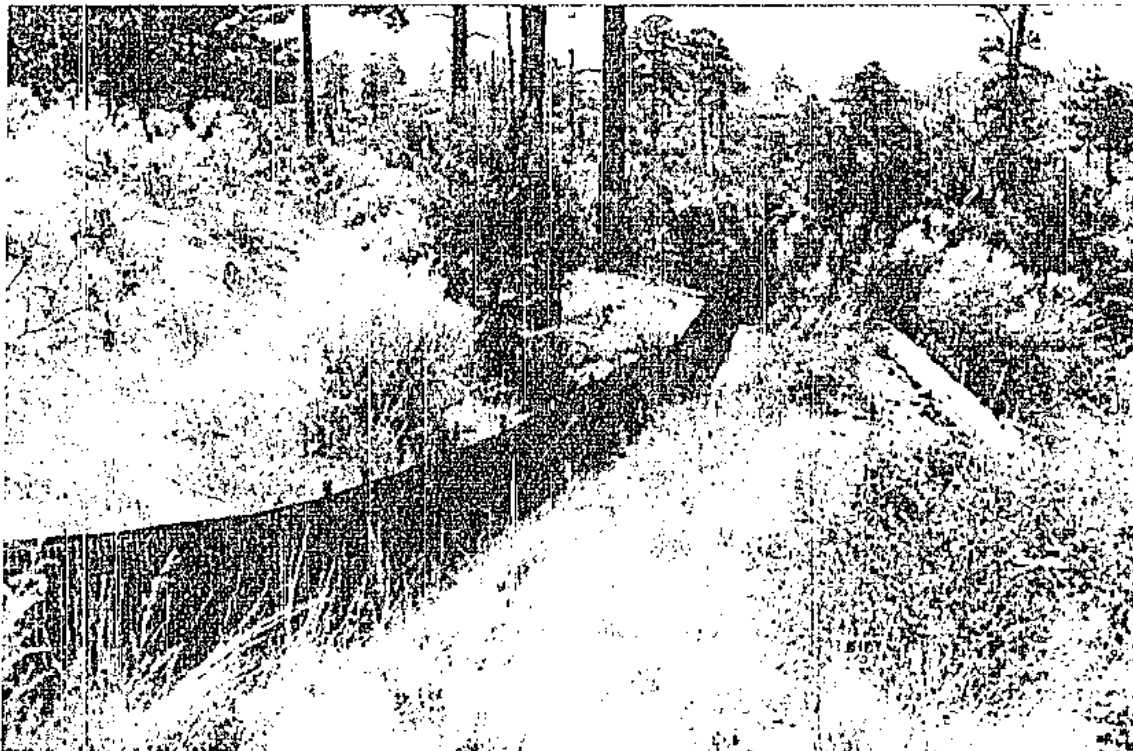
**Figure 2-2. Silt fence (view is from the west).**

A temporary silt fence was installed downgradient of the site, in accordance with the Storm Water Pollution Prevention Plan (Environmental Restoration Project 1998, 62910). This fence was located to capture sediments that could erode from the site during the diversion channel construction and the subsequent asphalt pad removal and site regrading. The silt fence is about 2 feet high and 610 feet long. It is constructed of heavy open weave fabric backed by a supporting wire mesh and is designed to allow water to flow through while trapping sediments. The as-built location of the silt fence is shown in Figure 2-1, and location coordinates are shown in Table 2-1. The fence crosses the two principal downgradient drainage channels north of the site and extends continuously between them. Continuing the fence around the east side of the site, as originally planned, was not necessary because drainage does not cross the road in that direction. A photograph of the silt fence is shown in Figure 2-2.

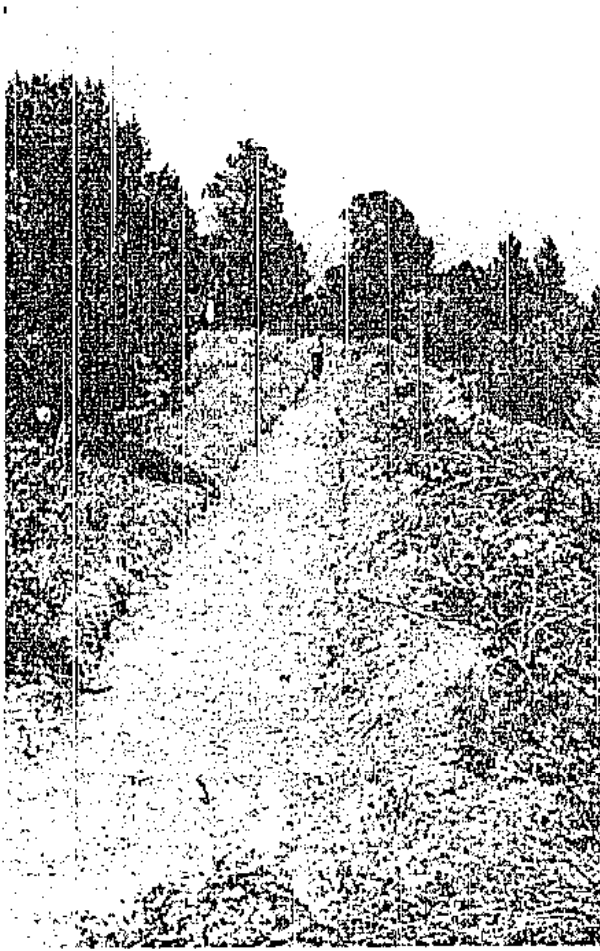
**Figure 2-4. Surface water diversion channel (view is from the north)**

Before construction of the surface water diversion channel, ESH-1 personnel screened surface soils at the site and found no above background radiation. Access for construction was gained by temporarily breaching the site fence at the channel outlet. The channel was excavated by backhoe under field direction, and the excavated soil was used to construct a low berm on the downgradient (east) side of the channel. The northern part of the channel followed the trace of an earlier diversion channel, according to NMED's request, to minimize disturbance to the land. The southern part of the channel extended the earlier channel so that all surface water run-on moving toward Area 2 is now intercepted and diverted into a tributary to Water Canyon. The channel was constructed with a nominal bottom width of 4 feet and a depth of 1 foot. The berm was also constructed with a nominal top width of 4 feet and height of 1 foot above the original ground surface. The channel's outlet was located to allow drainage directly into an existing culvert, as shown in Figure 2-1. Except for the length, design and location specifications in the stabilization plan were followed for the surface water diversion channel (LANL 1998, 59166). A land survey conducted before construction indicated that to maintain a continuous grade of about 1 percent, it was necessary to lengthen the southern part of the channel by about 80 feet and move it farther to the west than originally planned. The as-built channel is 406 feet long, and its location is shown in Figure 2-1. State plane coordinates for locations along the length of the channel are presented in Table 2-1. A photograph of the channel is shown in Figure 2-4. A cross-section of the channel and berm is shown in Figure 2-5.

After construction, the surfaces of the channel and berm were compacted with a backhoe and vibraplate to improve erosion resistance. An organic mulch was placed on the berm and

channel sides to protect against erosion. Brush and limbs removed during construction were placed on top of the berm. Erosion control mats were placed along the entire length of the upgradient (west) bank of the channel and on the downgradient (east) bank across from locations where major drainages enter the channel. These mats are made primarily of biodegradable natural wood fiber. They immediately stabilize the soil by slowing surface water flow and aid in germination of vegetation. The mats were installed following the procedure presented in Storm Water Best Management Practice (BMP) Guidance Document (Merrick Engineers and Architects 1998, 58696, p. 54). Because of evidence from the storm water diversion channel that natural reseeding occurs quickly at the site, artificial reseeding of the matted area was not conducted. Work was completed by cleaning up the site and restoring the site perimeter fence.
