Transuranic Waste Inspectable Storage Project (TWISP) Retrieval from Pads 1, 2, and 4 at Technical Area 54

Final Report

February 2002

Los Alamos National Laboratory

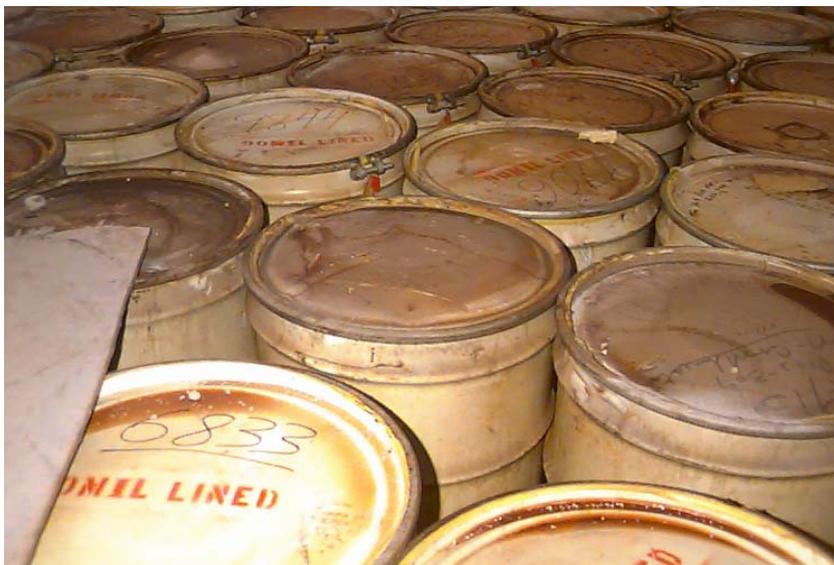
Figure 1-11. Examples of Pressurized 55-Gallon Open-Top Metal Drums

As drums associated with the TWISP were stored at the site for over a decade, the possibility exists that the drums would become pressurized. The exact cause of the pressurization is unknown, however, radiolytic decomposition of organic constituents; water/reactive metal reactions, or volatile components in the waste, may all be causes of the over pressurization. Examples of drums that have experienced pressurization are shown in Figure 1-11.

- bulge only occurred at the top and bottom ends
- audible pinging was noticeable between 15 and 20 psig
- drum body seams (top to bottom) experienced no visible distortion or apparent weakening
- drums appear to vent immediately adjacent to the nut and bolt fastener on the ring
- and 100% of the drums tested self-vented at pressures at or below 32 psig

It is important to note that a distorted drum top or bottom only indicates that the drum has been pressurized at one time, it may or may not be currently pressurized. Based on test results, minor deformation of a drum lid (which may or may not be visible to the naked eye) could indicate that the drum contained pressure in excess of 5 psi. Based drum lid distortion meter was developed that can detect an approximately 1.5 cm deformation of the lid. This distortion meter was used as a go/no go for remote venting of drums.

In order to minimize personnel hazards, these drums required venting and filter installation as soon as practical with little to no movement. Movement of a pressurized drum increased the possibility of an uncontrolled venting, therefore an in-situ method of venting drums was necessary. A description of the devices and methods used to accomplish this in-situ venting is found below.
