LTPP Pavement Maintenance Materials: SHRP Joint Reseal Experiment, Final Report

PUBLICATION NO. FHWA-RD-99-142

SEPTEMBER 1999

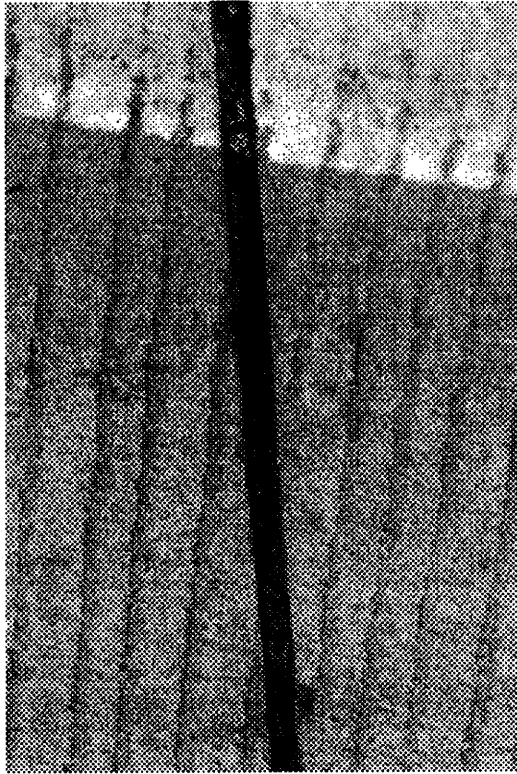
Figure 23. Full-depth adhesion failure.

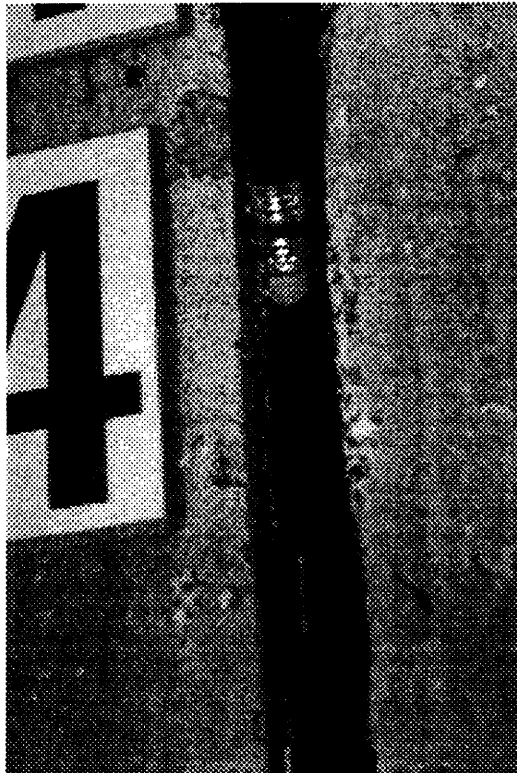
Figure 24. Partial-depth adhesion loss.

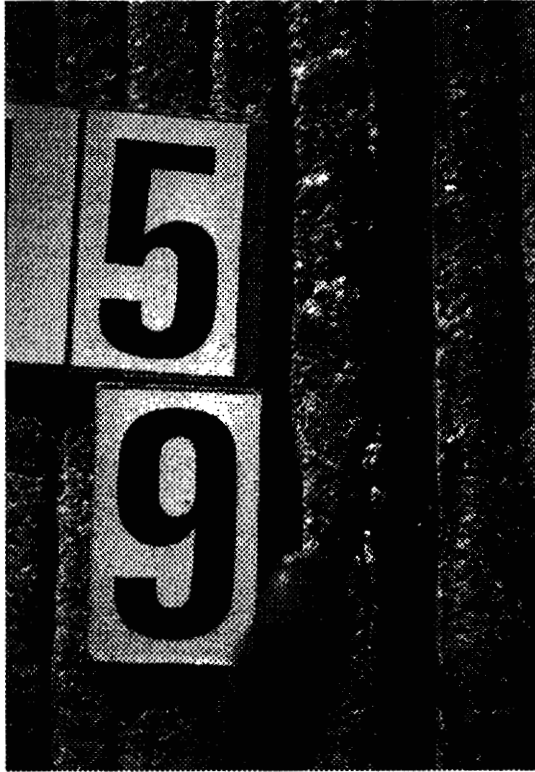
Figure 25. Full-depth spall failure.

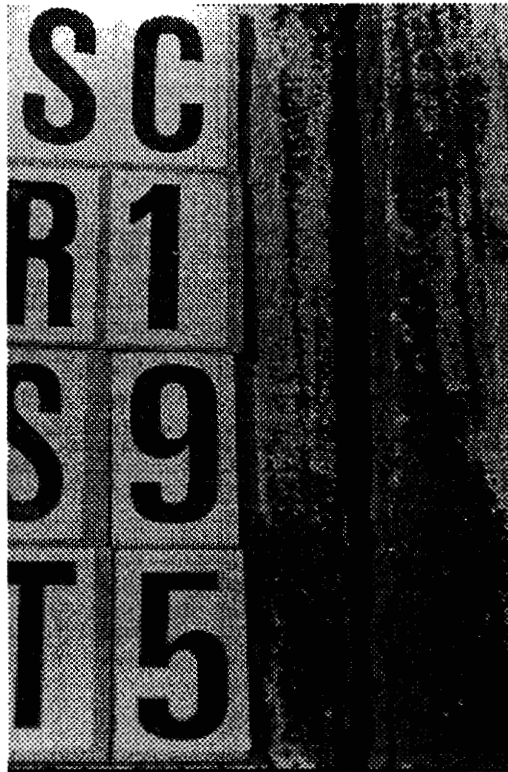
Figure 26. Overband wear.
