# SAFETY & HEALTH BULLETIN

## Vigilance in New or Infrequent High-Hazard Operations

DOE/EH-0697

Issue No. 2005-09

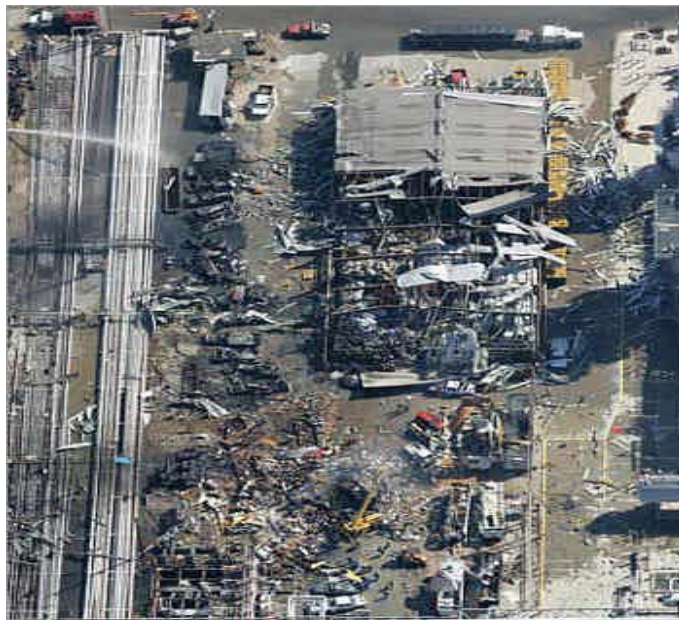
In March 2005, a large explosion killed 15 workers and injured over 150 at the BP Texas City Refinery. The unit was undergoing a phased restart operation following isomerization catalyst replacement, which is performed every 10 years. The explosion occurred during the restart of the Isomerization Unit and was caused by an ignited hydrocarbon vapor cloud that was inadvertently released from a raffinate splitter that was overfilled and overheated. The pressure in the splitter column increased rapidly and exceeded the set pressure of the overhead line relief valves, overloading the stack with vapors and liquid. An unknown ignition source from one of numerous sources in the uncontrolled area ignited the resulting vapor cloud and triggered the explosion.

safety concerns. For example, the 1950s-designed vent system on the blowdown drum was antiquated and did not tie into a flare system to safely combust flammable vapors during a release. Also, temporary office and work trailers were sited only 150 feet from the blowdown drum and vent stack, tragically placing their occupants in the blast area. The report also identified various conduct of operations deficiencies and inadequacies.

**Explosion site at BP Texas City Refinery in March 2005**
