**United States Department of the Interior
Bureau of Reclamation**

***Tyler Creek
Wasteway
Stabilization***

Environmental Assessment

Geology Appendix

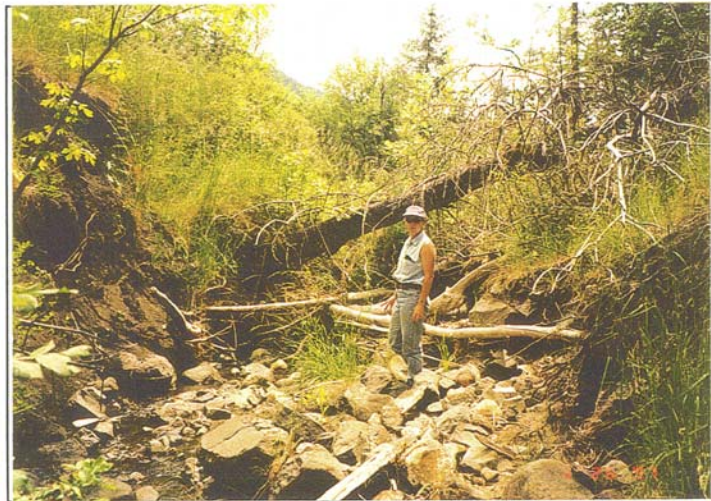
Photograph No. 1. Tyler Creek Wasteway. Looking downstream (southwest) near Station 47+33. Angular volcanic rock mostly 8 to 18 inches in size mantles channel bottom. Lateral cutting of banks is in progress. Note undercut tree toppled into channel.
USBR Photograph by B.H. Carter, 6/26/97.

RECOMMENDATIONS: Channel modification is required to stabilize this section of channel. All alluvial bars, debris bars, and downed trees should be removed and incorporated into side-slope toe protection and channel armoring. About 80 percent of the channel will need to have channel bank toe protection to stop lateral erosion. By mechanized channel modification, most of the toe protection can be obtained from rock and tree debris now within the channel. Some additional outside rock (estimated at 30 cu. yds. of 6 - 12 inch sizes) could be needed

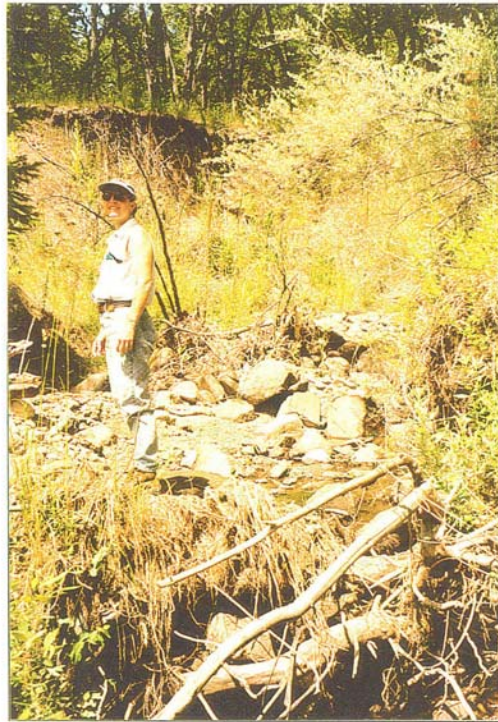
Photograph No. 2. Tyler Creek Wasteway.
Photograph taken near Station 50+80 looking northeast, upstream. Background erosional slope is about 15 feet high. Lateral erosion in this area is caused from channel organic and rock debris blockage and bar buildup.
USBR Photograph by B.H. Carter, 6/26/97.

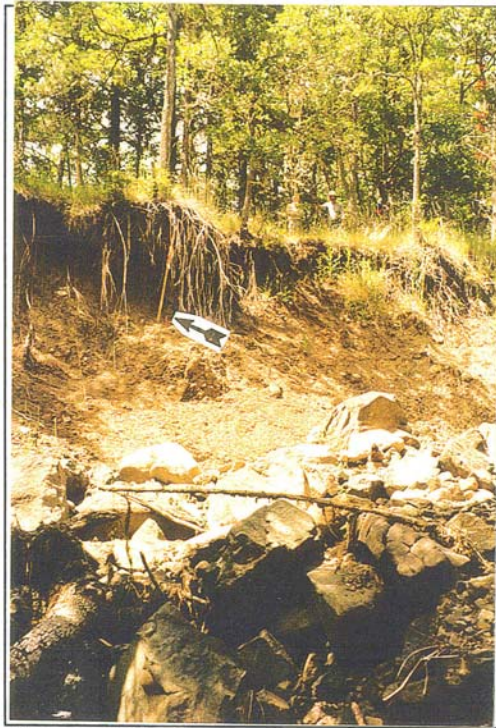
Photograph No. 3. Tyler Creek Wasteway. Eroded slope in altered/weathered volcanics from 10 to 17 feet high. Slope materials are soil-like. No *in situ* bedrock is exposed, but channel bottom is mantled with large angular cobbles to boulder size rocks. Stake with red ribbon and pole with flag on right side of right-of-way boundary. View is looking across Station 50+90 to the northeast. USBR Photograph by B.H. Carter, 6/26/97.

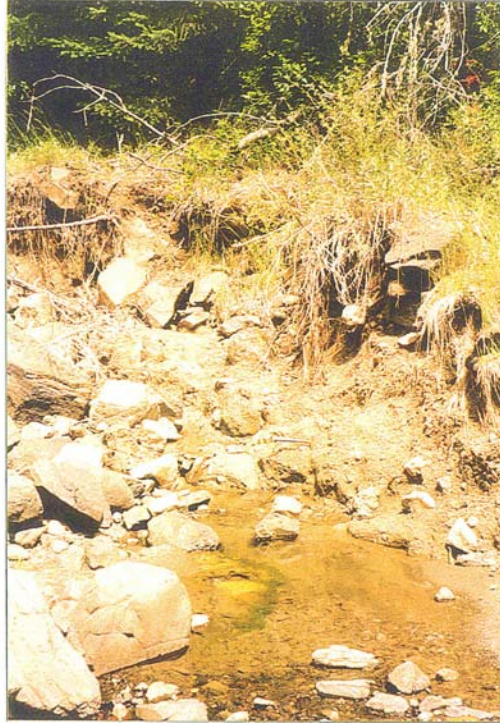
Photograph No. 4. Tyler Creek Wasteway.
Station 53+13, looking east at eroded channel bottom and eroded side slope underlain with altered/weathered, fine-grained volcanics with hard, angular clasts (gravel to boulder-size) eroding from volcanics and being deposited in channel. Channel is partially veneered with rock in this area. Note geology pick for scale.
USBR Photograph by B.H. Carter, 6/26/97.

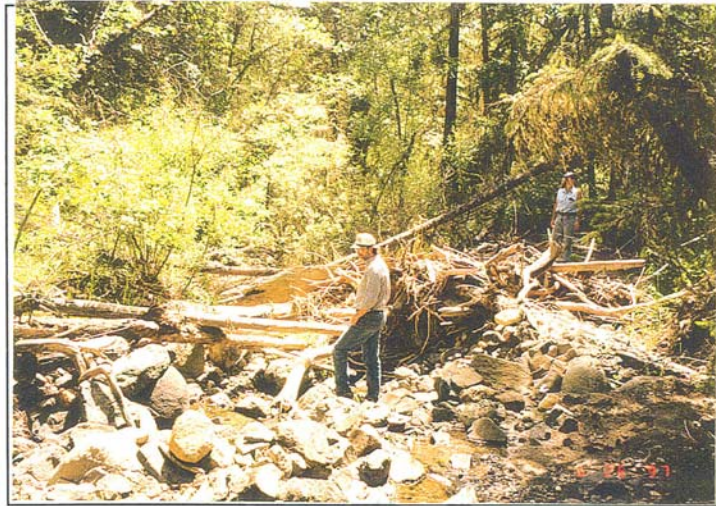
Photograph No. 5. Tyler Creek Wasteway. Looking downstream (southwest) at channel mantled with hard, volcanic gravel to boulder-size materials; Station 54+34. Channel area is well armored with tree/rock bar causing flow obstruction and lateral migration of streamflow.
USBR Photograph by B.H. Carter, 6/26/97.

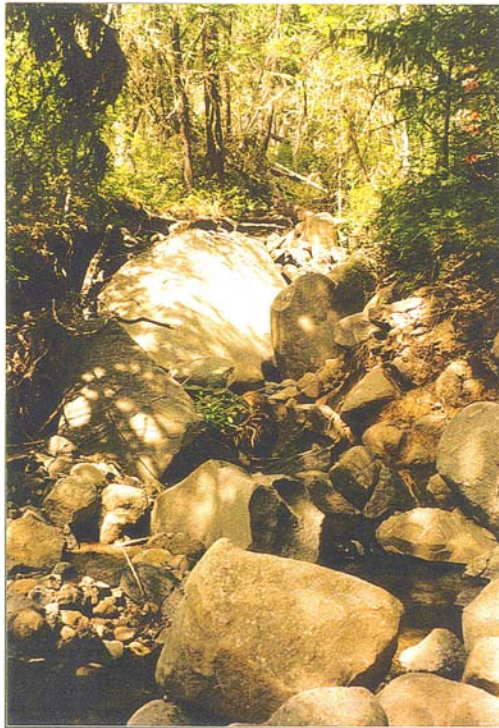
Photograph No. 6. Tyler Creek Wasteway.

Back station from 57+00, for about 150 feet, large blocks of rock have created an energy dissipation for the stream flow and very minor lateral erosion has occurred. Refer to Photograph No. 6. Very little channel modification will be required in this area.

Looking upstream (northeast) or back station, from Station 57+00. Large blocks of hard, volcanic rocks to 2 cubic yards in size have created energy dissipation of the streamflow. Very little to no lateral bank erosion has occurred in this interval of the stream channel.

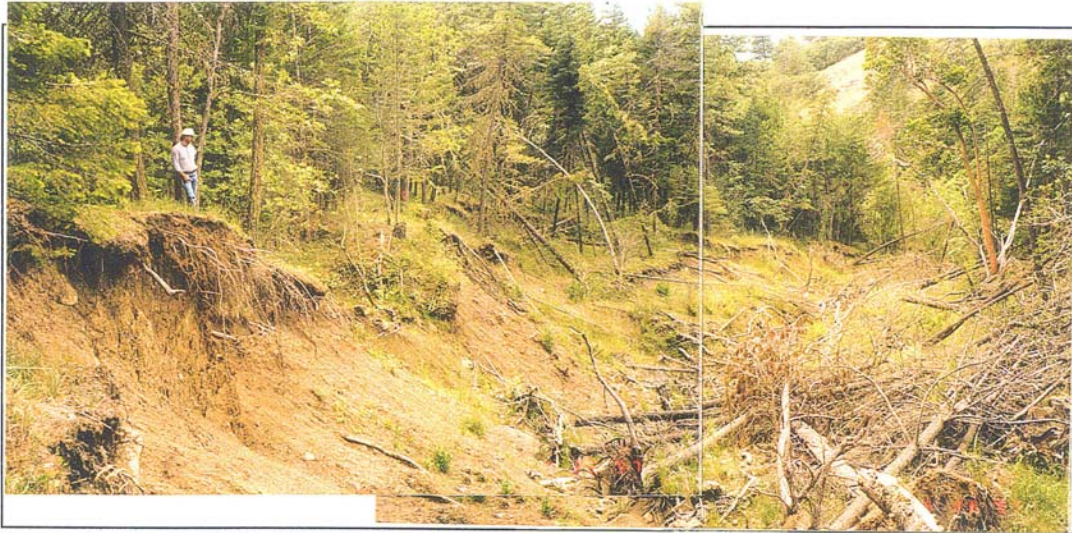
STATION 57+00 to 65+73 (old channel alignment): Deep channel degradation has occurred in this interval of the wasteway. During my visit in November 1993, near vertical unstable channel banks were observed to heights of 40 to 50 feet; refer to Photographs Nos 9 and 10. Present (1997) observations show the higher banks with near vertical slopes failed by landslide movement and erosion to a stable slope of about 1.5:1 or flatter. The present conditions are shown in Photographs Nos 7 and 8.

Panoramic Photograph No. 7. Tyler Creek Wasteway. Looking downstream from about Station 60+70 to 64+40. Photograph shows acute erosion in altered/weathered fine-grained volcanics with very few hard rock clasts exposed. Toppled trees are a result of bank undercutting. Note landslide topography in center of photograph. Maximum height of eroded bluffs is about 40 feet.
USBR Photograph by B.H. Carter, 6/26/97.

RECOMMENDATIONS: This portion of the channel has not been utilized for wasteway discharges for several years. Because of the deep section of soil-like volcanic materials (landslide materials) and lack of rock in this area, rehabilitation of the wasteway would be very costly. All debris would need to be removed from the channel and large quantities of rock would need to be hauled in and placed for channel protection. In order to provide long term stability of the oversteepened slopes, present slopes should be cut back to 1.5 to 1 or flatter.

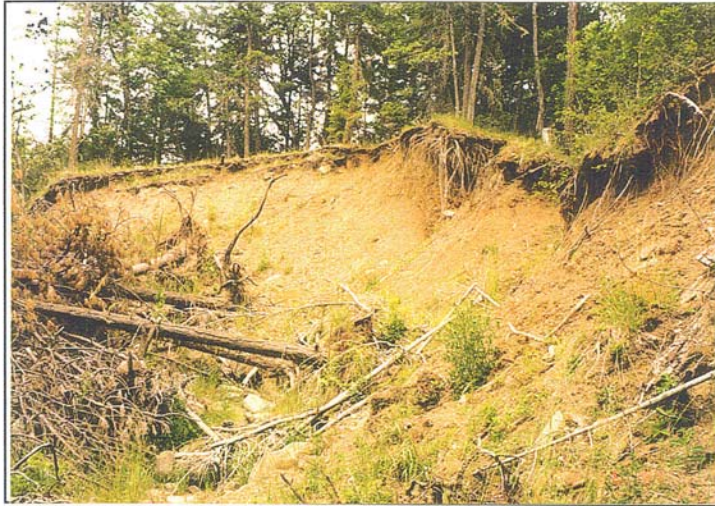
Photograph No. 8. Tyler Creek Wasteway. Looking upstream from Station 64+40 at 30-foot high erosional wall of channel. Numerous toppled trees are to the left and undercut trees are to the right.
USBR Photograph by B.H. Carter, 6/26/97.

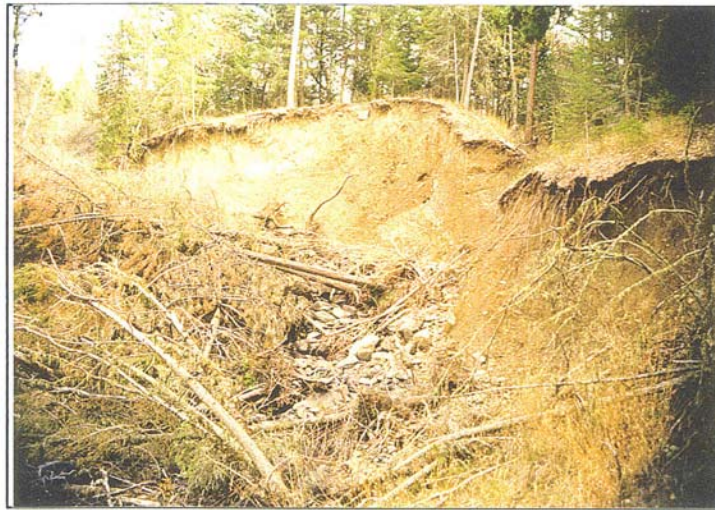
Photograph No. 9. Tyler Creek Wasteway. This photograph was taken in November 16, 1993 when the recent channel erosion had formed near vertical bluff to 40 feet in height. In comparison with Photograph No. 8 taken in 1997, note the bluff exposures have migrated upslope producing flatter slopes.

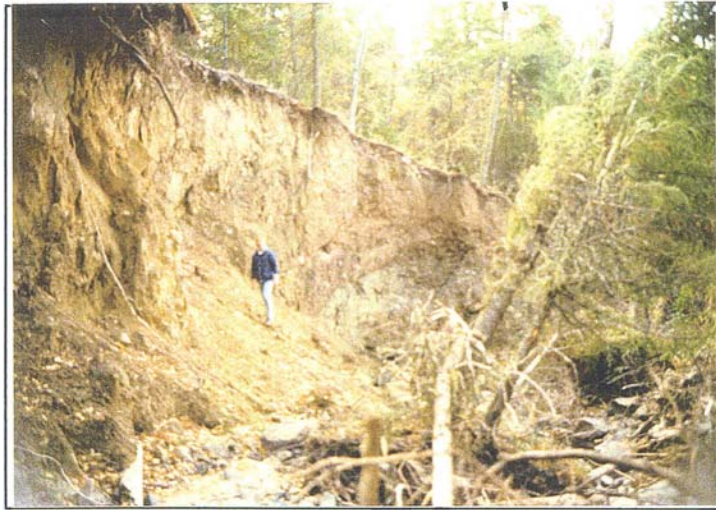
Photograph No. 10 Tyler Creek Wasteway. Looking downstream of Station 62+26, November 1993. Channel bank about 50 feet high in near vertical exposure. Panoramic Photograph No. 7, taken in 1997, shows this area failed back in flatter slope by landslide movement. USBR Photograph by B.H. Carter, 11/16/93.

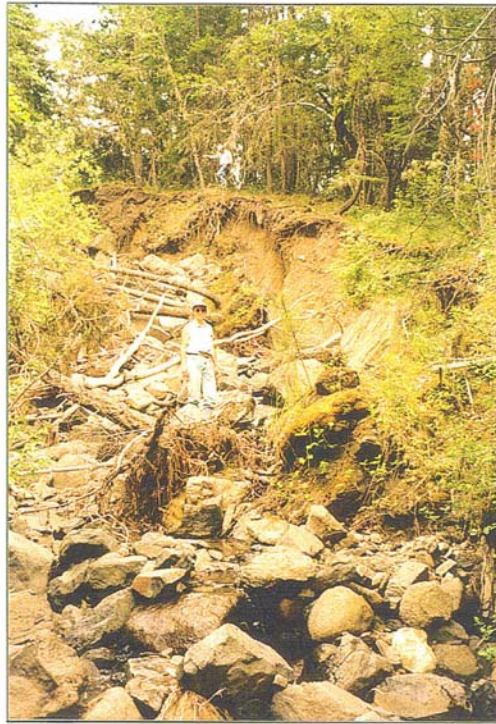
An estimated 75 percent of the alternate alignment has exposed bedrock in the channel section. Some lateral channel erosion has occurred locally as shown in Photograph No. 11. Also, alluvial bars, debris bars, and fallen trees are common.

Photograph No. 11. Tyler Creek Wasteway.
Control Point 3015, alternate channel, looking
upstream to the east. Channel bottom is mantled
with heavy rock, but stream is migrating laterally
into soft, fine-grained, altered/weathered volcanics.
USBR Photograph by B.H. Carter, 6/26/97.

RECOMMENDATIONS: Some channel modification with associated channel and side-slope protection will be required for long term channel stability. Alluvial bars and toppled trees should be removed and incorporated in the channel protection. Bedrock exposures and concentrations of loose rock debris in the channel will satisfy most of the channel protection needs. However, about 200 feet of channel will require an estimated 10 cu. yds. of additional rock. Over steepened channel slopes with heights over 10 feet should be flattened to 1.5:1.
