**SCENIC DRIVE LANDSLIDE OF JANUARY-MARCH 1998, LA HONDA, SAN MATEO COUNTY, CALIFORNIA**  
BY  
Angela S. Jayko, Michael J. Rymer, Carol S. Prentice, Ray C. Wilson, and Ray E. Wells  
1998

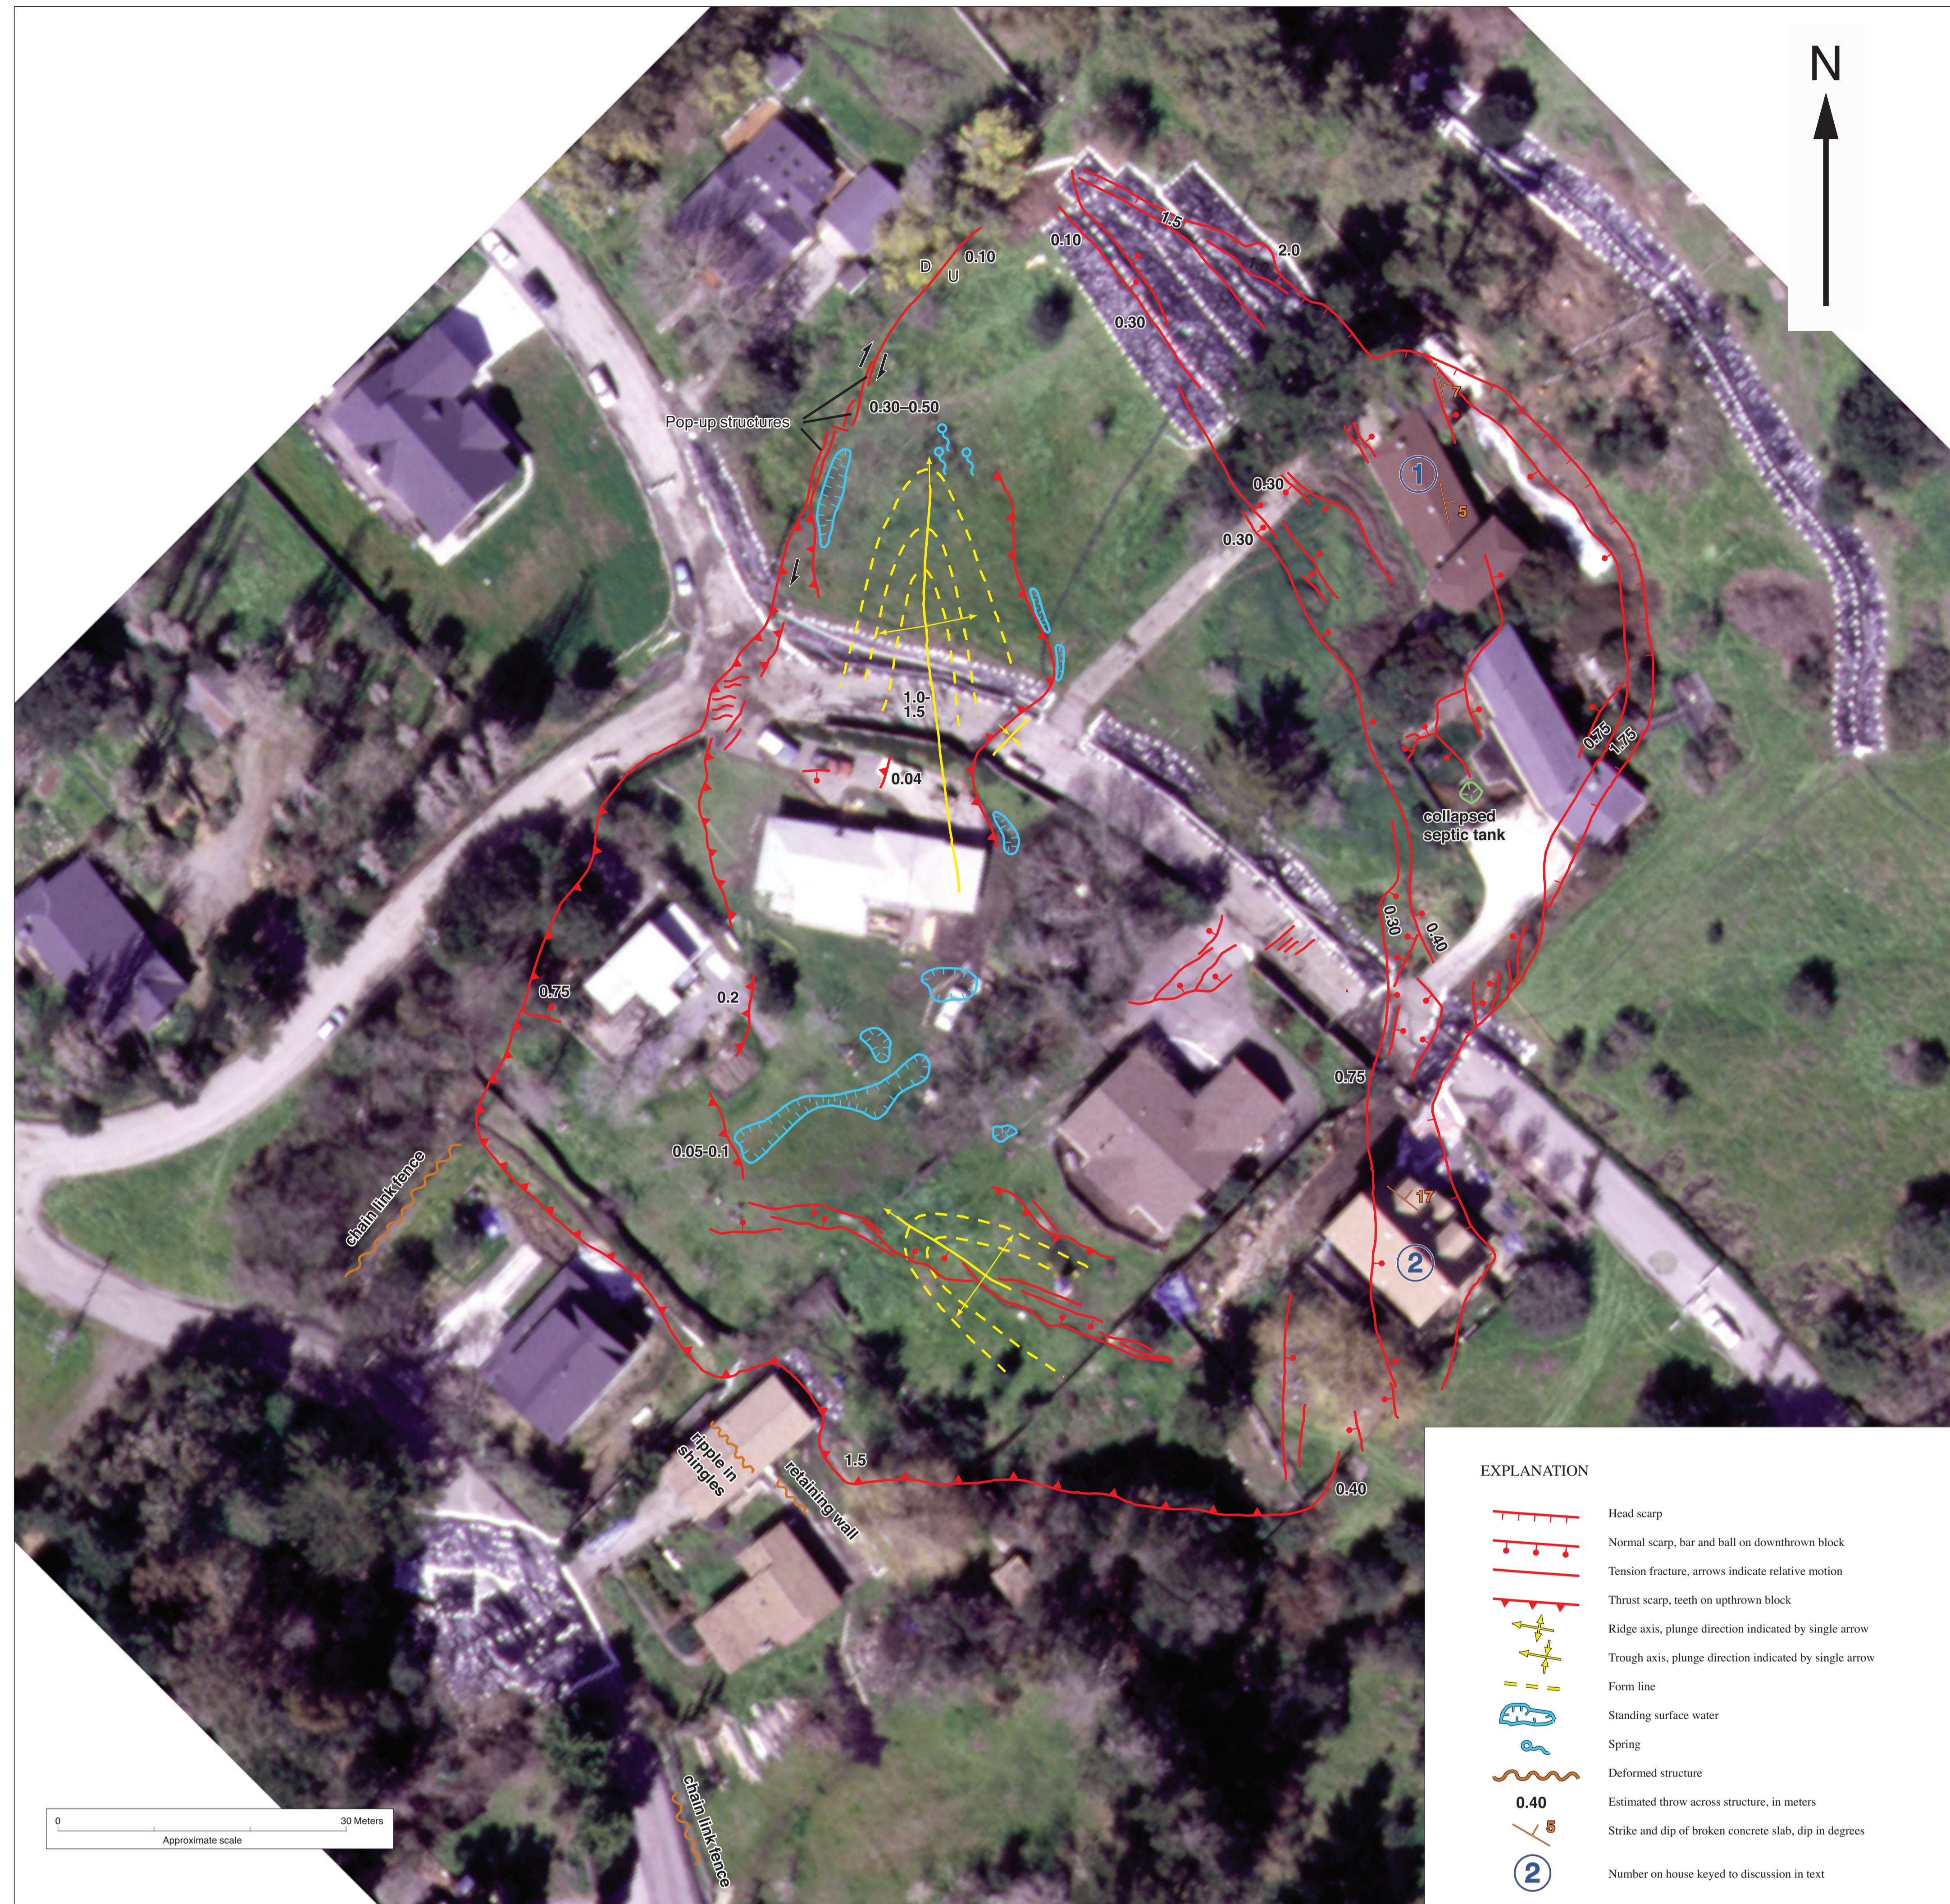
Map 1. Plan of Scenic Drive landslide boundaries and internal features. Features base not rectified. Features shown suggest on 21 March 1998.

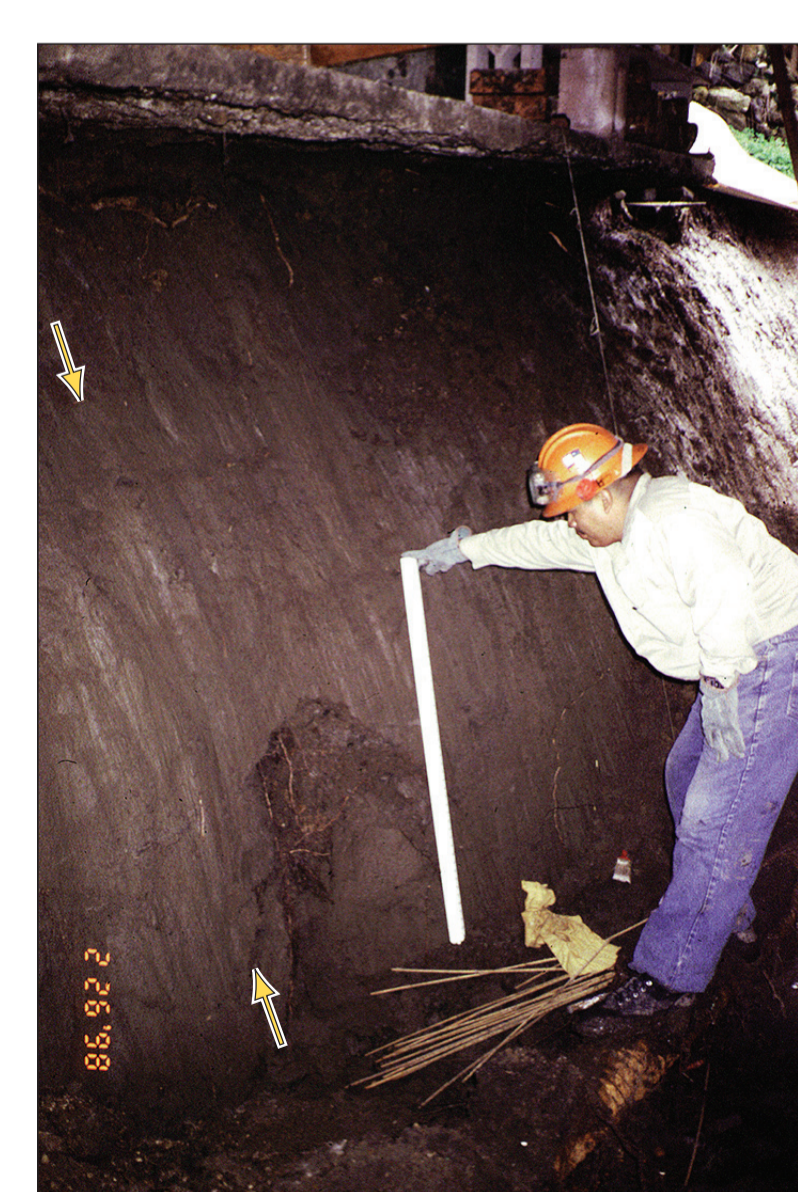
Figure 7. Six-tones (orange highlighted, for example, between yellow arrows) formed by scarping during slippage along head scarp.

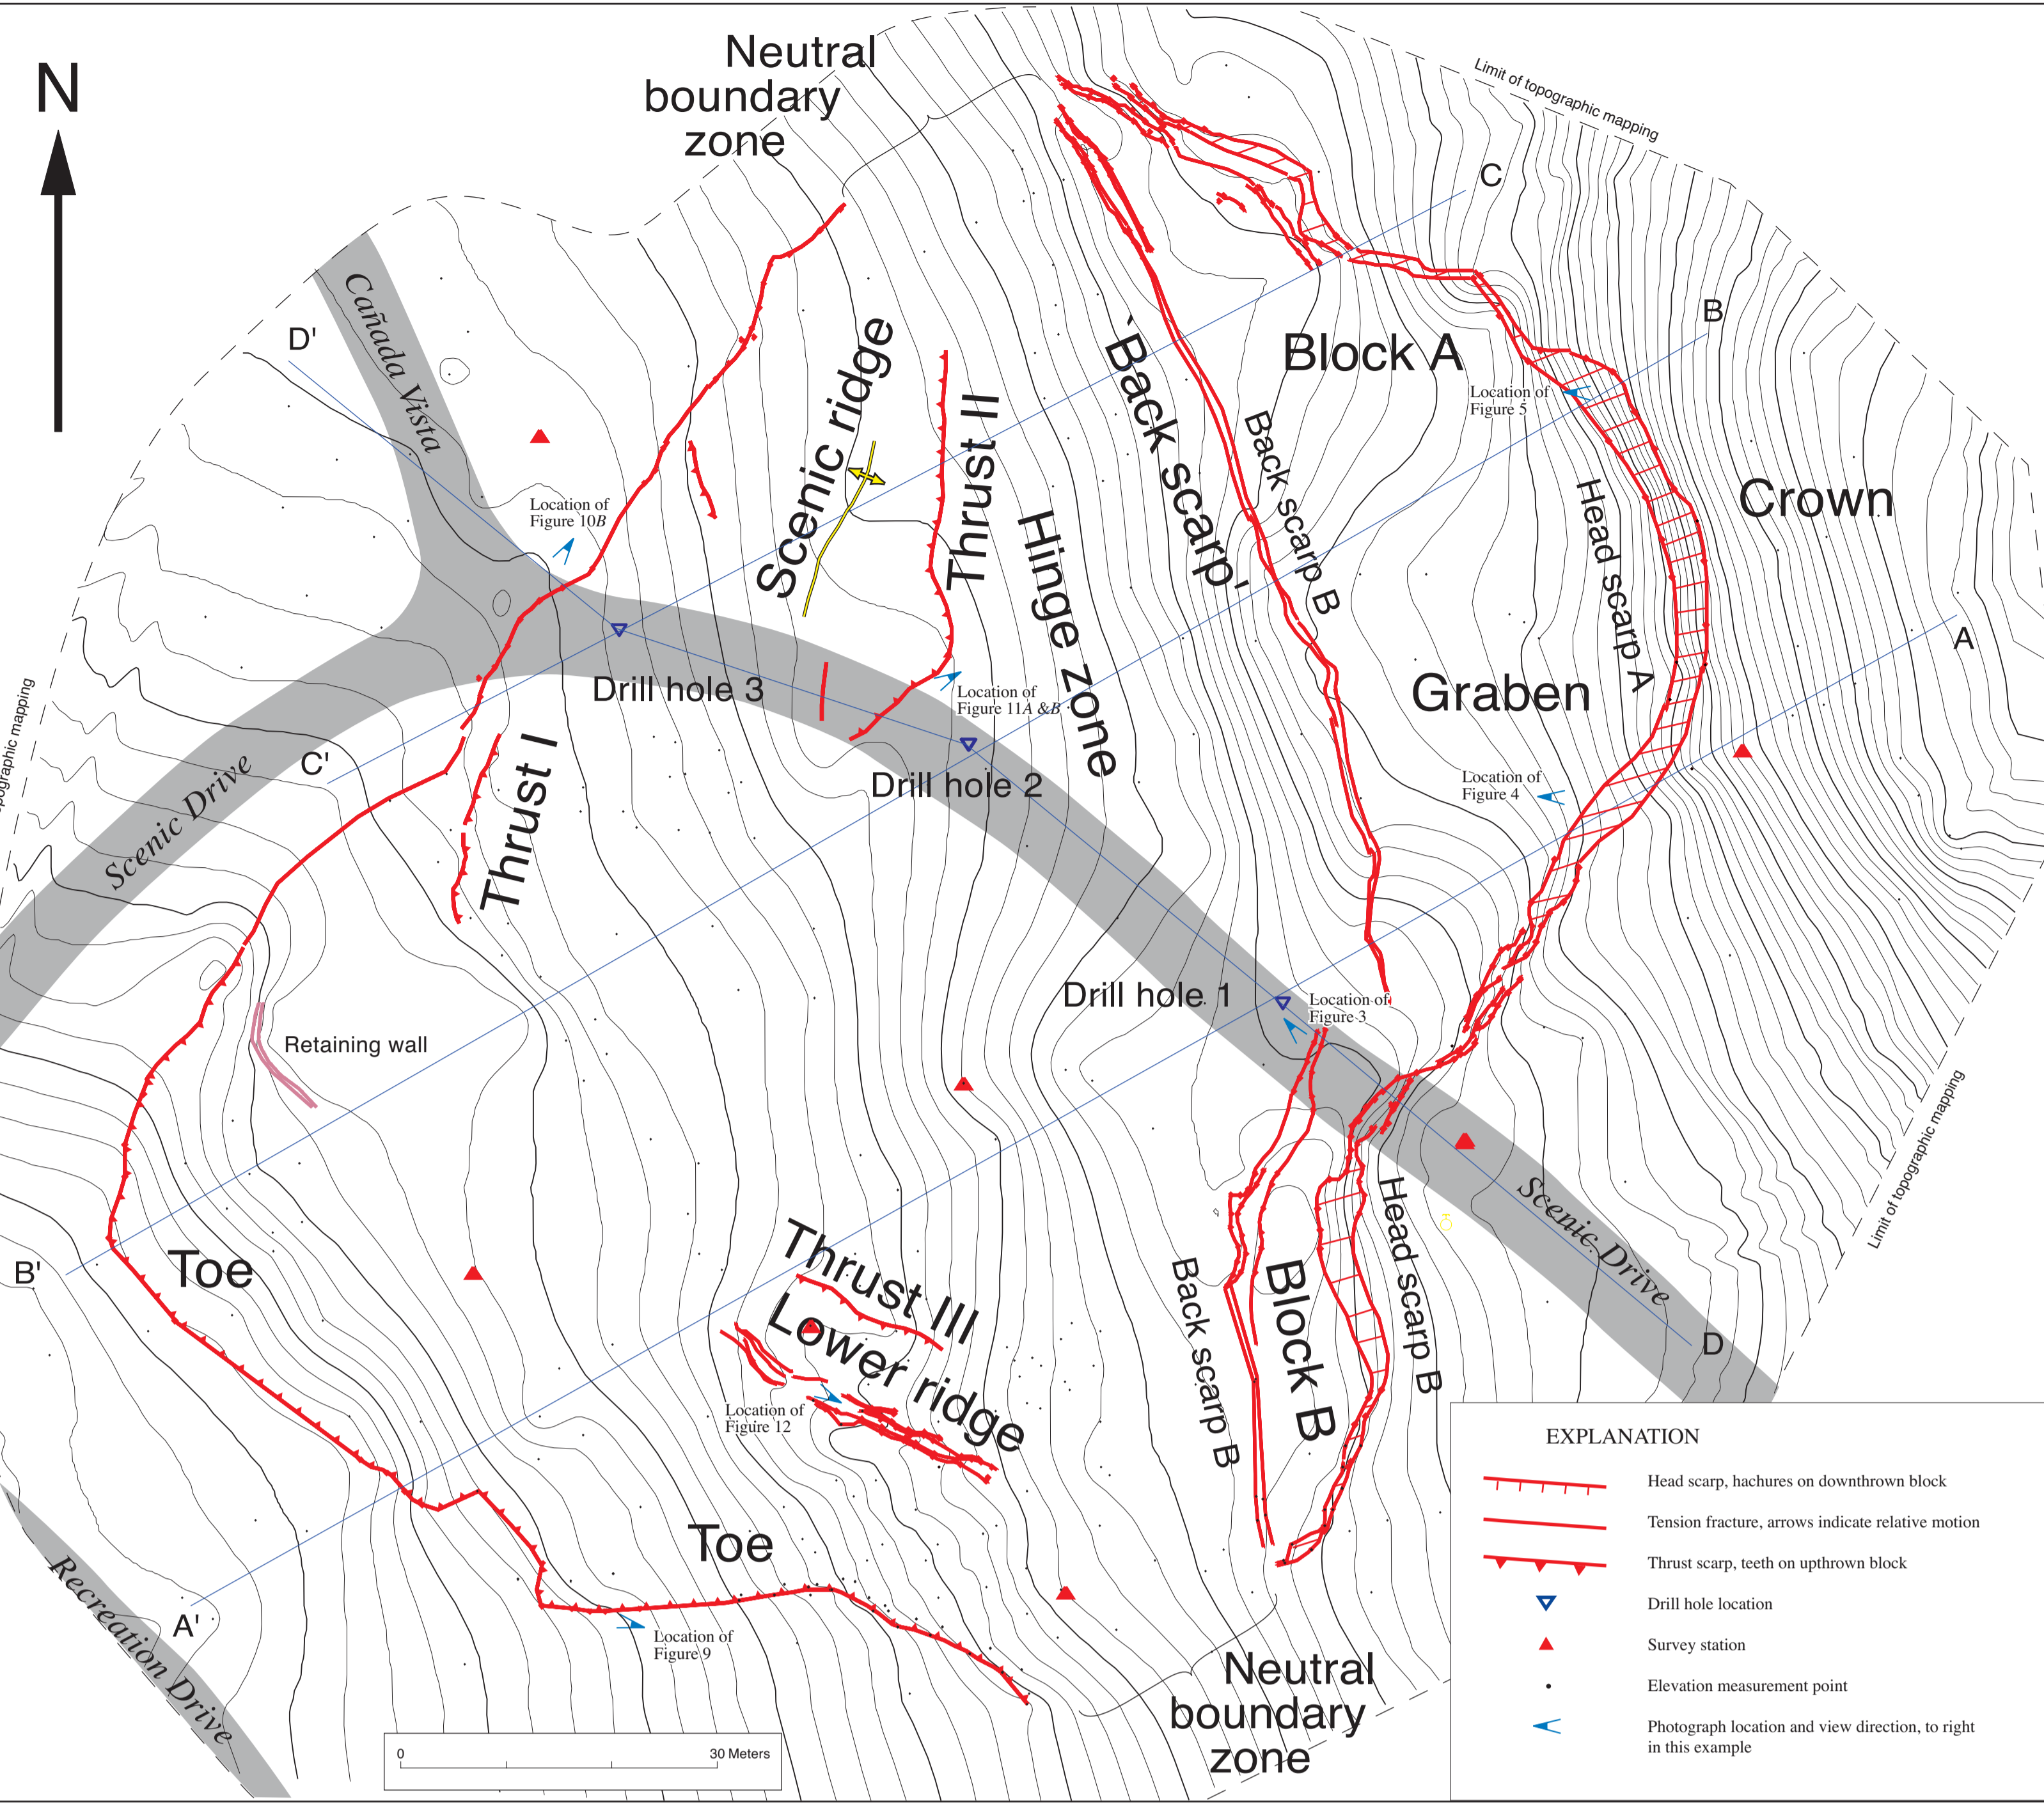
Map 2. Topographic map of Scenic Drive landslide boundaries and internal features. Contour interval = 50 cm. Features shown are as mapped 29 February to 8 March 1998.

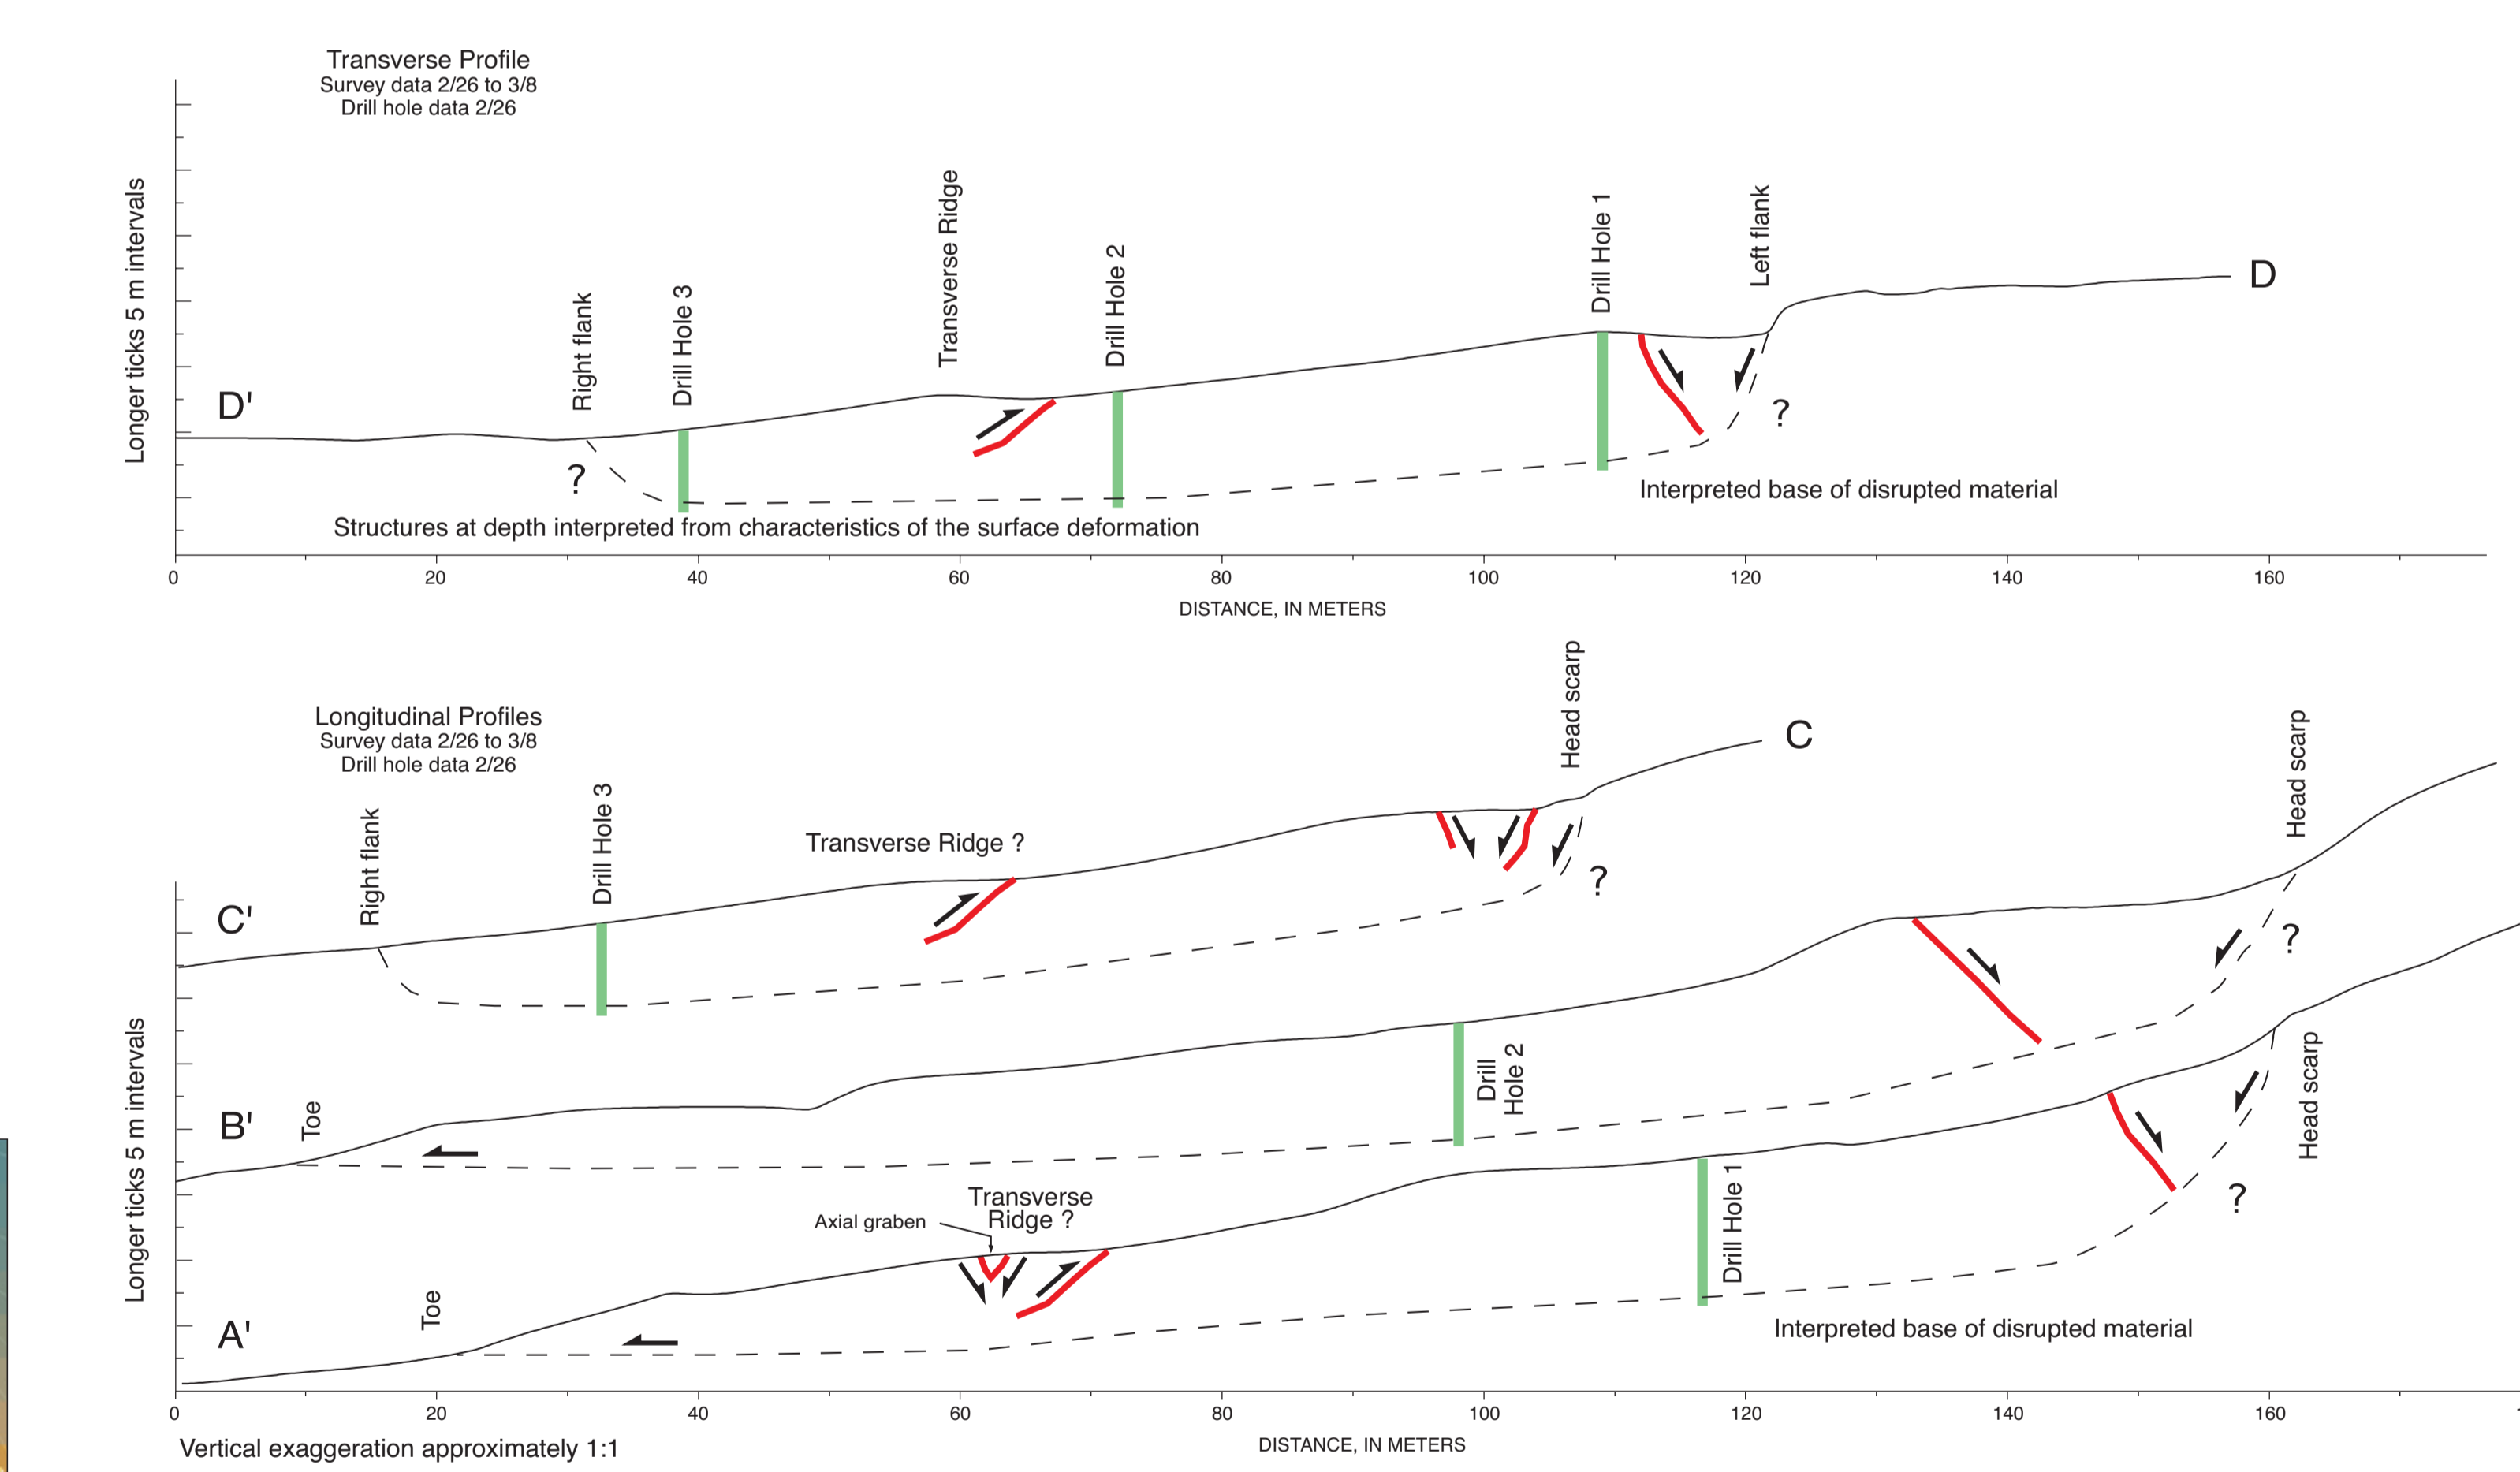
Figure 8. Cross sections of Scenic Drive landslide. Upper profiles show transverse sections across the median part of the slide. The lower profiles are constructed approximately parallel to the slope aspect (and the displacement direction). Ground surface contoured by survey data, subsurface contoured by soil holes 1, 2, and 3 (Eckel, vitros, curren, 1998).

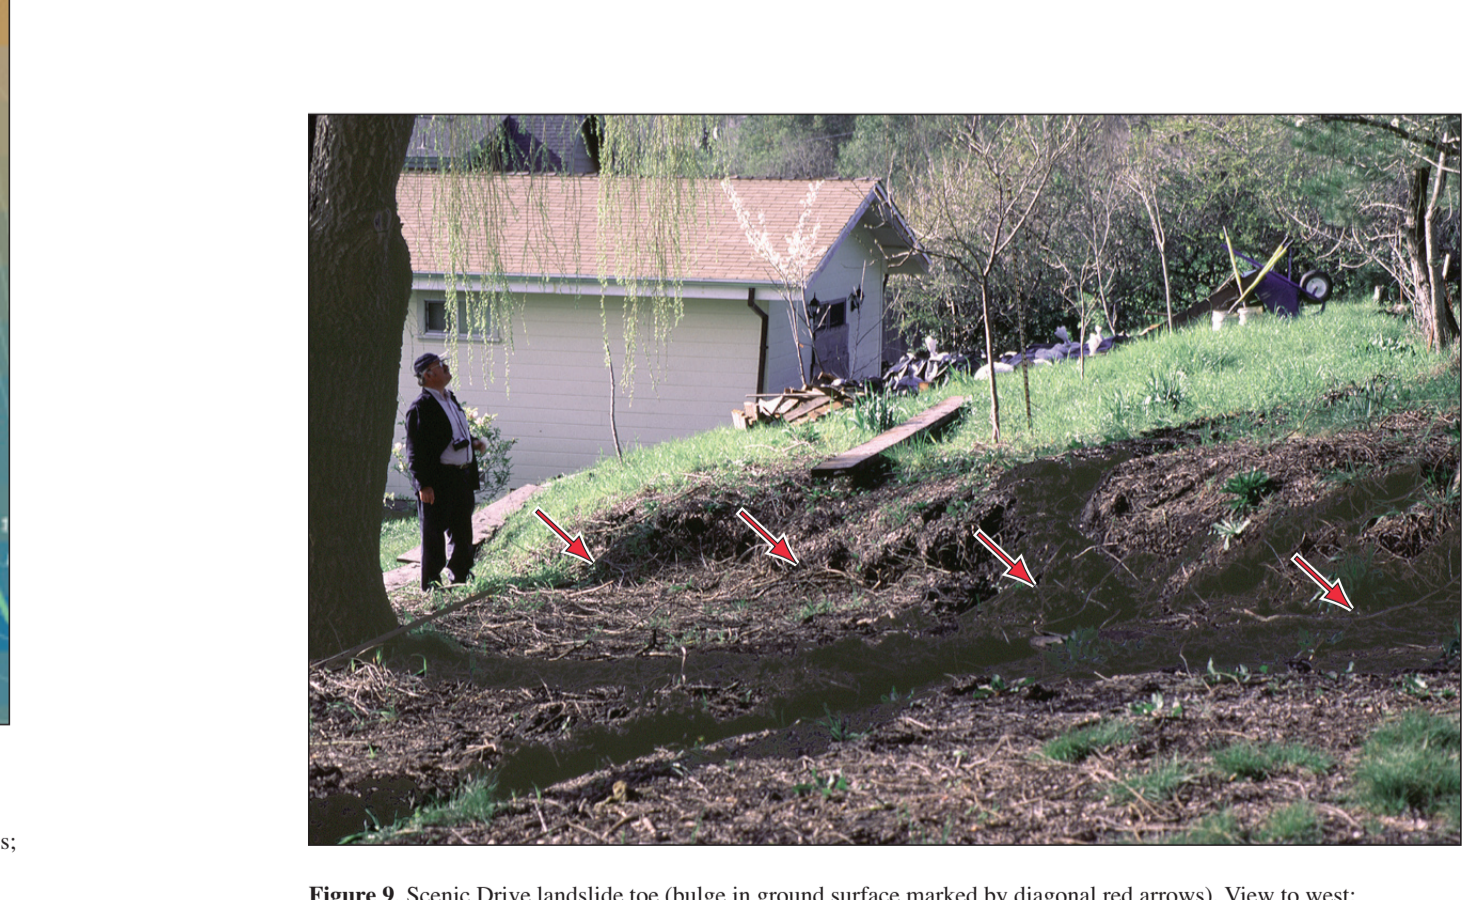
Figure 9. Scenic Drive landslide toe (ridge in ground surface marked by diagonal red arrows). View to west, photograph 21 March 1998.

The toe of the slide lies about 1.5 m of relief and is 1 m of horizontal displacement (Fig. 9). Dip-slip or tension fractures characterize the toe of the slide. Tension fractures (mostly strike-slip and partly compressional) are expressed along the right flank. From the intersection of Calada Vista and Scenic Drive, the toe of the slide is about 1.5 m wide and is developed about 1 to 1.5 meters of relief between 11 February and 21 March. The top half of the ridge is bounded by a down-dip dipping three fault (thrust zone III). Tension cracks extend 180° counter to down-slope on the edge of the ridge. The Lower ridge trends about 285° and has a strongly developed axial graben (Fig. 12) over its center. The axial graben of the ridge is also bounded by a down-slope dipping three fault (thrust zone III).

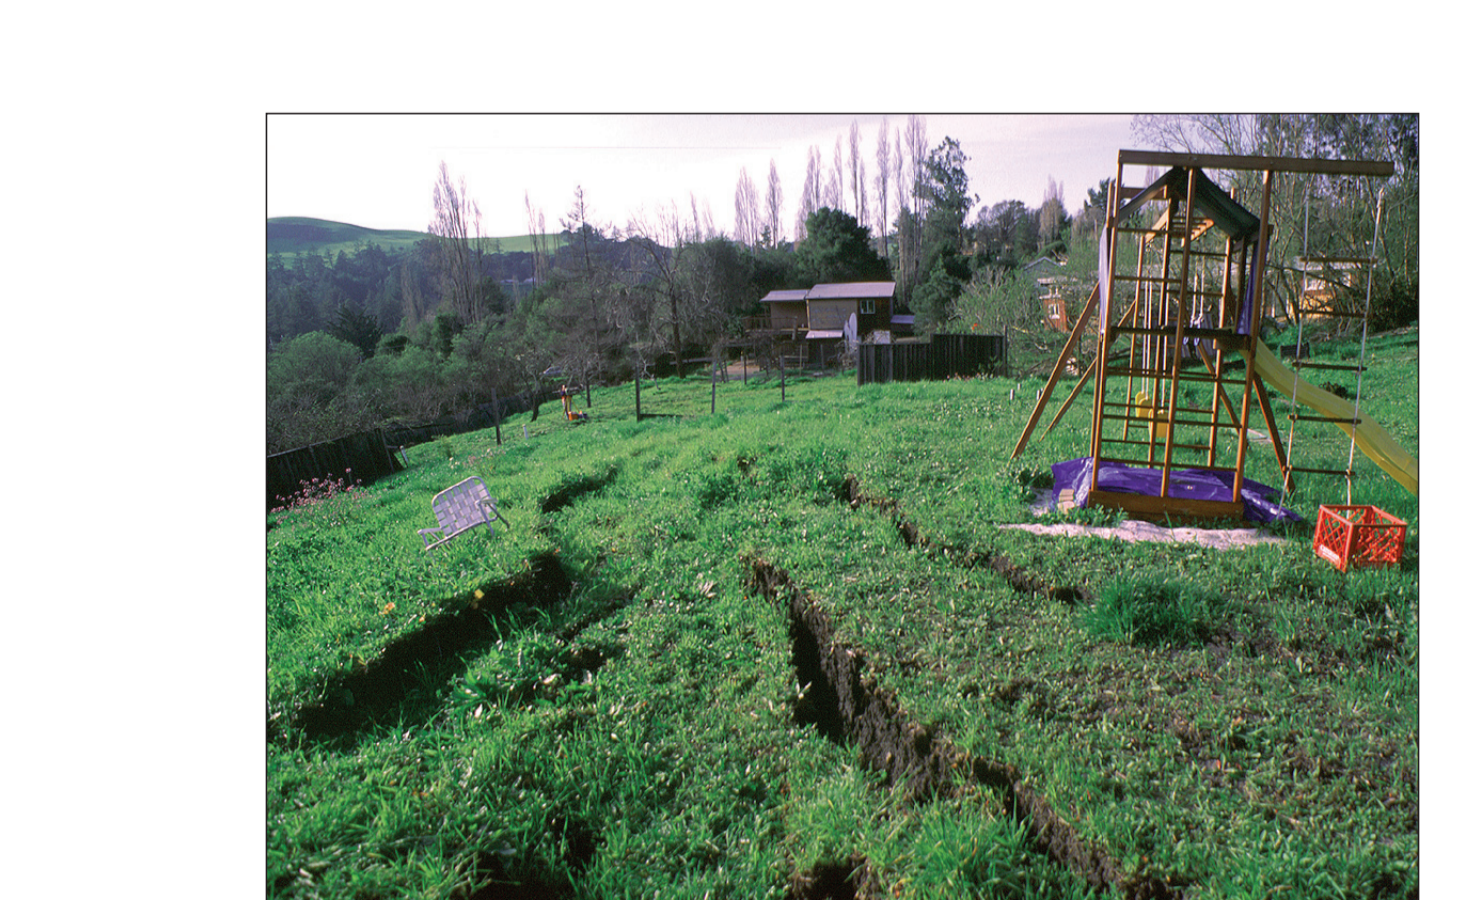
Figure 10. Graben that formed along axis of 'Lower ridge' of Scenic Drive landslide. View to west, photograph 21 March 1998.

The principal displacement direction is southwest with an azimuth of about 250°, down the overall strike of the hill (Fig. 10). Slip occurred along the head scarp near extensional features (indicated on the scarp surface (Fig. 10) and offset cultural features of landscape forms. Slip occurs along the toe scarp near extensional features. The head scarp dip is predominantly between 65° and 75° and inclination plane directly down-slope (Fig. 10).

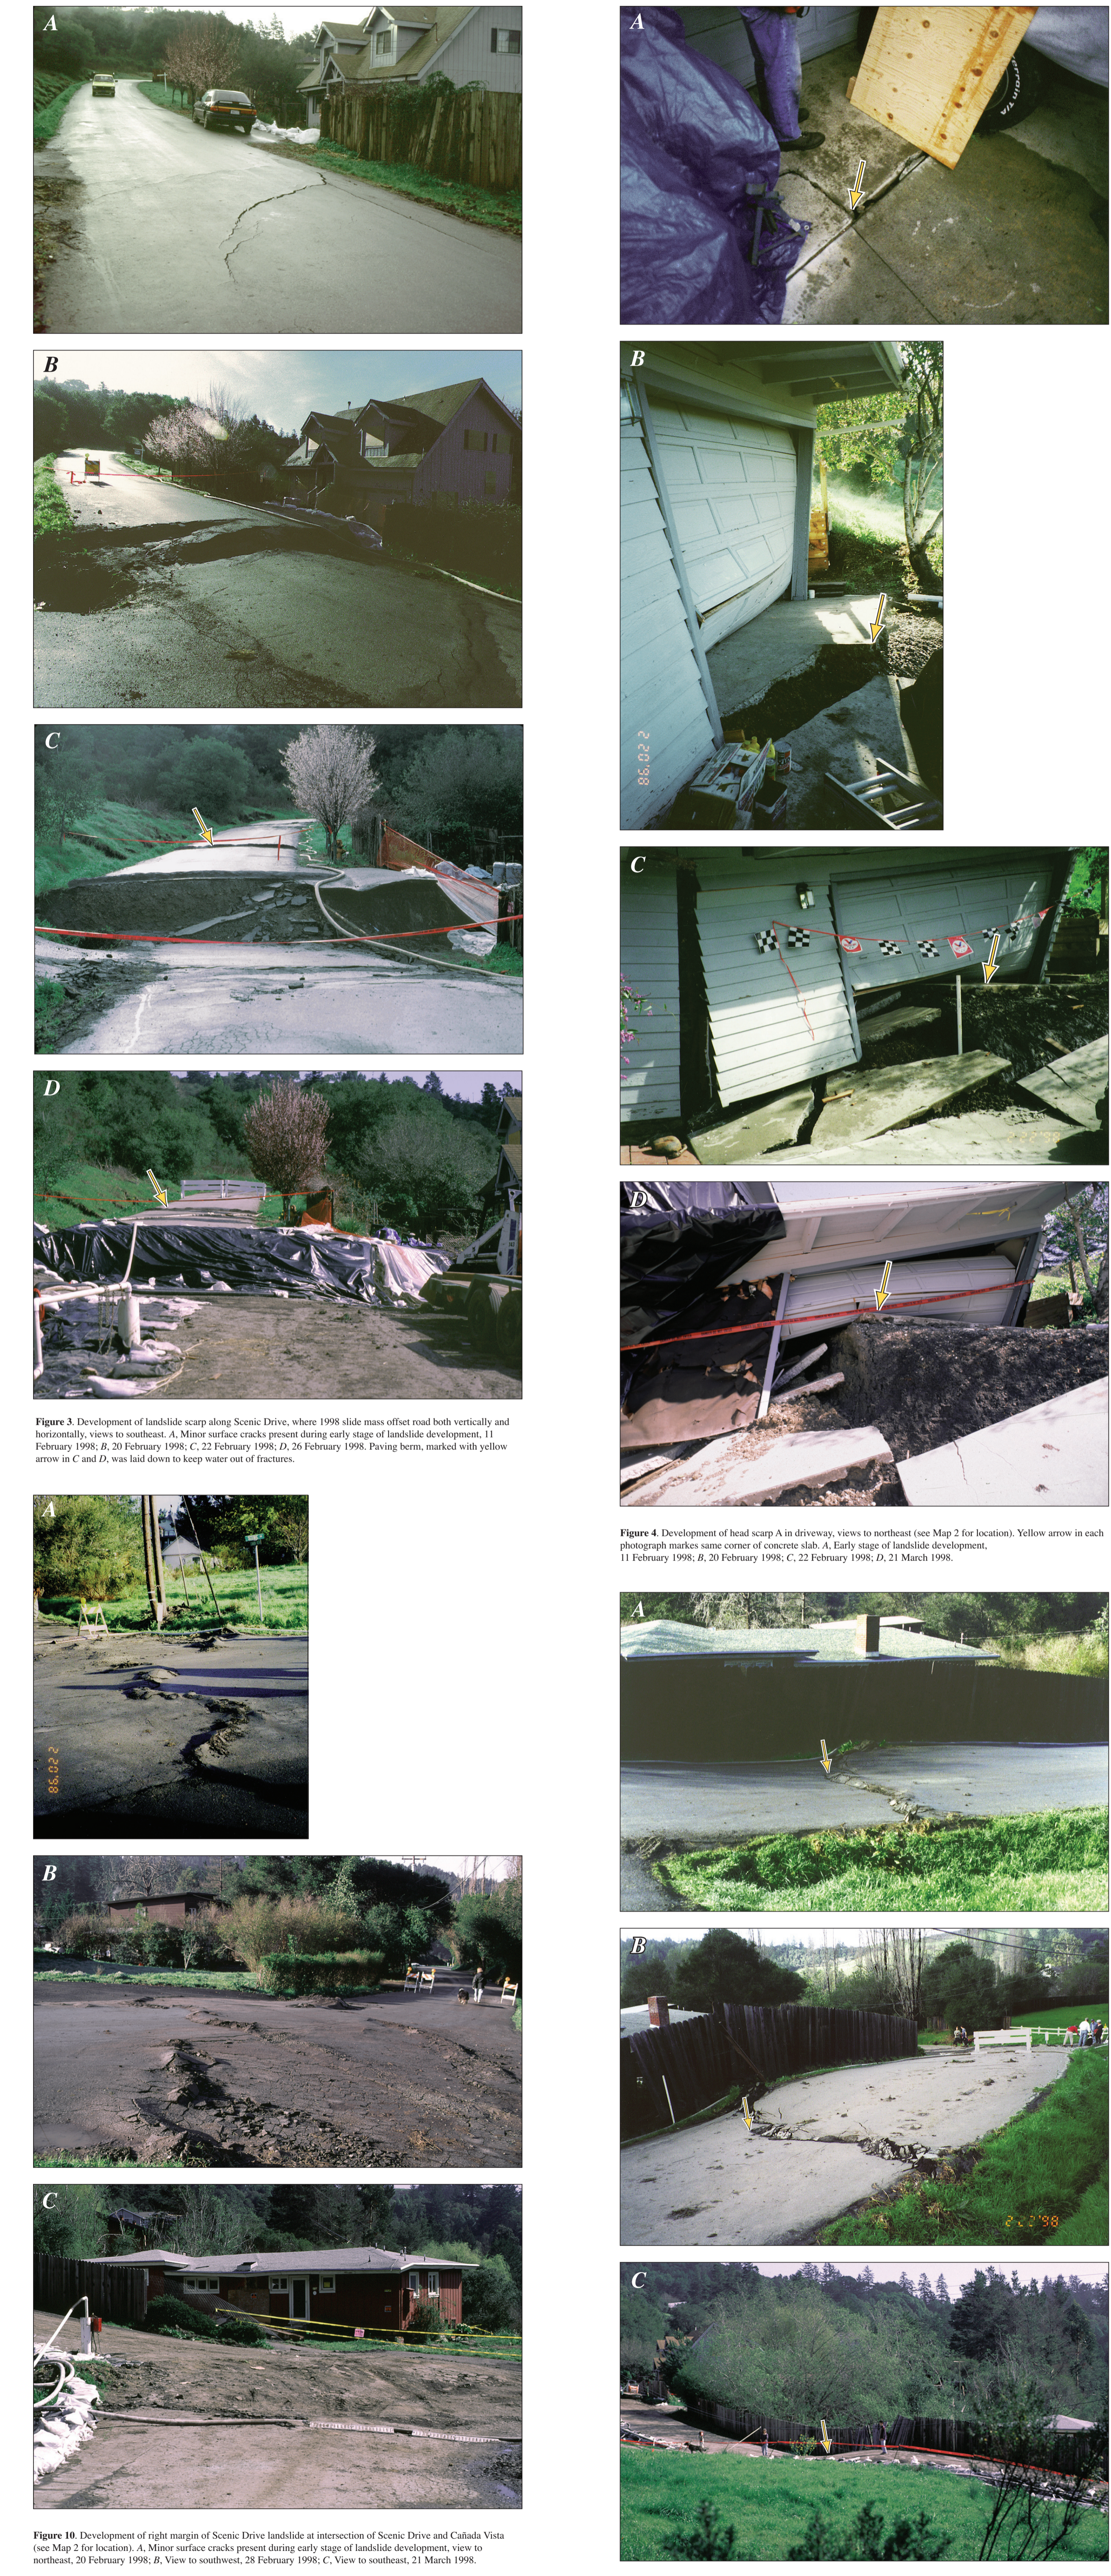
Figure 9. Development of Scenic Drive landslide at intersection of Scenic Drive and Calada Vista (see Map 2 for location). A. More surface cracks appear during early stage of landslide development, view to southwest, 11 February 1998. B. 20 February 1998. C. 22 February 1998. D. 20 February 1998. E. 20 February 1998. F. 20 February 1998. G. 20 February 1998. H. 20 February 1998. I. 20 February 1998. J. 20 February 1998. K. 20 February 1998. L. 20 February 1998. M. 20 February 1998. N. 20 February 1998. O. 20 February 1998. P. 20 February 1998. Q. 20 February 1998. R. 20 February 1998. S. 20 February 1998. T. 20 February 1998. U. 20 February 1998. V. 20 February 1998. W. 20 February 1998. X. 20 February 1998. Y. 20 February 1998. Z. 20 February 1998.
