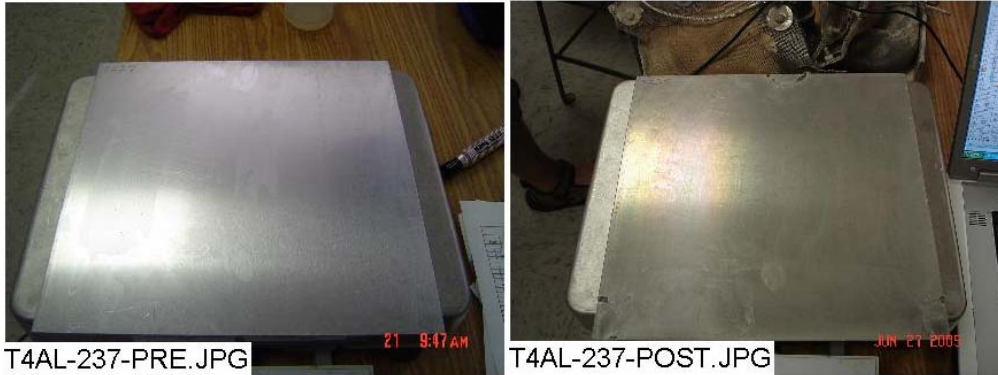
There are three submerged aluminum coupons in each test. Figures 3-98 through 3-100 display the pre- and post-test pictures of those coupons that were in Test #4. The relative locations of the aluminum coupons from east to west of the tank are: Al-239, Al-238, and Al-237. Al-239 and Al-238 were the two aluminum coupons that were isolated next to the concrete coupon. There were no visual differences between the three coupons after they were removed from the tank. The overall appearance of the aluminum coupons did not significantly change from their pre-test appearance. The post-test coupons appeared to have a light film on them and had lost their pre-test shiny appearance.

**Figure 3-98. Al-237 submerged, pre-test (left) and post-test (right).**

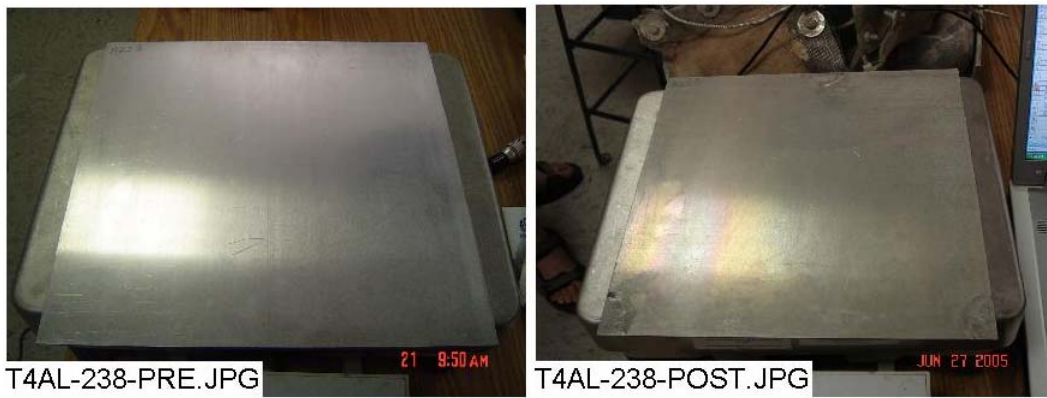
**Figure 3-99. Al-238 submerged, pre-test (left) and post-test (right).**

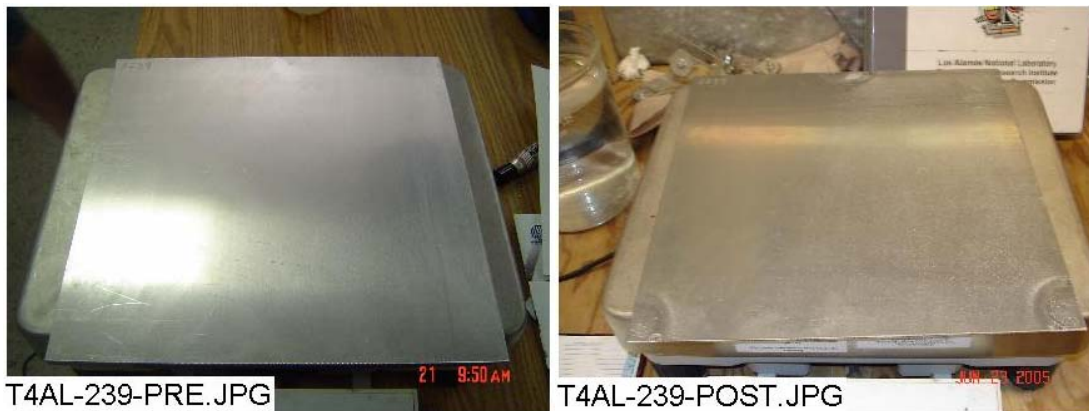
**Figure 3-100. Al-239 submerged, pre-test (left) and post-test (right).**

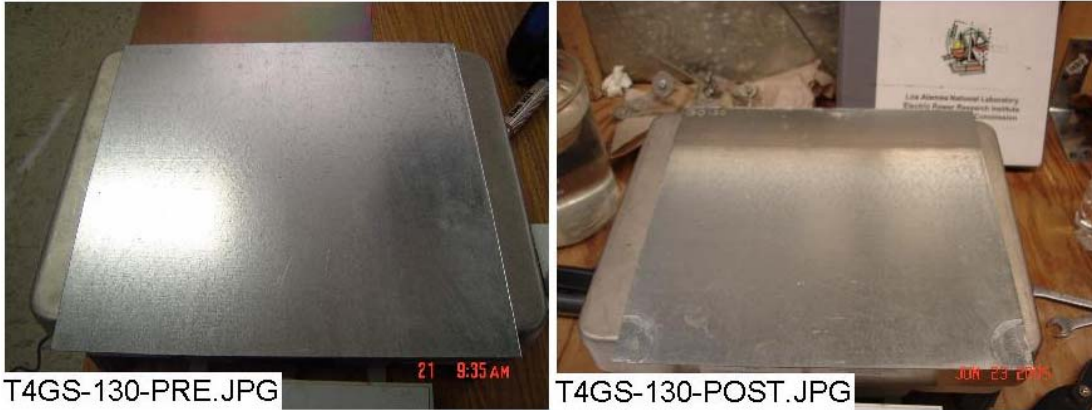
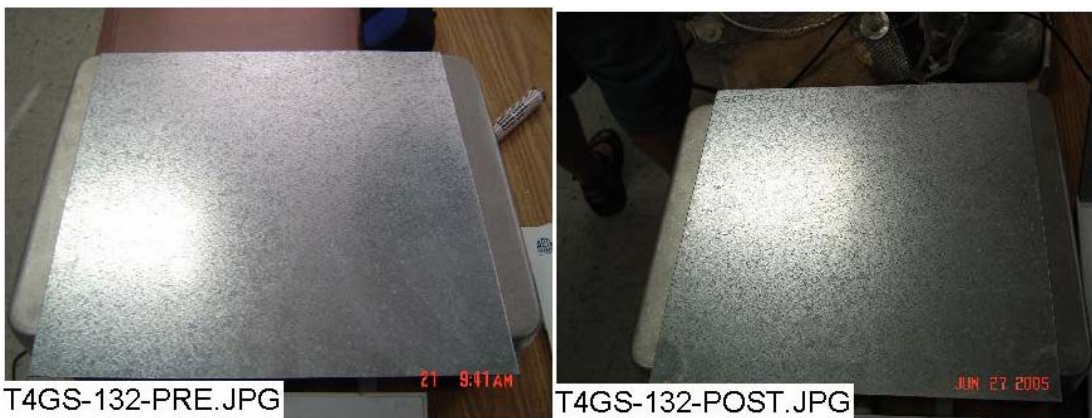
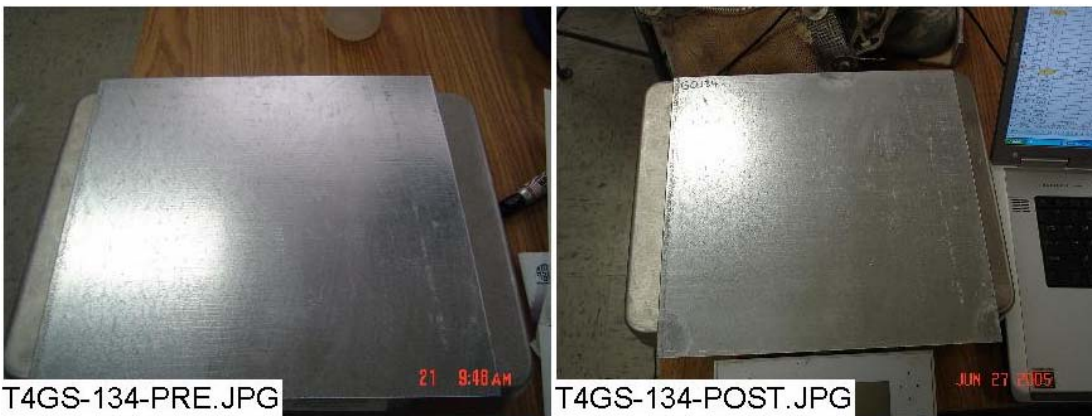
Figures 3-101 through 3-103 present the pre- and post-test pictures of three submerged galvanized steel coupons. The galvanized steel coupons did not experience any significant observable change. The coupons appeared to be relatively clean and the only noticeable marks of any sort are the circular marks caused by the racks that they are mounted in. GS-130 does appear to have some particle deposition that is concentrated mainly on the bottom corners and on the top where the coupon resides in the rack.

**Figure 3-101. GS-130 submerged, pre-test (left) and post-test (right).**

**Figure 3-102. GS-132 submerged, pre-test (left) and post-test (right).**

**Figure 3-103. GS-134 submerged, pre-test (left) and post-test (right).**

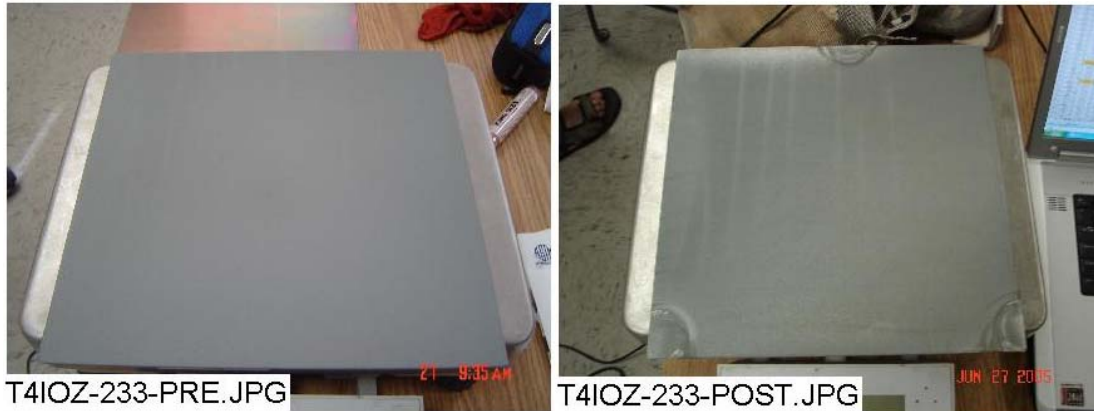
Figures 3-104 and 3-105 present the pre- and post-test pictures of two submerged inorganic zinc (IOZ) coated steel coupons. Both submerged IOZ coated steel coupons have similar, light particle depositions. There is a small accumulation of a white precipitate that originates mostly from the points of contact with the racks. However on IOZ-233, the particles seem to be distributed over the majority of the surface of the

coupon. This coupon was the westernmost IOZ coupon in the rack in relation to the others.

**Figure 3-104. IOZ-233 submerged, pre-test (left) and post-test (right).**

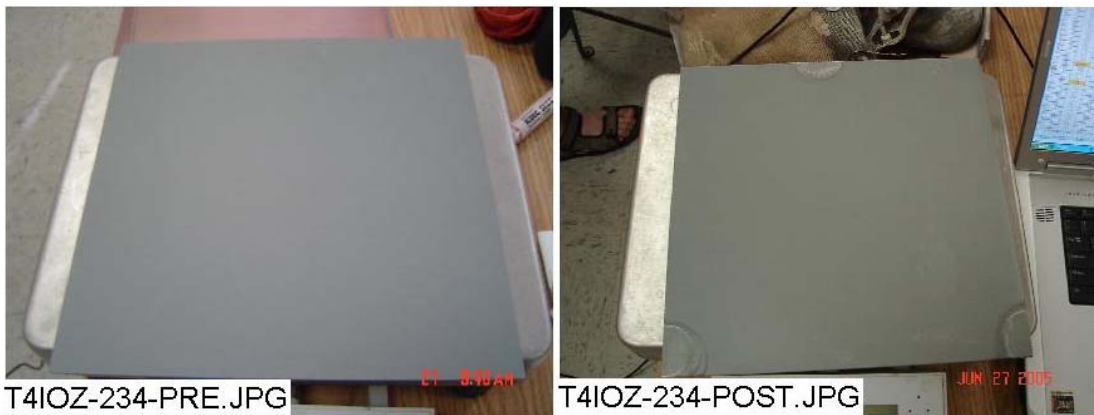
**Figure 3-105. IOZ-234 submerged, pre-test (left) and post-test (right).**

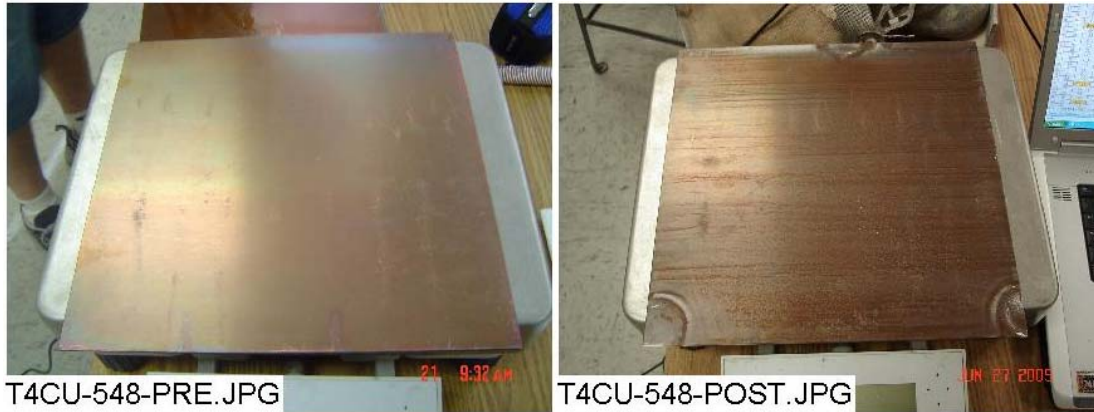
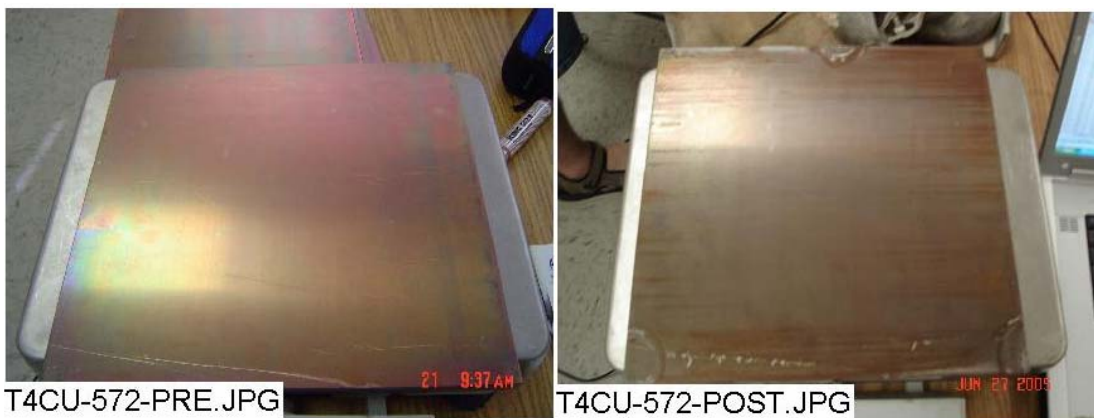
Figures 3-106 and 3-107 present the pre- and post-test pictures of two submerged copper coupons. The copper coupons were mainly unchanged. Like the other coupons, there is a very light concentration of particulate deposits in the areas where the coupons contact the rack.

**Figure 3-106. Cu-548 submerged, pre-test (left) and post-test (right).**

**Figure 3-107. Cu-572 submerged, pre-test (left) and post-test (right).**

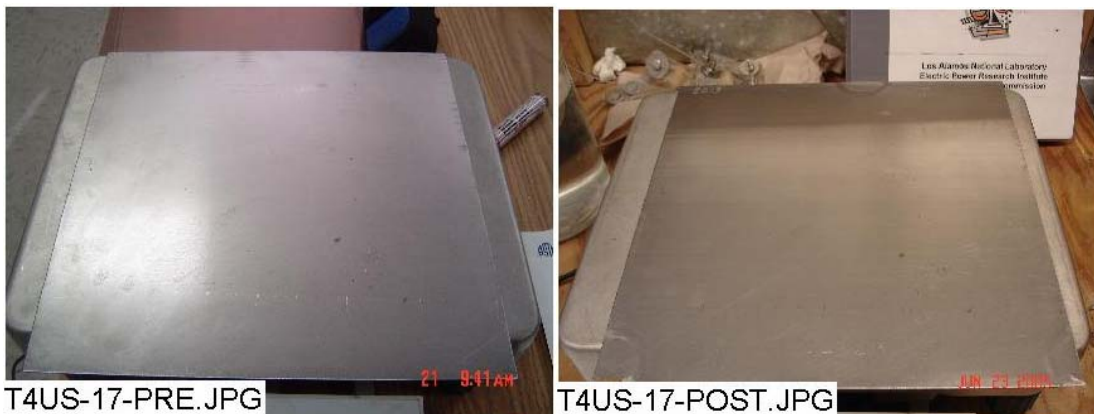
Figure 3-108 presents the pre- and post-test pictures of the submerged carbon steel coupon. Other than some discoloration, there was no change. There was a small amount of rust on the bottom corners.

**Figure 3-108. US-17 submerged, pre-test (left) and post-test (right).**

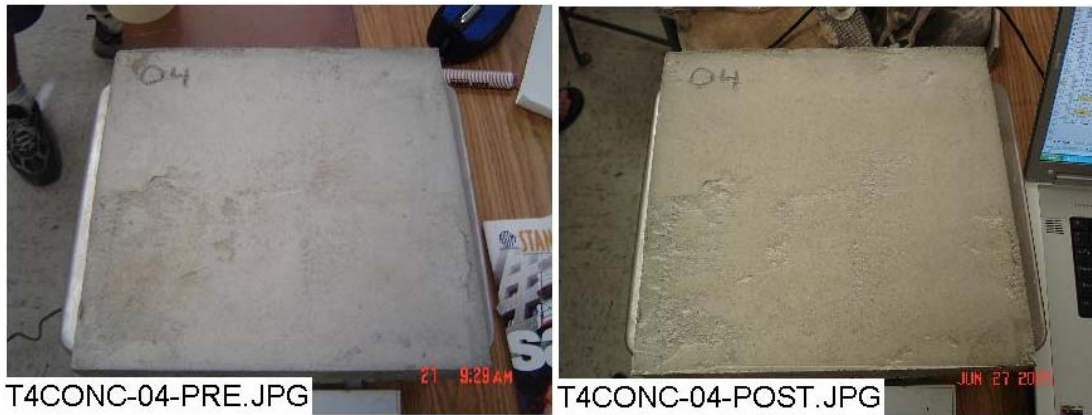
Figure 3-109 presents the pre- and post-test pictures of the submerged concrete coupon. The post-test concrete coupon exhibits a brownish color.

**Figure 3-109. Conc-004 submerged, pre-test (left) and post-test (right).**

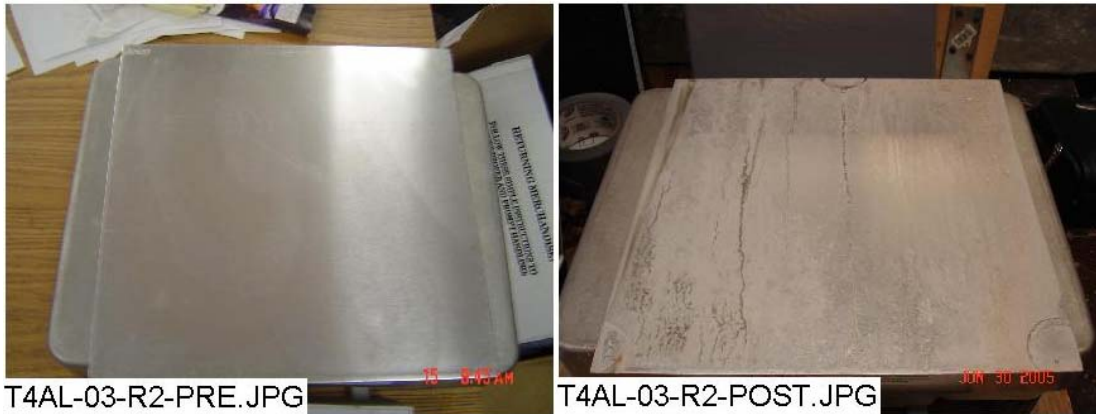
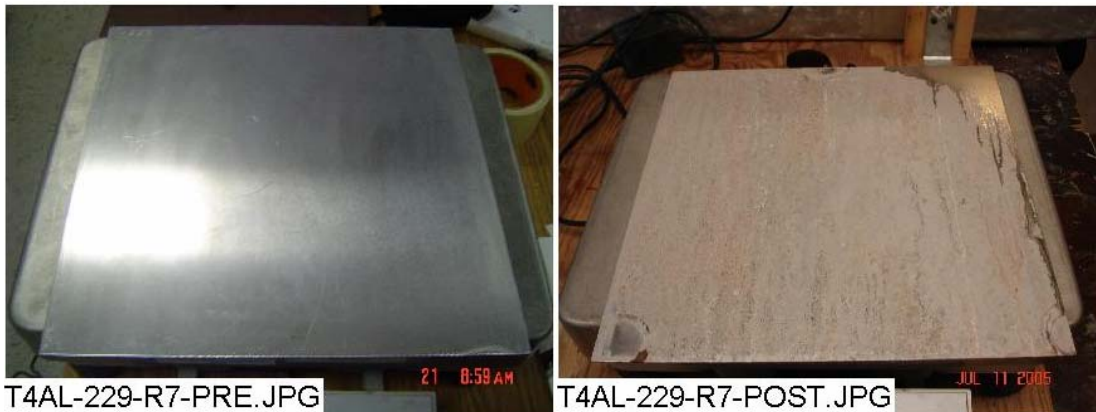
Figures 3-110 and 3-111 show the pre- and post-test pictures of two unsubmerged aluminum coupons. Each unsubmerged aluminum coupon accumulated a white particle deposition along with some areas of a brownish color. This coating caused the surface of the aluminum coupons to become coarse and rough. The photo of Al-229 shows that most of the surface is coated with the particle deposition, however, in the upper right hand corner the surface is relatively smooth with a color change observable. This is likely caused by uneven spray on the coupons. Even though the four spray nozzles were set to spray uniformly across their spray radius, the spray was not a perfect mist. There were some non-uniform areas, and the positions of the six coupon racks also interfered with the sprays. Al-003 was loaded in Rack 2 (bottom tier, southernmost), and Al-229 was loaded in Rack 7 (upper tier, northernmost).

Figure 3-110. Al-003 unsubmerged, pre-test (left) and post-test (right).

Figure 3-111. Al-229 unsubmerged, pre-test (left) and post-test (right).

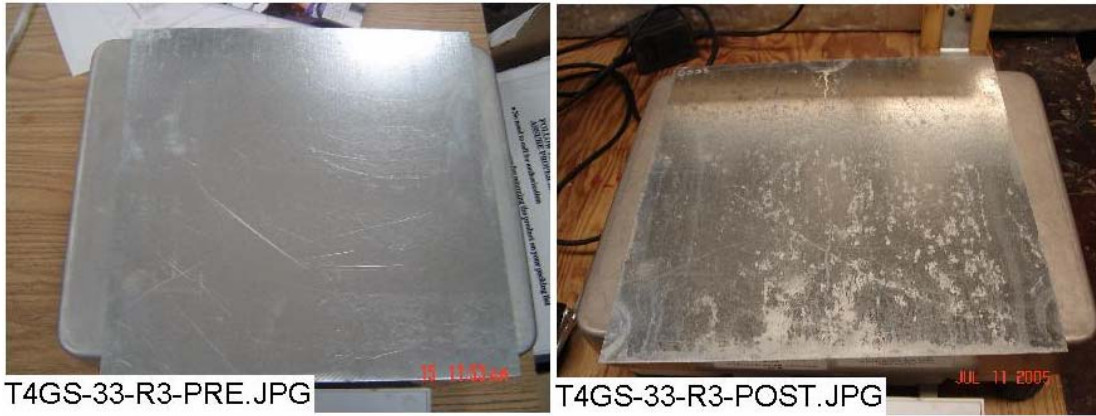
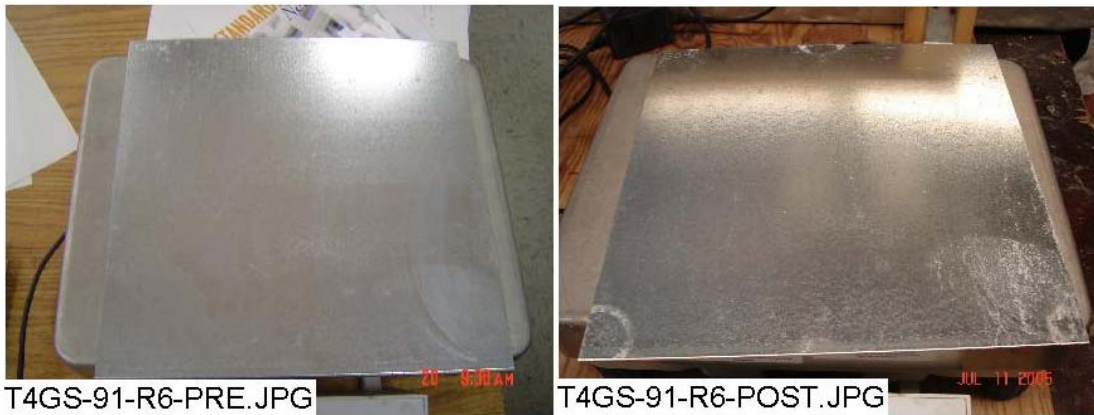
Figures 3-112 and 3-113 show the pre- and post-test pictures of two unsubmerged galvanized steel coupons. There was some white deposition on the surface of these coupons although it was in small amounts. The post-test coupons were relatively clean,

with little change. GS-33 was mounted in Rack 3 (bottom tier, middle rack), and GS-91 was mounted in Rack 6 (upper tier, middle rack).

**Figure 3-112. GS-33 unsubmerged, pre-test (left) and post-test (right).**

**Figure 3-113. GS-91 unsubmerged, pre-test (left) and post-test (right).**

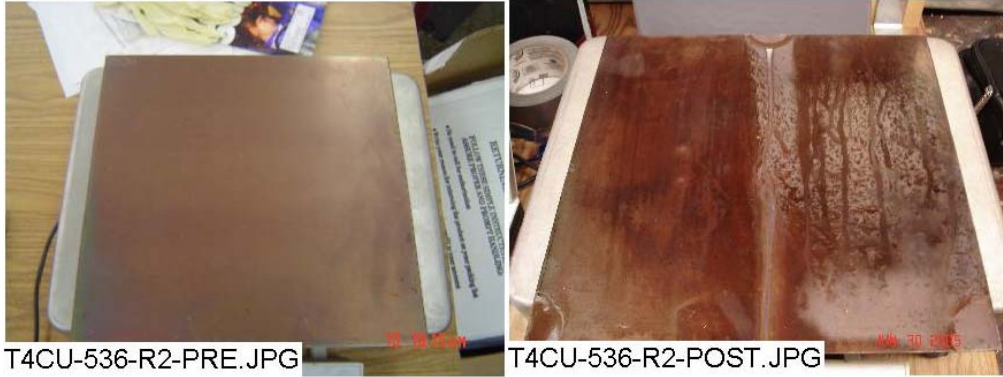
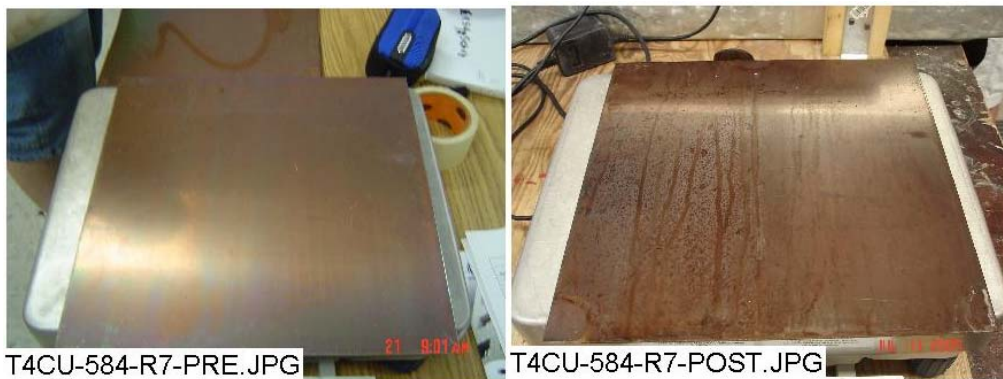
Figures 3-114 and 3-115 present the pre- and post-test pictures of two unsubmerged copper coupons. All of the copper coupons had vertical water marks that were caused by water flowing downward on the coupon surface during the spray portion of the test. The copper coupons did not appear to accumulate any particle deposition. Cu-536 was mounted in Rack 2 (bottom tier, southernmost), and Cu-584 was mounted in Rack 7 (upper tier, northernmost).

**Figure 3-114. Cu-536 unsubmerged, pre-test (left) and post-test (right).**

**Figure 3-115. Cu-584 unsubmerged, pre-test (left) and post-test (right).**

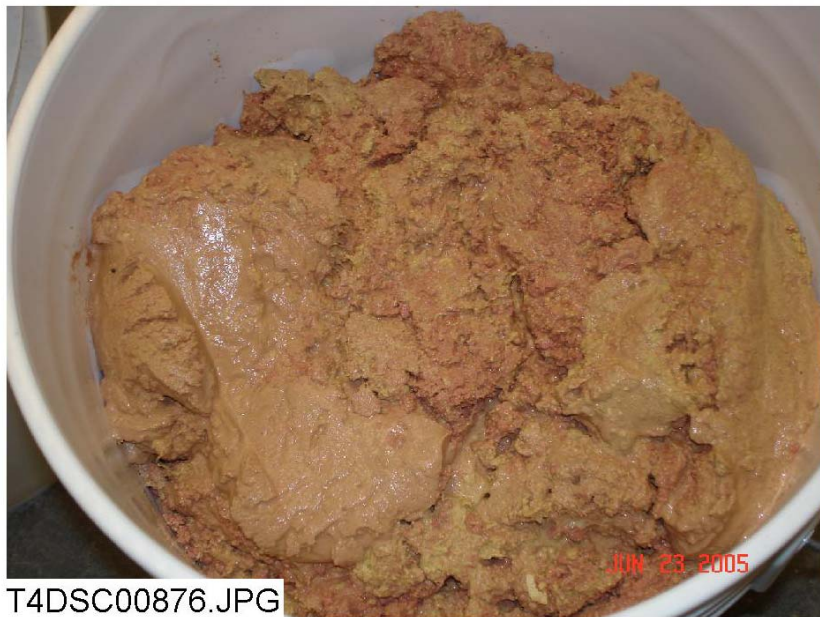
Sediment was collected from the tank bottom after the test solution was drained. It consisted of a particulate sediment that covered the entire tank bottom. Figure 3-119 shows some of this sediment. In addition, Figure 3-120 shows the tank bottom with the sediment, after the samples were removed. Figure 3-121 shows the top of the drain screen with the drain collar surrounded by sediment, and Figure 3-122 shows the drain screen and drain collar after removal from the tank. Figure 3-123 shows the birdcage sitting on top of a basket of cal-sil after the tank was drained. The cal-sil baskets sat on top of the sediment, and thus, the birdcage was not in direct contact with the sediment.

**Figure 3-119. Sediment removed from the tank.**

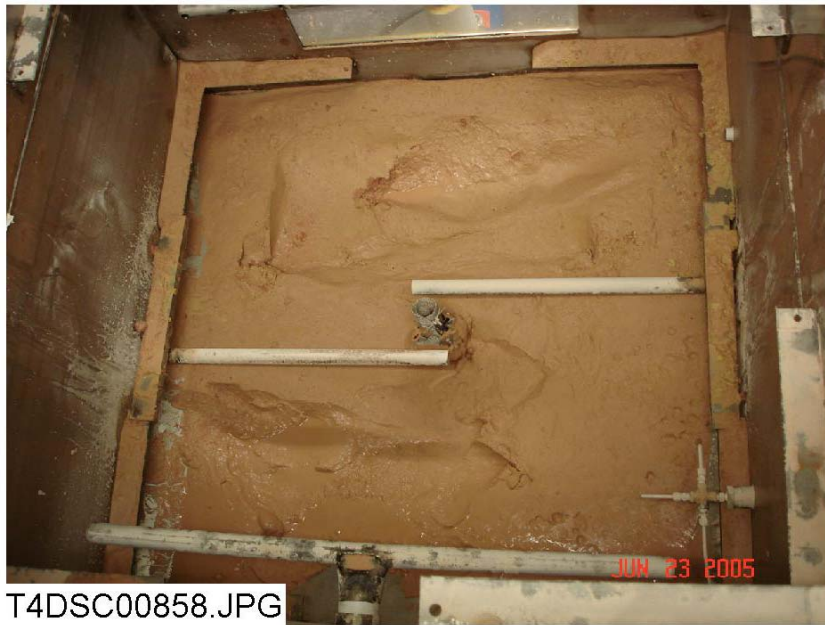
**Figure 3-120. Sediment on the tank bottom.**

Sediment on the tank bottom was prevalent, accumulating to depths of over 8 in. The sediment contained crystalline substances and calcite, making it primarily cal-sil, although some fugitive fiberglass was also present.

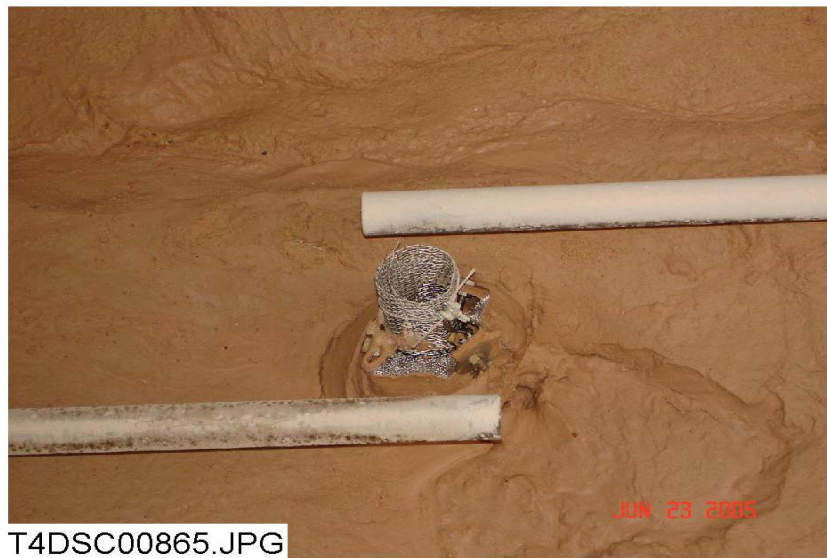
**Figure 3-121. Drain collar surrounded by sediment on the tank bottom.**

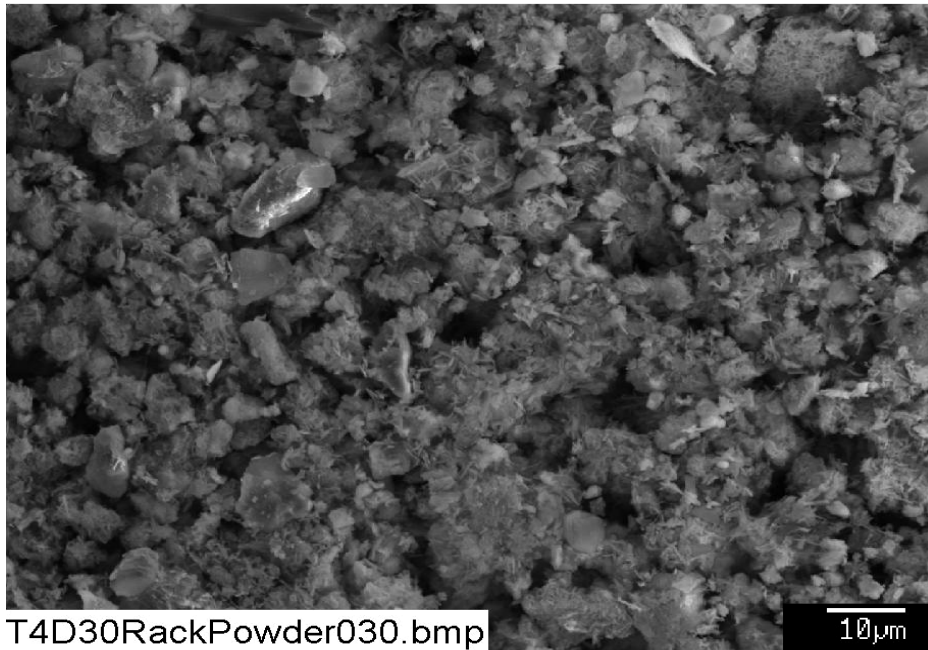
The deposition of debris/corrosion products in the tank after it was drained was observed on the submerged objects in the tank. These corrosion/deposition products, which looked like a fine powder, were collected for analysis. Those collected were from the submerged CPVC coupon rack. SEM/ EDS results indicated that these fine powders were mainly composed of O, Ca, Si, Na, Al, and C. The high content of Ca and Si suggests that the powders were likely from cal-sil and fiberglass debris.

**Figure 3-130. SEM image magnified 1000 times for a Test #4, Day-30 fine powder on the submerged rack. (T4D30RackPowder030.bmp)**
