Preface to Appendices

Appendix A

SEM/EDS Data for Test #2, Day-15 High-Volume Filter

SEM/EDS Data for Test #2, Day-30 Corrosion Products

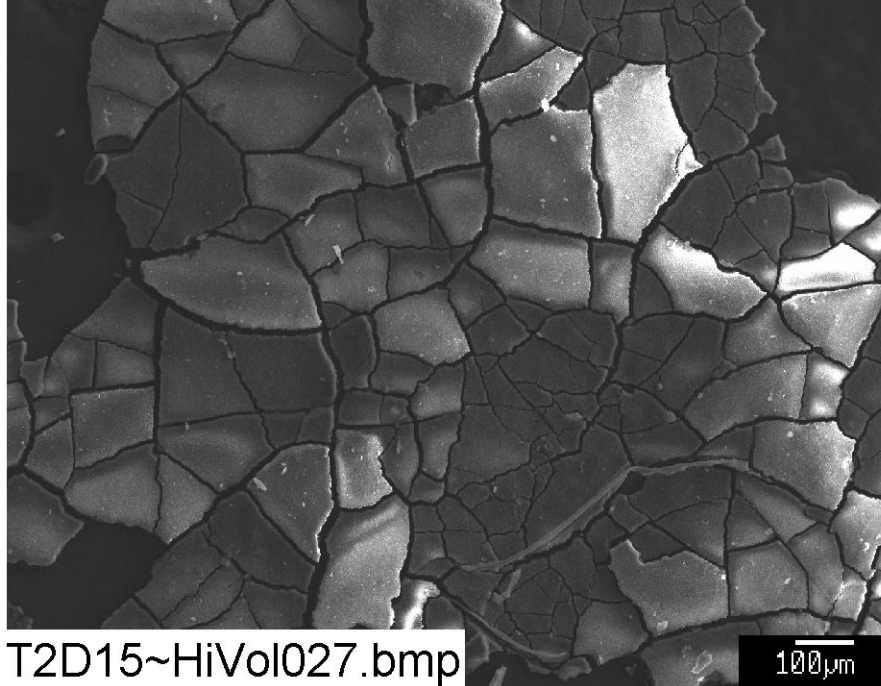
Figure A-1. SEM image at 120 \times magnification for a Test #2, Day-15 sample of particles on the high-volume filter. (T2D15_HiVol027)

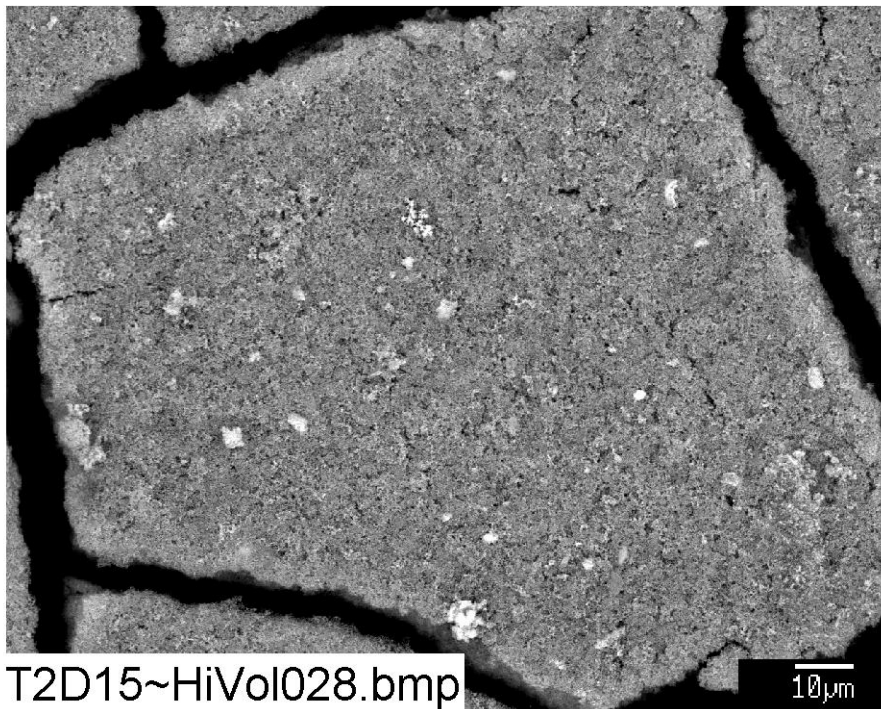
Figure A-2. Backscatter SEM image at 800 \times magnification for a Test #2, Day-15 sample of particles on a high-volume filter. (T2D15_HiVol028)

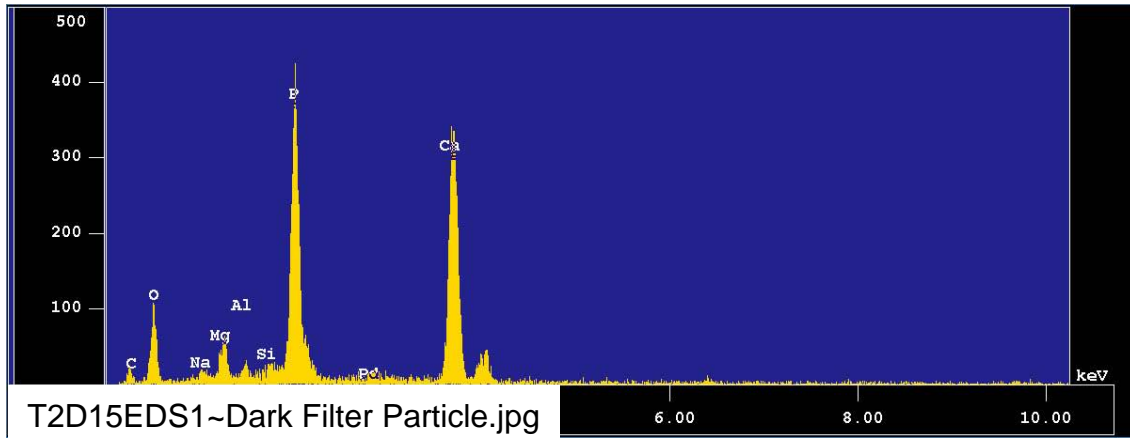
Figure A-3. EDS counting spectrum for the darker filtrate material shown in Figure A-2, indicating that the dark material is rich in calcium and phosphorus. (T2D15EDS1~Dark Filter Particle)

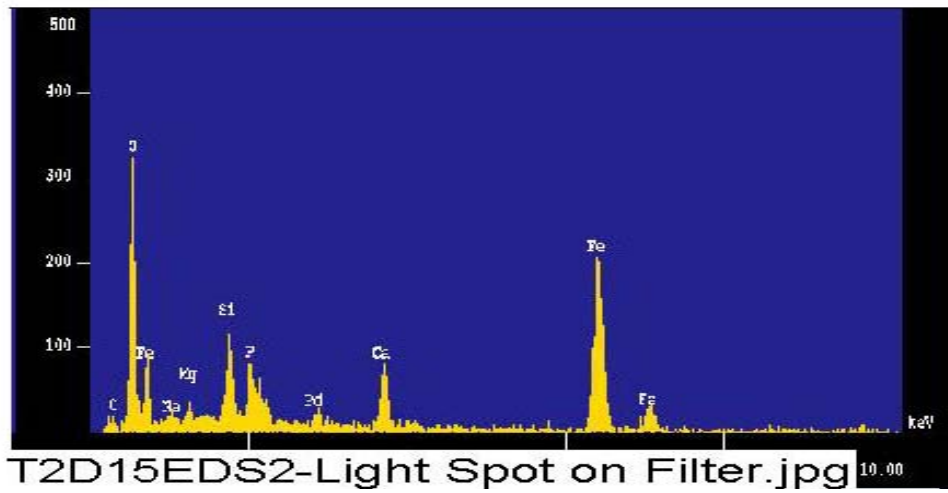
Figure A-4. EDS counting spectrum for bright flecks on BSE image shown in Figure A-2, suggesting that they are rich in iron, oxygen, and silicon. (T2D15EDS2-Light Spot on Filter)

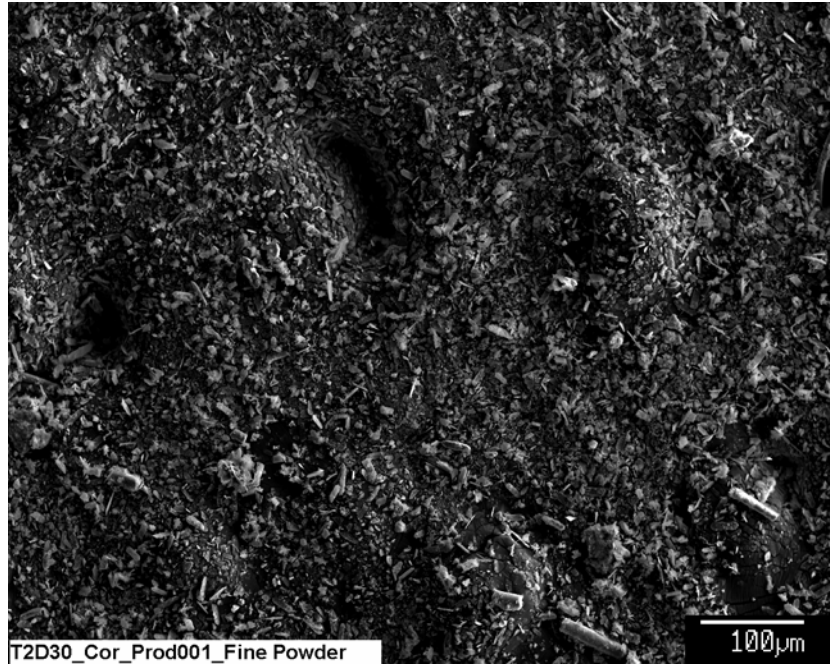
Figure B-1. SEM image (150×) for a Test #2, Day-30 sample of fine powder on a vertical piece of the submerged PVC rack. (T2D30_Cor_Prod001_Fine Powder)

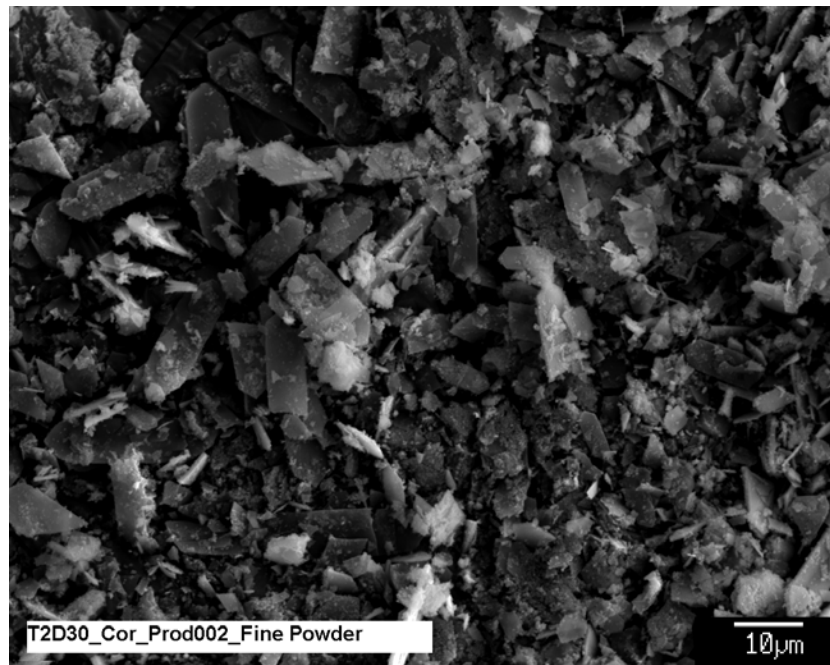
Figure B-2. SEM image at 1000× magnification for a Test #2, Day-30 sample of fine powder on a vertical piece of the submerged PVC rack. (T2D30_Cor_Prod002_Fine Powder)

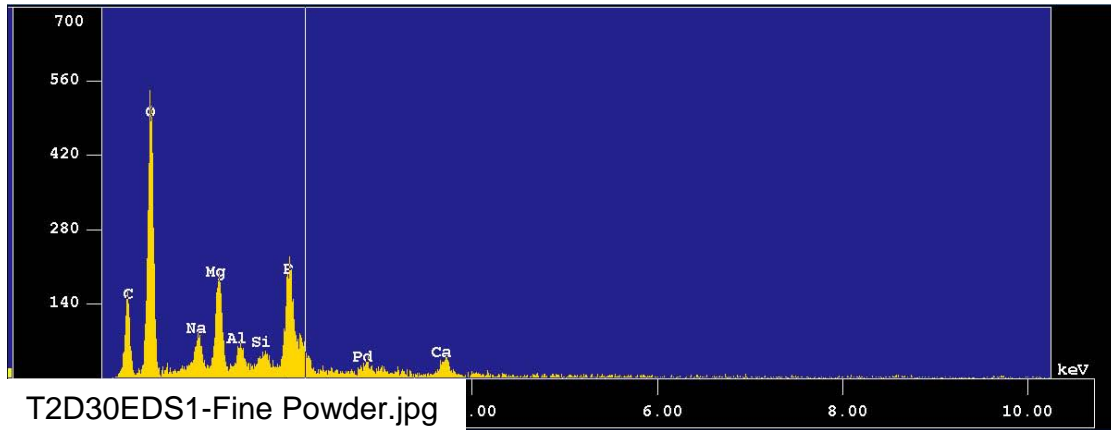
Figure B-3. EDS counting spectrum for the SEM image shown in Figure B-2, suggesting that the fine powder may contain magnesium salts [MgCO_3 and/or $\text{Mg}_3(\text{PO}_4)_2$]. (T2D30EDS1-Fine Powder)

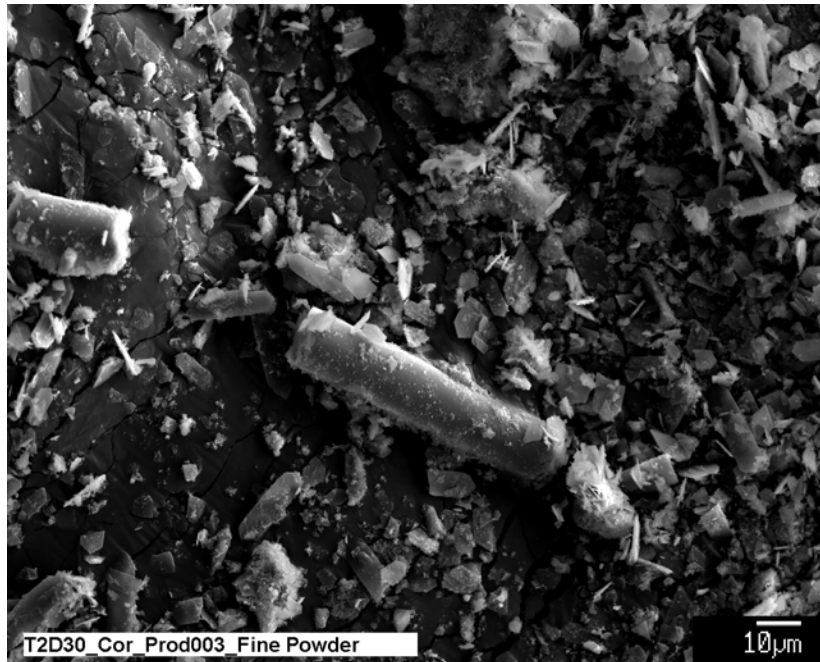
Figure B-4. Another SEM image at 650 \times magnification for a Test #2, Day-30 sample of fine powder on a vertical piece of the submerged PVC rack. The cylinder-shaped debris is likely to be fiberglass. (T2D30_Cor_Prod003_Fine Powder)

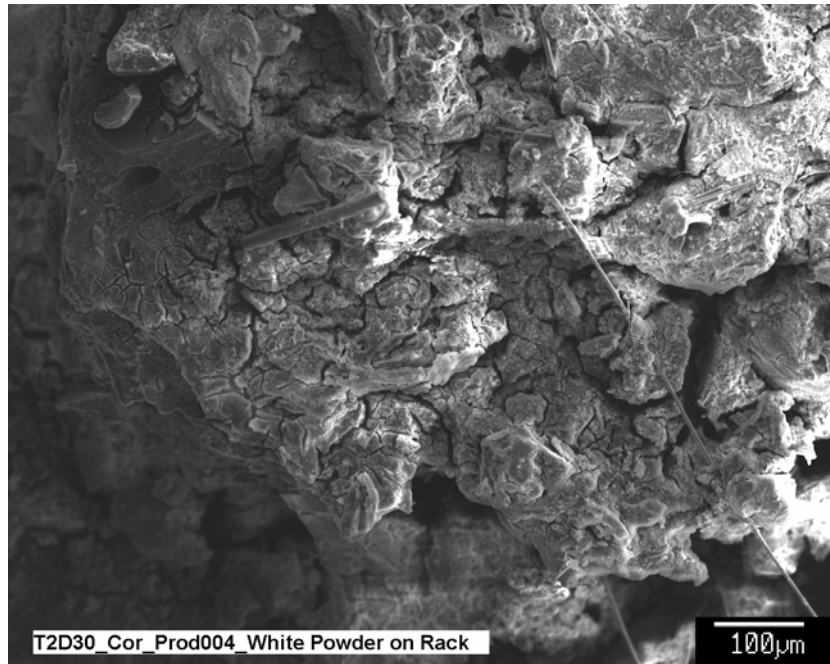
Figure B-5. SEM image (130×) for a Test #2, Day-30 sample of white residue on a horizontal piece of the submerged CPVC rack. (T2D30_Cor_Prod004_White Powder on Rack)

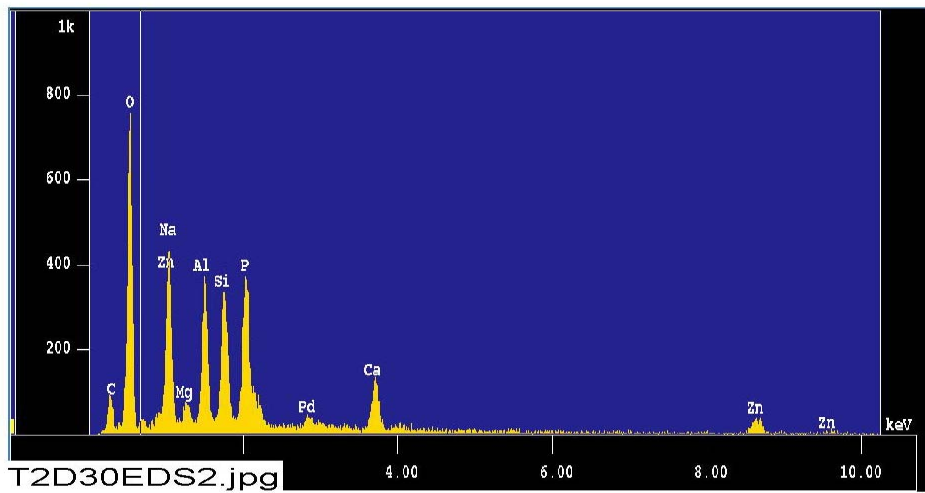
Figure B-6. EDS counting spectrum collected on the field of view at 130× magnification for the white residue shown in Figure B-5. (T2D30EDS2)

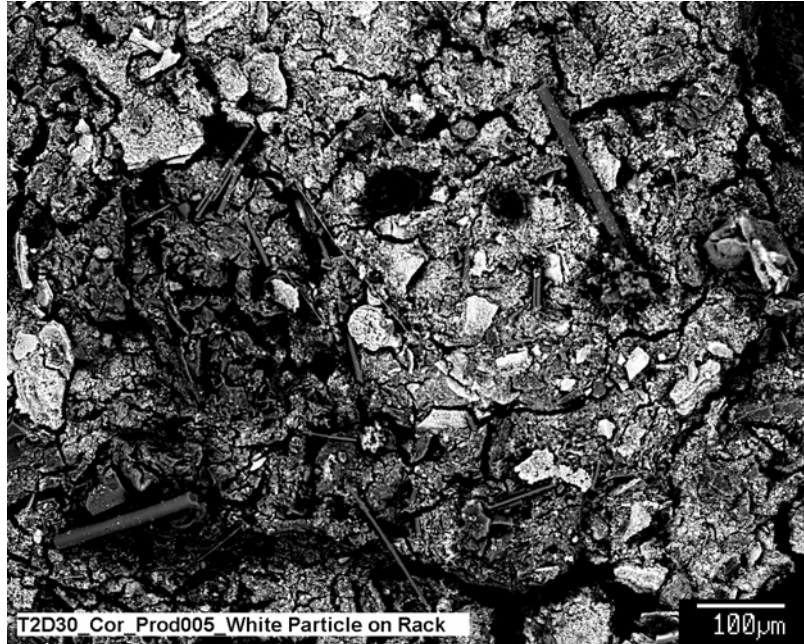
Figure B-7. Backscattered SEM image at 130× magnification for a Test #2, Day-30 sample of white residue on a horizontal piece of the submerged PVC rack. (T2D30_Cor_Prod005_White Particle on Rack)

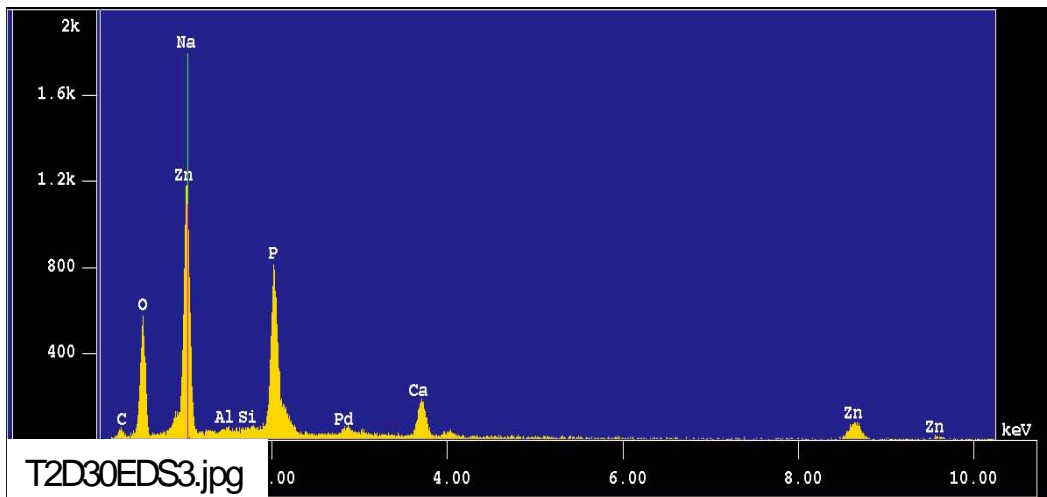
Figure B-8. EDS counting spectrum collected on the bright particles shown in Figure B-7. (T2D30EDS3)

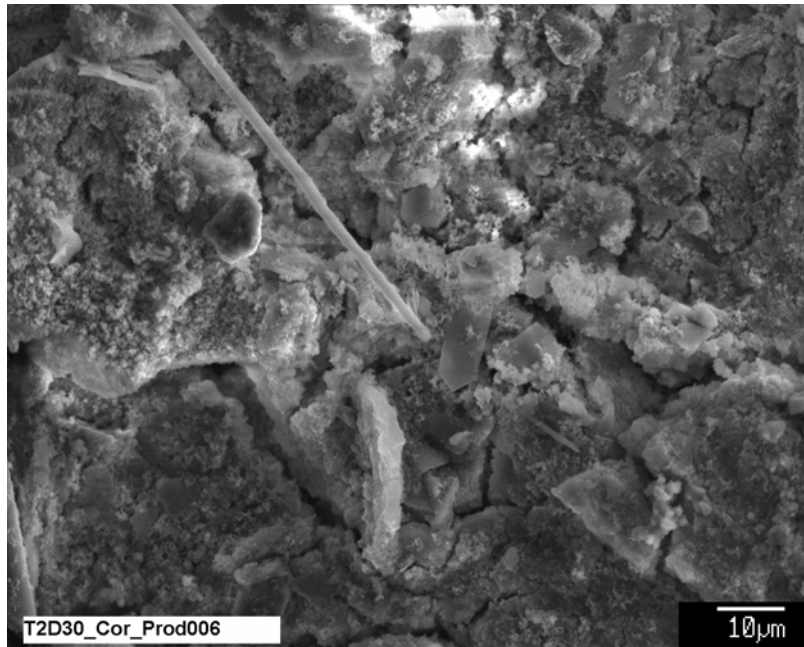
Figure B-9. SEM image at 1000× magnification for a Test #2, Day-30 sample of white residue on the horizontal piece of the submerged PVC rack. (T2D30_Cor_Prod006)

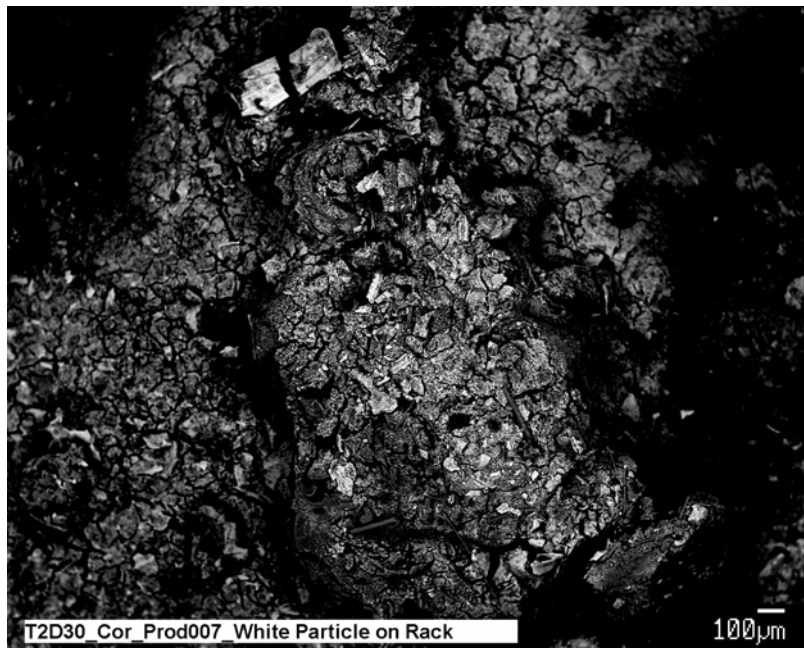
Figure B-10. Backscatter SEM overview at 40× magnification of a Test #2, Day-30 sample of white residue on the horizontal piece of the submerged CPVC rack. (Looks similar to the corrosion product on GS). (T2D30_Cor_Prod007_White Particle on Rack)

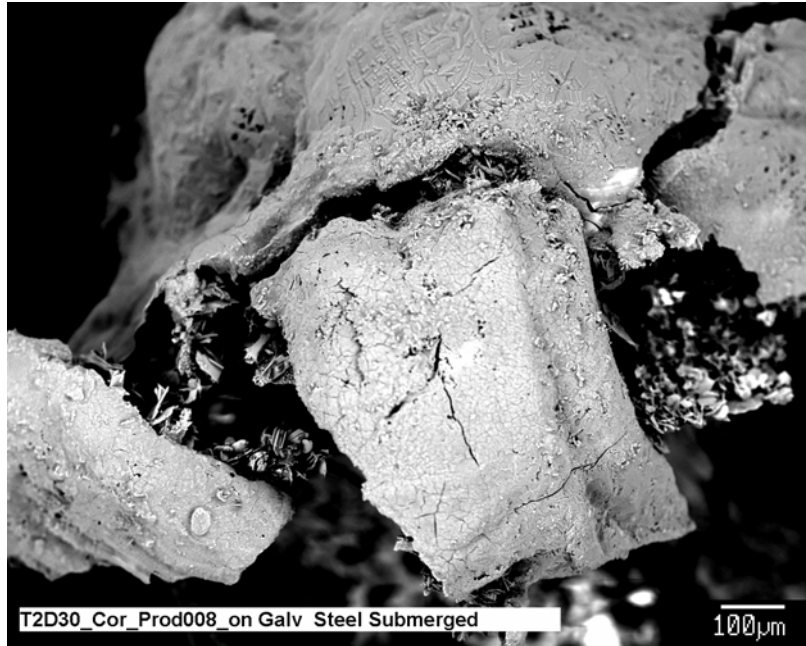
Figure B-11. Backscatter SEM image at 95× magnification of a Test #2, Day-30 sample of corrosion products on a submerged GS coupon. (T2D30_Cor_Prod008_on Galv Steel Submerged)

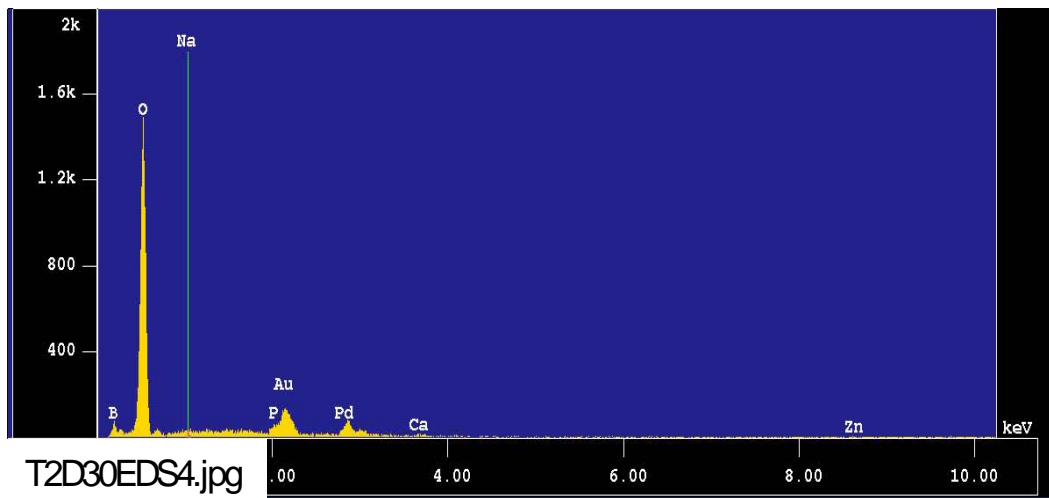
Figure B-12. EDS counting spectrum collected from the center of the SEM image shown in Figure B-11. (T2D30EDS4)

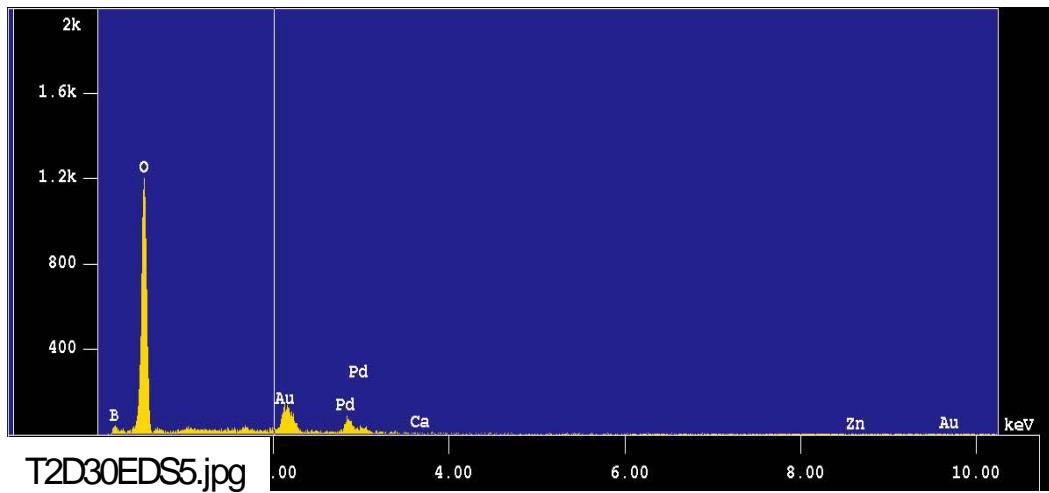
Figure B-13. EDS counting spectrum collected from the upper part of the SEM image shown in Figure B-11. (T2D30EDS5)

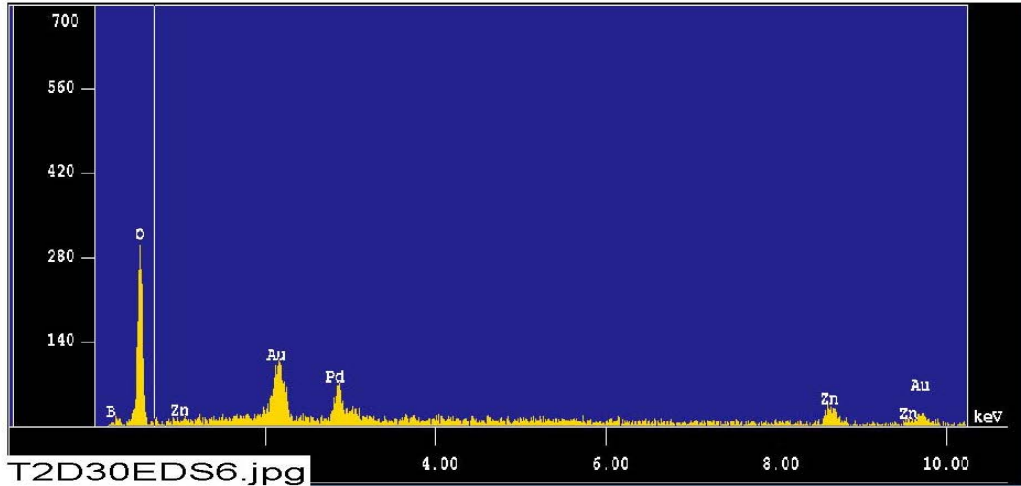
Figure B-14. EDS counting spectrum collected from the center of the SEM image shown in Figure B-11 but using a 25-kV beam voltage. (T2D30EDS6)

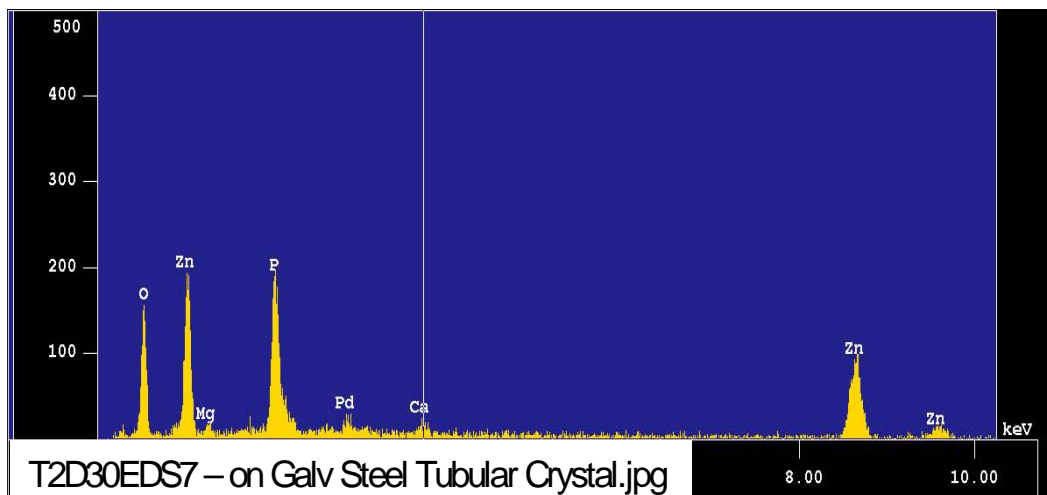
Figure B-15. EDS counting spectrum for small tubular crystals in Figure B-11, suggesting that the corrosion products of galvanized steel are rich in zinc, phosphorus, and oxygen [possible presence of $Zn_3(PO_4)_2$].

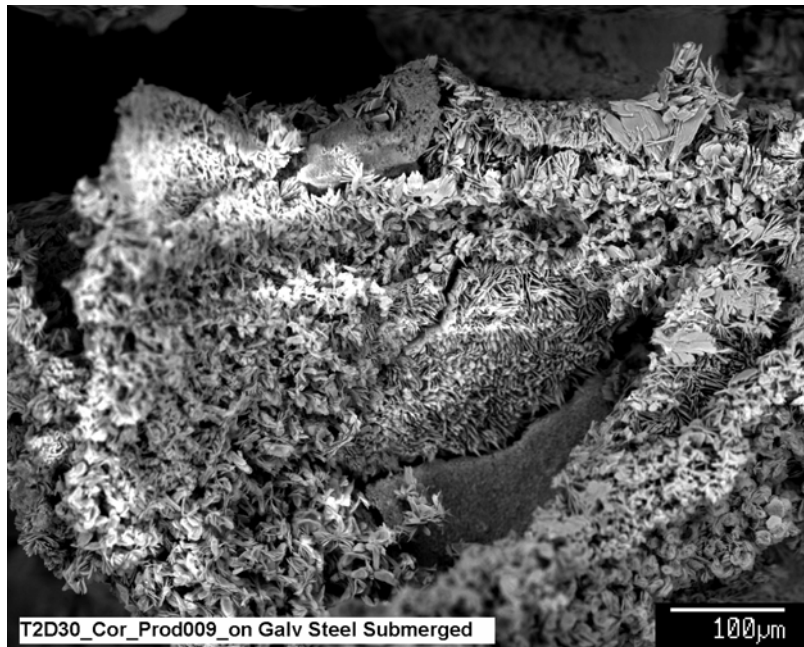
Figure B-16. Backscatter SEM image at 120× magnification for a Test #2, Day-30 sample of corrosion products on a submerged GS coupon. (T2D30_Cor_Prod009_on Galv Steel Submerged)

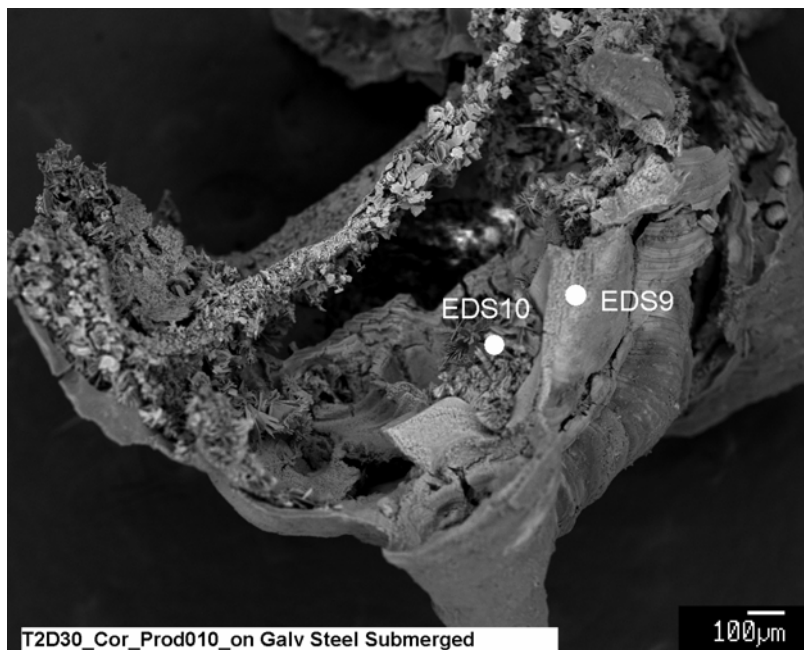
Figure B-17. Backscatter SEM image at 55× magnification for a Test #2, Day-30 sample of corrosion products on a submerged GS coupon, annotated to show EDS sample locations. (T2D30_Cor_Prod010_on Galv Steel Submerged)

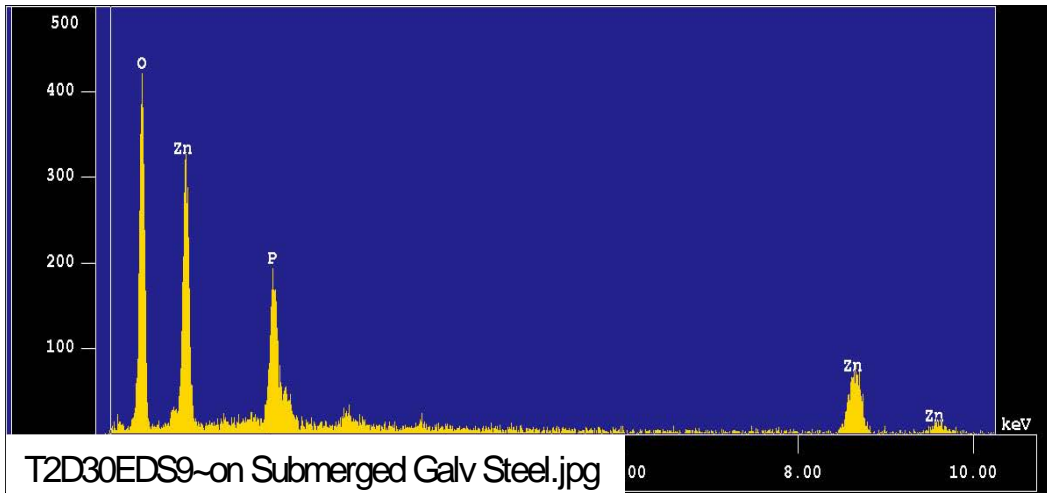
Figure B-18. EDS counting spectrum collected from the spot EDS9 indicated in Figure B-17. (T2D30EDS9~on Submerged Galv Steel)

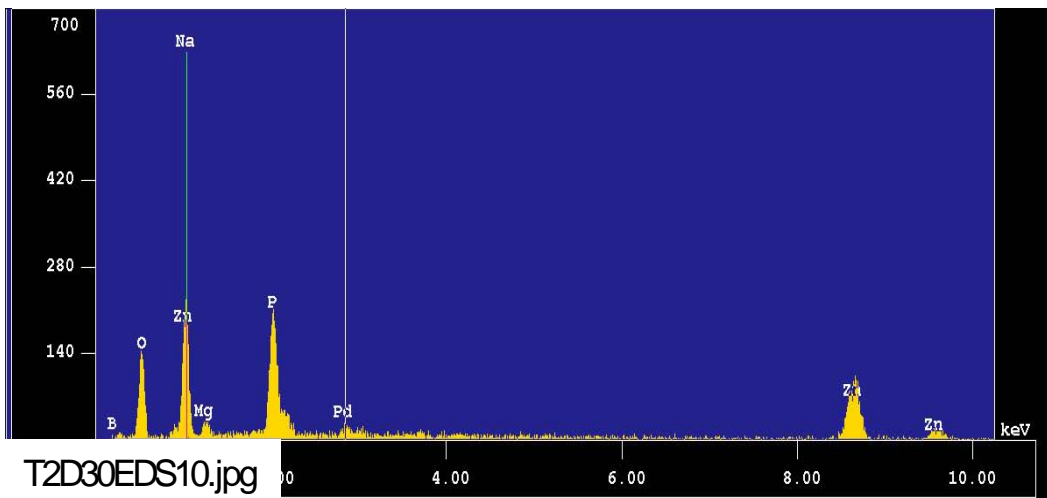
Figure B-19. EDS counting spectrum collected from the spot EDS10 indicated in Figure B-17. (T2D30EDS10)

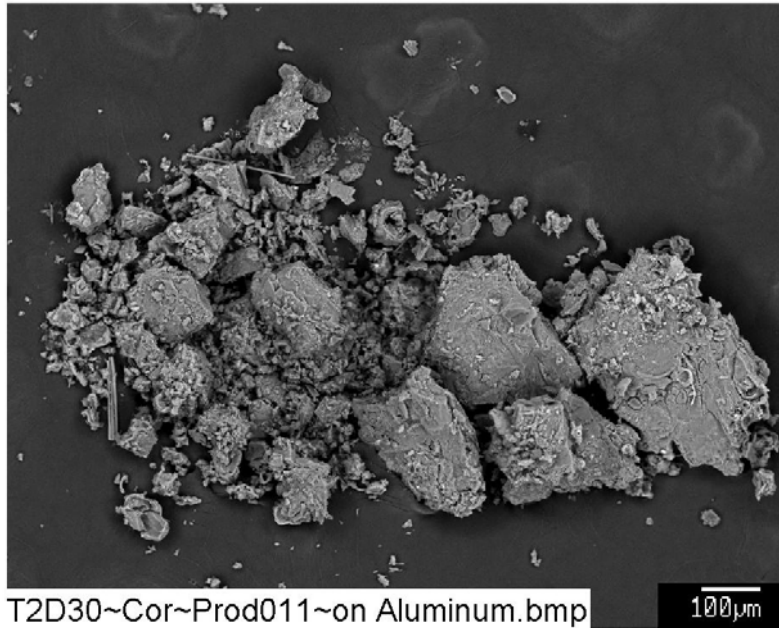
Figure B-20. Backscatter SEM image at 90× magnification for a Test #2, Day-30 sample of corrosion products on a submerged aluminum coupon. (T2D30_Cor~Prod011~on Aluminum)

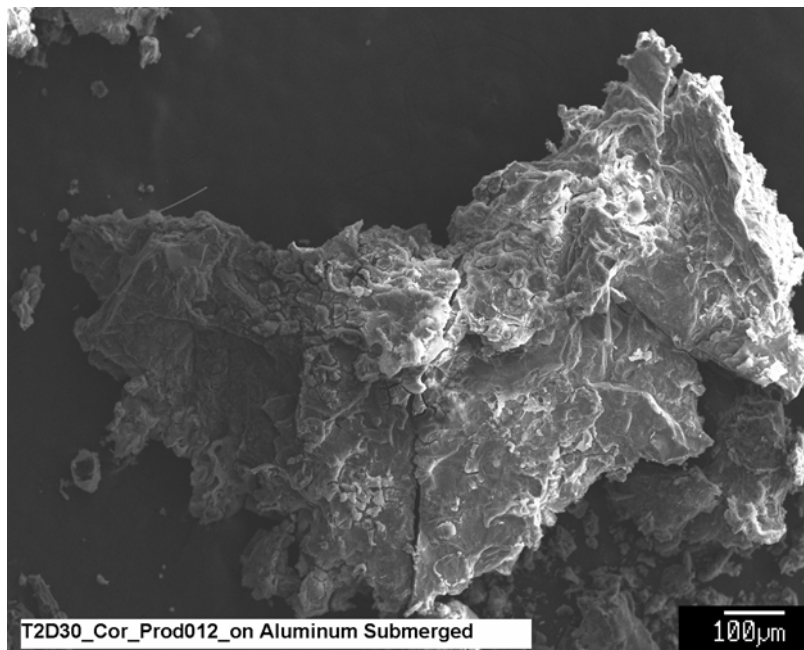
Figure B-21. SEM image at 90× magnification on another area of a Test #2, Day-30 sample of corrosion products on a submerged aluminum coupon. (T2D30_Cor_Prod012_on Aluminum Submerged)

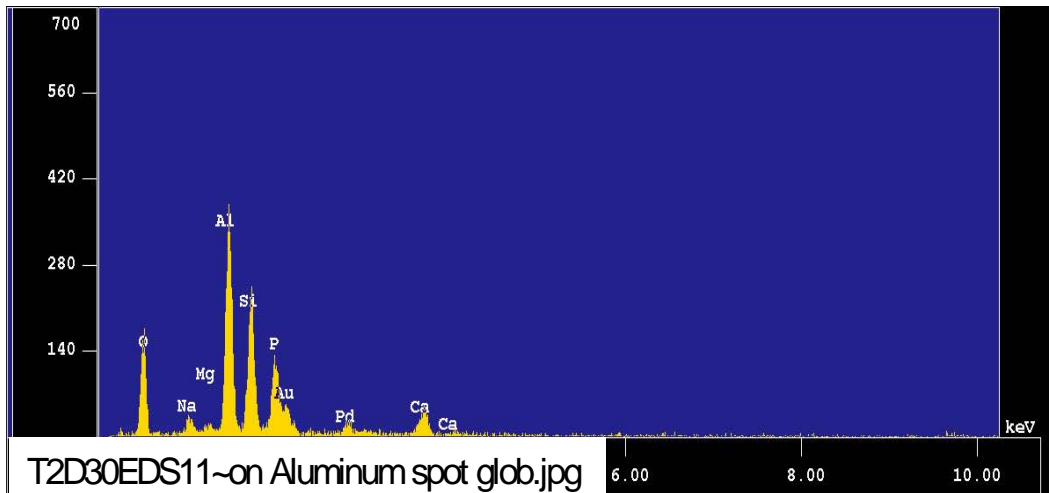
Figure B-22. EDS counting spectrum for upper right spot in Figure B-21, suggesting that the corrosion products of aluminum are rich in aluminum, silicon, phosphorus, and oxygen. (T2D30EDS11~on Aluminum spot glob)

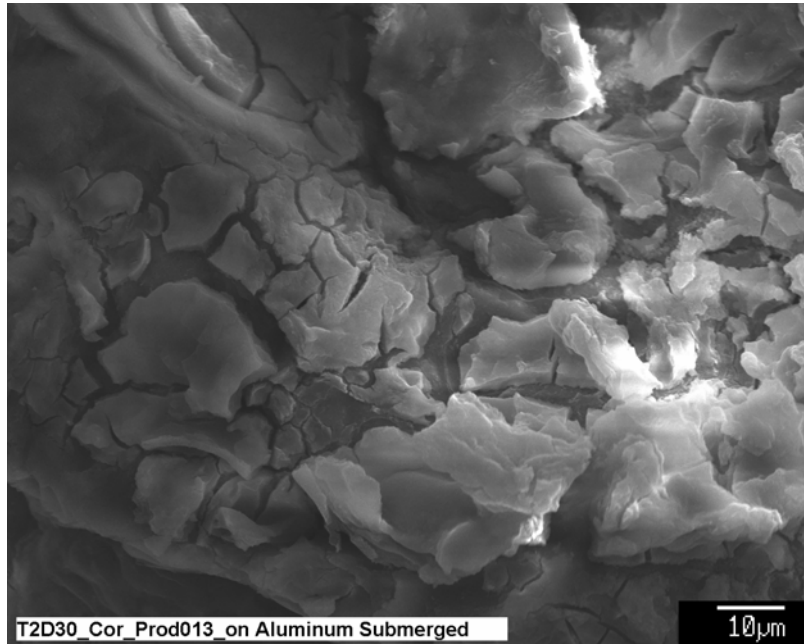
Figure B-23. SEM image at 1000× magnification of a Test #2, Day-30 sample of corrosion products on a submerged aluminum coupon. (T2D30_Cor_Prod013_on Aluminum Submerged)

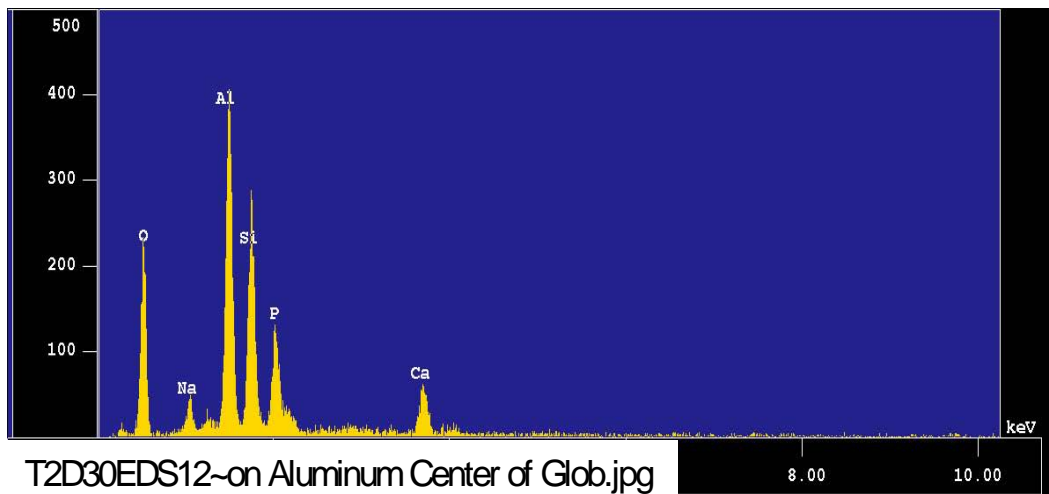
Figure B-24. EDS counting spectrum on the center of Figure B-23, suggesting that the corrosion products of aluminum are rich in aluminum, silicon, phosphorus, and oxygen. (T2D30EDS12~on Aluminum Center of Glob)
