April 16, 2008

UNITED STATES
NUCLEAR REGULATORY COMMISSION
OFFICE OF NUCLEAR MATERIAL SAFETY AND SAFEGUARDS
WASHINGTON, D.C. 20555

NRC INFORMATION NOTICE 2008-08: MAINTENANCE PROCEDURES COMPROMISE
DOUBLE-CONTINGENCY OF UO₂ POWDER-
HANDLING EQUIPMENT AT FUEL CYCLE
FACILITY

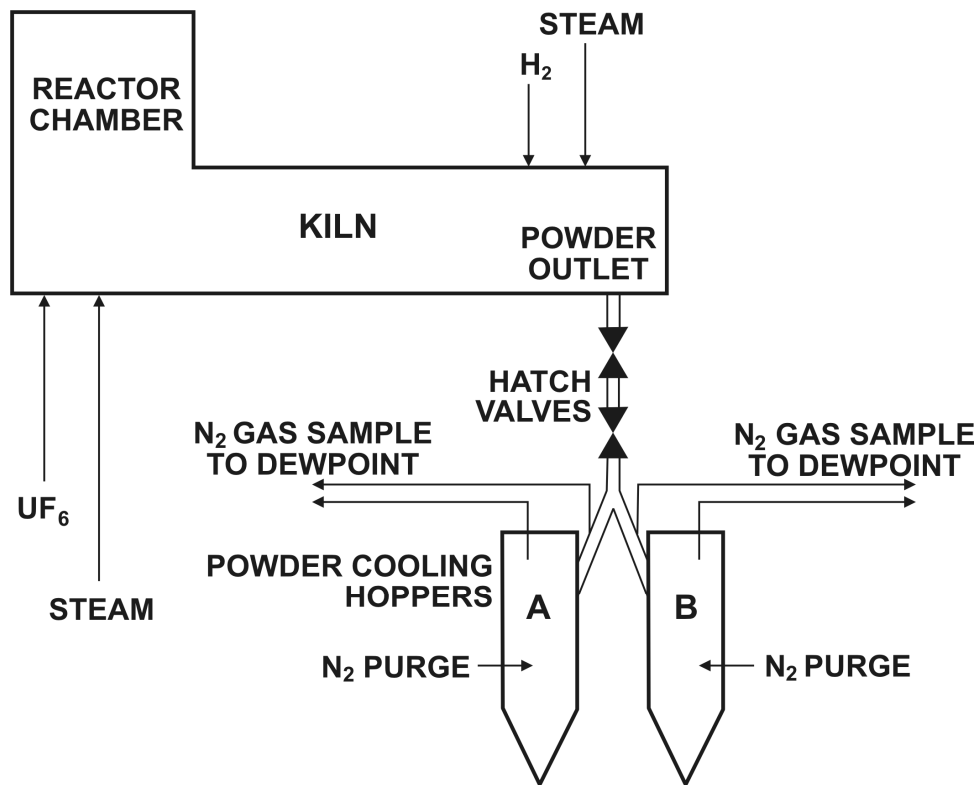
Figure 1
Conversion Reactor/Kiln and Cooling-Hopper Equipment Arrangement

The licensee was performing maintenance consisting of rebuilding the conversion reactor/kiln on one of the dry-conversion lines. The maintenance included replacing the two in-line hatch valves leading to the cooling-hoppers. During the maintenance, one of the two hatch valves was incorrectly connected to its actuator, which resulted in the valve not being able to fully close. After completion of the maintenance, the licensee performed startup testing of the rebuilt equipment, which included sending steam to the reactor/kiln and cycling the hatch valves, to ensure that both hatch valves were properly seating. Hatch valve cycling consists of opening and closing one valve at a time and then pressure checking between the valves, while both are closed, to ensure that there is no direct path for steam to enter the hoppers. Pressure conditions between the two closed hatch valves could not be achieved and the licensee halted the start-up testing. To troubleshoot the condition, the licensee placed the equipment in hot-maintenance standby, which included shutting off the steam to the reactor/kiln.

During the specific troubleshooting of the condition, licensee maintenance personnel secure nitrogen flow to the cooling-hoppers to reduce the likelihood of airborne contamination. Licensee personnel anticipated that moisture sensors would trip the appropriate alarms and interlocks because of the intrusion of ambient air when the nitrogen was shut off. Maintenance personnel informed the dry-conversion area control room of the nitrogen flow being secured. As the troubleshooting progressed, the moisture sensors alarmed and then interlocked, which triggered the steam/UF₆ cutoff. Licensee operators acknowledged the moisture alarm, but failed to notice the interlock status.

Dry-conversion process operators beginning a subsequent shift in the facility noticed the activated cooling-hopper moisture interlock and observed that cooling-hopper A contained approximately 36 kilograms of UO₂ powder. Licensee management, unaware that the interlock had occurred during troubleshooting, decided that the moisture interlock possibly resulted from steam introduced during startup testing. Because the cooling-hoppers are a nonfavorable geometry and the amount of uranium involved appeared to be over the licensee's 31 kilogram safety limit for uncontrolled powder, licensee staff initiated an alert.

Subsequently, the powder in cooling-hopper A was determined to be dry. The licensee investigation concluded that the moisture detector tripped the interlock because of ambient air intrusion during troubleshooting, and that the maintenance staff had not passed on the information because they had not noticed the interlock status.

Double-contingency may be compromised if maintenance affecting criticality controls is performed on nonfavorable-geometry equipment containing fissile material. The event revealed that, although the licensee maintenance procedure required fissile material to be absent from equipment that was being worked on, the procedure did not clearly specify boundaries. Licensee staff failed to recognize that the hatch valves were criticality safety controls for the nonfavorable-geometry powder cooling-hoppers. Thus, the hatch valves were replaced during the maintenance without first emptying the hoppers of UO₂ powder thereby compromising the first double-contingency control against water intrusion into the cooling-hoppers.

Because the licensee criticality safety staff thought that no fissile material would be present in equipment during maintenance, this staff did not normally review maintenance procedures. NRC expects licensees to provide for double-contingency protection during all phases of operations at their facilities, including maintenance. To this end, fuel cycle licensee criticality safety staff members are expected to be familiar with the conduct of process equipment maintenance, in particular, how maintenance procedures affect criticality-related controls.

The failure to review or otherwise be familiar with in-plant maintenance procedures and the condition and status of equipment during all phases of operations and maintenance can result in the compromise of established criticality safety controls. NRC criticality safety inspections routinely review licensee facility operations, to ensure that credible accident sequences have been identified, analyzed, and controlled. NRC criticality safety inspections include review of licensee criticality analyses and related criticality controls, to ensure that analytical assumptions are adequate and not compromised after implementation.
