NTSB National Transportation Safety Board

Office of Aviation Safety

Wiring, Circuit Breakers, and Training Presentation

Fire Group Findings

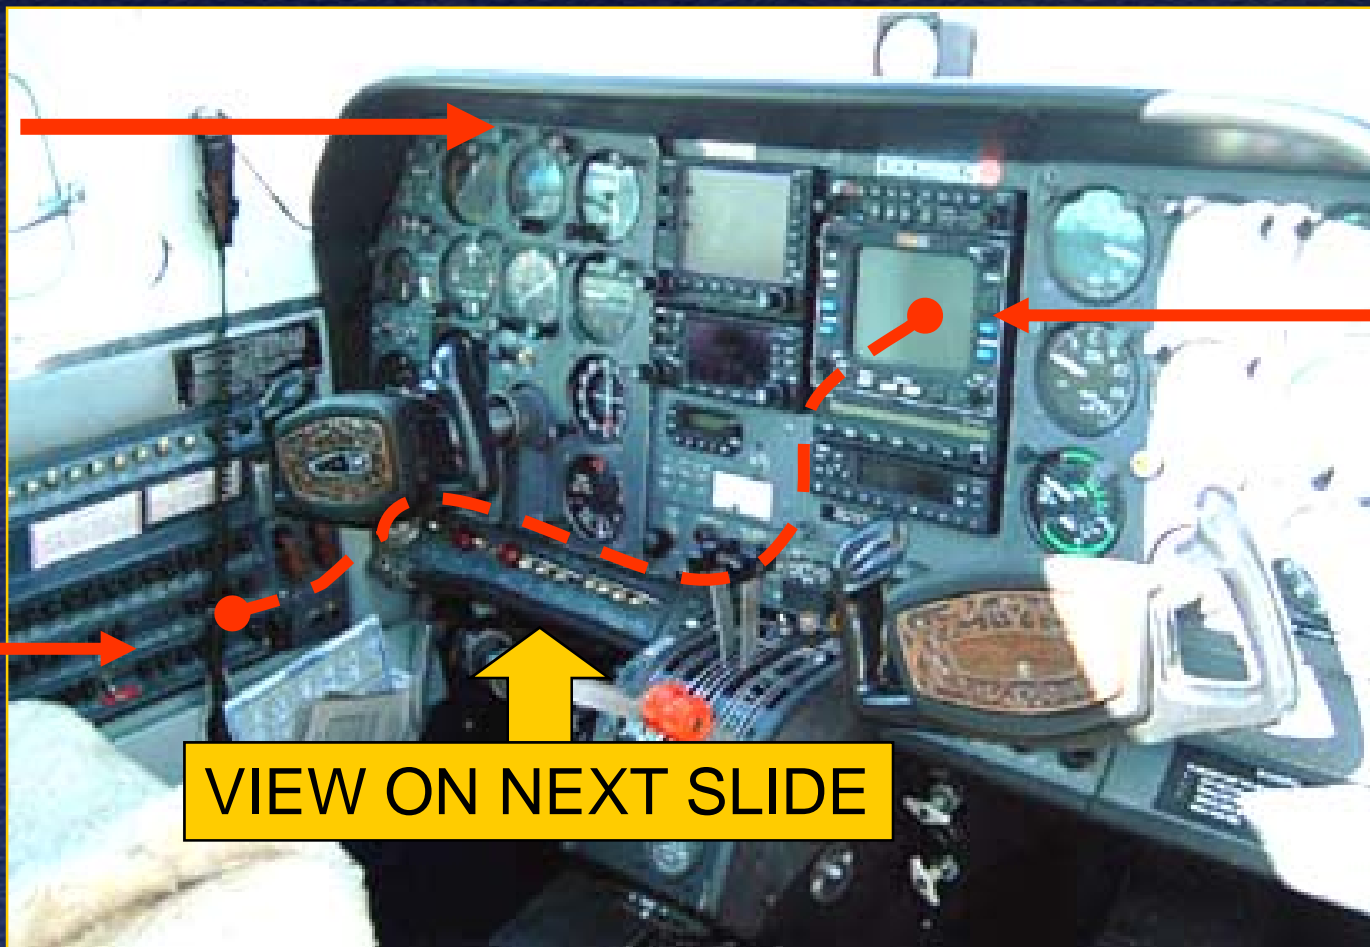
Wiring Routed Beneath Fire Damage

Heat damage (behind)

Radar display

Circuit breaker panel

The dashed line shows the wiring path behind the instrument panel of a similar airplane

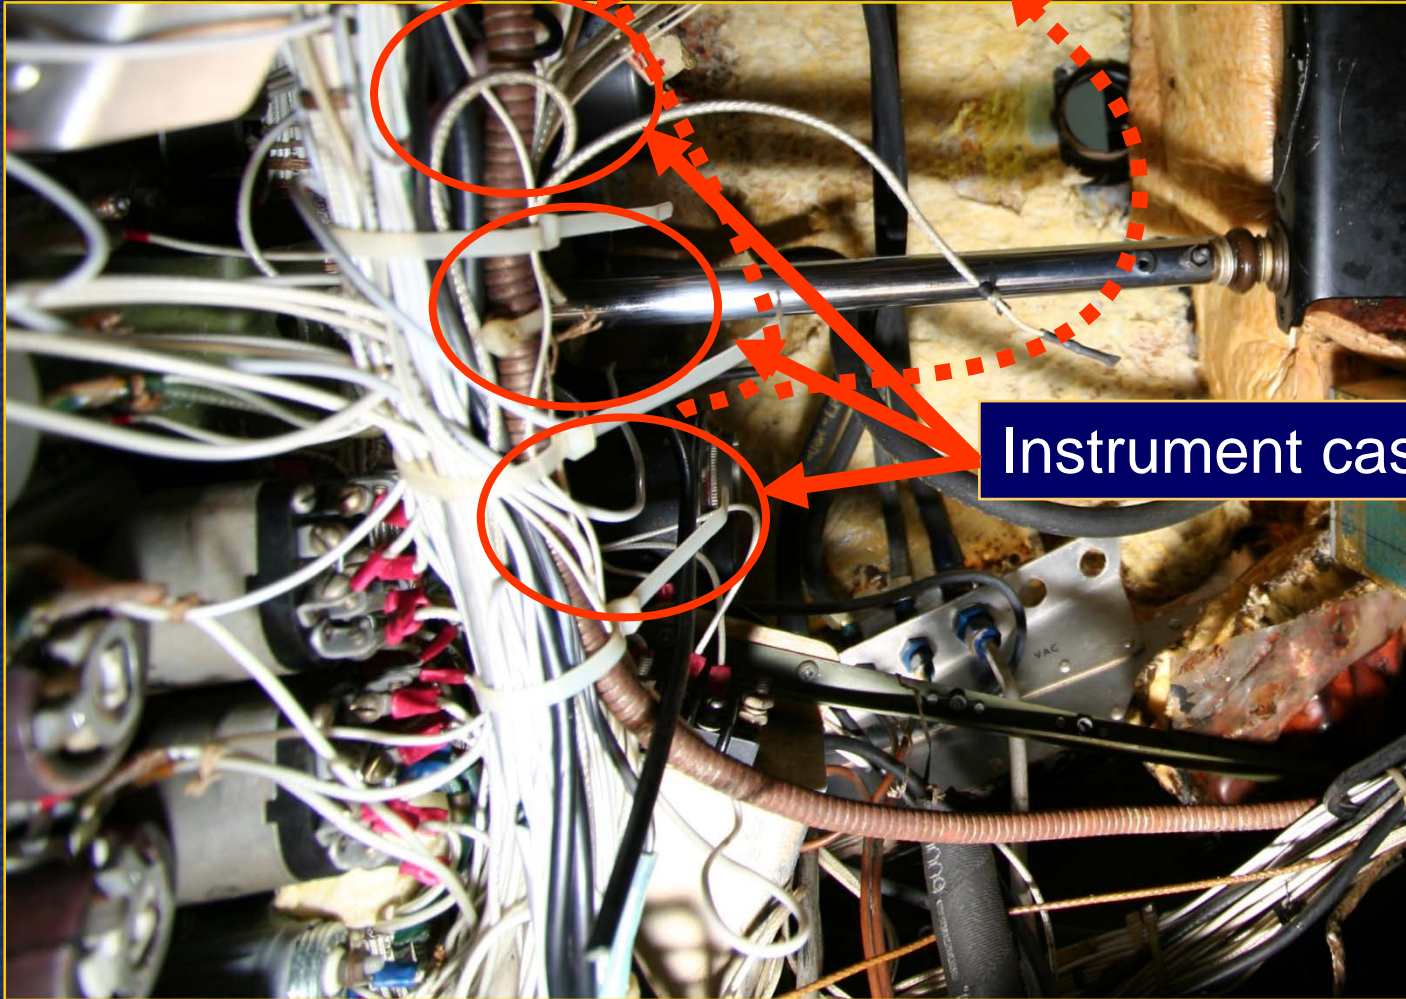
Wiring Behind Instrument Panel

(Exemplar airplane)

To radar display

Soot flow paths

Aft,
toward
pilot seat

Forward,
toward
nose

To circuit breaker panel

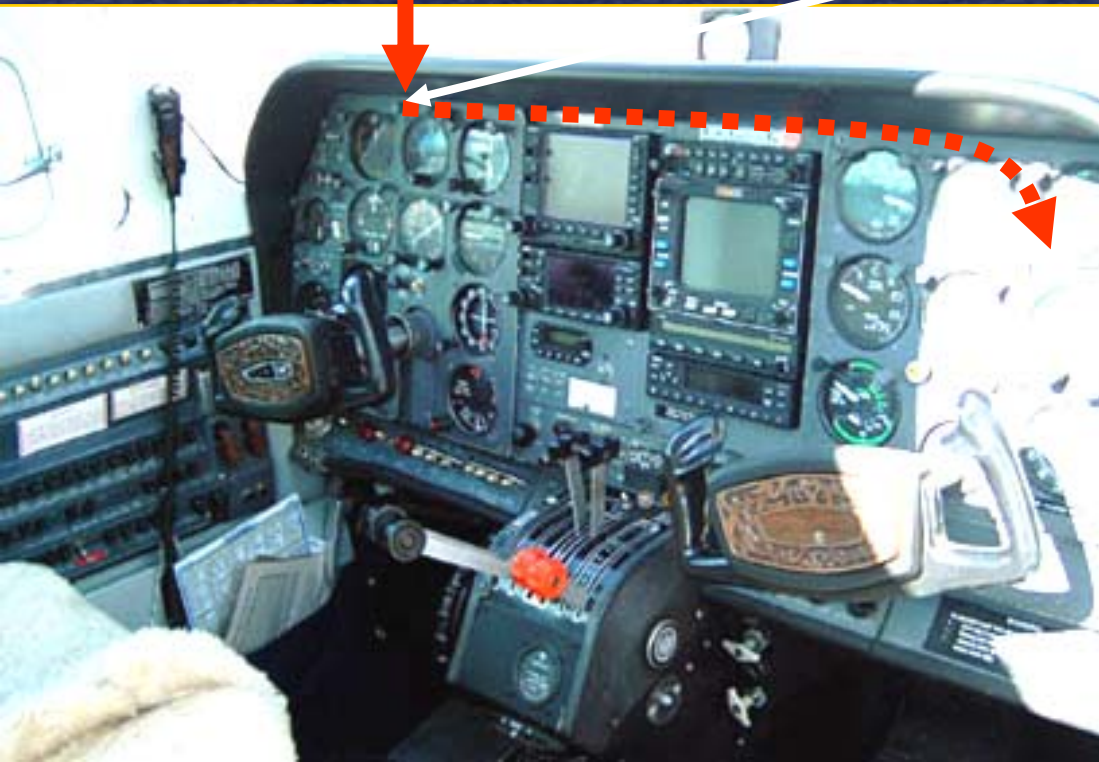
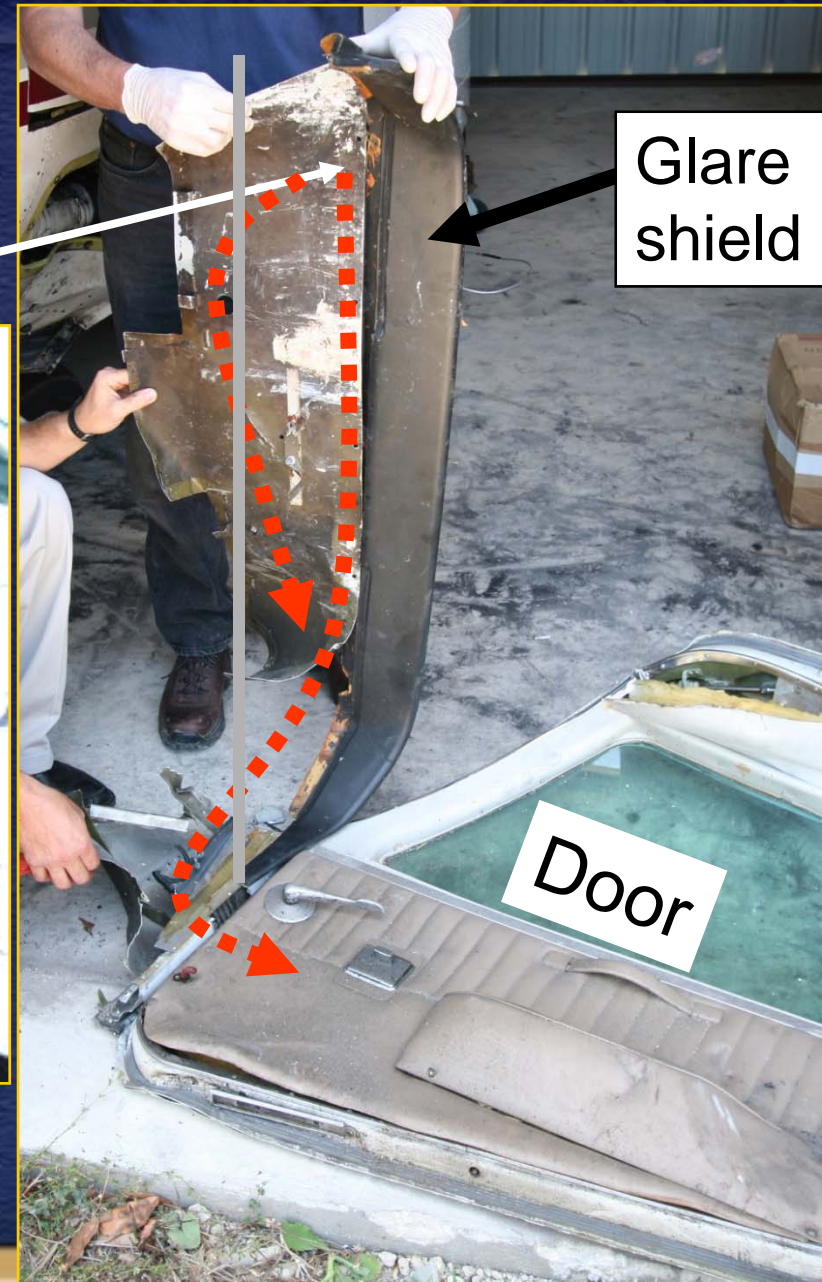
Soot Flow

Heat damage
on bottom surface
