## **DCA-08-MR-003**

Collision of Amtrak Train 371 and  
Norfolk Southern Railway Company  
Freight Train 23M

Chicago, Illinois

November 30, 2007

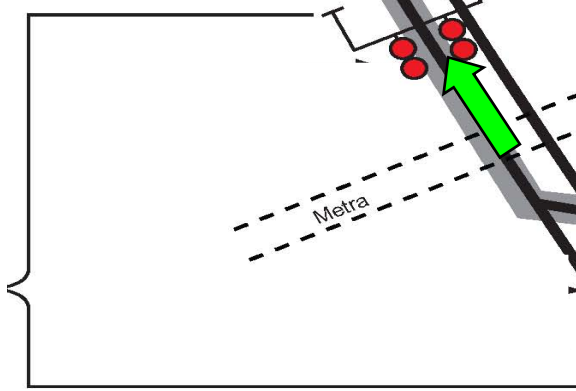
Accident MP 517.34

Red over Yellow

Stopped Freight Train
